RESEARCH MEMORANDUM

PRELIMINARY INVESTIGATION OF SEVERAL ROOT DESIGNS FOR
CERMET TURBINE BLADES IN TURBOJET ENGINE

III - CURVED-ROOT DESIGN

December 28, 1955

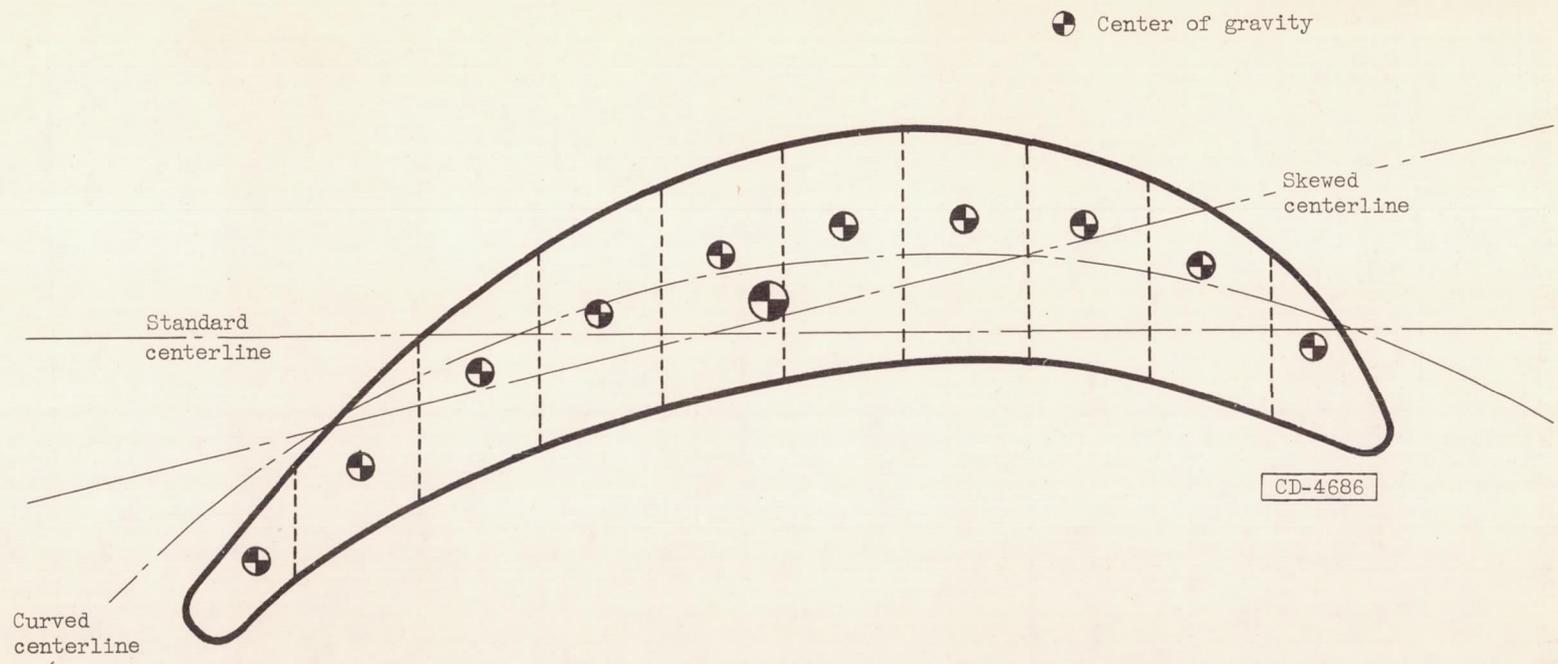
To determine the optimum root centerline for the curved root blade, the airfoil was divided into ten radial columns instead of in halves. The computed center of gravity of each column was plotted on the base cross section of the airfoil (fig. 1).

Figure 1. - Airfoil-base cross section showing various centerlines and centers of gravity of whole airfoil and of ten radial columns.

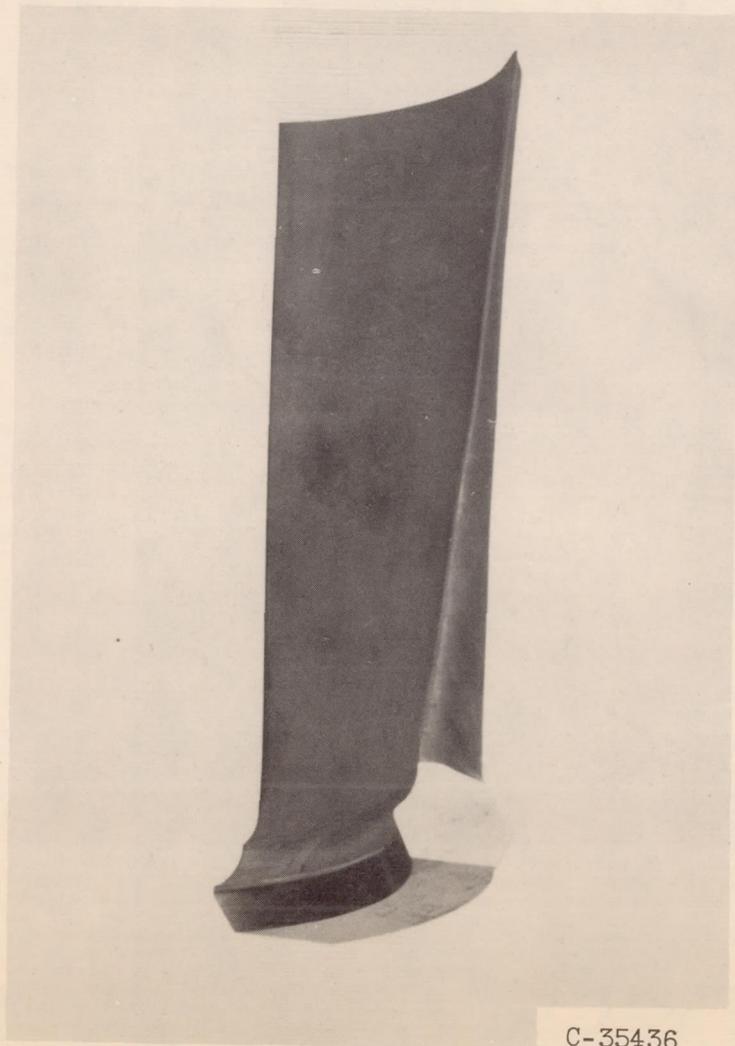
Cermet blades with a curved root (fig. 2) were fabricated by Kennametal Inc. The airfoil was the same shape and size as those of the standard metal blades, as were the cermet blades discussed in reference

Figure 2. - Curved-root cermet turbine blade.
