NACA RM E55L06

RESEARCH MEMORANDUM

EFFECTS OF A STRAIGHTENING OPERATION ON PERFORMANCE
OF INCONEL 550 BUCKETS

WASHINGTON
February 29, 1956

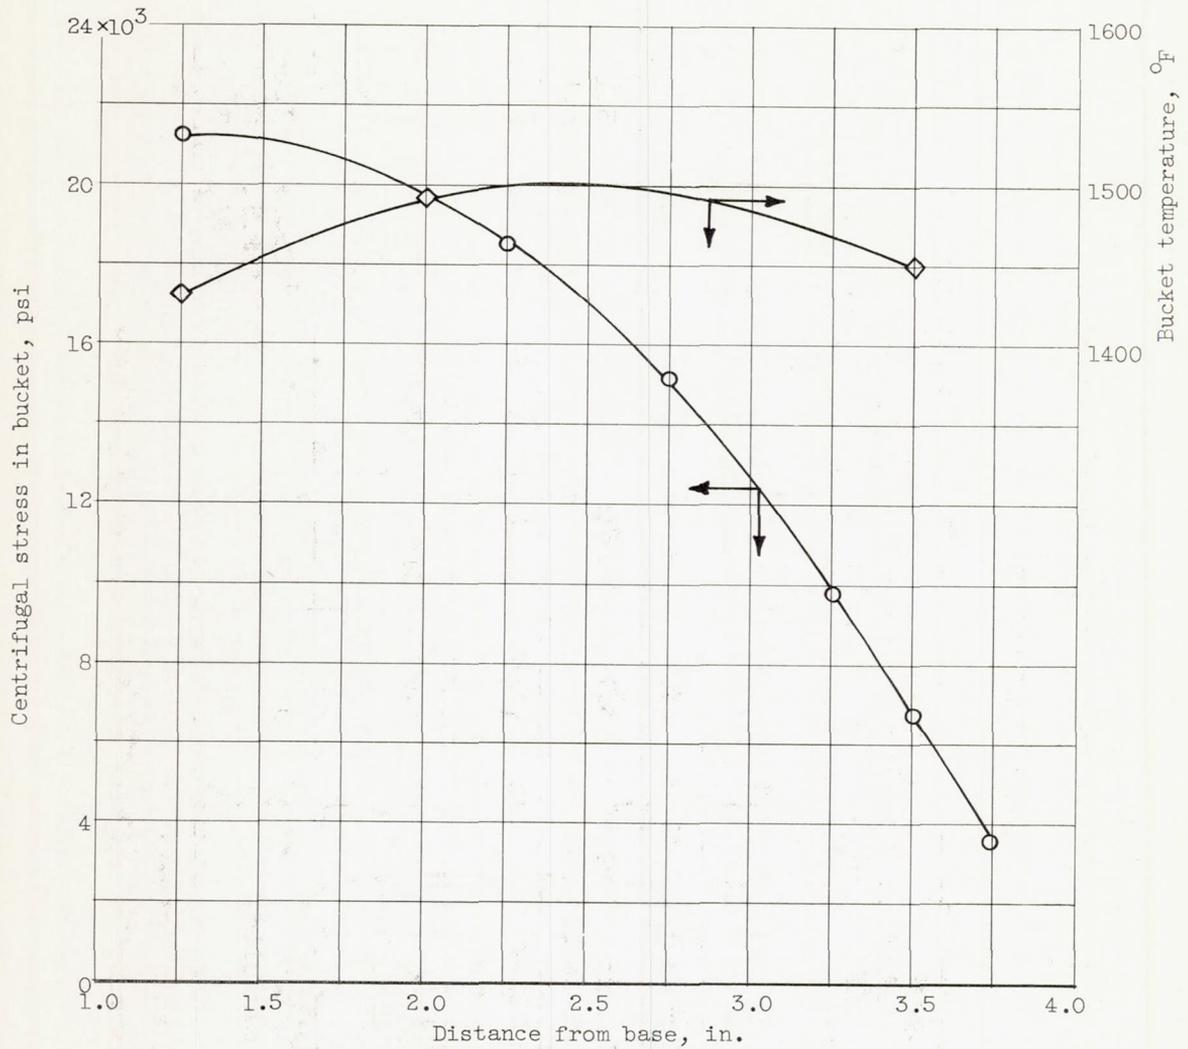
Figure 1. - Stress and temperature distribution in Inconel 550 J33-9 turbine bucket at rated speed.

Stress and temperature distribution in turbine buckets during engine operation. - Since the buckets used for this study were from the same lots as those of reference 1, the centrifugal stresses and temperature distribution for these buckets would be the same as those of reference 1 (see fig. 1).

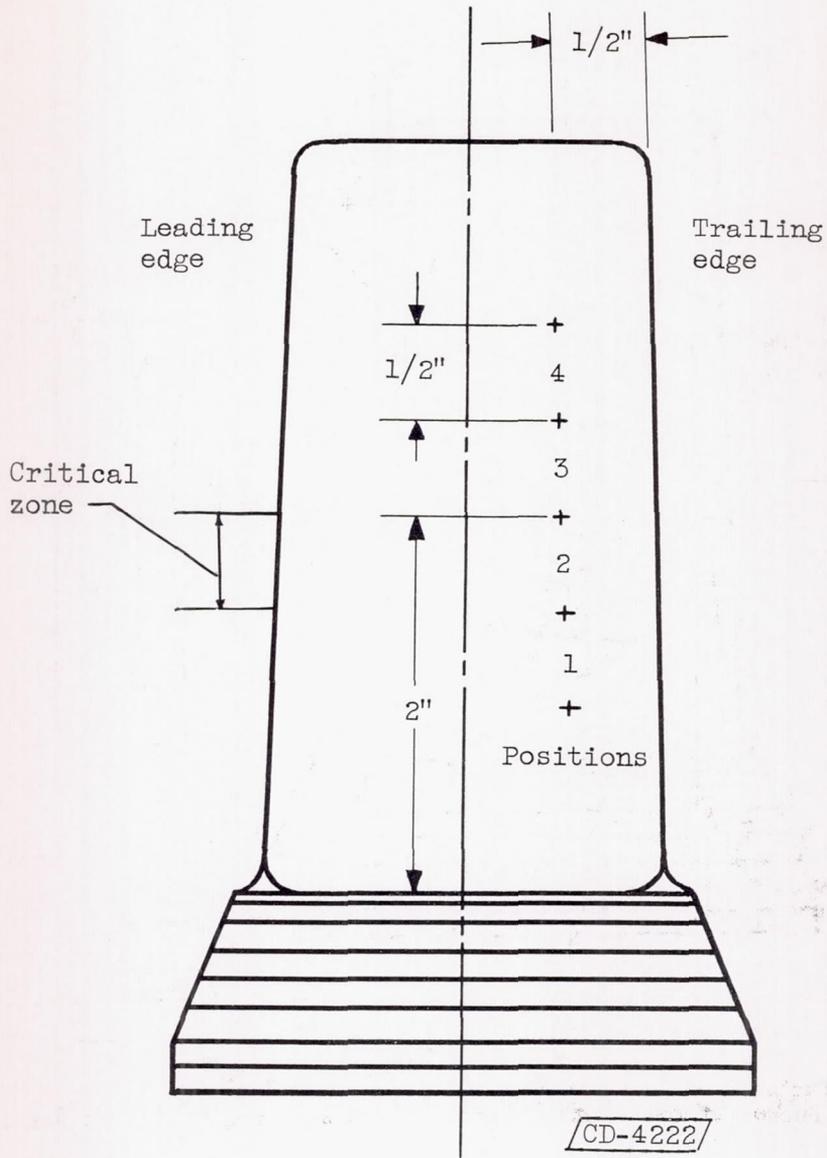
Figure 2. - Location of scribe marks on convex side of turbine bucket for use in measuring elongation.

Bucket-elongation measurements. - Two buckets of each group were scribed at 1/2-inch intervals, as shown in figure 2. Elongation measurements were made at approximately 8-hour intervals for the first 25 hours of test time and at approximately 20-hour intervals for the remainder of the test life. The elongation of each scribed segment was measured with an optical extensometer having a sensitivity of 0.001 inch. Accuracy of the elongation measurement is, however, influenced by the degree of bucket distortion and warpage.

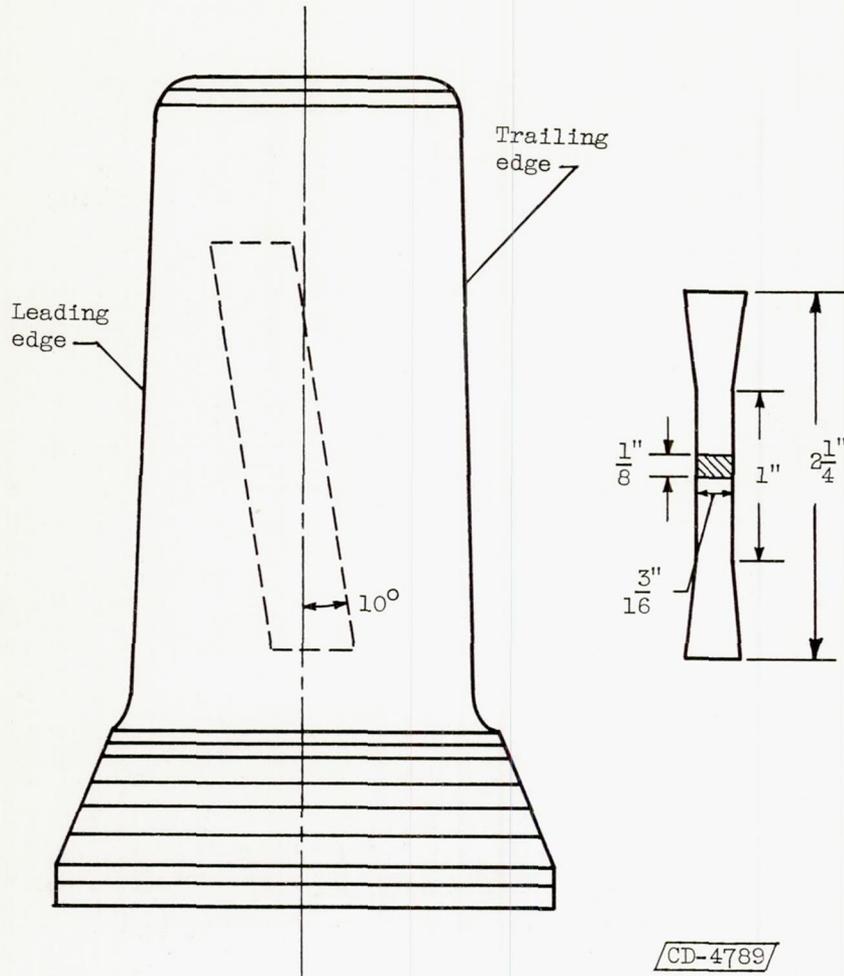
Figure 3. - Bucket stress-rupture specimen and zone from which it was machined.

Stress-rupture tests were conducted to determine the stress-rupture life at 1500° F of the different groups of buckets. Stress-rupture specimens were machined from the airfoil as shown in figure 3. Two to five specimens of each group were tested at stress levels of 20,000, 25,000, and 30,000 psi.

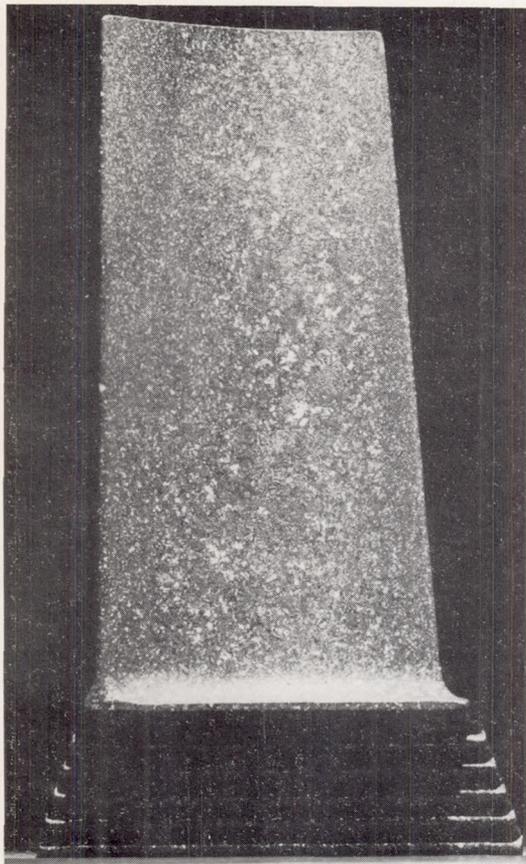
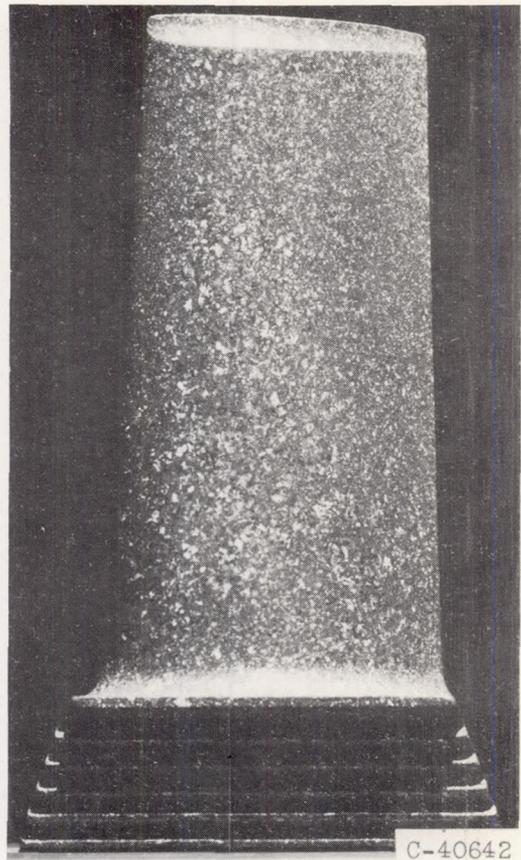
(c) Group 3.

Macro- and microexaminations. - Photographs of macroetched buckets are shown in figure 5. Grain sizes within each group were relatively uniform, and the grain sizes of the different groups were somewhat similar. The largest grain size was noted in buckets of groups 1 and 2. Both fine and coarse grains were found in most of the groups of buckets, but no germinated ("elephant") grains were observed.

Figure 5. - Continued. Macrograin size of Inconel 550 buckets.
Etchant, 80 parts concentrated HCl, 20 parts H₂O₂, immersion.

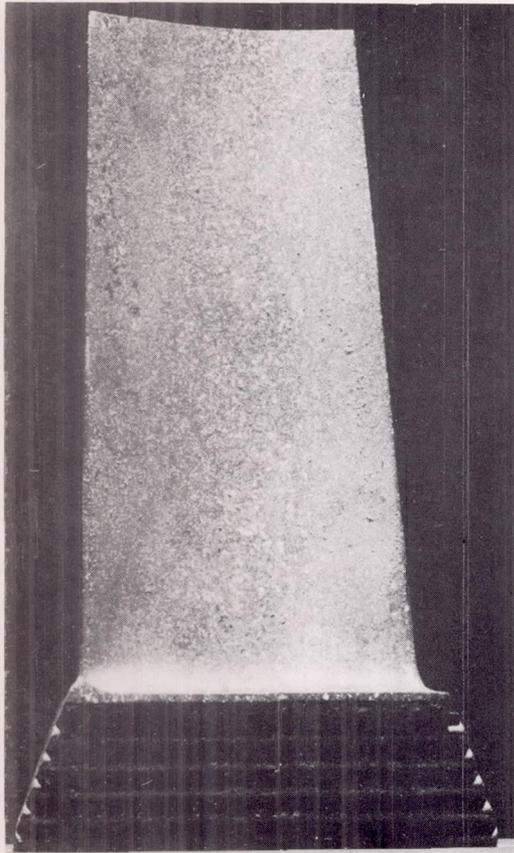
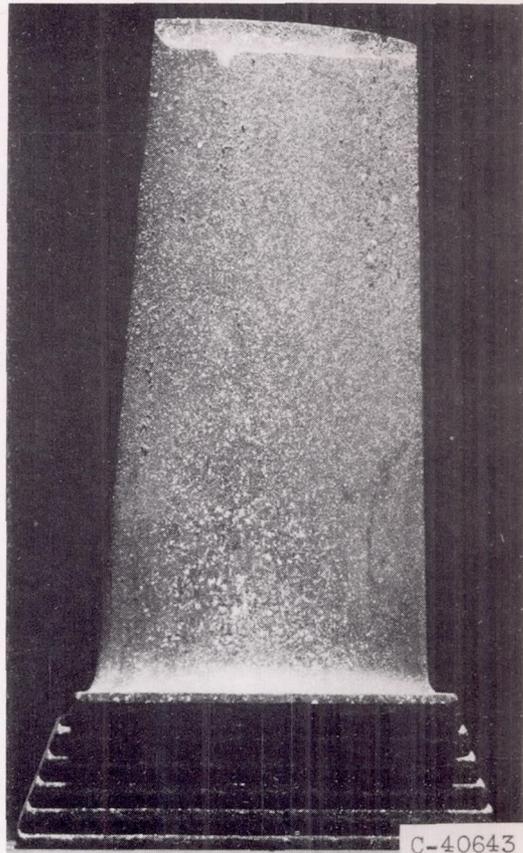
(d) Group 4.

Figure 5. - Concluded. Macrograin size of Inconel 550 buckets.
Etchant, 80 parts concentrated HCl, 20 parts H₂O₂, immersion.
