RESEARCH MEMORANDUM

AN EXPERIMENTAL EVALUATION OF SEVERAL DESIGN
VARIATIONS OF HOLLOW TURBINE BLADES FOR
EXPENDABLE ENGINE APPLICATION

By W. C. Morgan and R. H. Kemp

February 23, 1955

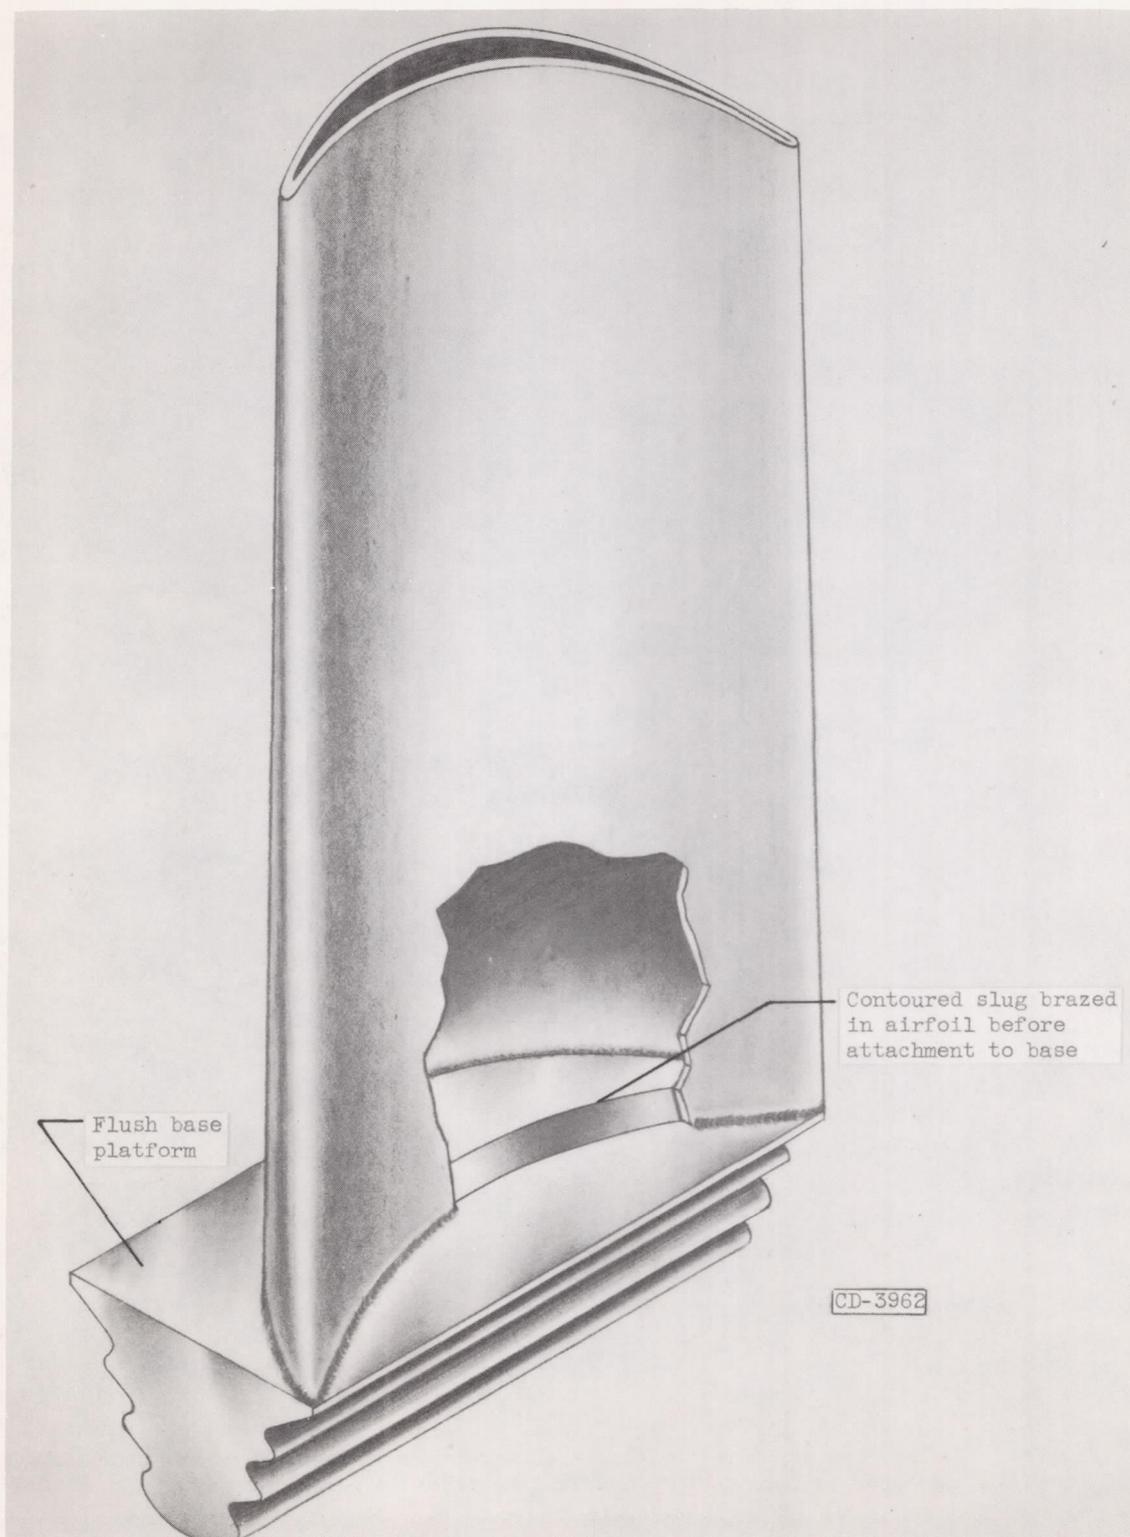
Group 7. - (L-605, 0.030-in. wall, welded airfoil brazed to flush platform as shown in fig. 4, fig. 3, base C.) The three specimen blades were intact at the end of 30 hours of operation. The results indicated that it would be practical to use a brazed joint in tension for the base attachment.

Figure 4. - Construction of sheet-metal airfoil brazed to flush base platform.

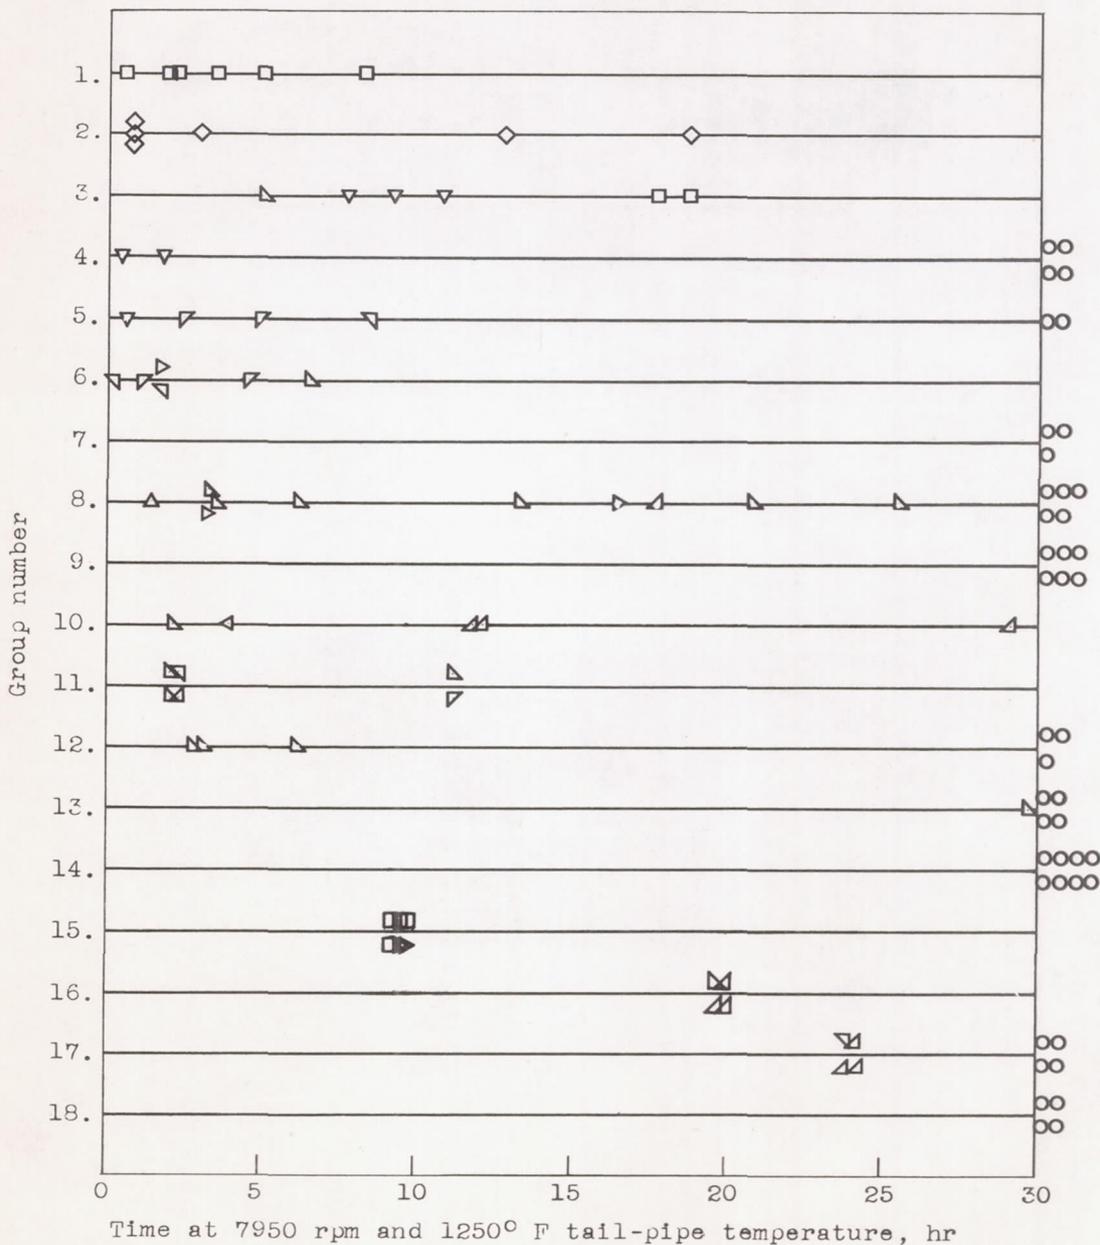
The results of the investigation are presented in figure 8. The order of listing is not chronological in all cases.

- Completed 30 hours
- Root serration failure
- ◇ Failure in welded attachment at base
- ◊ Failure in brazed attachment at base
- ▽ Failure in airfoil near base
- ▽ Failure in airfoil near midsection
- ▽ Failure in airfoil near tip
- ◊ Cracks in leading or trailing edge
- ◊ Cracks in tip
- ▽ Failure caused by improper fabrication
- △ Failure from impact damage

Figure 8. - Results of engine operation of 18 hollow-blade design variations.
