NATIONAL ADVISORY COMMITTEE FOR AERONAUTICS

FLIGHT MEASUREMENTS OF HORIZONTAL TAIL LOADS ON A
TYPICAL PROPELLER-DRIVEN PURSUIT AIRPLANE DURING
STALLED PULL-OUTS AT HIGH SPEED

MEMORANDUM REPORT

Materiel Command, U.S. Army Air Forces

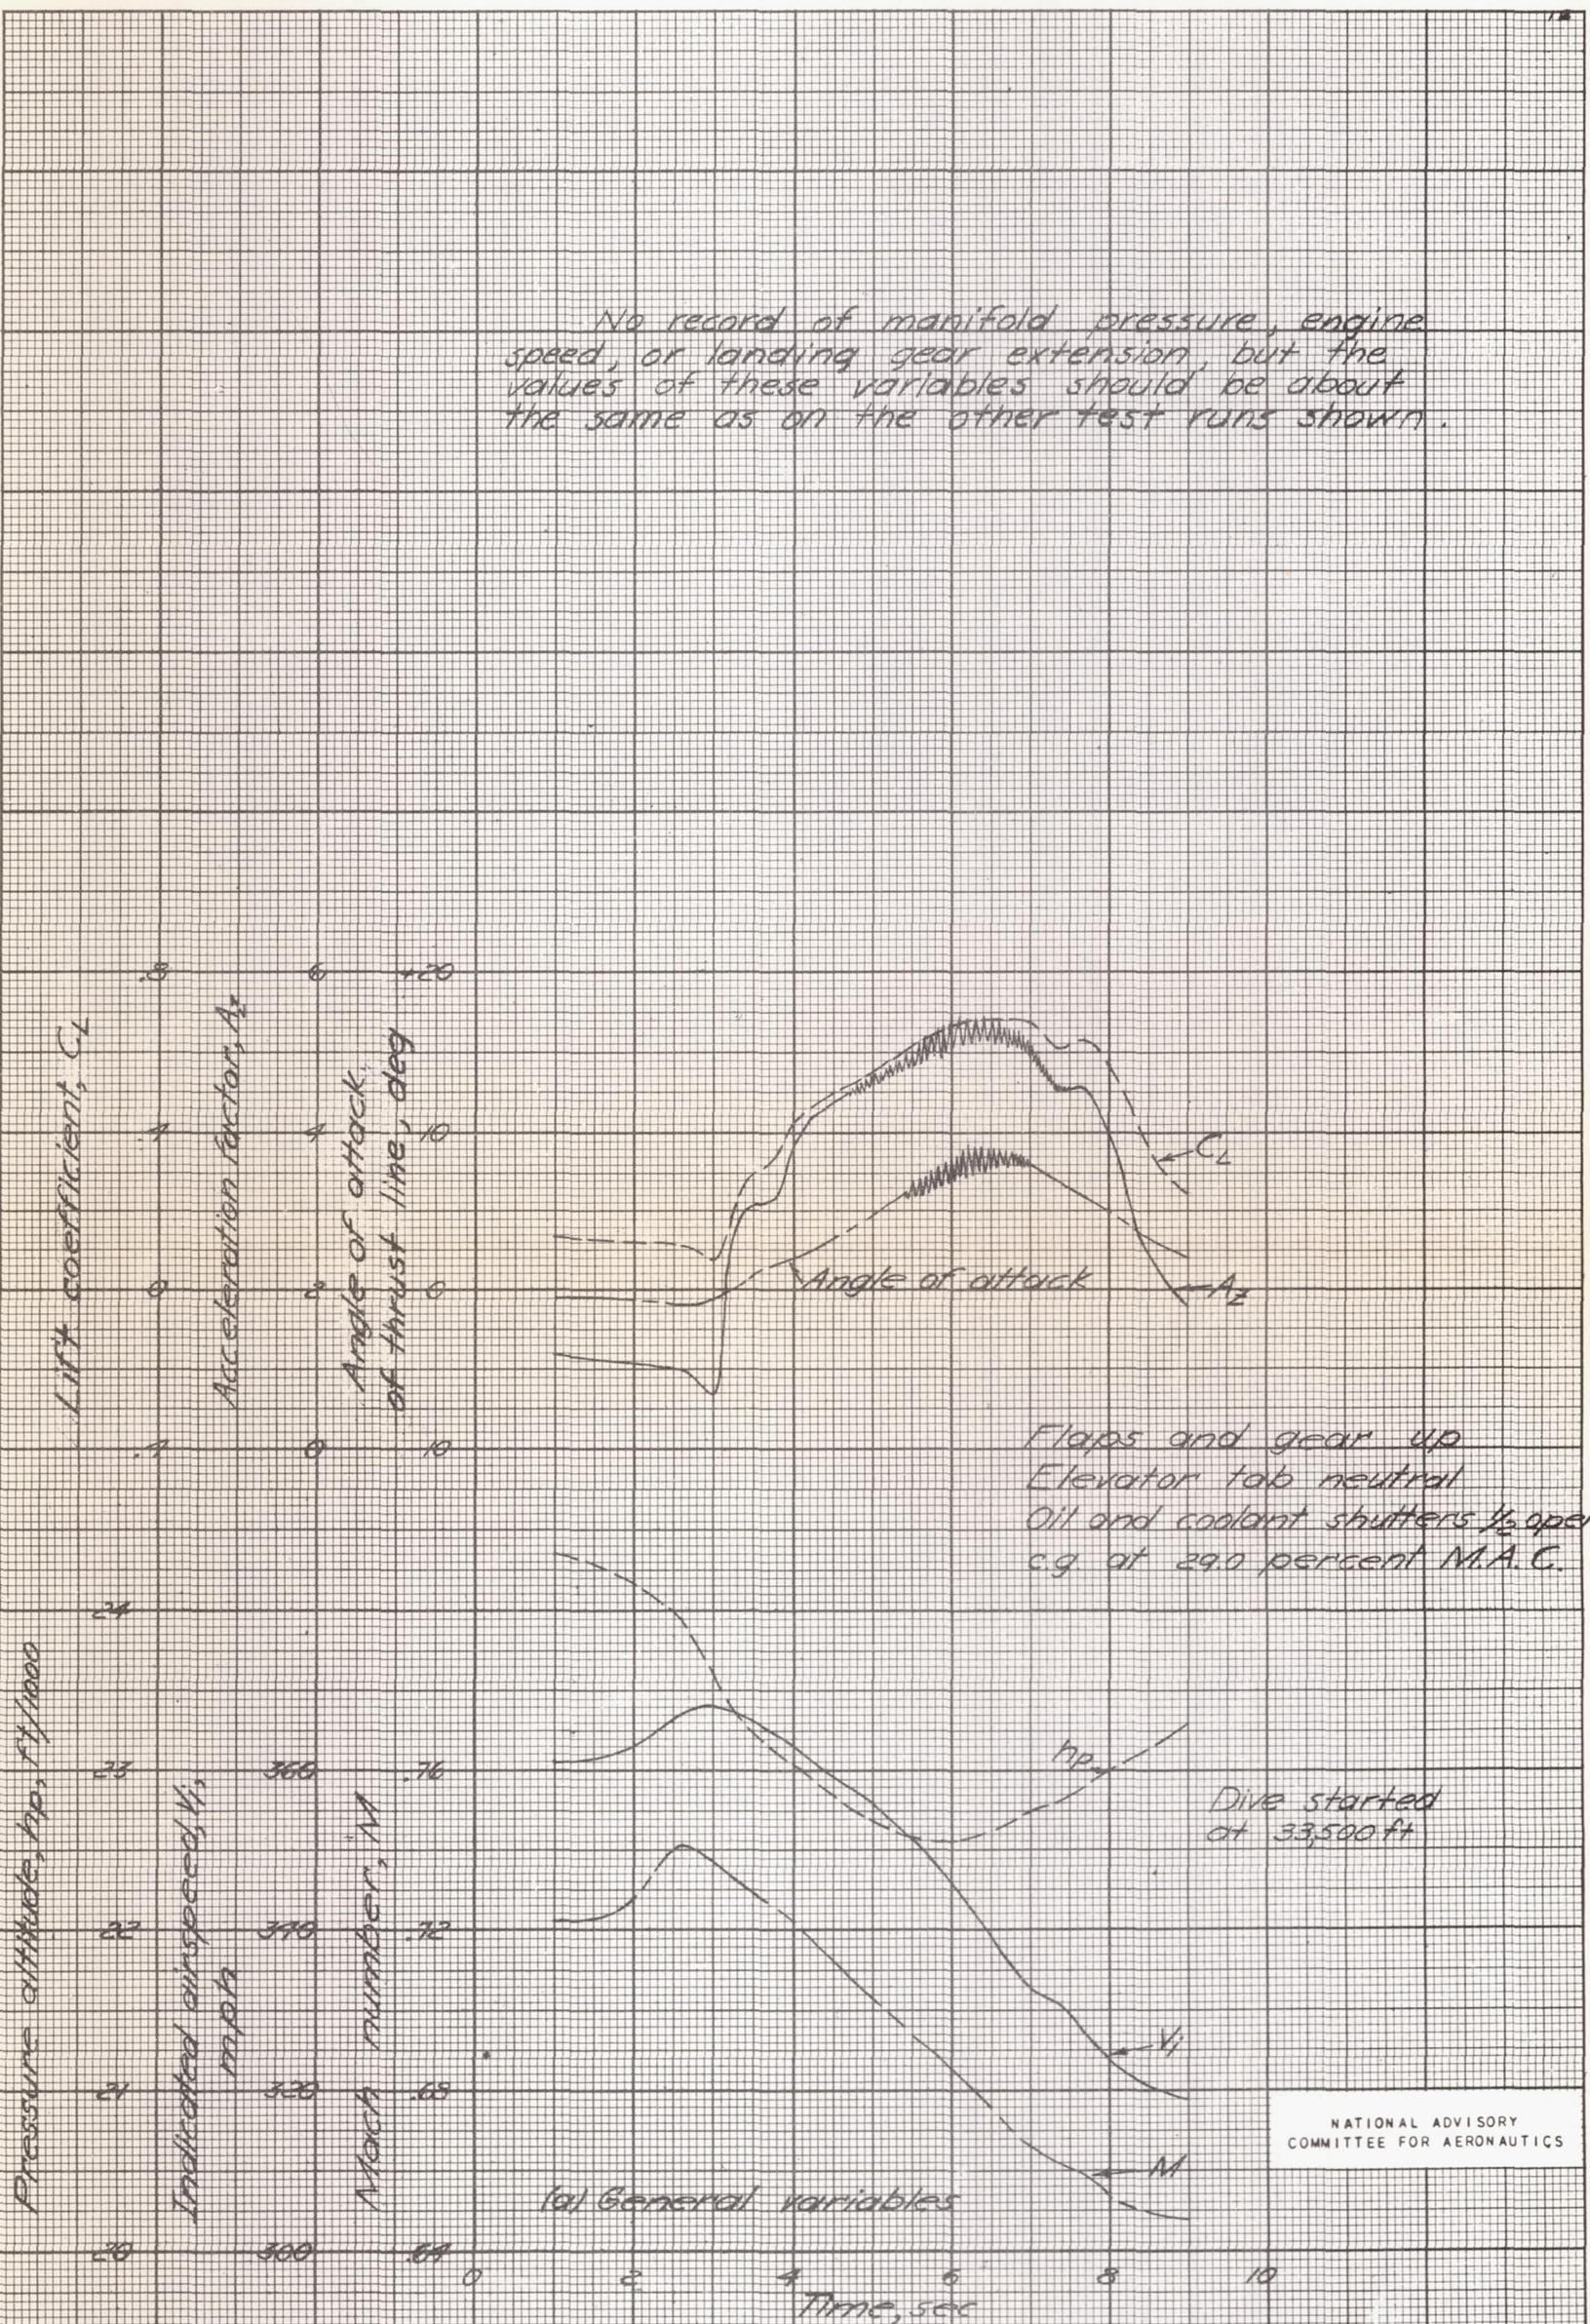
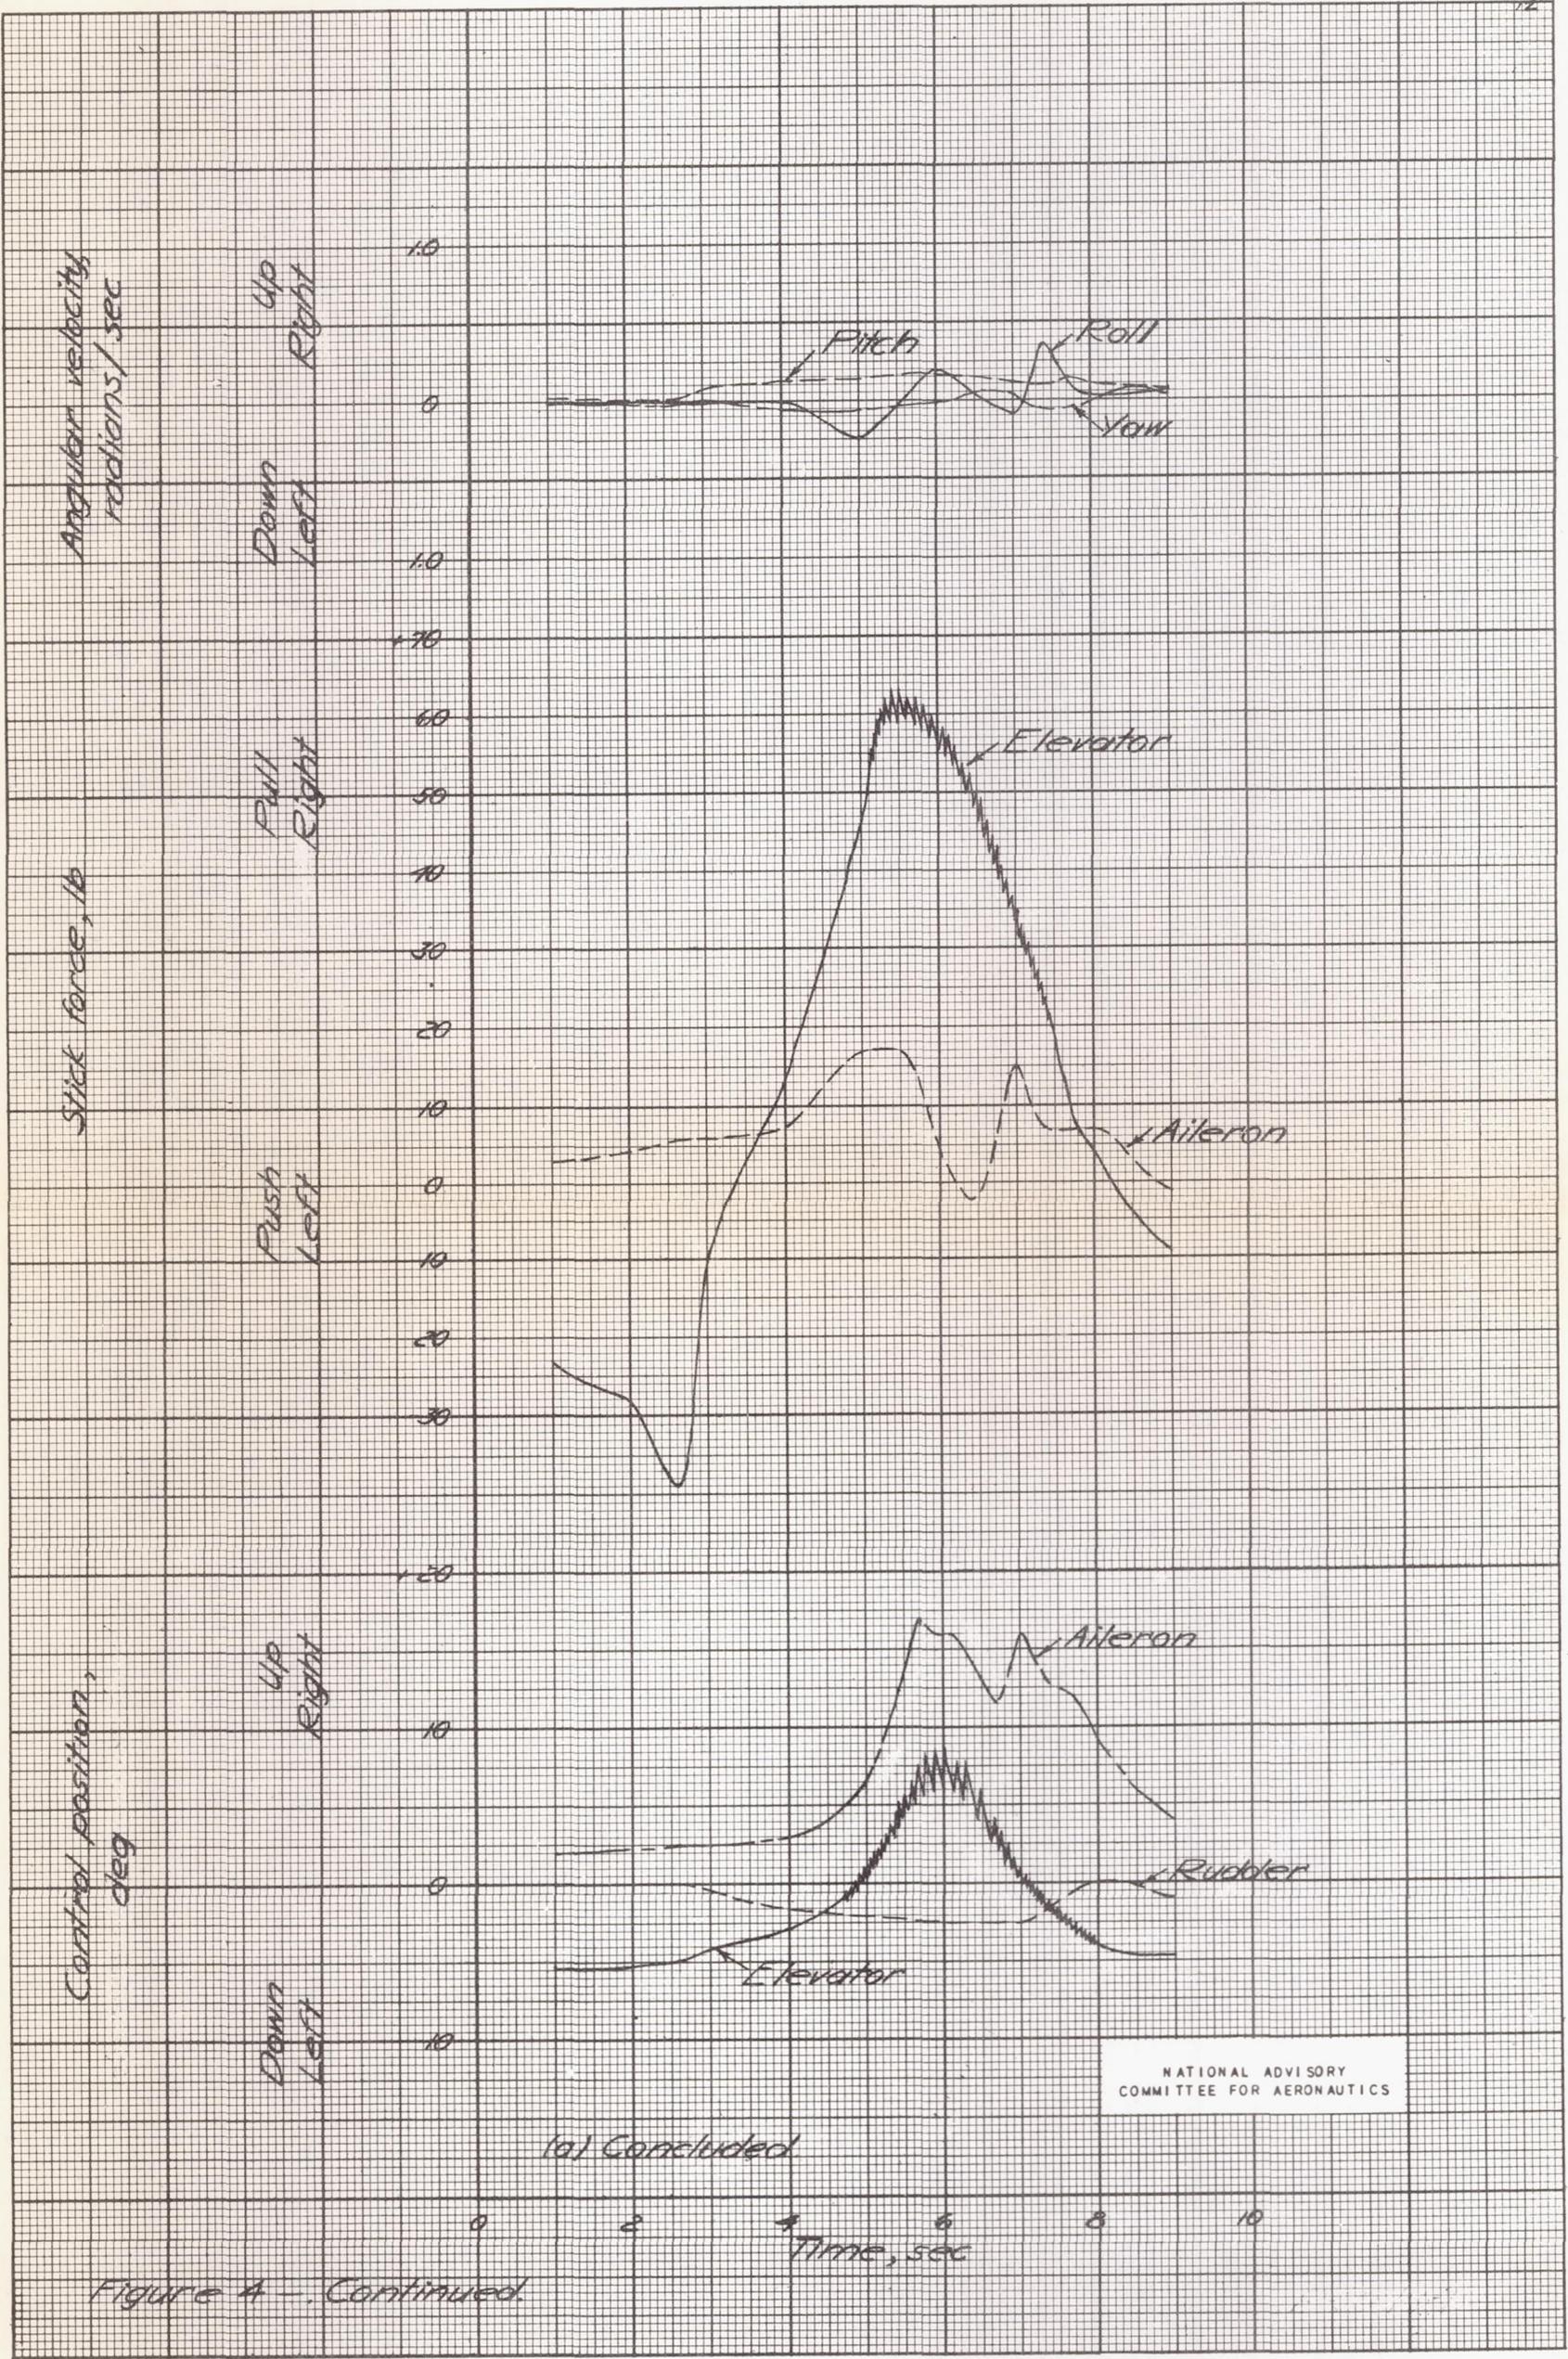
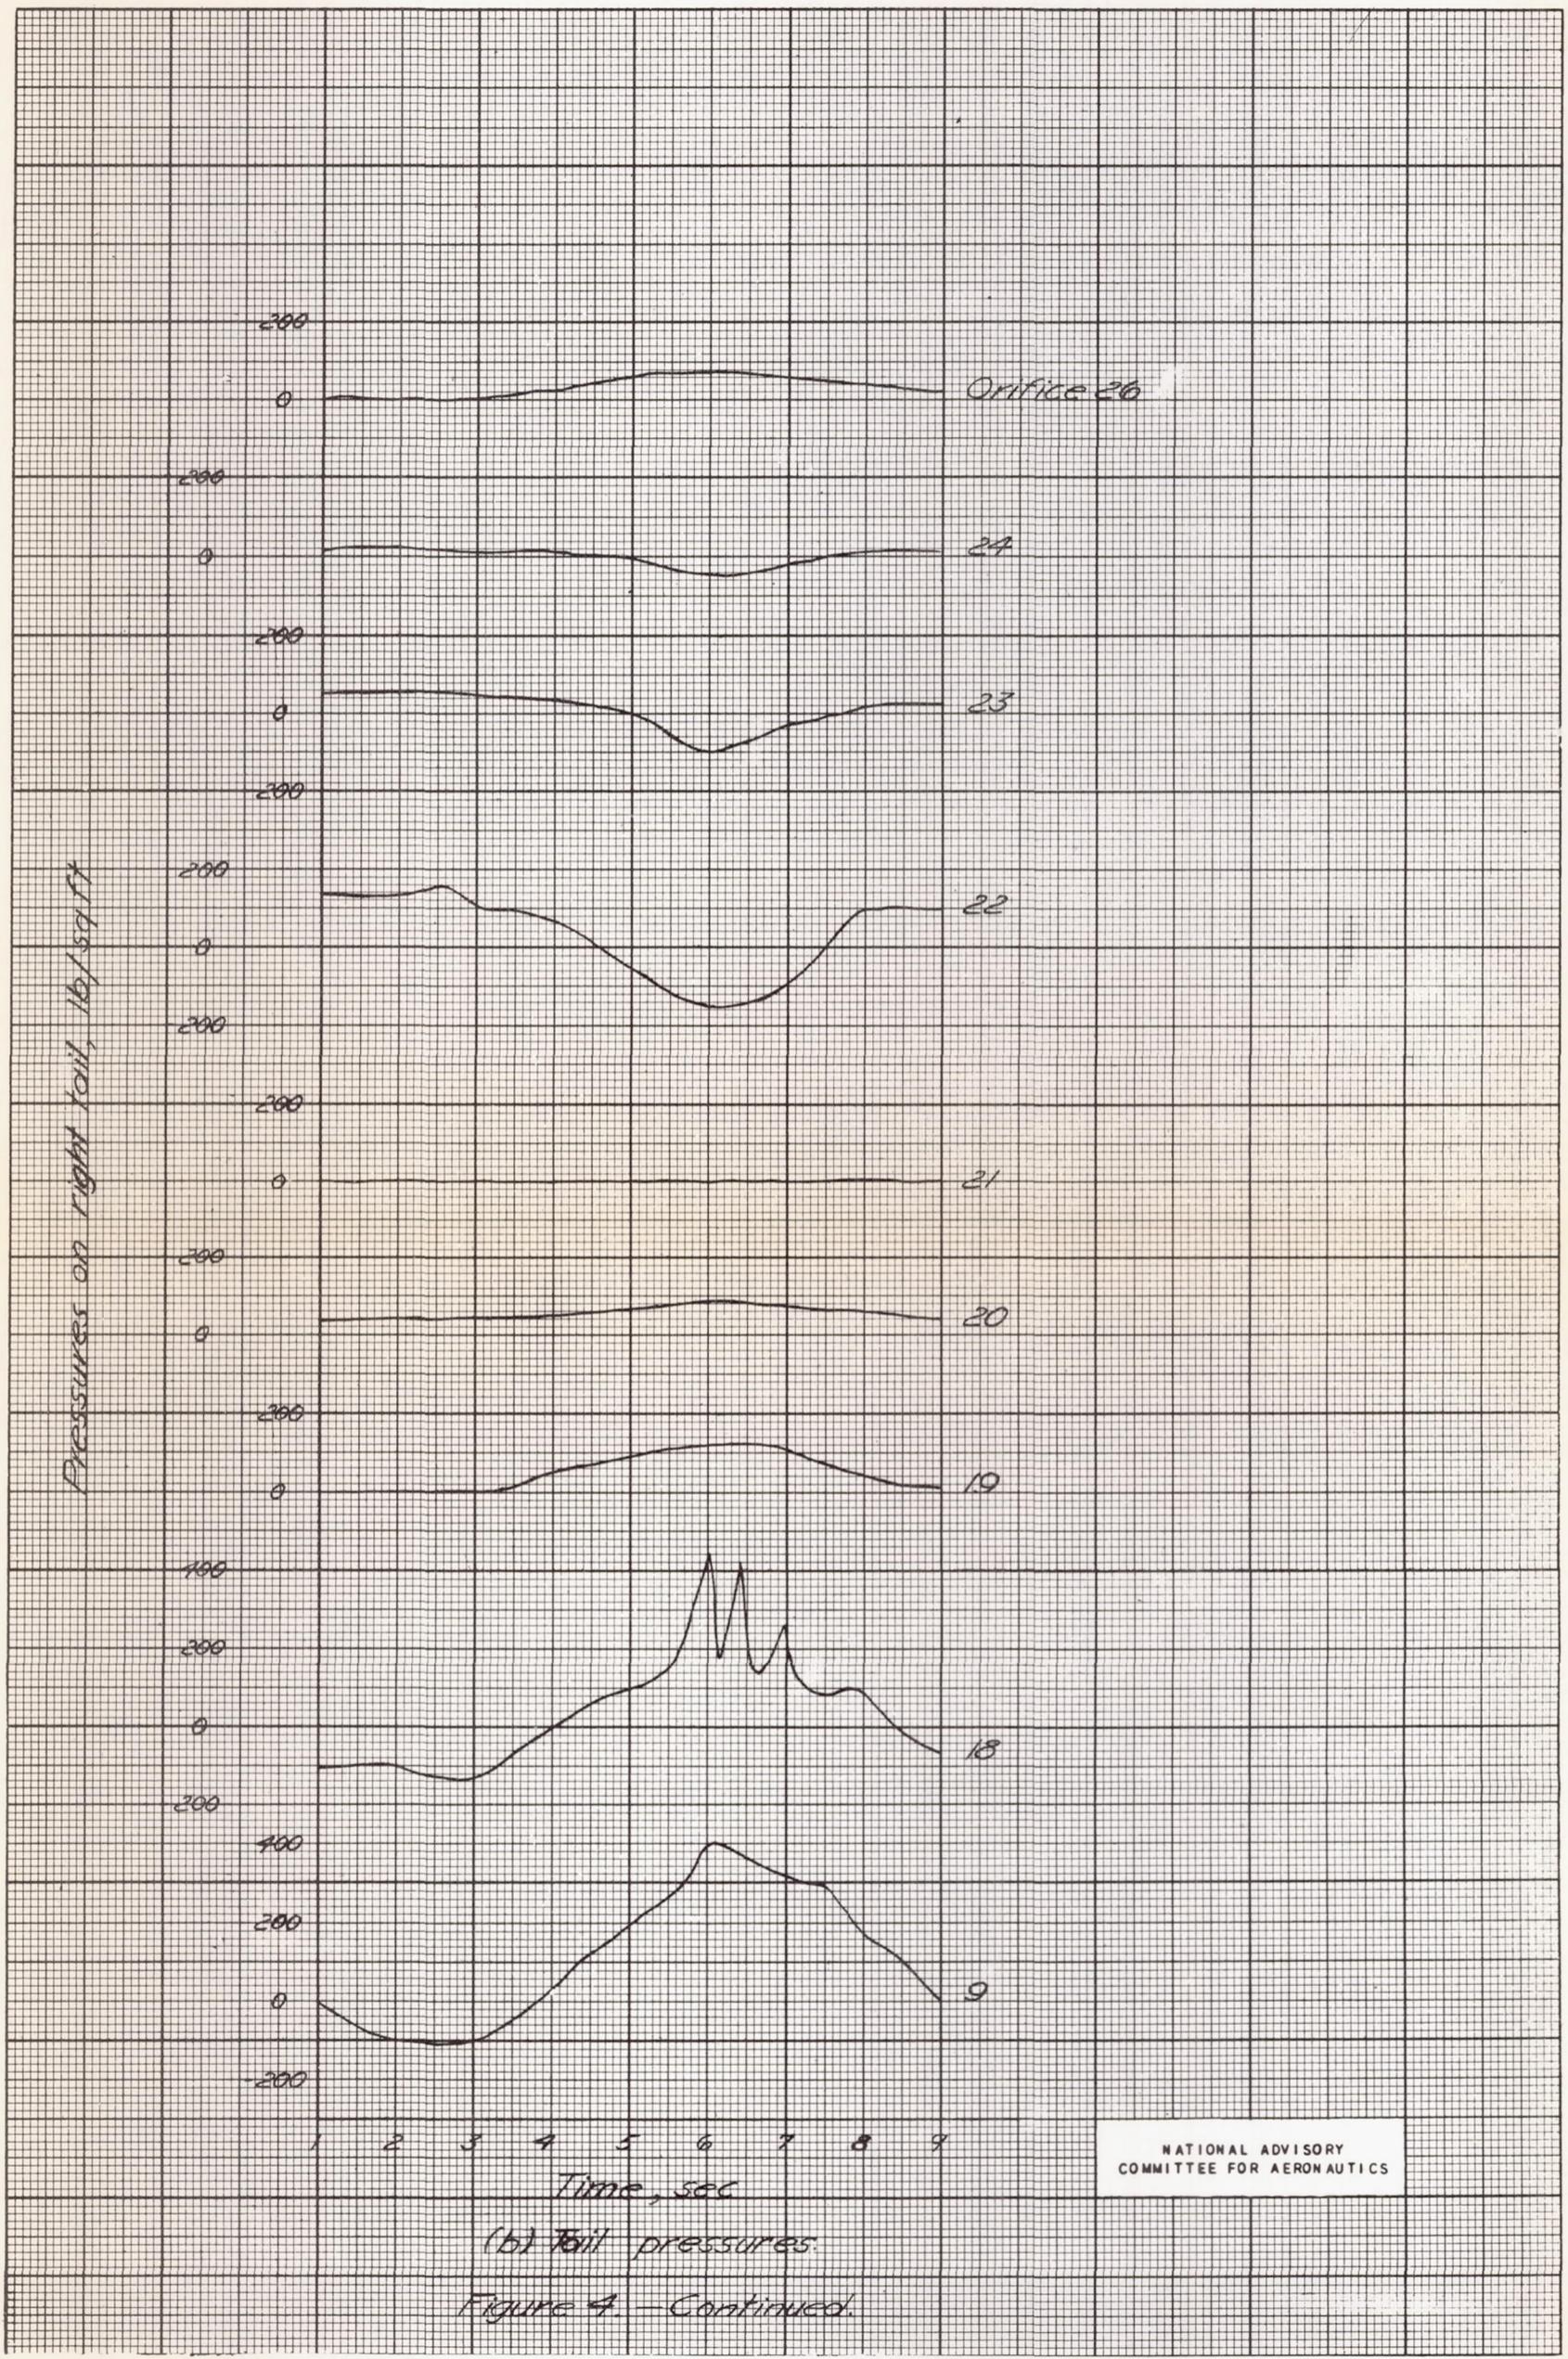
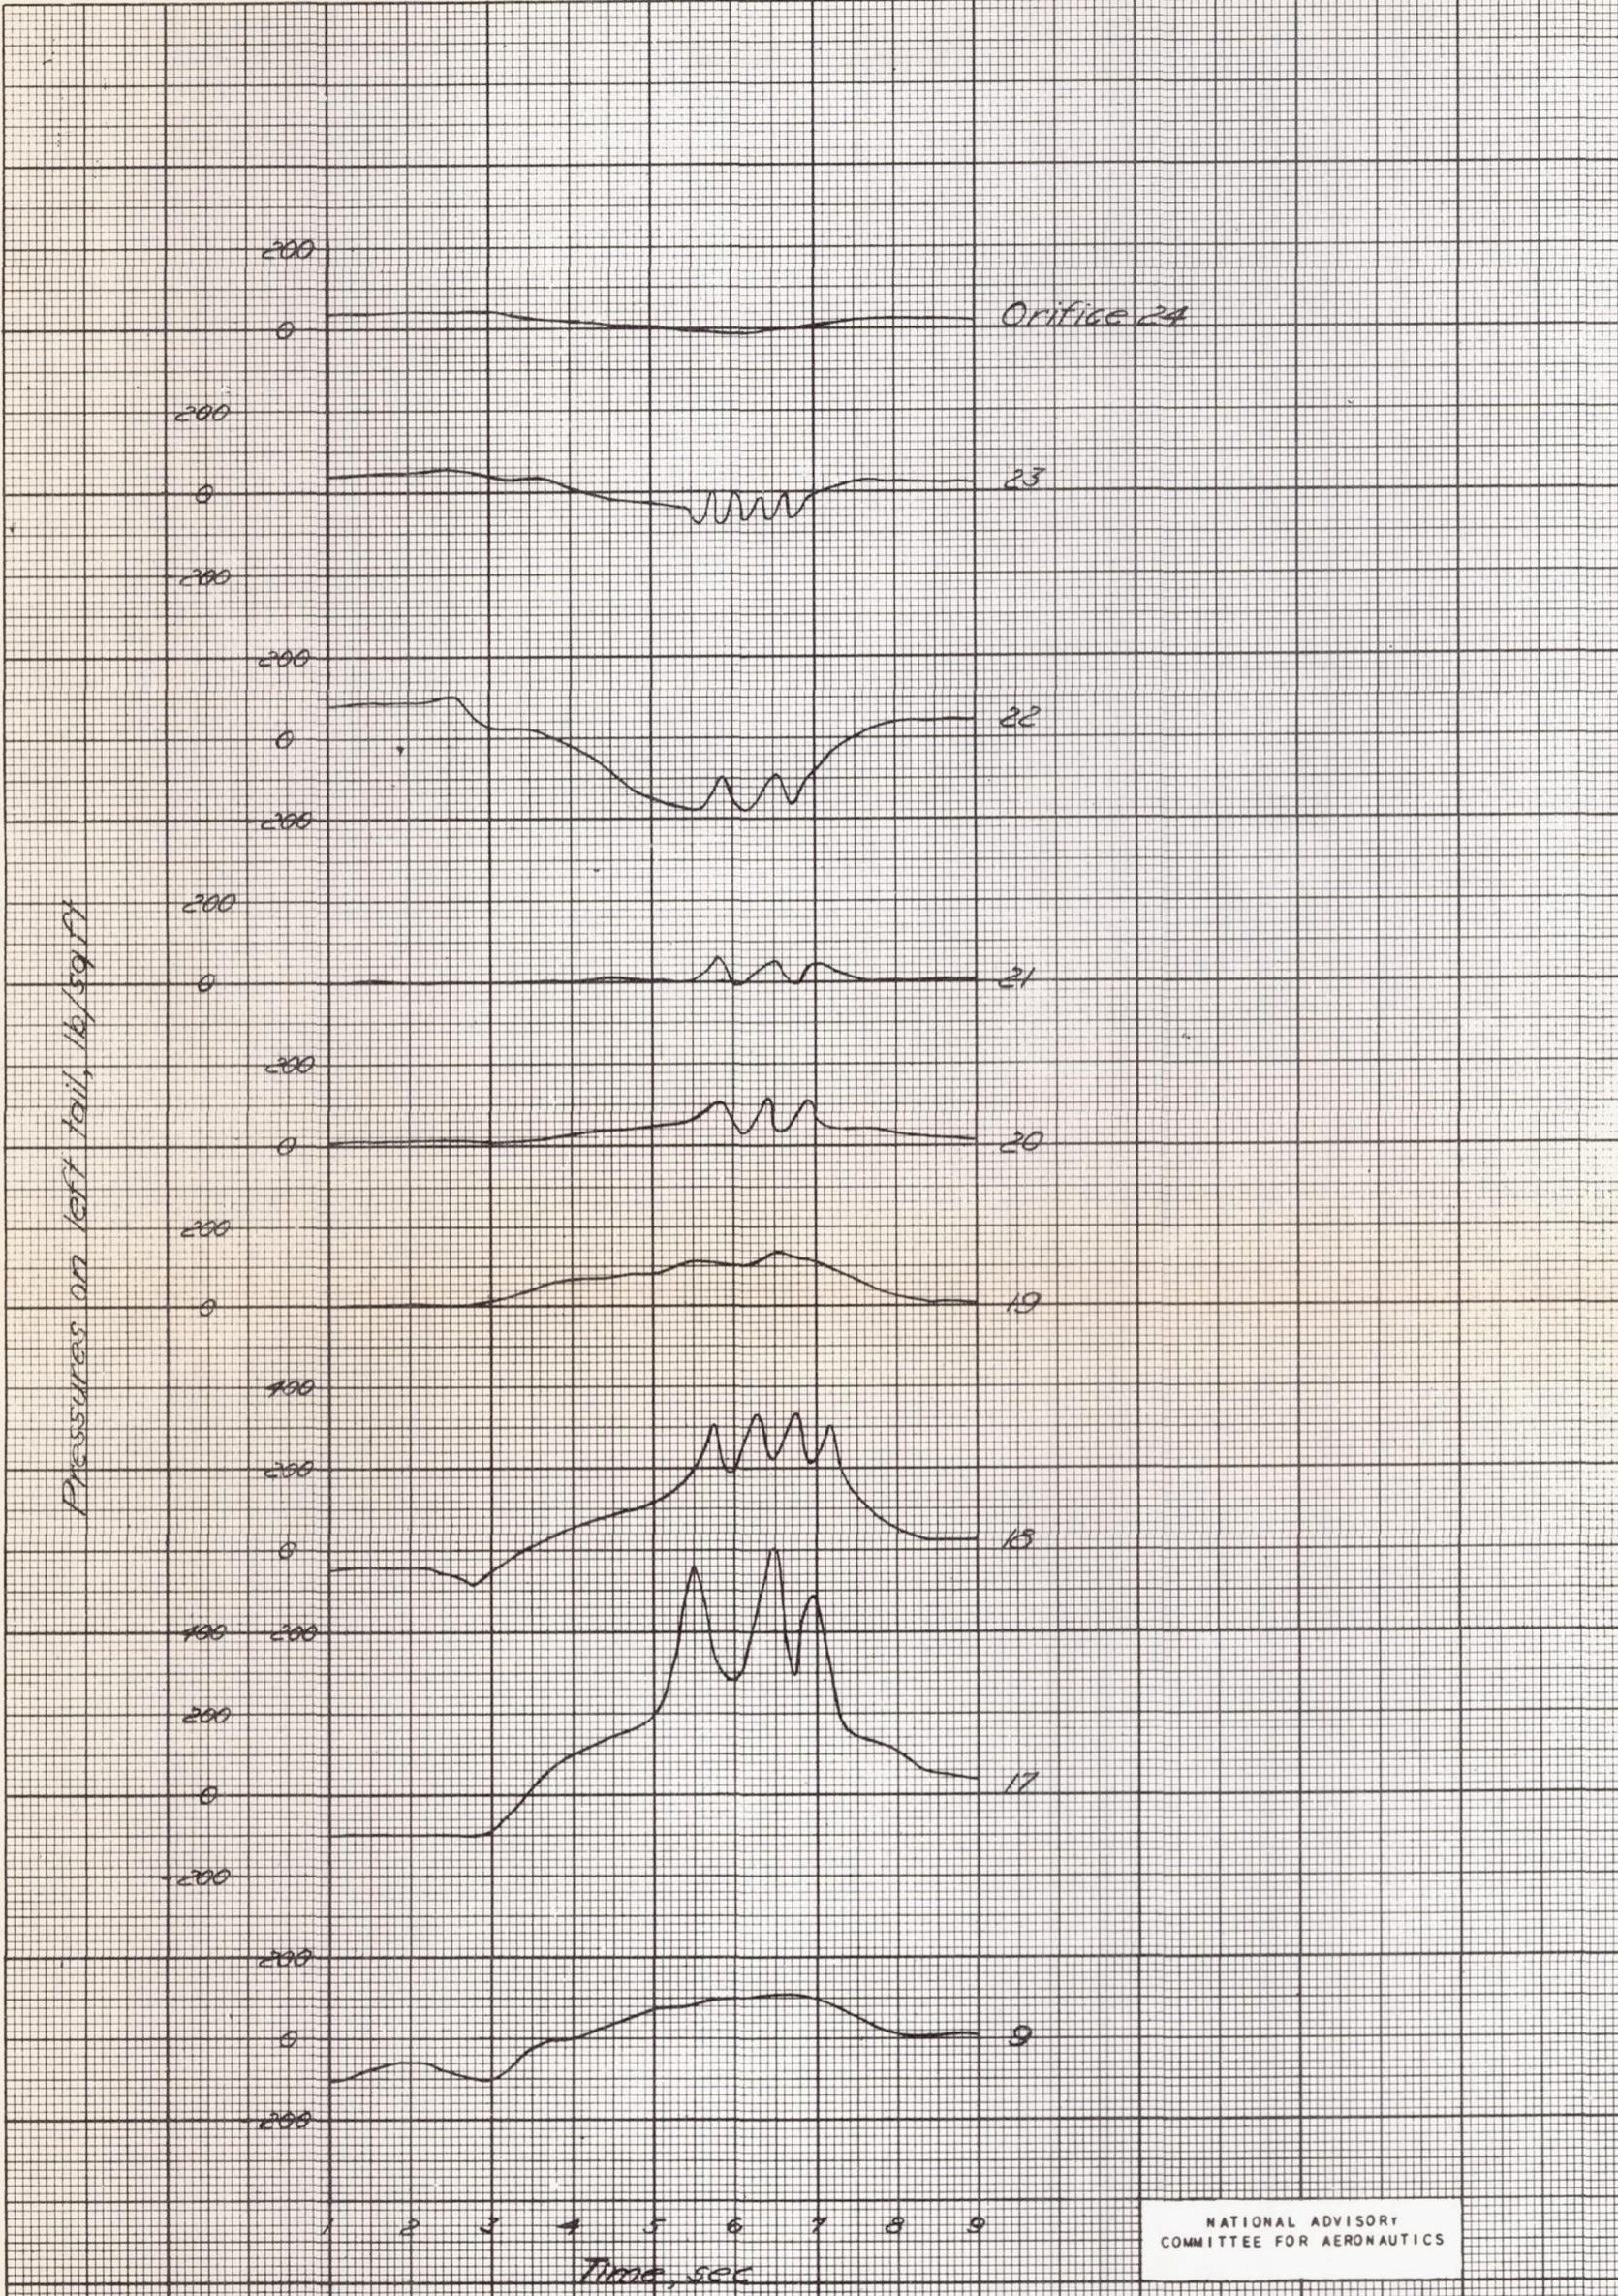
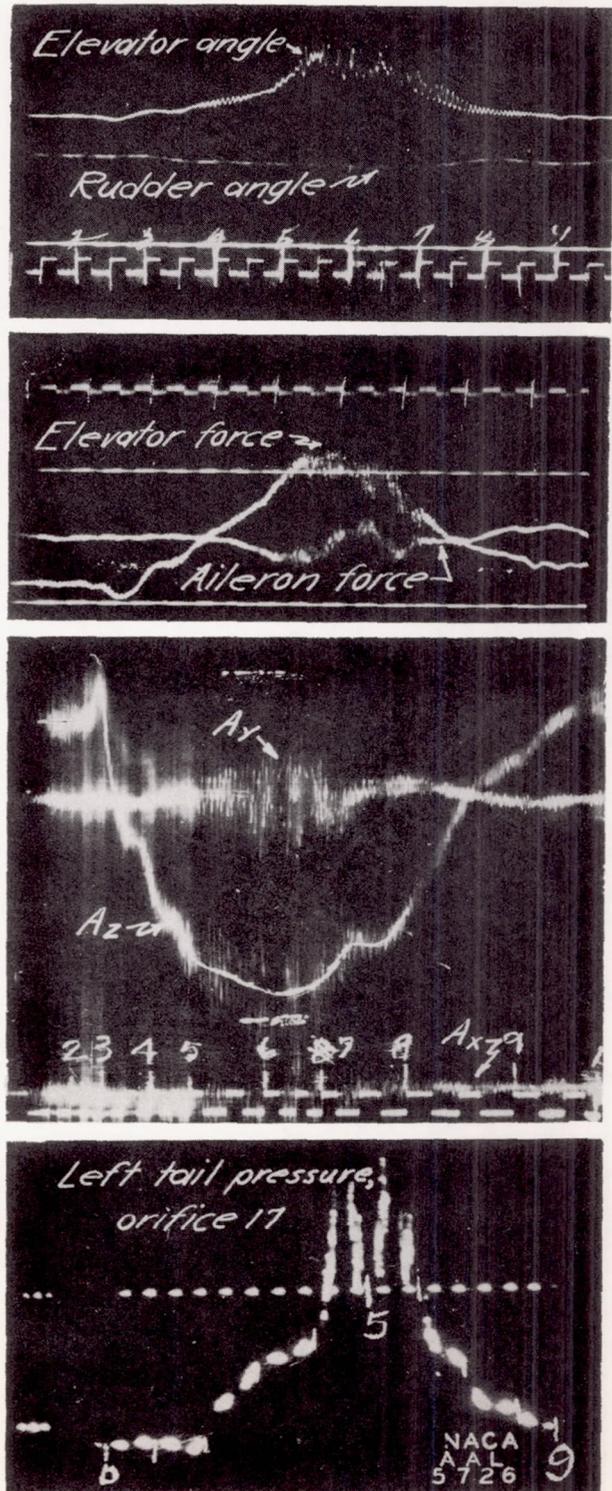
Figure 4 - Time history of a power-off dive pull-out at $M \approx 0.68$. Test airplane with reinforced stabilizer and elevators.

In figures 4, 5, and 6 it is seen that the airplane was pulled in until a mild stall occurred at an airplane lift coefficient of 0.68 and a Mach number of 0.68. The maximum acceleration factor reached was 5.3 at an angle of attack of the thrust line (uncorrected) of 8.5° . The maximum elevator angle used was 7° up. Buffeting was present, apparently, as may be seen from figure 4 (b), to a greater extent on the left tail than on the right. Rapid fluctuations of pressure, amounting to changes of 200 to 300 pounds per square foot, occurred at the leading edge of the stabilizer during the stall. (Any inaccuracy due to lag in the pressure lines will tend to make the recorded load changes too low.) During the main part of the pull-out, as may be seen from figure 5, the load was upward on the stabilizer and downward on the elevator. The maximum recorded pressures and unit span loads for the pull-out shown in figures 4, 5, and 6 are listed in the following table:
