NATIONAL ADVISORY COMMITTEE FOR AERONAUTICS

FLIGHT MEASUREMENTS OF HORIZONTAL TAIL LOADS ON A
TYPICAL PROPELLER-DRIVEN PURSUIT AIRPLANE DURING
STALLED PULL-OUTS AT HIGH SPEED

MEMORANDUM REPORT

Materiel Command, U.S. Army Air Forces

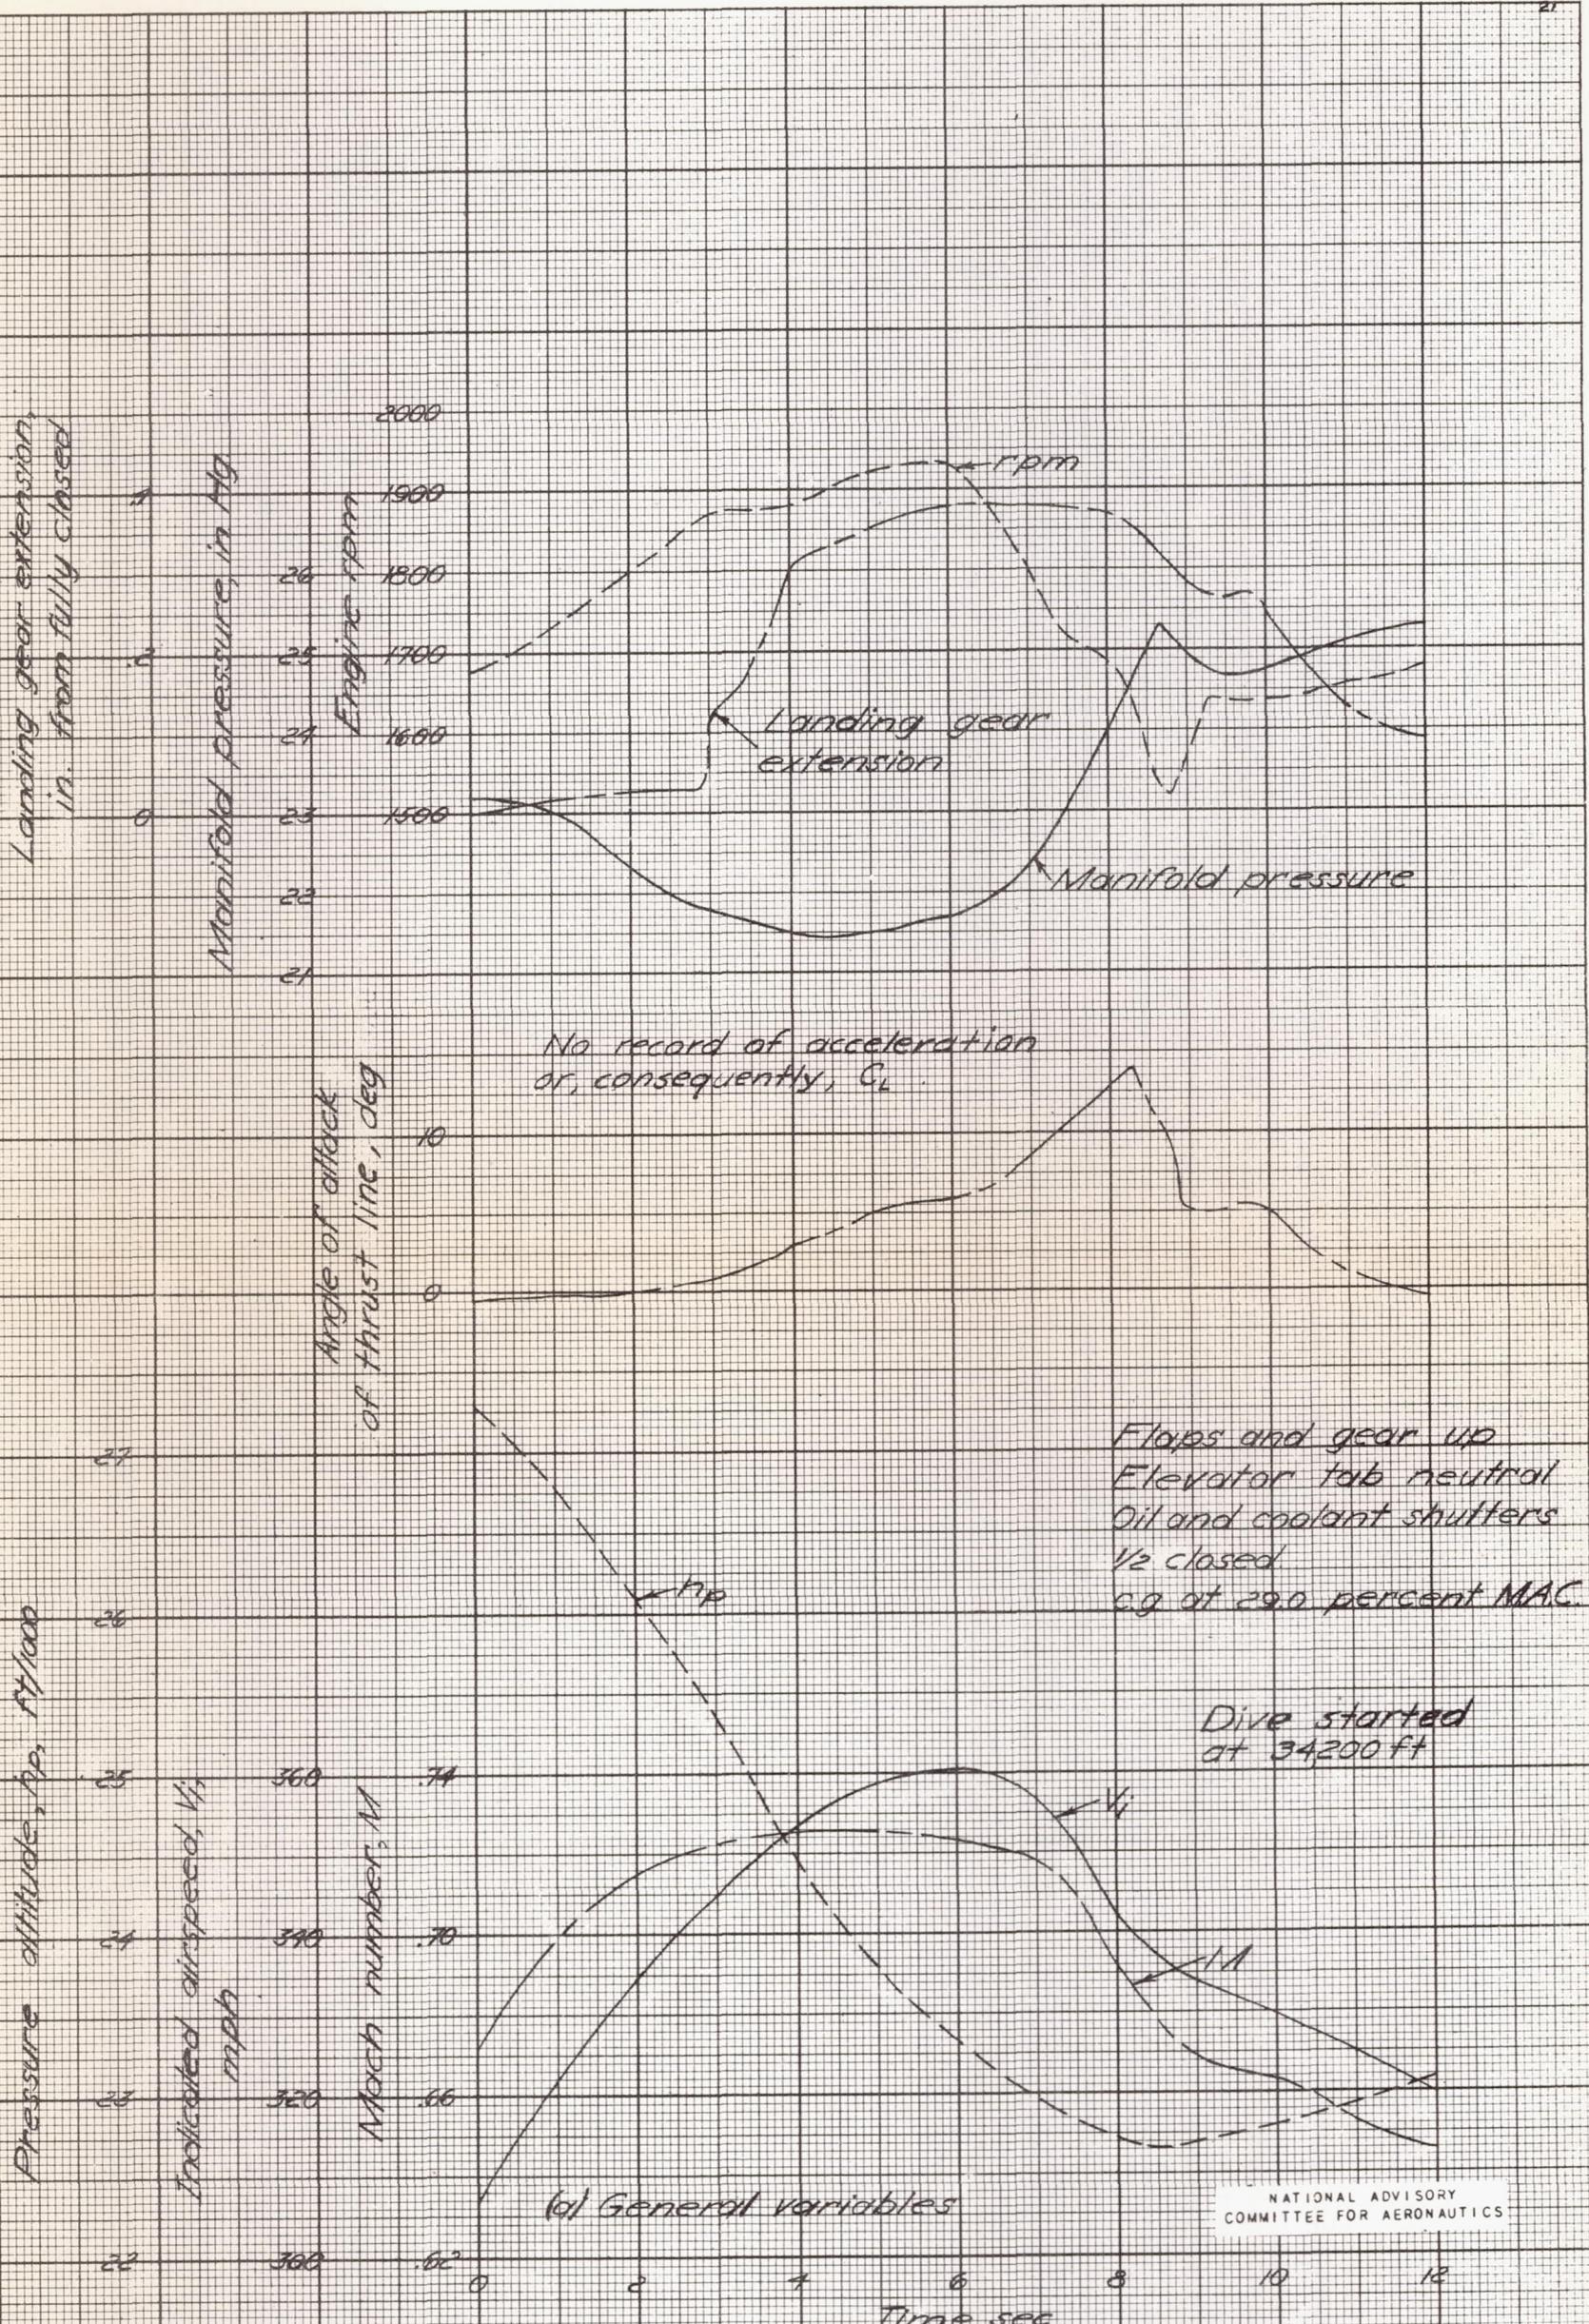
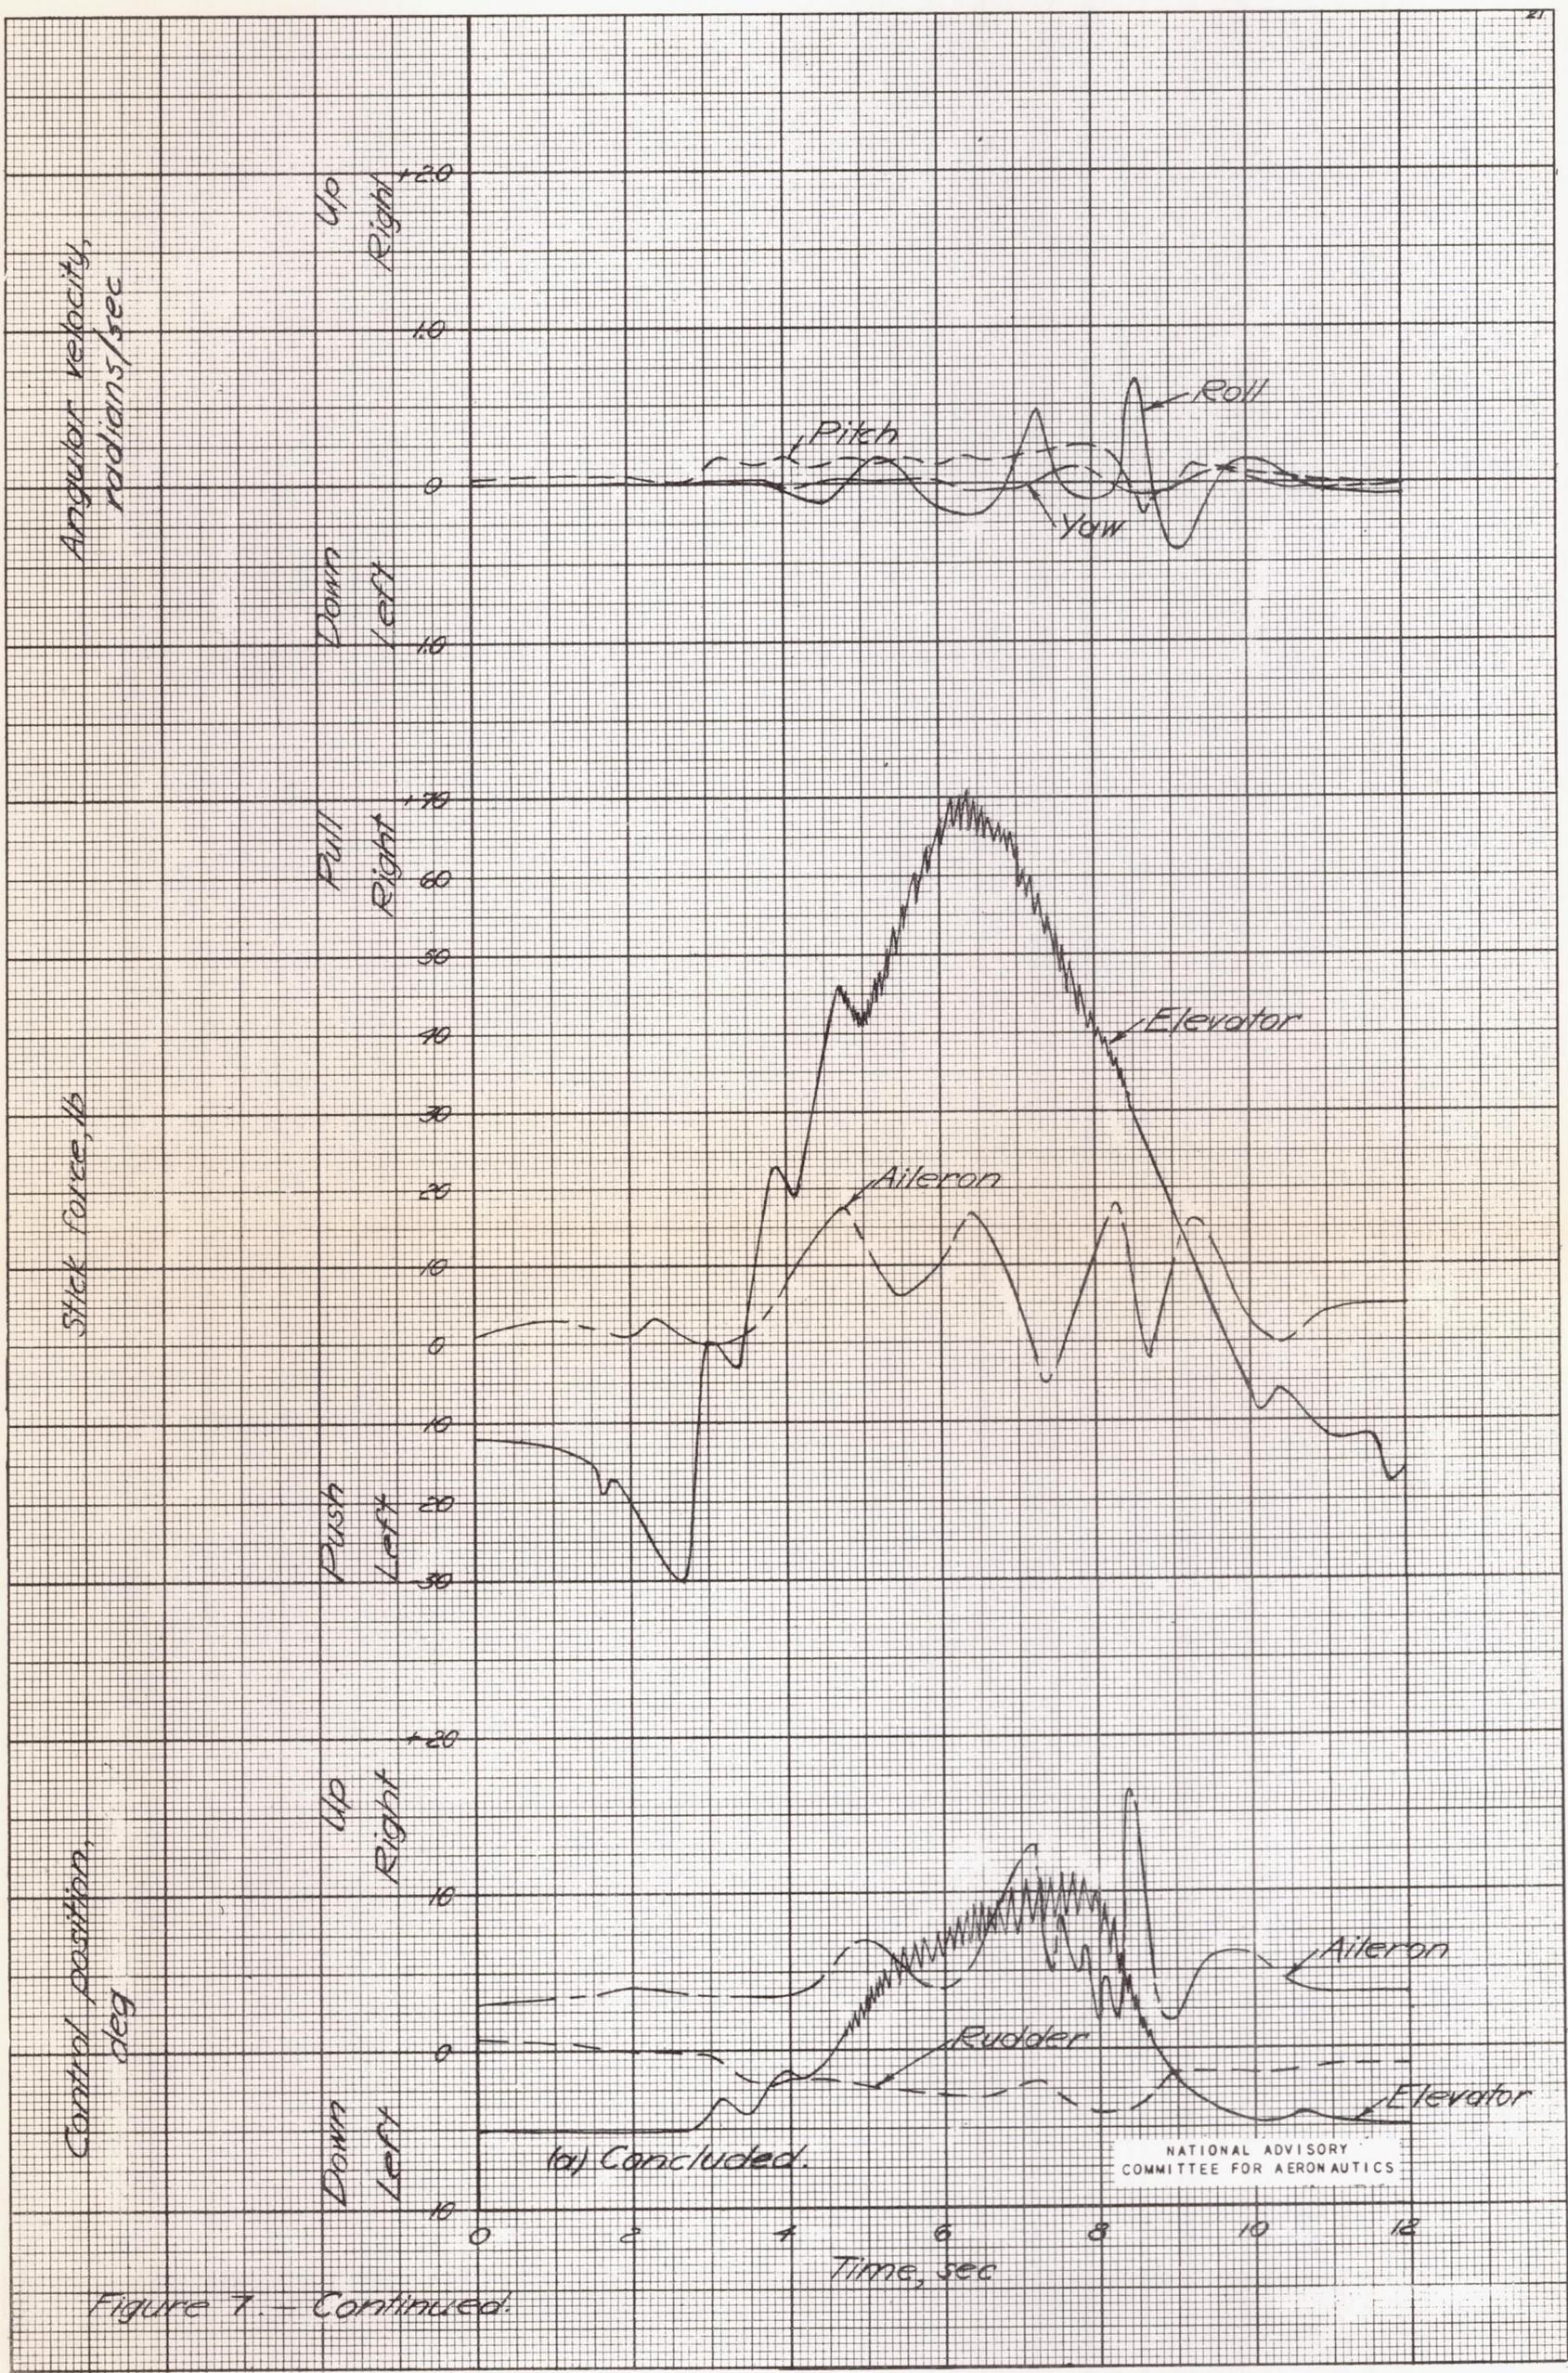
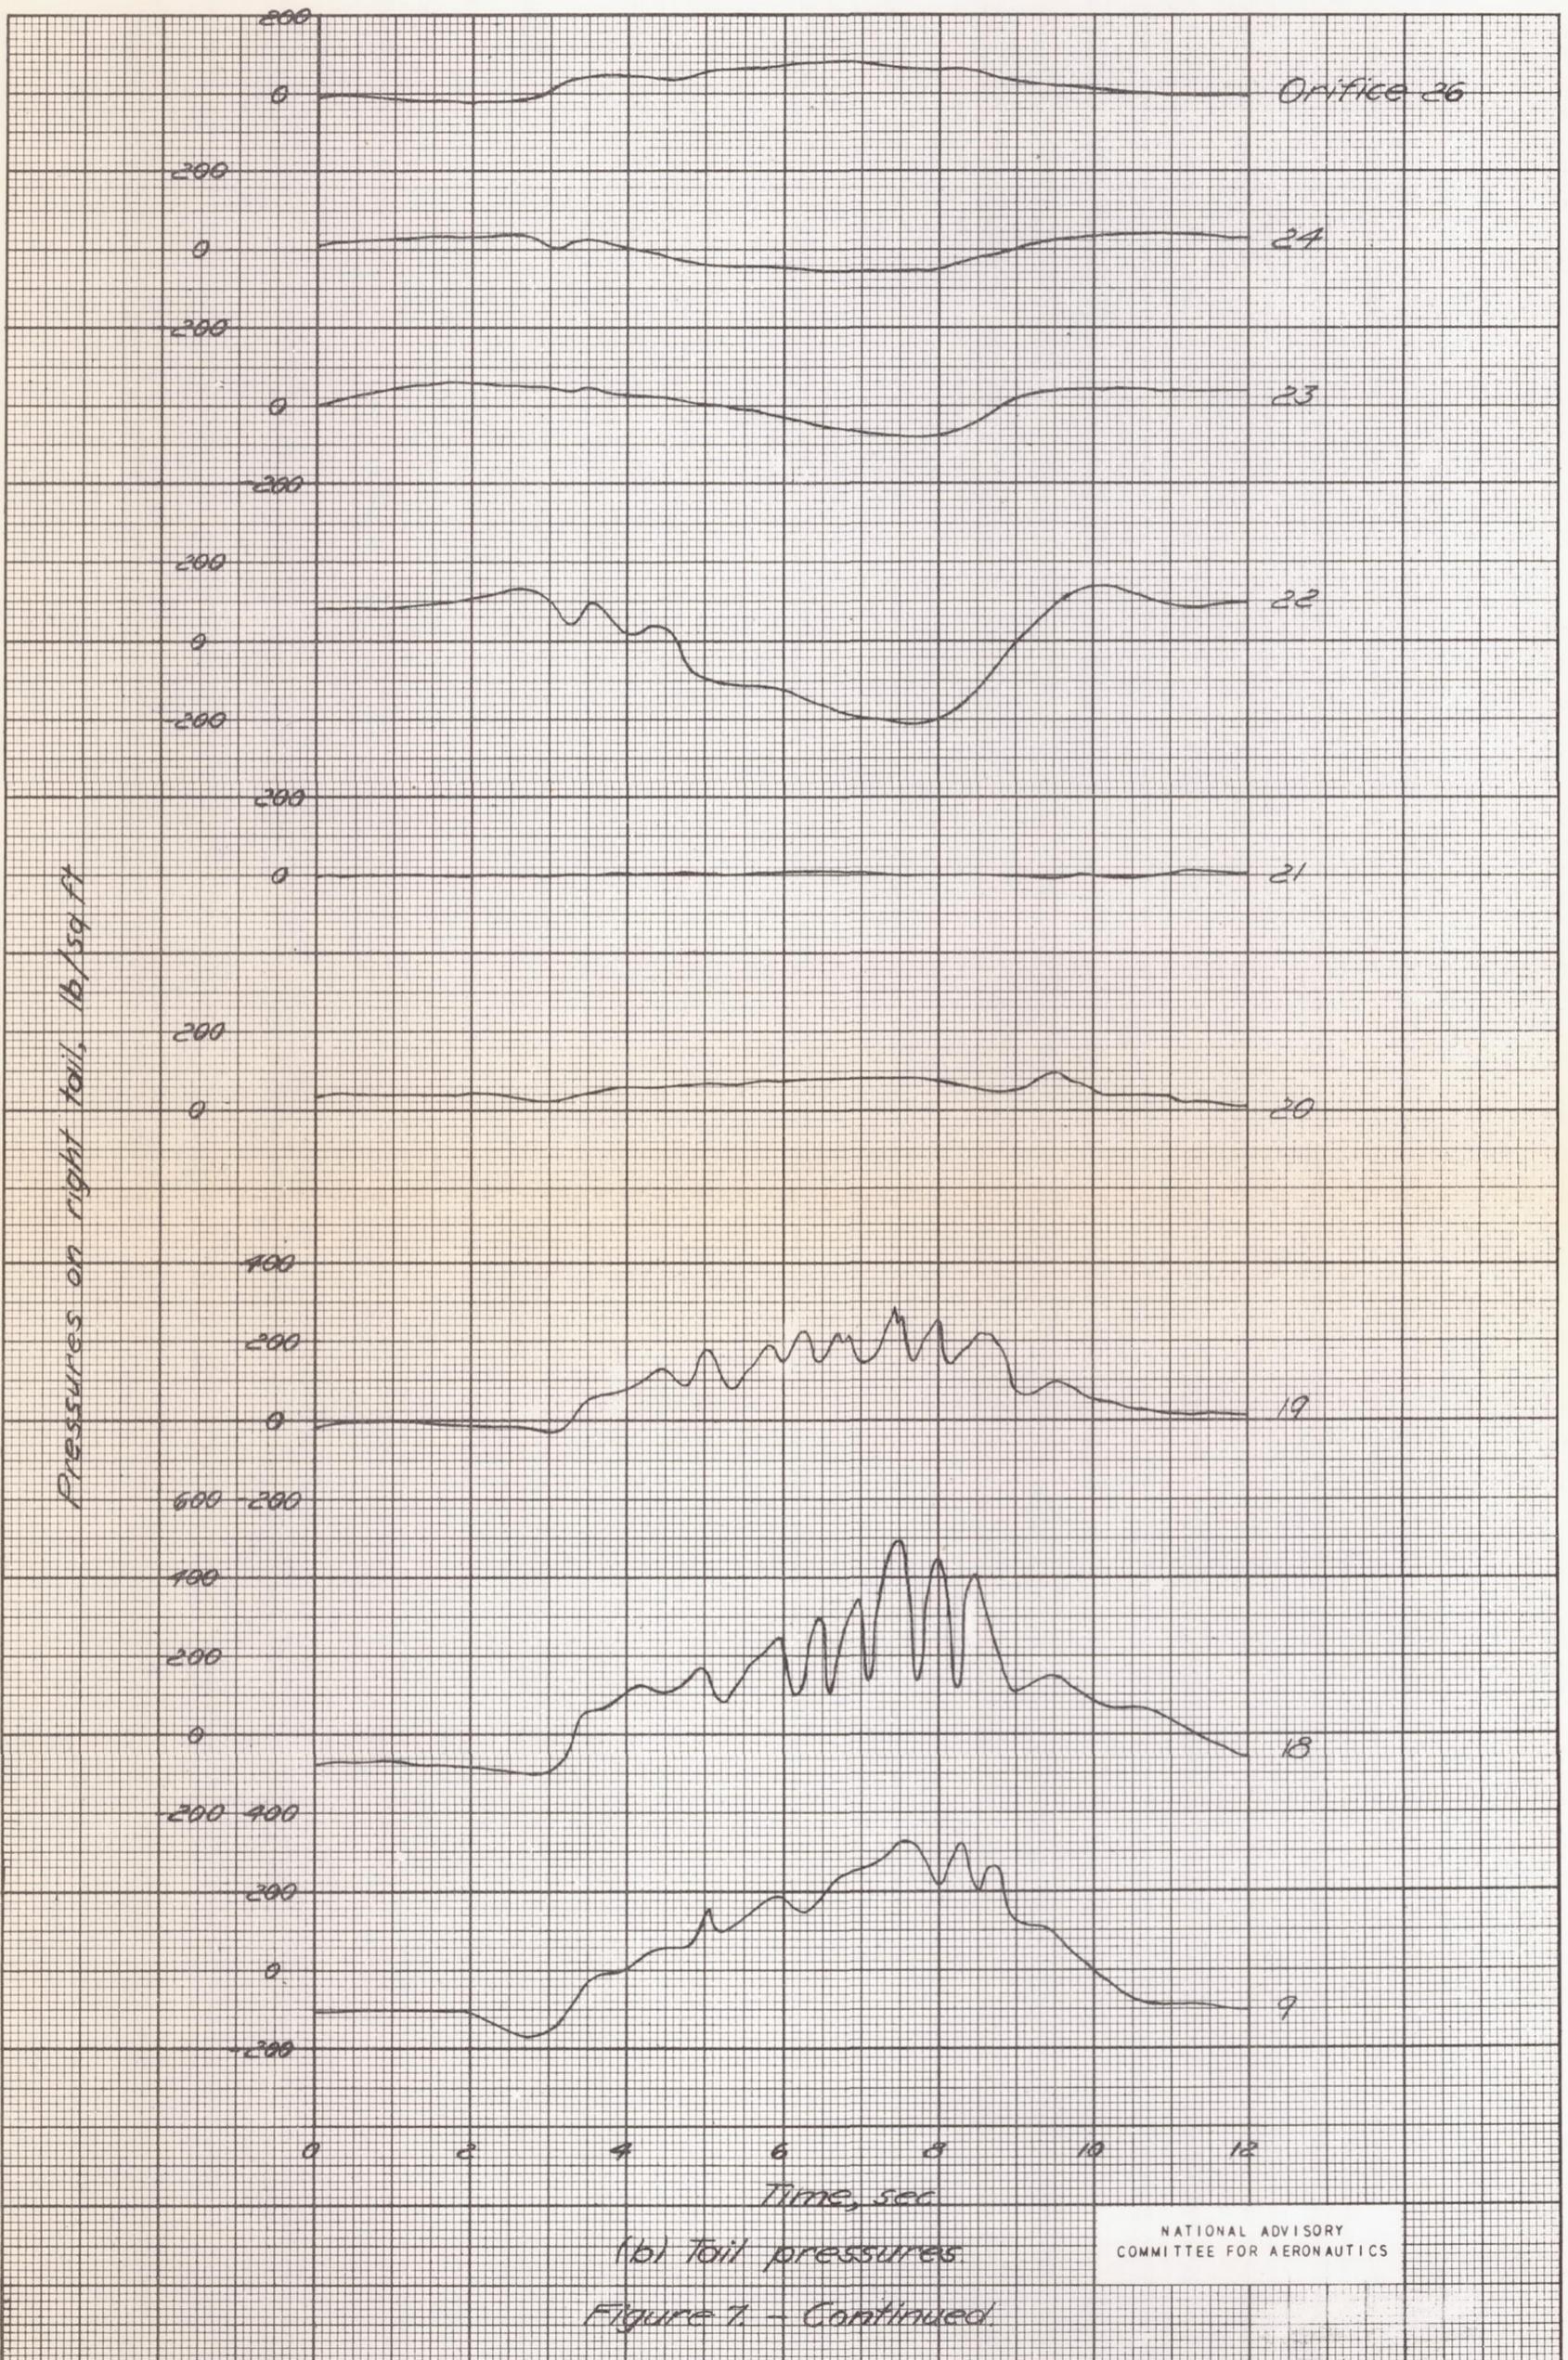
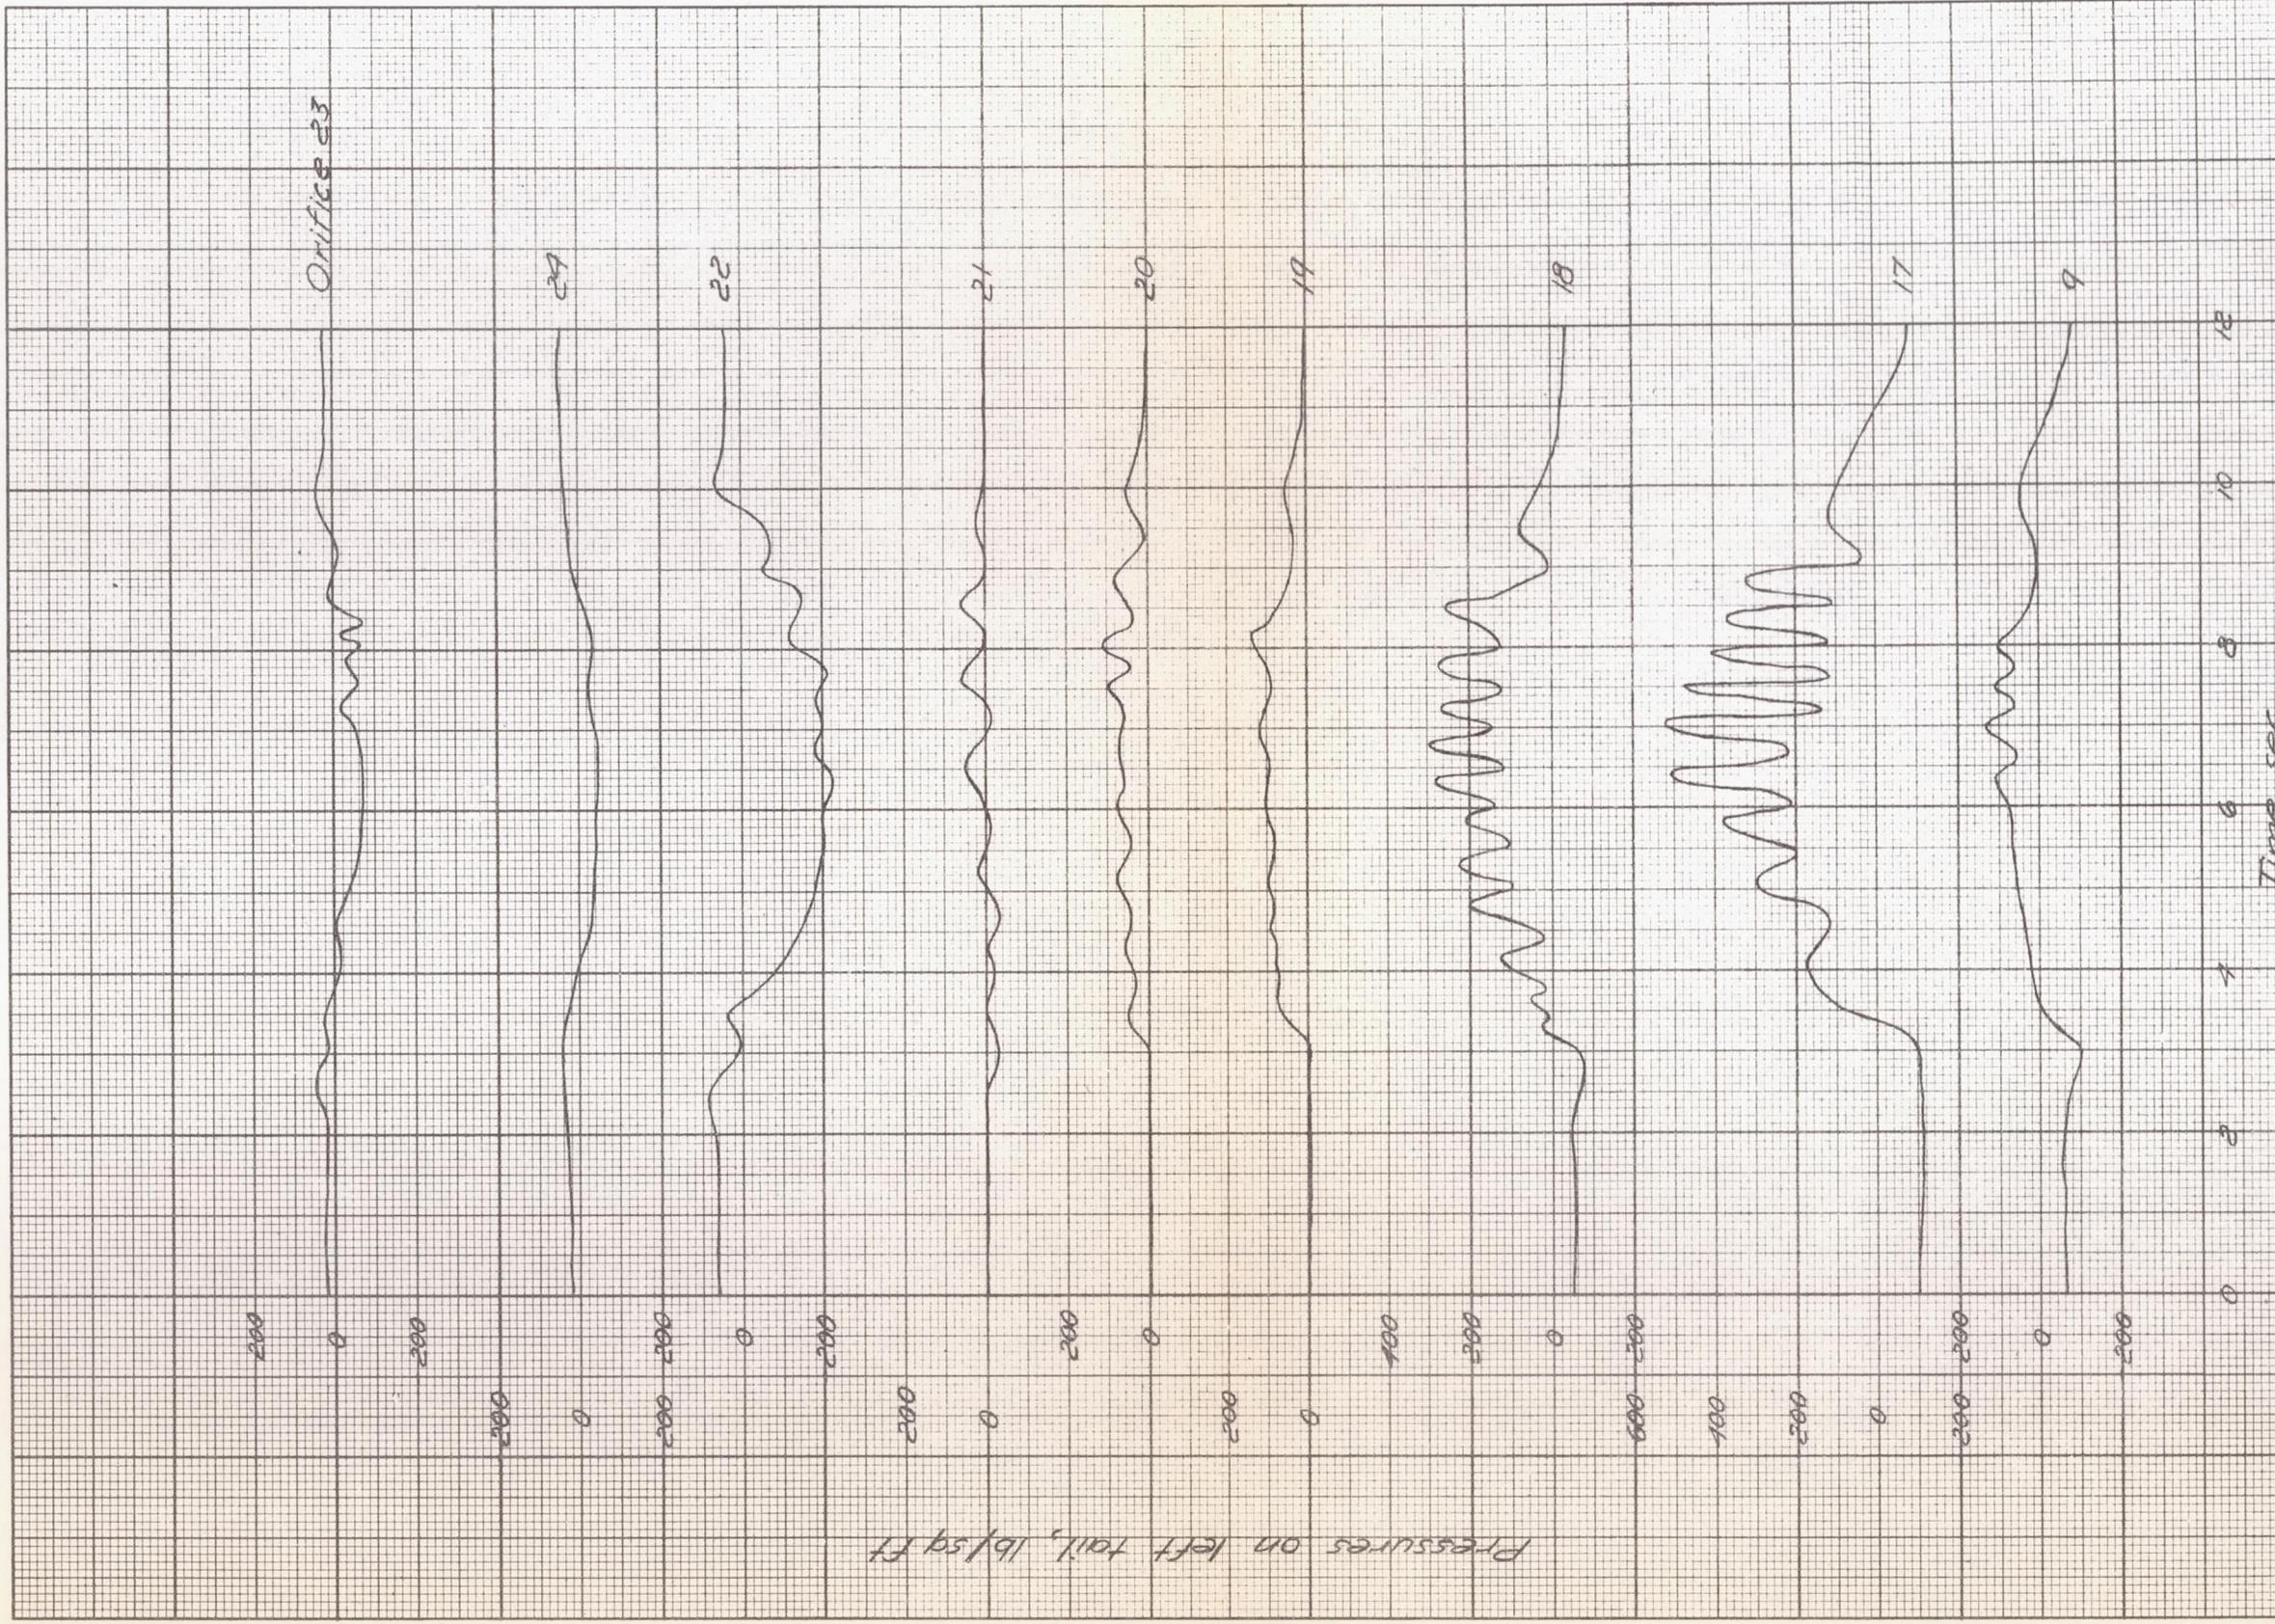
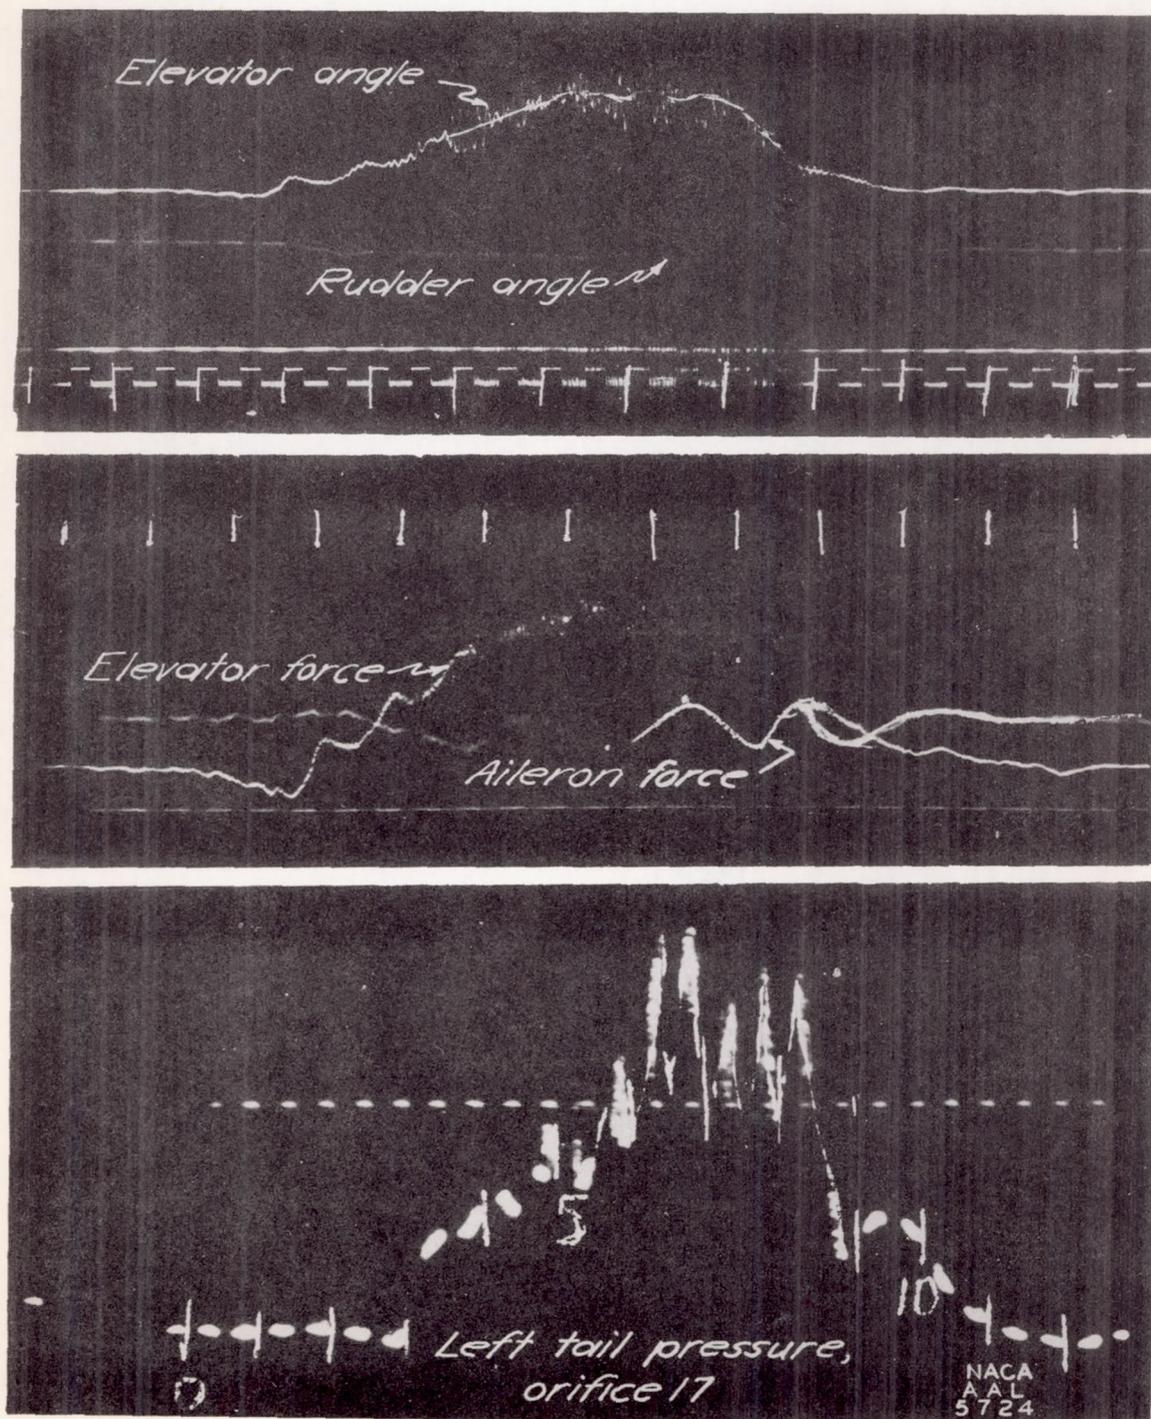
Figure 7 - Time history of a power-off dive pull-out at $M \approx 0.70$.
 Test airplane with reinforced stabilizer and elevators.

In figures 7, 8, and 9 it is seen that the airplane was pulled in until a moderately violent stall occurred at a Mach number of about 0.72. The lift coefficient could not be determined as the accelerometer did not function on this flight. The maximum angle of attack

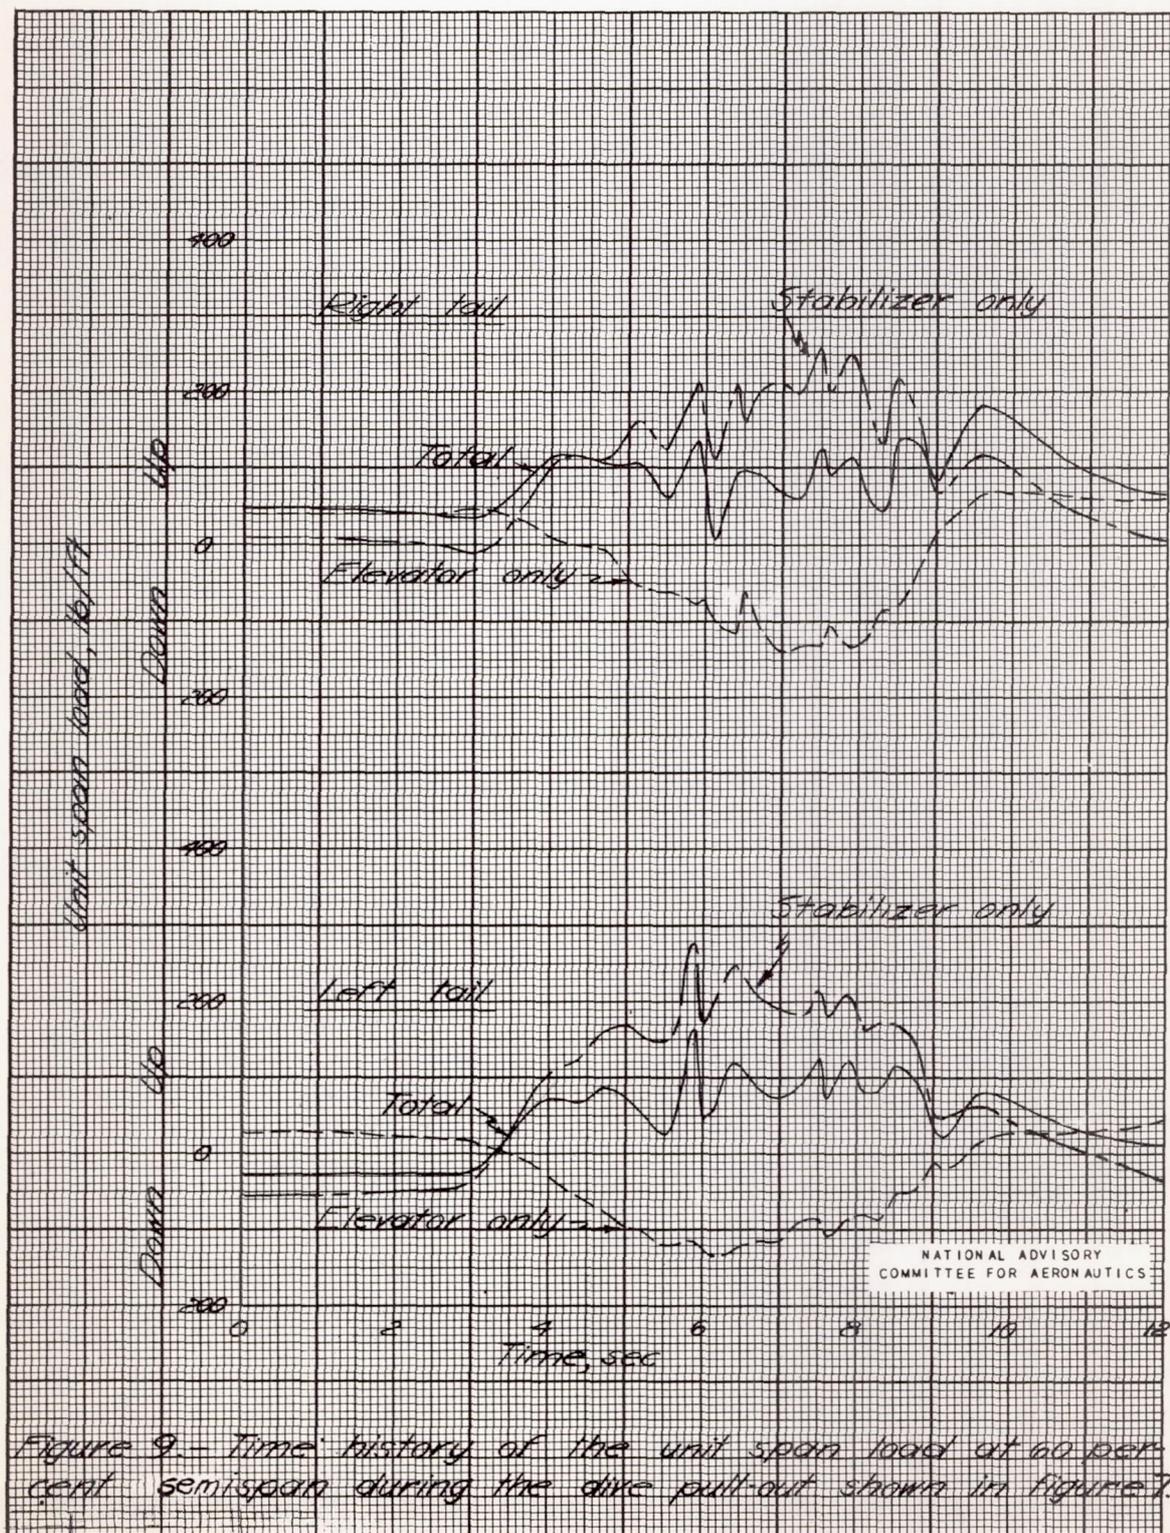
Figure 9.- Time history of the unit span load at 60 per cent semispan during the dive pull-out shown in figure 7.

Inasmuch as the elevator loads at the time of failure did not appear to have been in excess of those for which the surface was designed, the reasons for the failure of the elevator are not entirely clear. Also, higher elevator down loads had been encountered on a previous flight (fig. 9) at least at the spanwise location at which measurements were made.
