NATIONAL ADVISORY COMMITTEE FOR AERONAUTICS

FLIGHT MEASUREMENTS OF HORIZONTAL TAIL LOADS ON A
TYPICAL PROPELLER-DRIVEN PURSUIT AIRPLANE DURING
STALLED PULL-OUTS AT HIGH SPEED

MEMORANDUM REPORT

Materiel Command, U.S. Army Air Forces

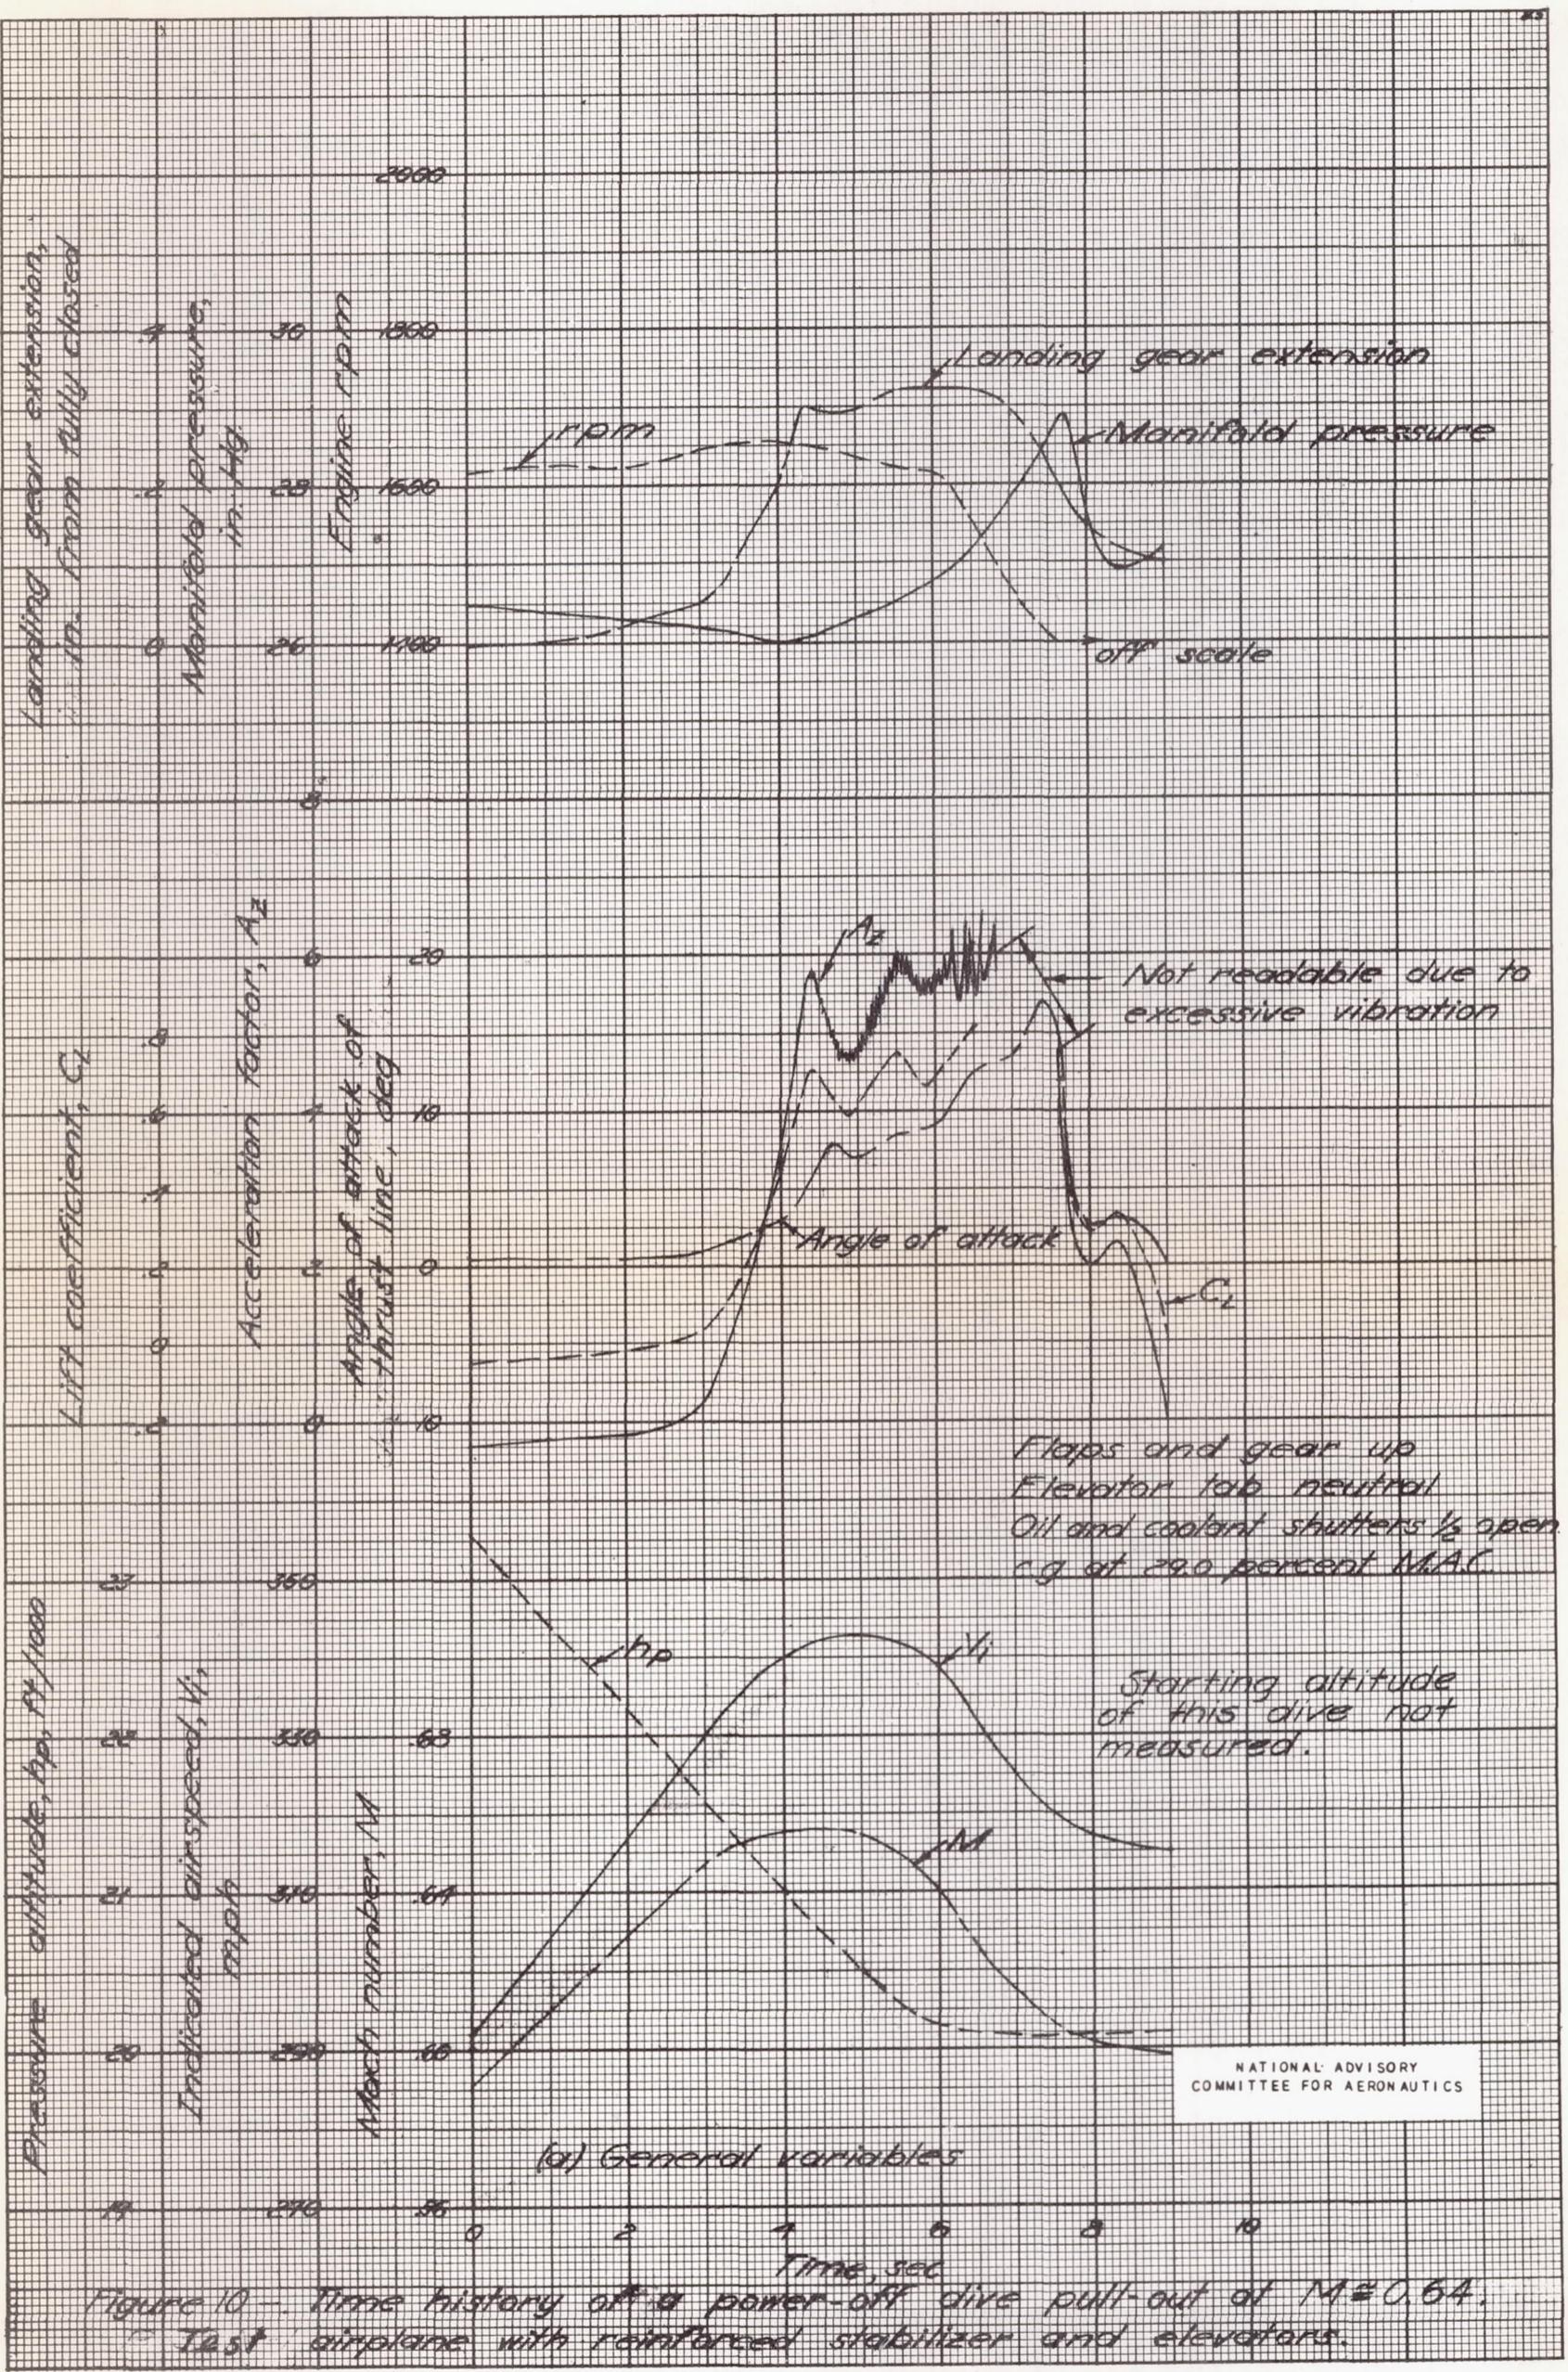
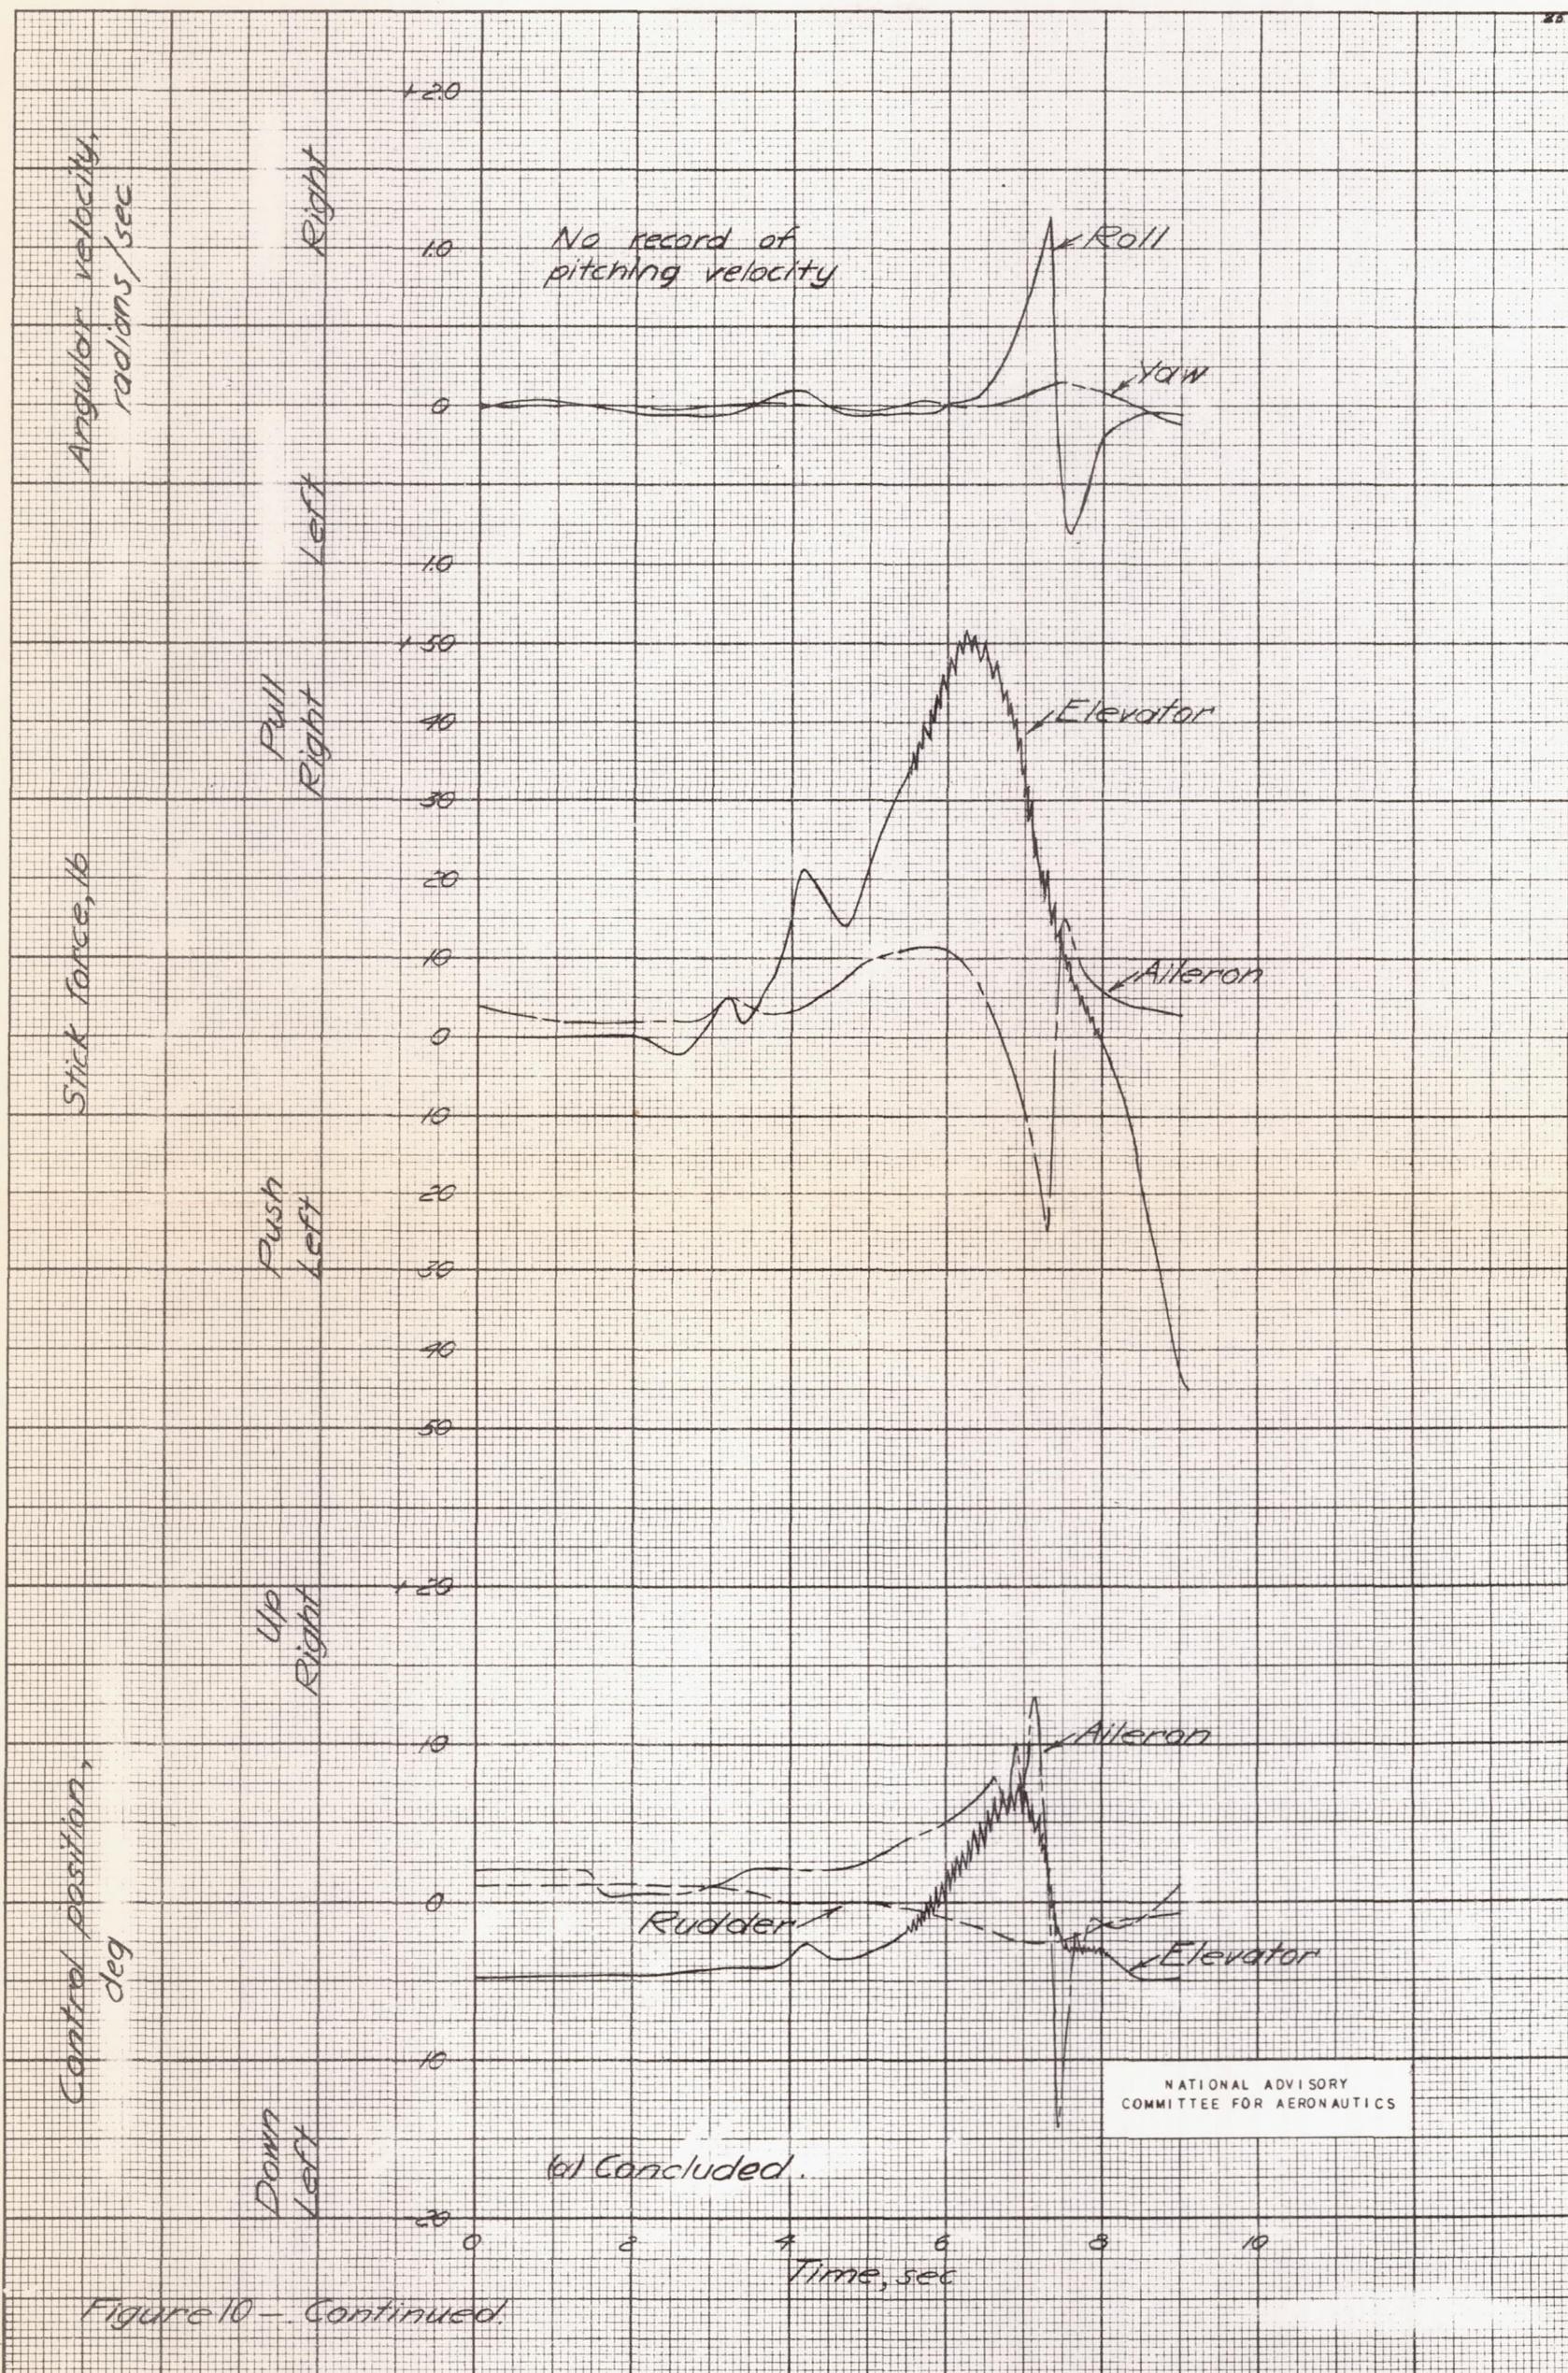
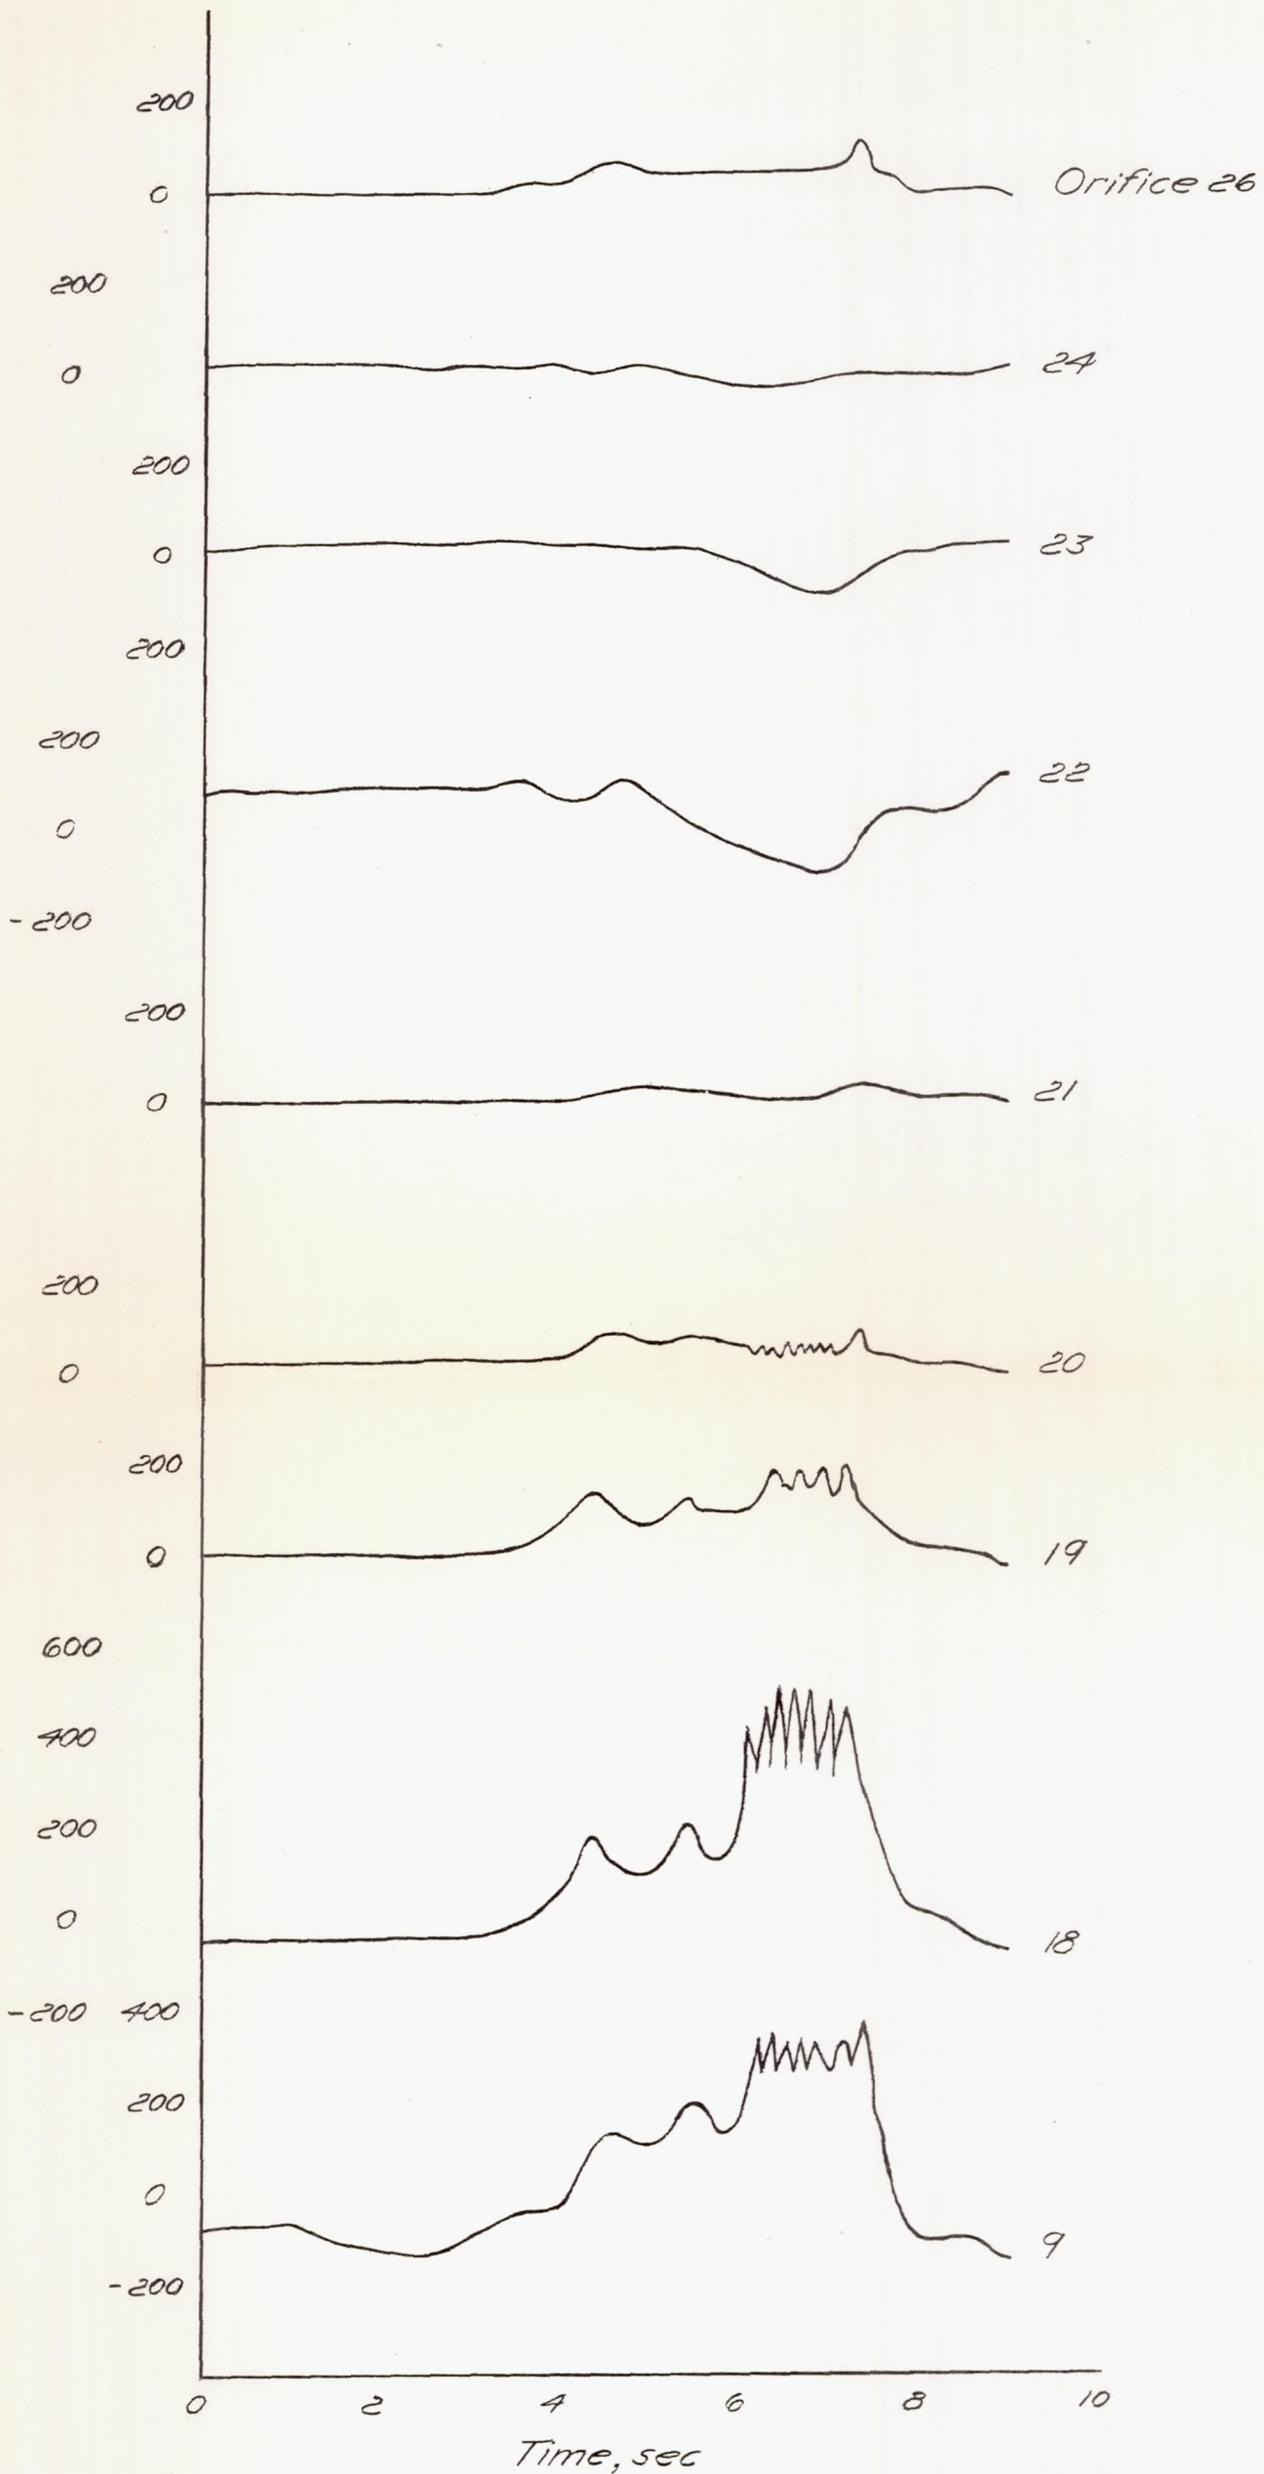
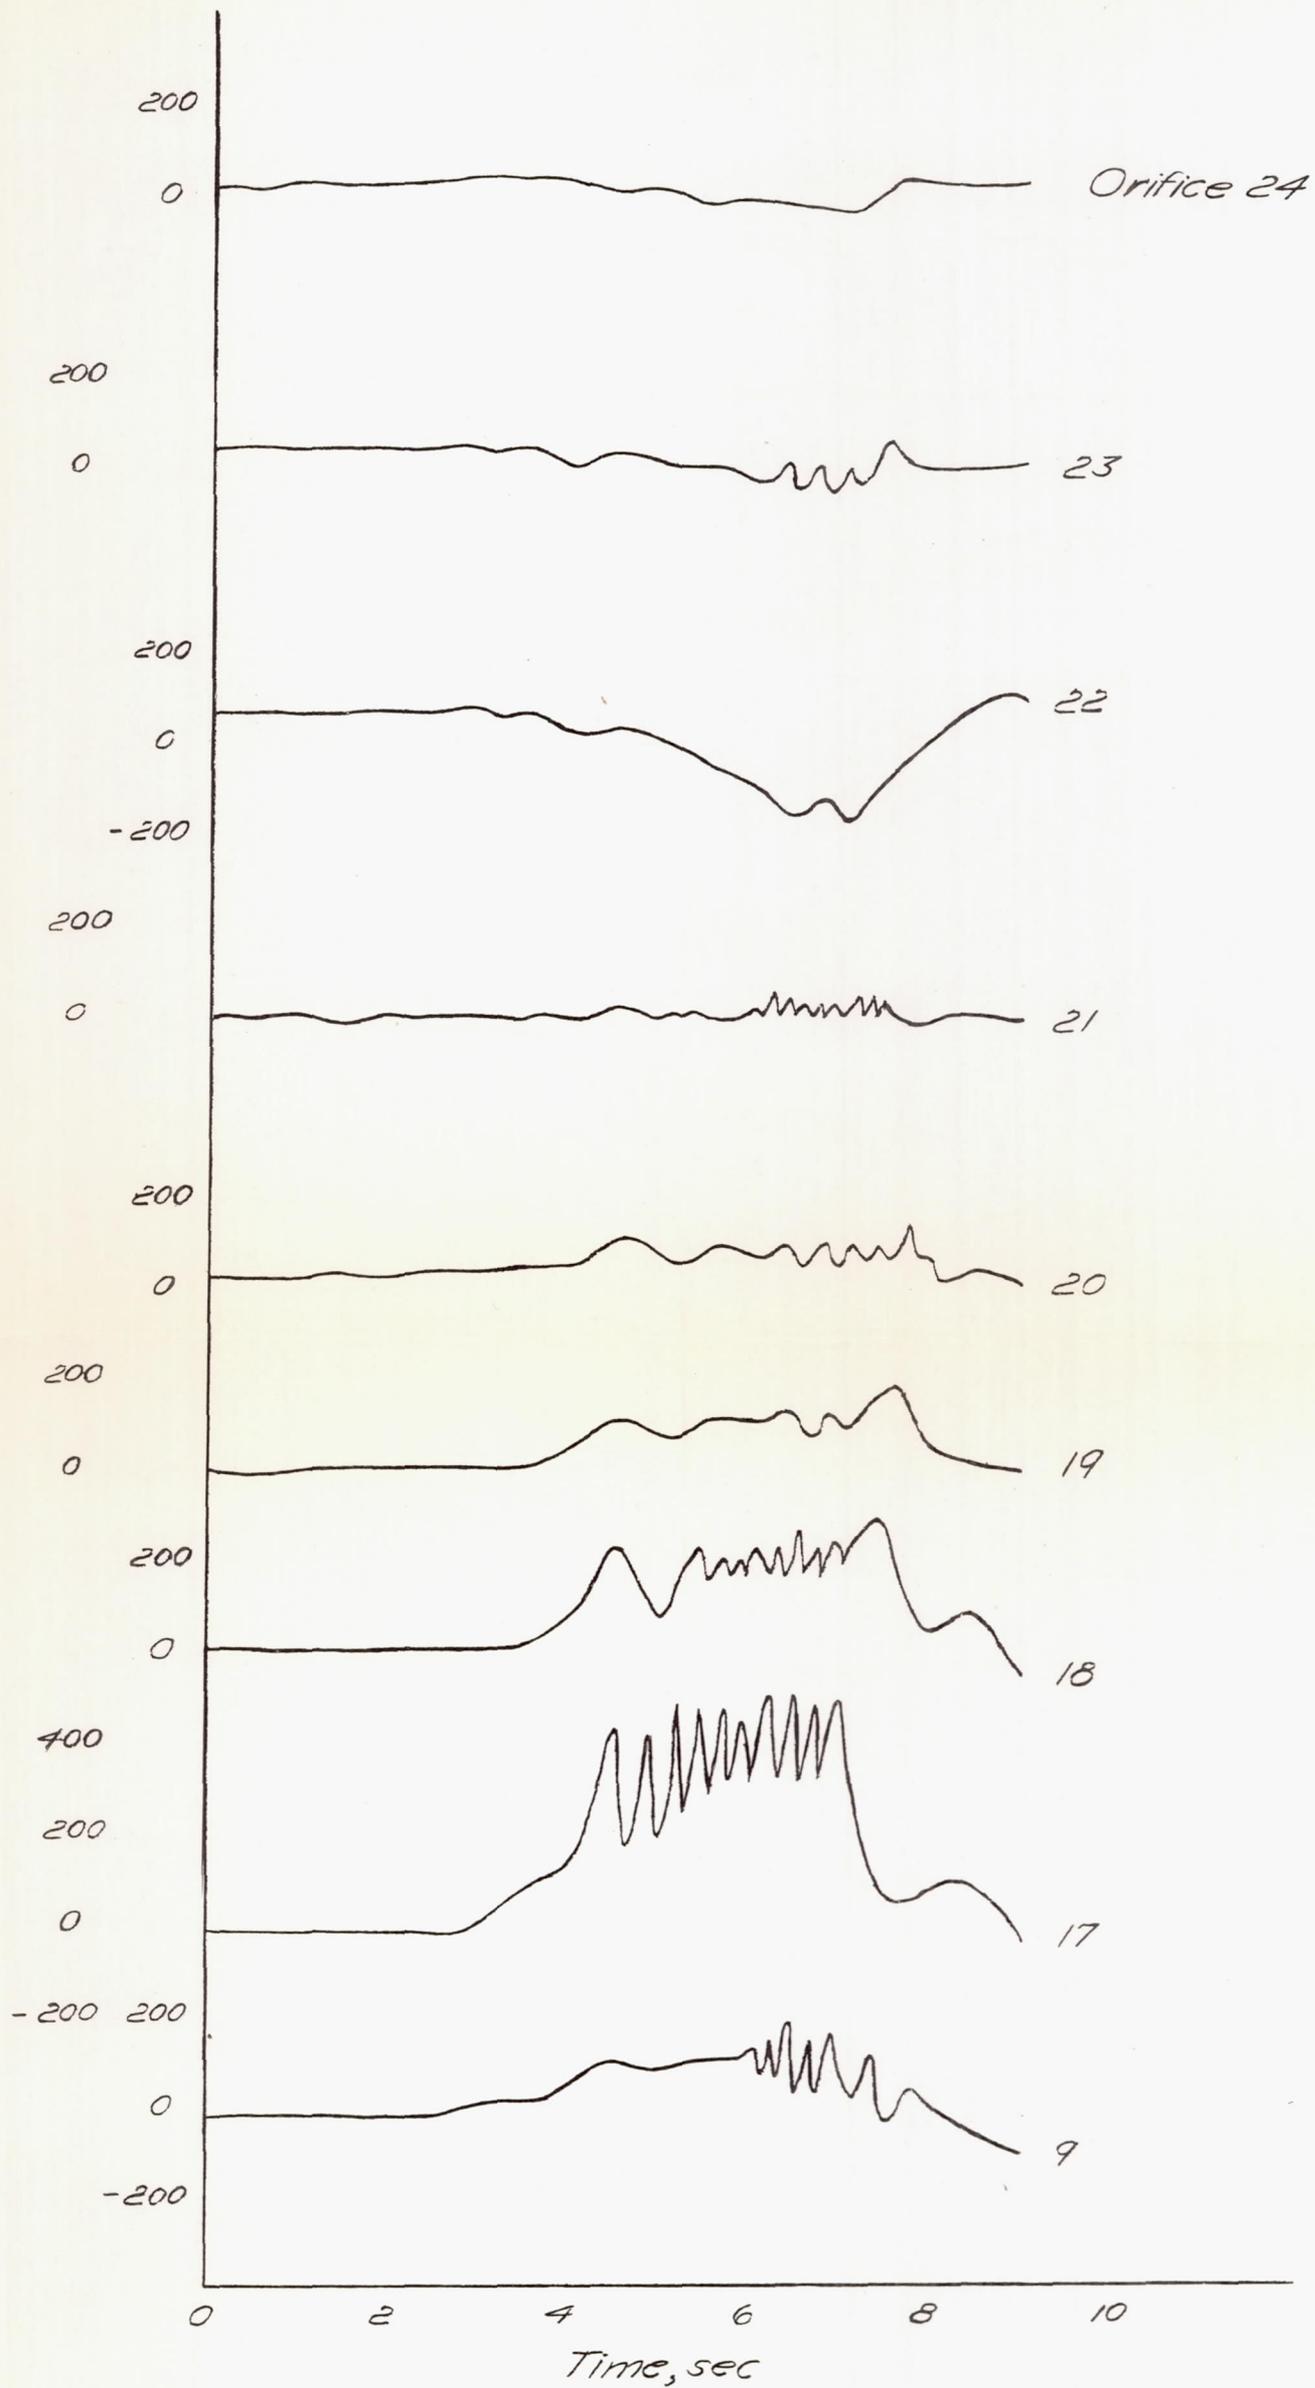
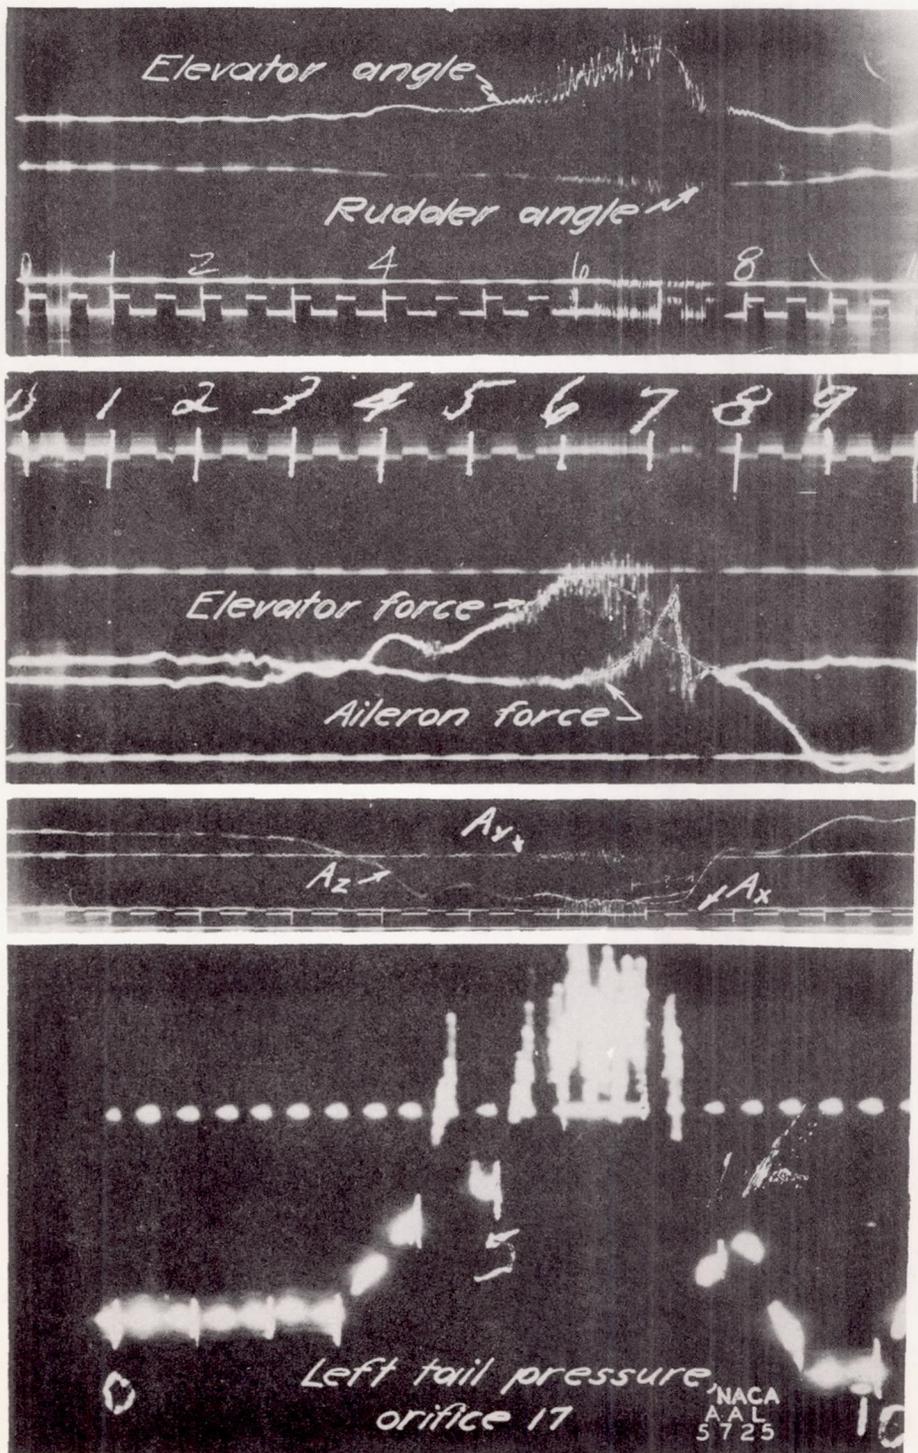
Figure 10 - Continued

In figures 10, 11, and 12 it is seen that the airplane was pulled in until a violent stall occurred at a lift coefficient of about 0.90 and a Mach number of 0.61. The maximum acceleration factor reached was about 6.2 at an angle of attack of 17° . The maximum elevator angle used was 6.5° up. Buffeting was present, again to a greater extent on the left tail than on the right tail. Rapid fluctuations of pressure of 200 to 300 pounds per square foot occurred at the leading edge of the stabilizer during the buffeting. The maximum recorded pressures and unit span loads in this run are listed in the following table:
