NATIONAL ADVISORY COMMITTEE FOR AERONAUTICS

FLIGHT MEASUREMENTS OF HORIZONTAL TAIL LOADS ON A
TYPICAL PROPELLER-DRIVEN PURSUIT AIRPLANE DURING
STALLED PULL-OUTS AT HIGH SPEED

MEMORANDUM REPORT

Materiel Command, U.S. Army Air Forces

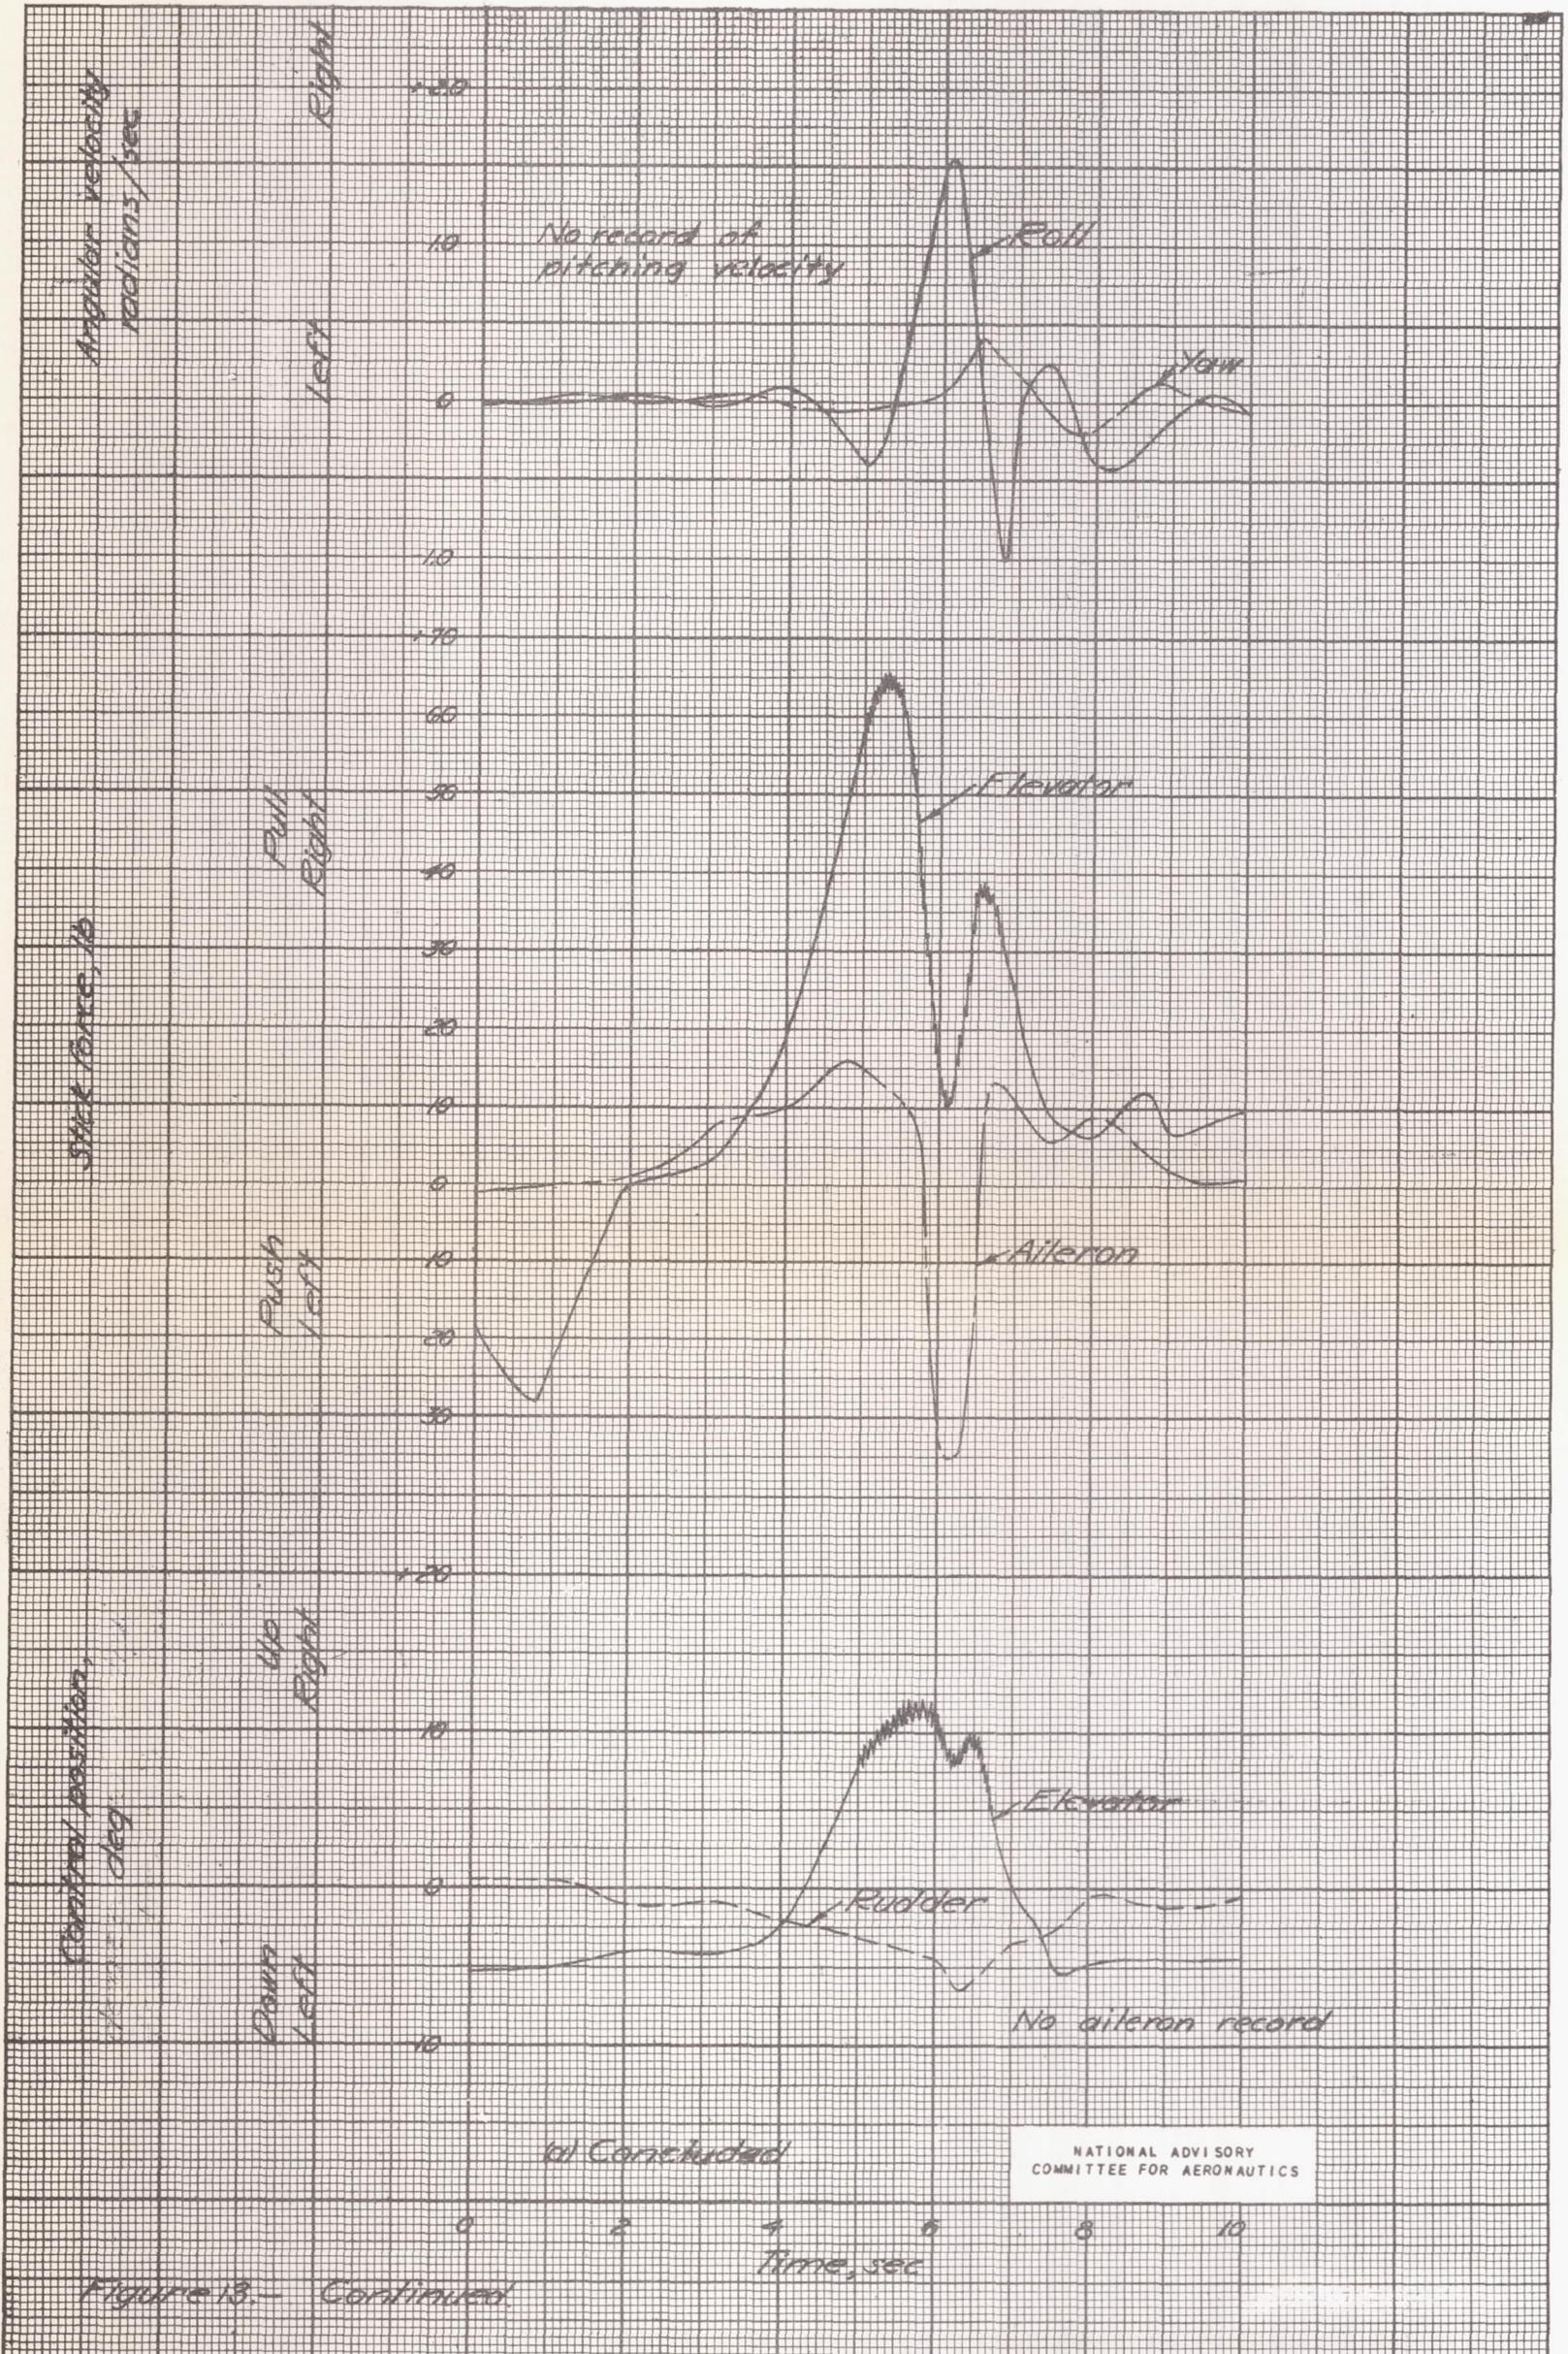
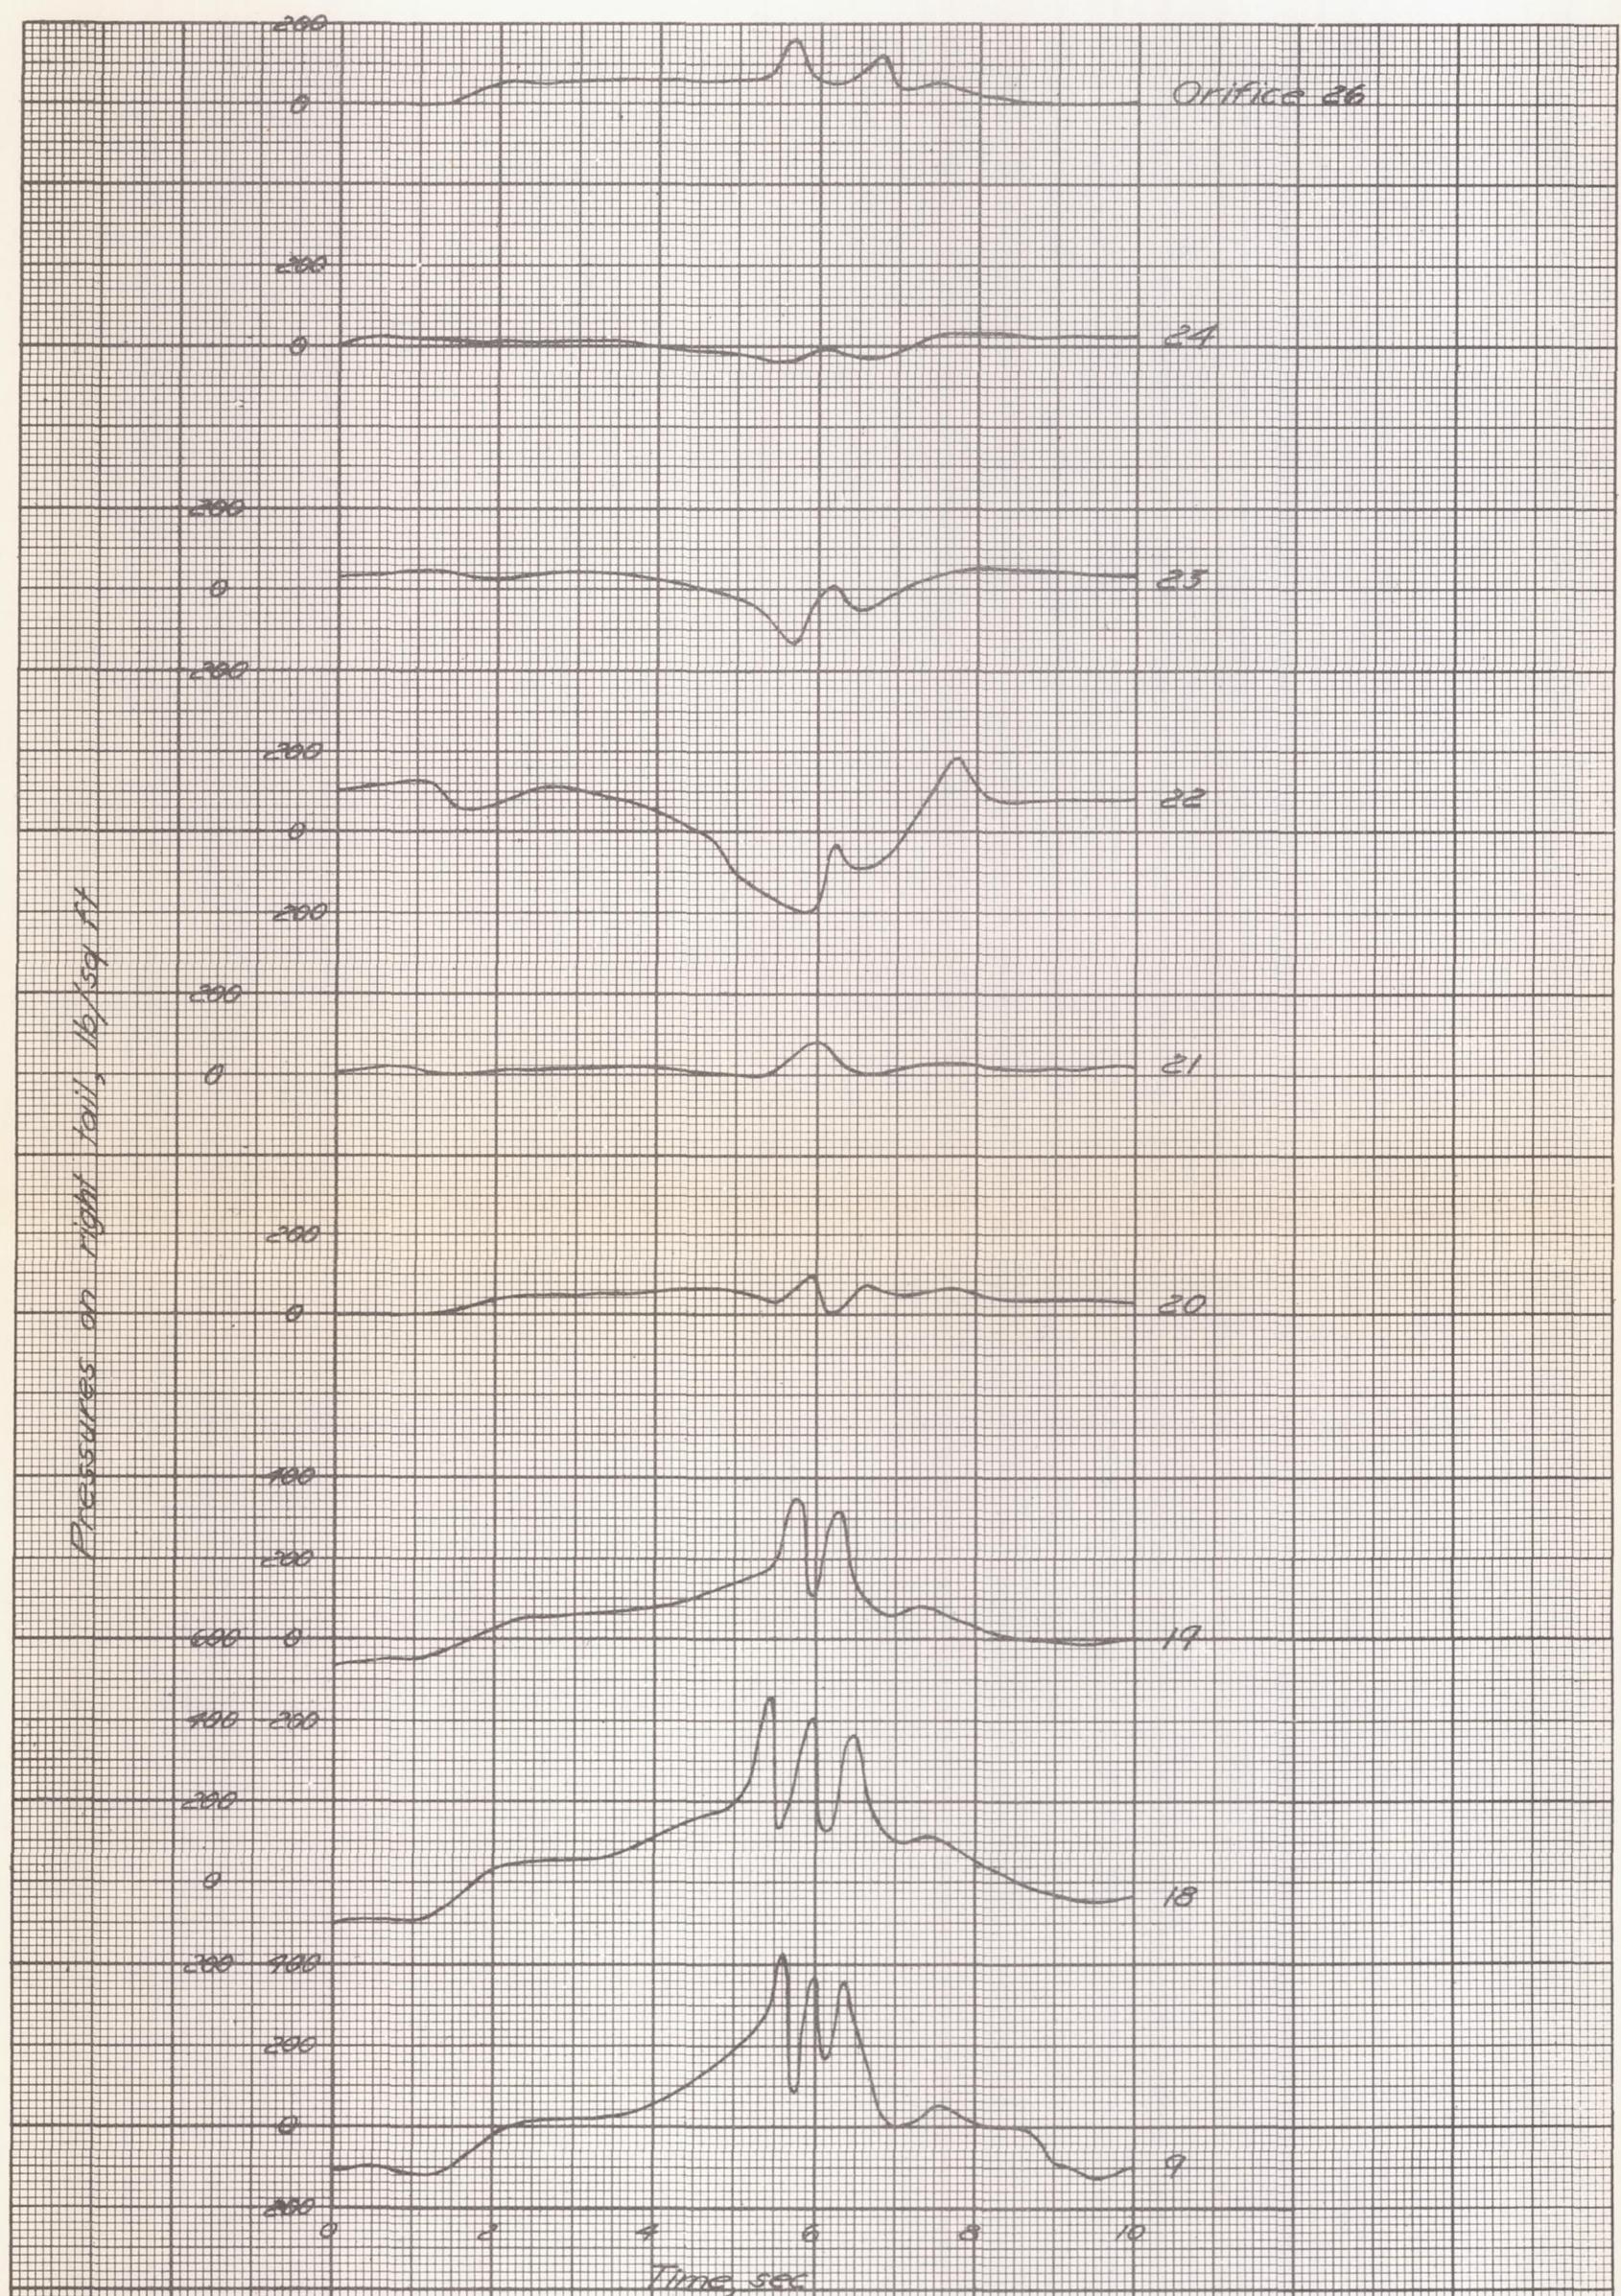
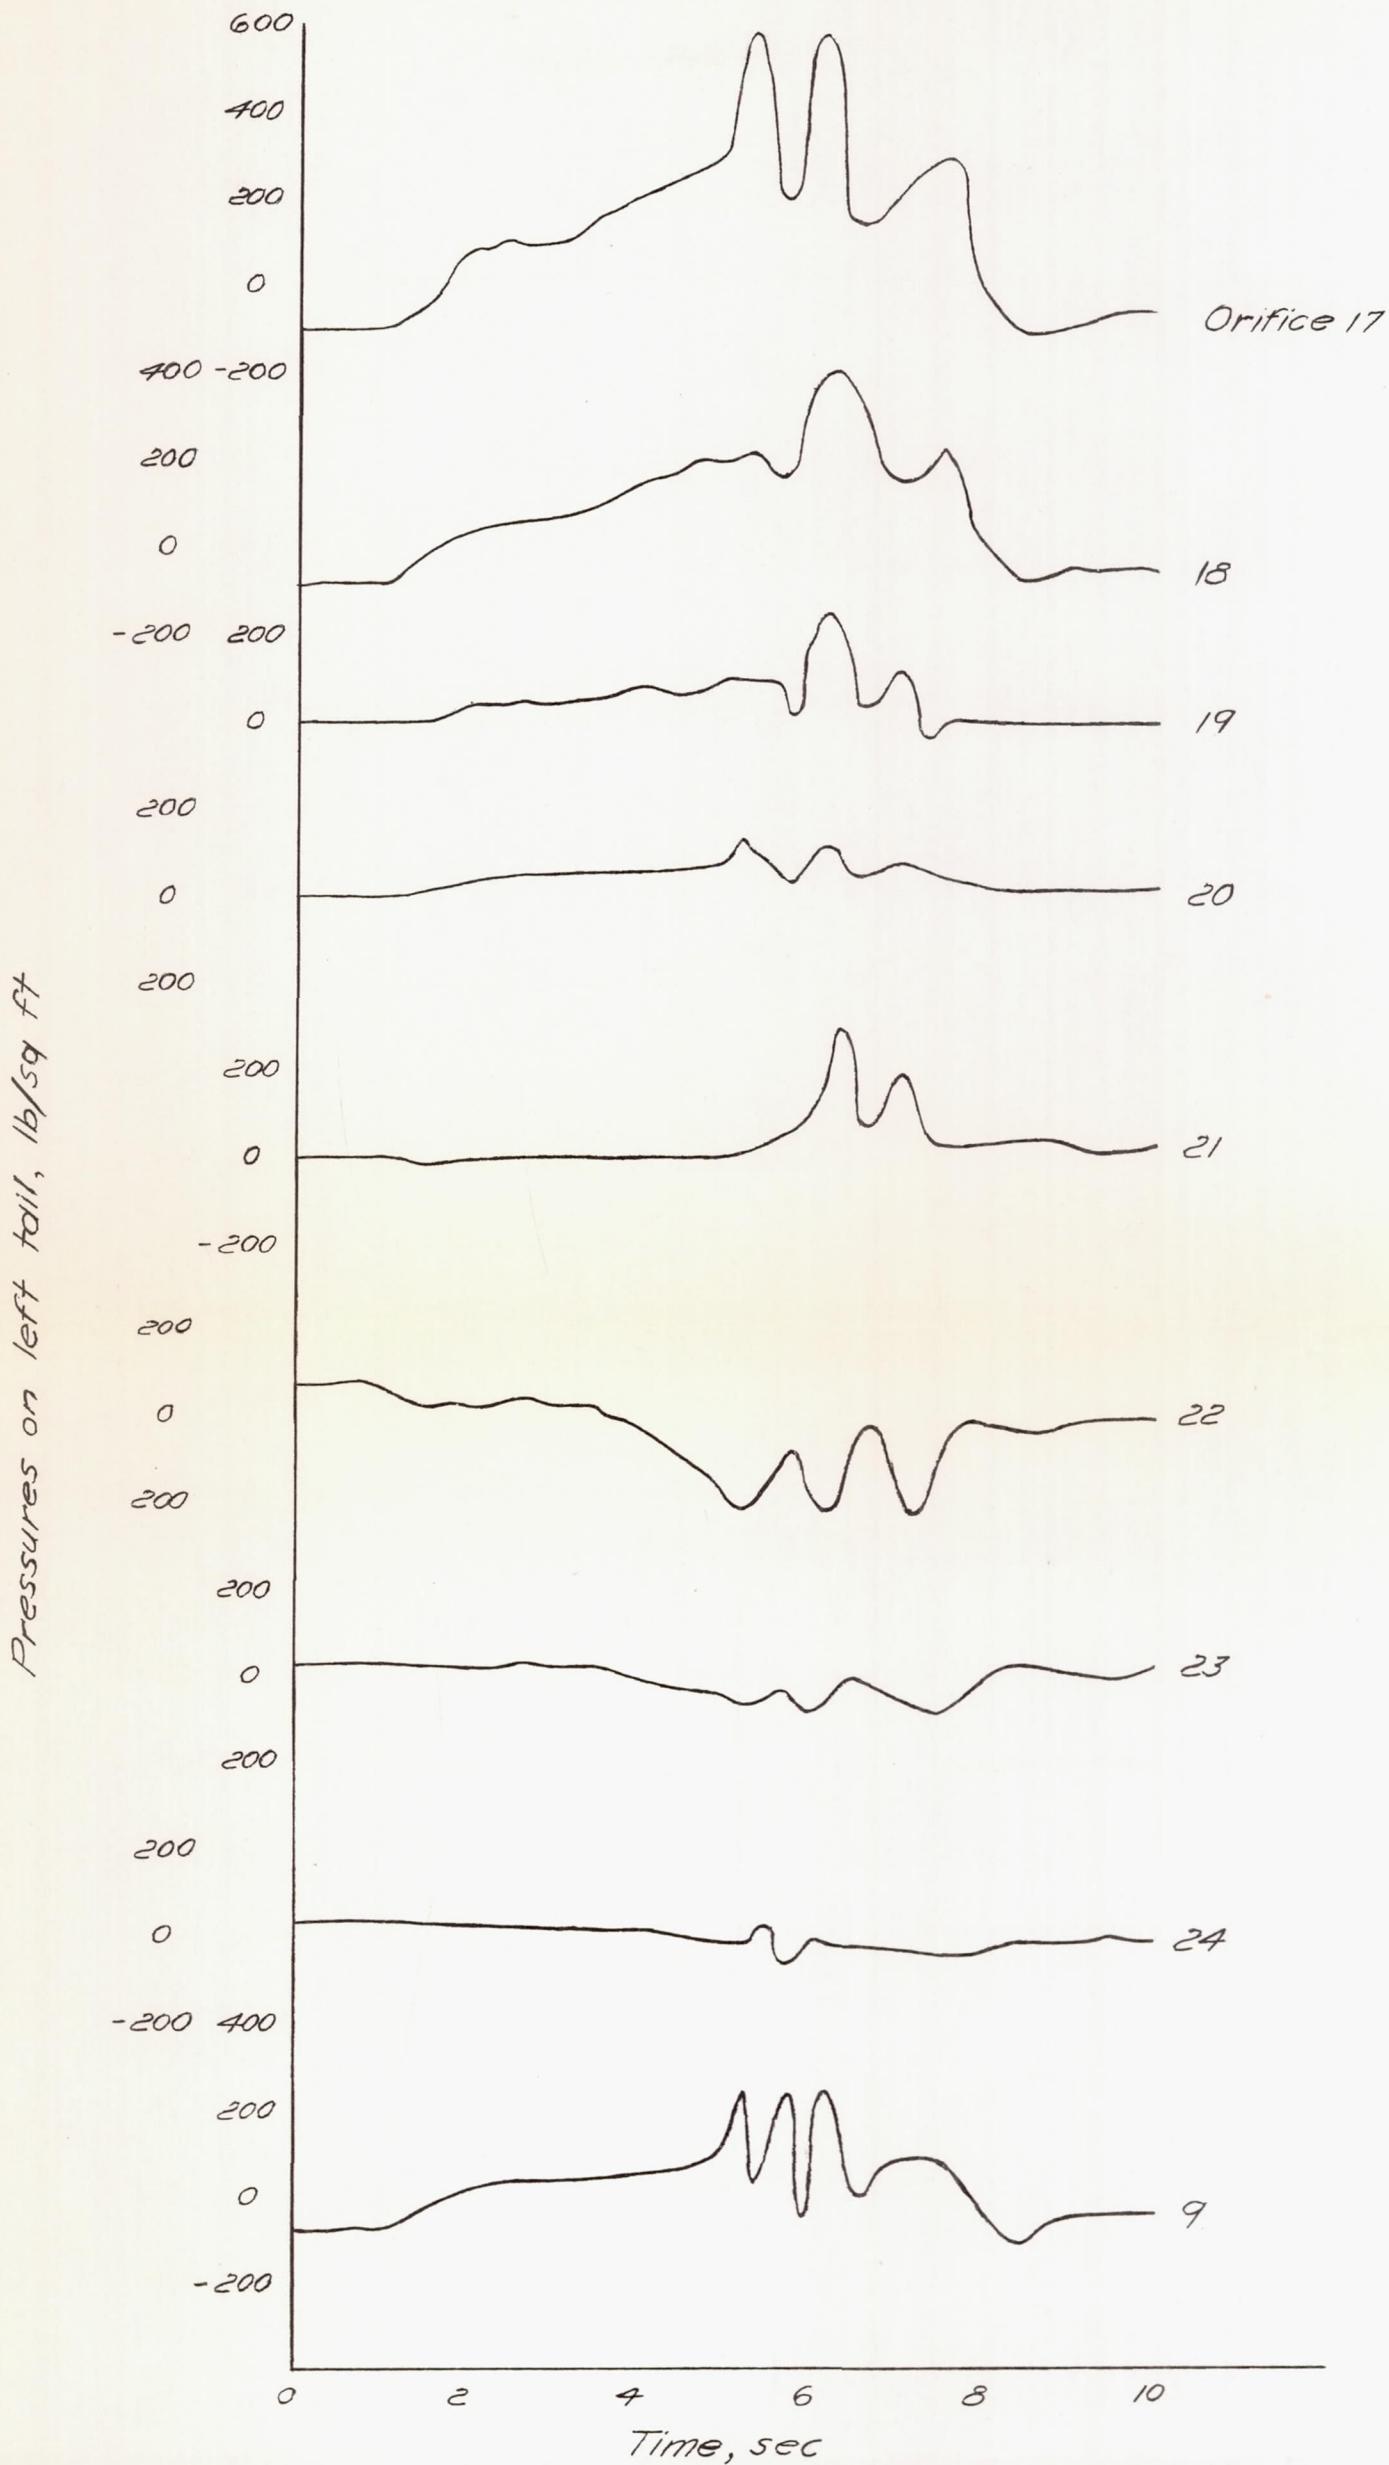
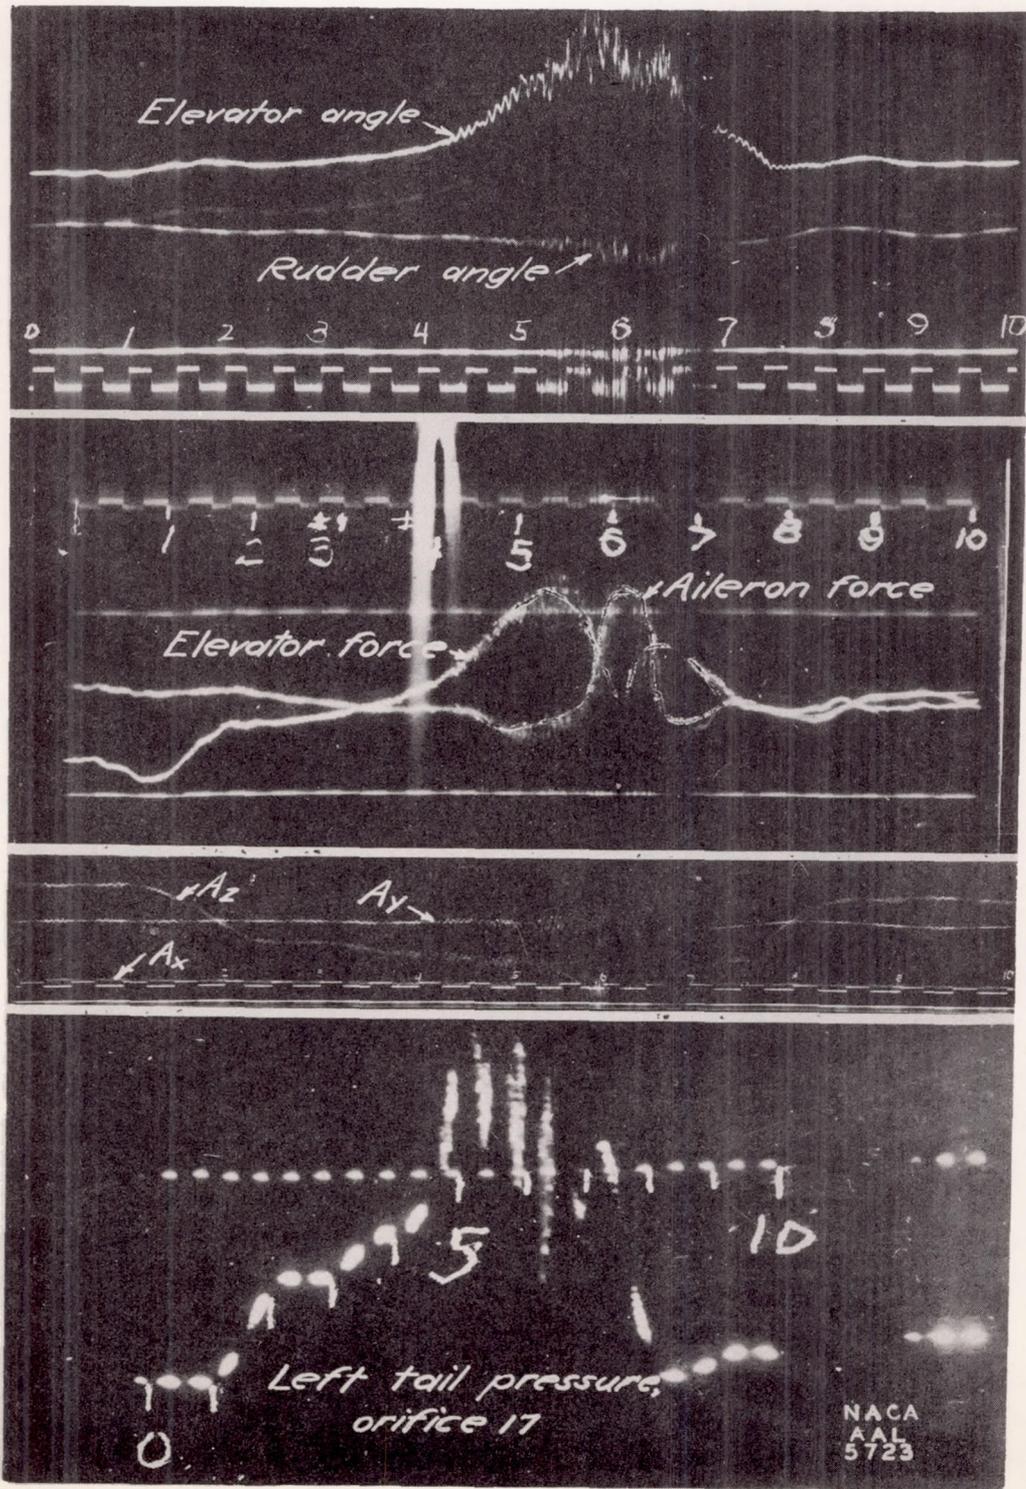
Figure 13.- Continued

In figures 13, 14, and 15 it is seen that the airplane was pulled in until a very violent stall occurred at a lift coefficient of 1.01 and a Mach number of 0.67. The maximum acceleration factor reached was 7.5 at an angle of attack of 19° . The maximum elevator angle used was 11.5° up. The buffeting was apparently about the same on both sides of the tail in this run. Rapid fluctuations of pressure of 300 to 400 pounds per square foot occurred at the leading edge of the stabilizer during the buffeting. The maximum recorded pressures and unit span loads in this run are listed in the following table:

During this run structural failure of the horizontal tail occurred. Since the airplane was operating within maneuvering limits which were considered safe by design specifications in use at the time the airplane was designed, it is of interest to examine the nature of the tail failure in relation to the loads measured, and in relation to the necessity for revision of air load requirements and the manner of specifying safe maneuverability limits to a pilot.

It is difficult to ascertain at just what time in the pull-out the structural failure occurred. Its effect was not noticeable until after steady straight flight had been re-established. Then it was noticed that the longitudinal balance and stability characteristics of the airplane had altered. Figure 13 shows that a sudden decrease of elevator control force occurred at 5.3 seconds while the elevator angle and normal acceleration continued to rise; figure 15 shows a numerical decrease in the elevator load curve at this point also. Again, at 6.2 seconds, as the acceleration is decreasing, there is a sudden increase in elevator control force and recorded elevator angle. It appears, however, that the elevator control at 6.2 seconds may have been applied inadvertently as the ailerons were being deflected to counteract the roll-off occurring during the stall. The lack of effect of the elevator control on the value of the acceleration factor of the airplane was probably due to the stalled attitude of the wing. The increase of acceleration factor at 7.0 seconds, as the elevator control force and elevator angle were decreasing, was probably due to the re-establishment of normal flow over the wing, although the possibility that it was caused by the buckling of the elevator should not be completely discounted.

loads caused much more severe structural strain than the same loads would have caused if applied under static conditions. In the last pull-out, in which the structural failure occurred (figs. 13, 14, and 15), the buffeting was more severe than in any previous maneuver. In this pull-out an attempt had been made to insure absolutely that the maximum acceleration factor possible to attain had been obtained. A strong pull force was exerted on the stick even after heavy buffeting had set in. A slightly greater elevator angle was used than in the previous pull-outs. It should be realized, too, that the loads which were measured during the buffeting condition may actually have been somewhat greater than those recorded, due to lag in the pressure lines.

Revision of the tail-load design requirements and of the manner of specifying safe maneuverability limits to pilots appears necessary.

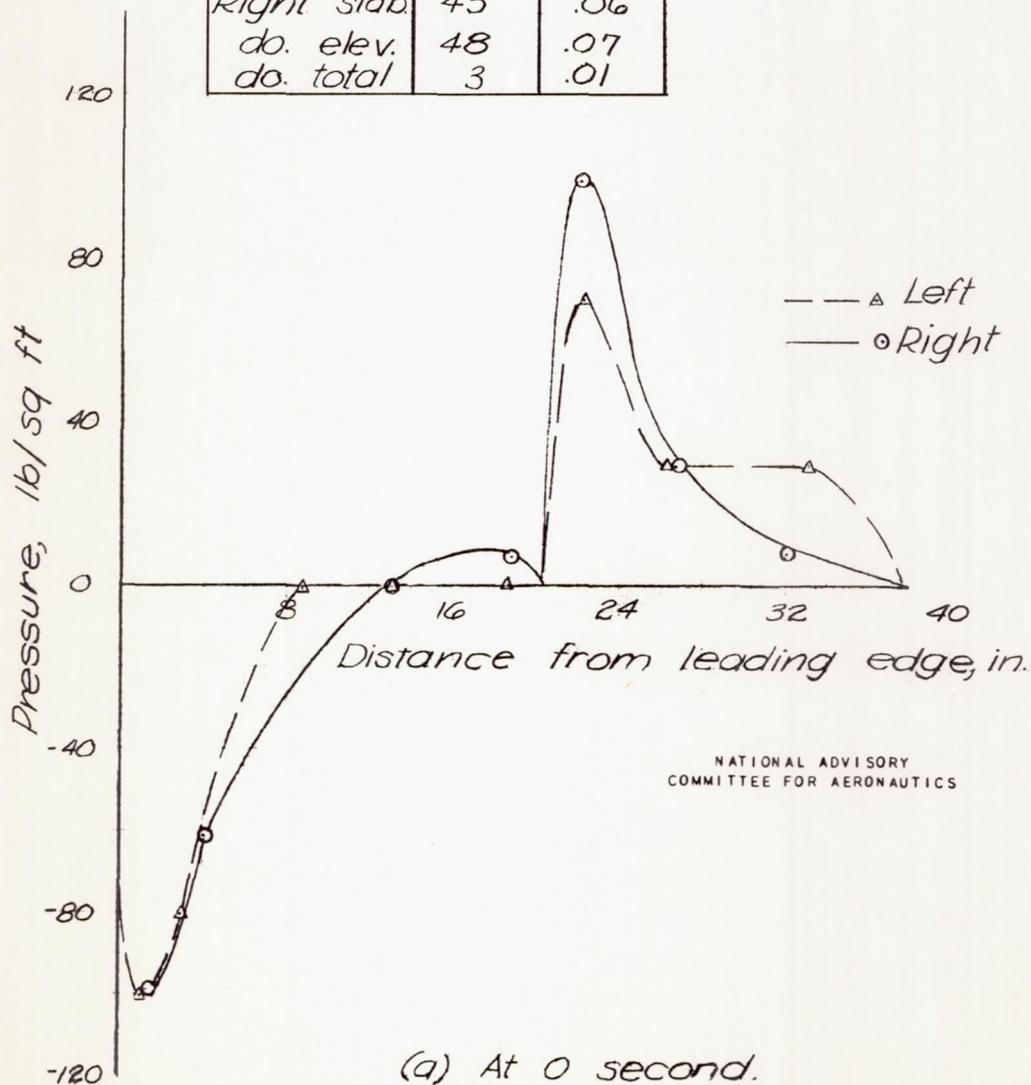
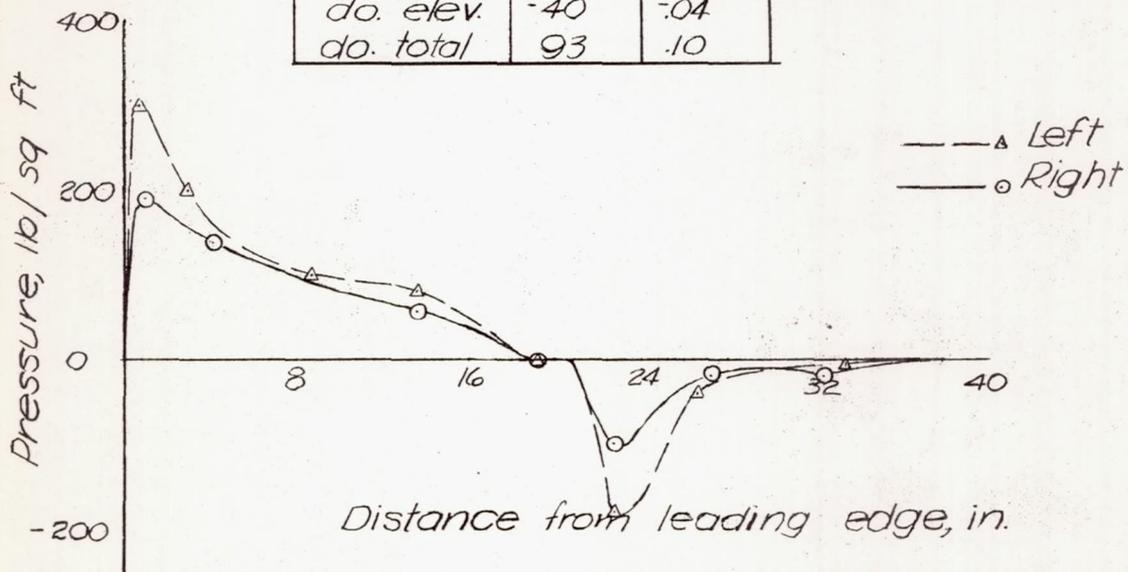
Figure 14. - Chordwise load distribution at 60 percent of semispan in the dive pull-out shown in figure 13.

Figure 24 shows the loading conditions for which the horizontal tail surface was designed. Comparison of this figure with the actual flight measurements (figs. 5, 8, 11, and 14) shows that in many instances the unit loads actually measured on the stabilizer in flight were not only considerably in excess of the design unit loads, but that they occurred in a direction opposite to the design loads. At the leading edge of the elevator, the design unit loads were not exceeded in the pull-outs, at least not at the particular spanwise stations at which measurements were made. However, it was the elevator and a fitting supporting the elevator that failed and not the stabilizer.

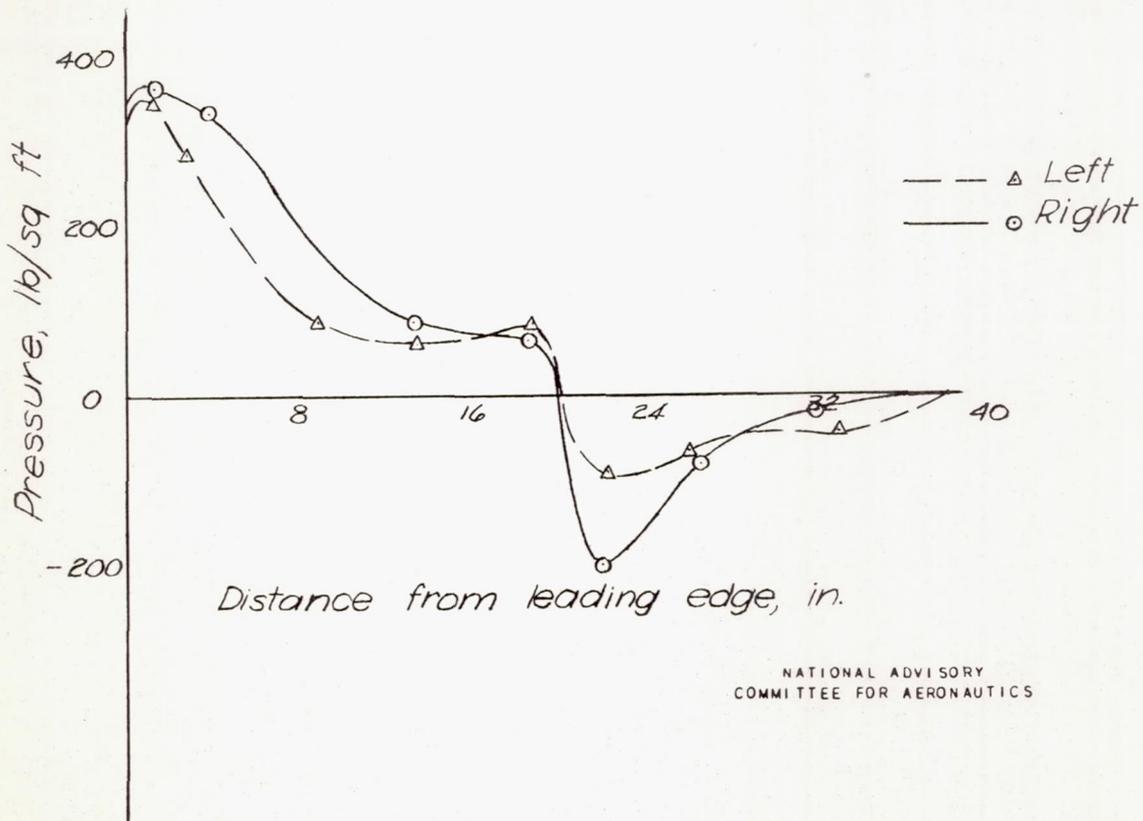
Figure 14.- Concluded.

$V_i = 336 \text{ mph}$
 $M = 0.670$
 Altitude 23,500ft

Chord	lb/ft	C_l
Left stab.	227	.26
do. elev.	-79	-.09
do. total	148	.17
Right stab.	308	.36
do. elev.	-118	-.14
do. total	190	.22

(c) At 5.9 seconds.

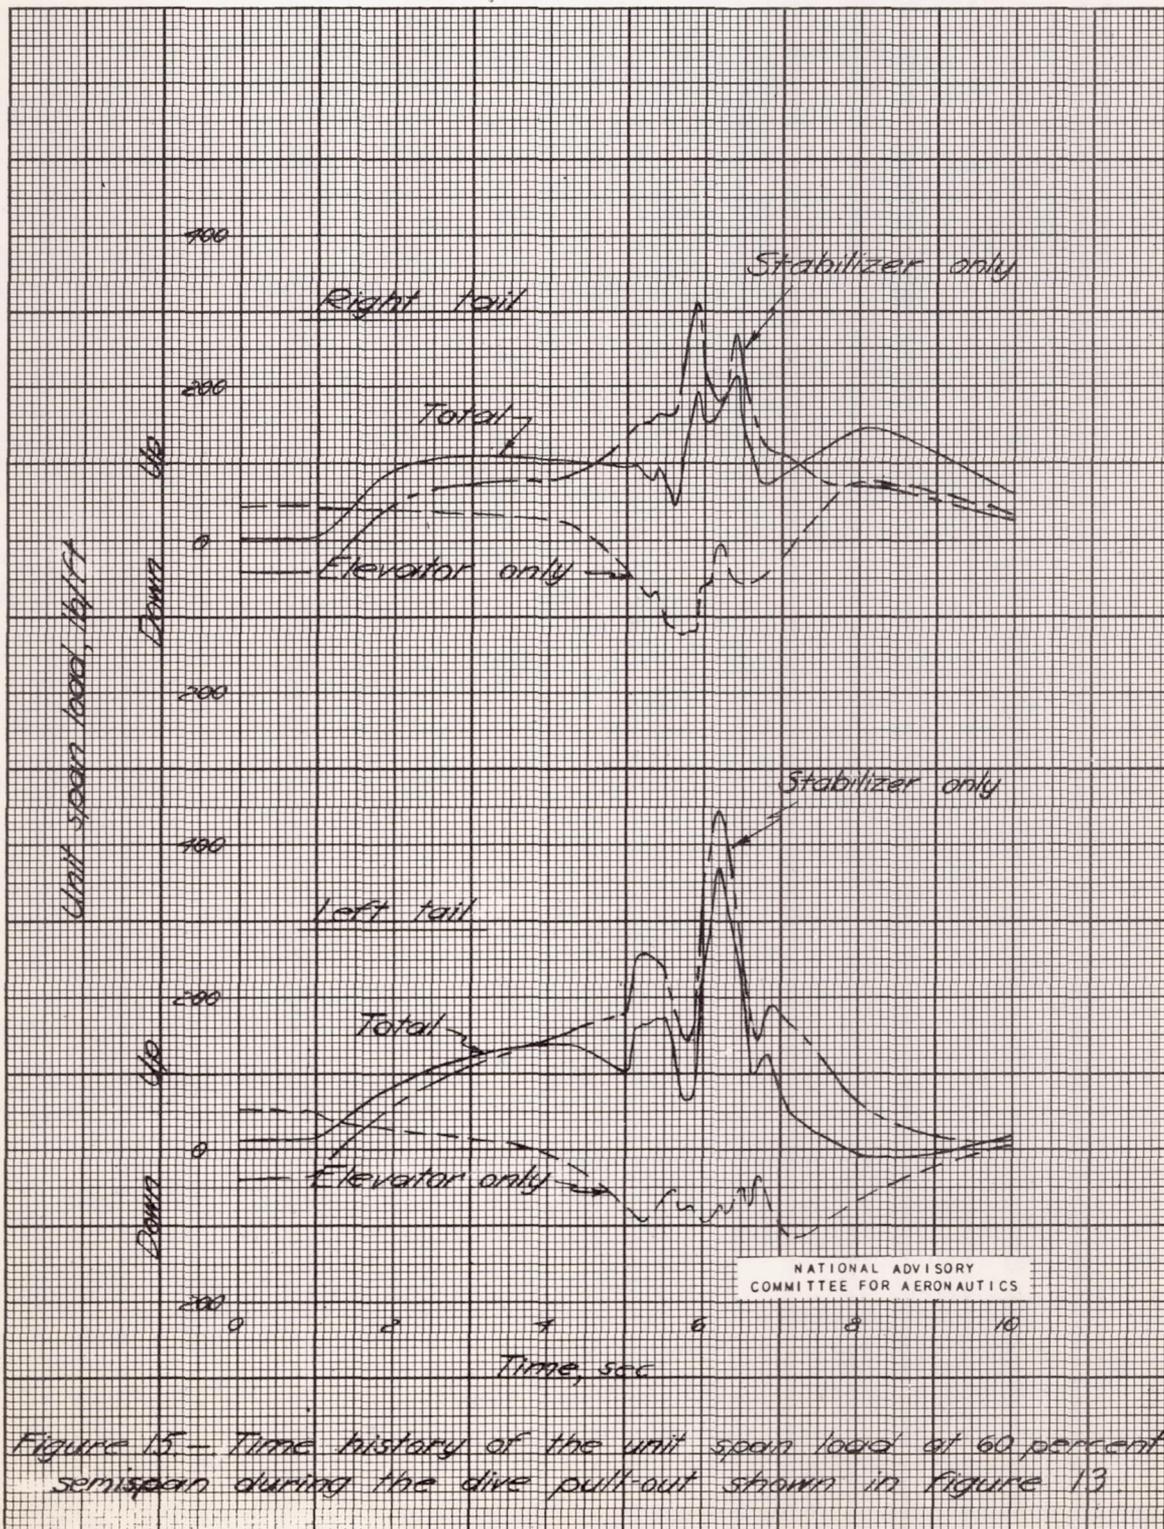
Figure 15 - Time history of the unit span load at 60 percent semispan during the dive pull-out shown in figure 13
