Flight Service Evaluation of Composite Components on the Bell Helicopter Model 206L

Final Report

Henry Wilson

CR-191499

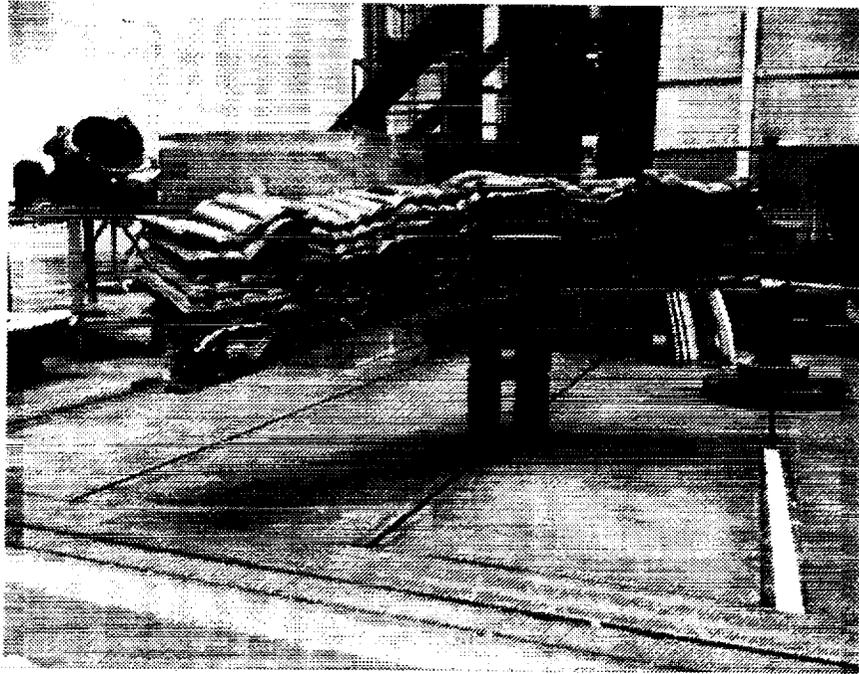
2-L508

The vertical fin was attached to a large base structure, simulating the fin-to-fuselage installation, as shown in Figure 11. Load was applied to the fin by incrementally adding lead shot bags across the surface of the vertical fin, in a manner similar to an aerodynamic loading. Displacement was measured at the upper tip of the fin, using a tube scale. A total of 25 vertical fins were tested. Failure of every vertical fin occurred approximately 10 inches above the upper set of fuselage attach bolts in bending compression of the facesheet (Figure 12).

Figure 11. Vertical Fin Test Set-Up

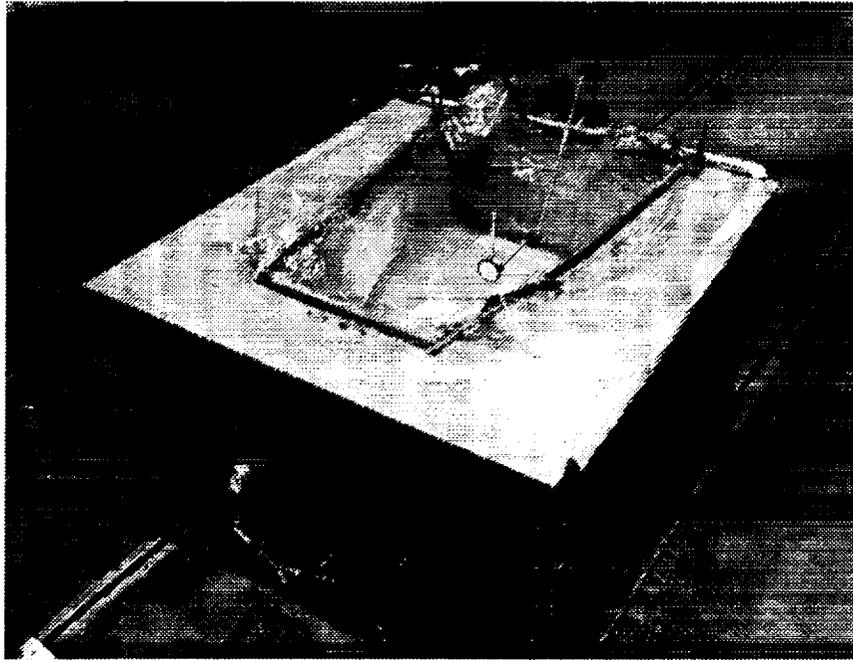
2-L510

Figure 13 displays the test apparatus for the fairing. Due to the shape of this part, aerodynamic pressure testing had to be conducted using a vacuum chamber. Deflection measurements were made at the center of the upper side of the fairing as shown in Figure 14. The fairing was found to deflect very little for the design limit load, thereby making deflection comparisons difficult. There were two distinct failure modes for the forward fairings. A total of 23 fairings were

Figure 13. Forward Fairing Test Set-Up

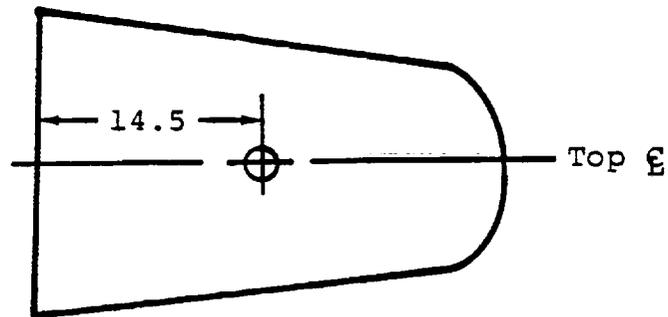
2-L511

Figure 14. Forward Fairing Deflection Measurement Location

tested. The first, and most common, was a local failure around the latches. Approximately five of the fairings failed along the upper corner radius on the inner surface.

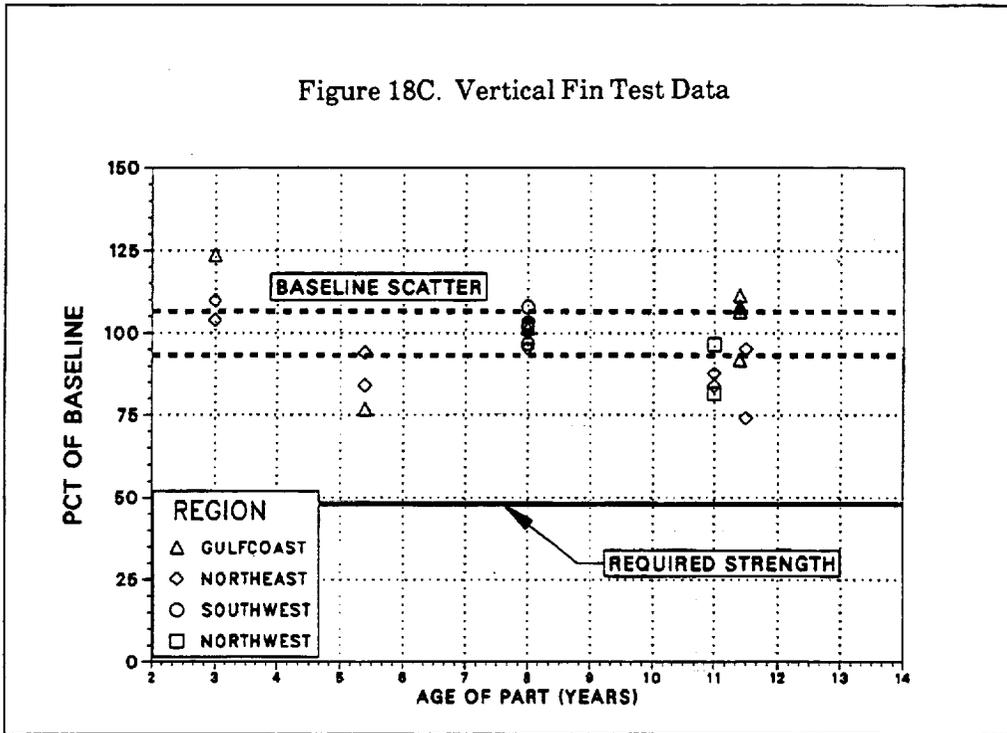
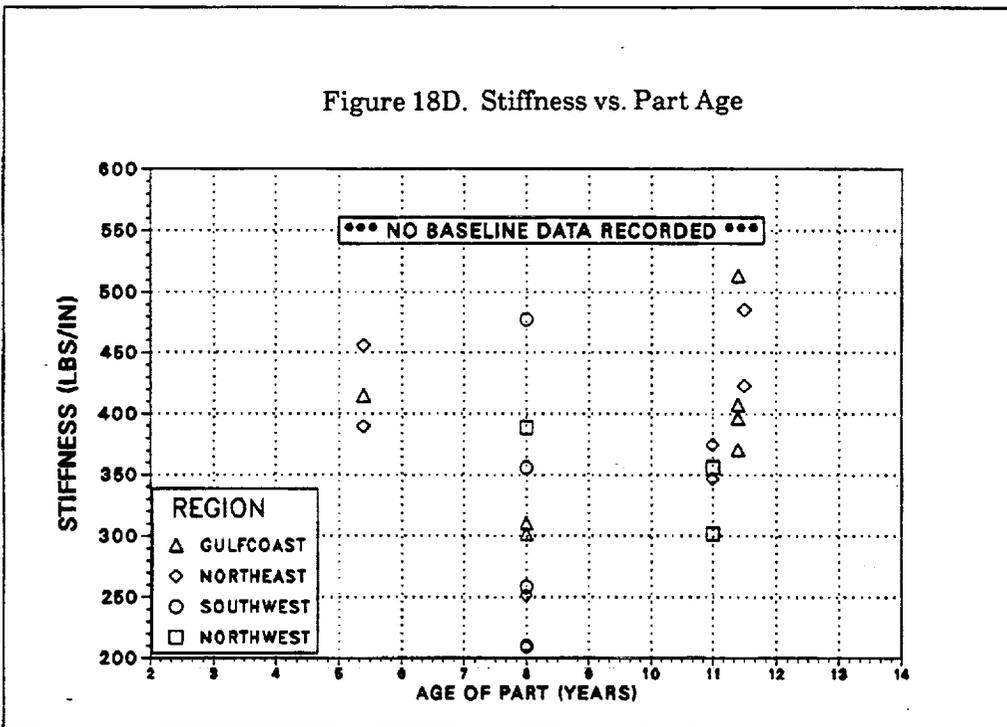
2-L525

The stiffness measurements are extremely scattered, ranging from 40 percent of baseline, to almost 150 percent of baseline. This wide range of data is a result of the manner in which stiffness measurements are collected for this part. At 100 percent limit load, there is generally very little deflection at the critical location on the forward fairing. The measurement device (dial indicator) used during these tests, was not sensitive enough to register very small amounts of deflection. Therefore, small deviations in the measured deflection from specimen to specimen, resulted in large differences in recorded stiffness. It is noted that between the 8-year and 11-year test inter-

Figure 18D. Stiffness vs. Part Age

Figure 18. Vertical Fin Test Data (Continued)

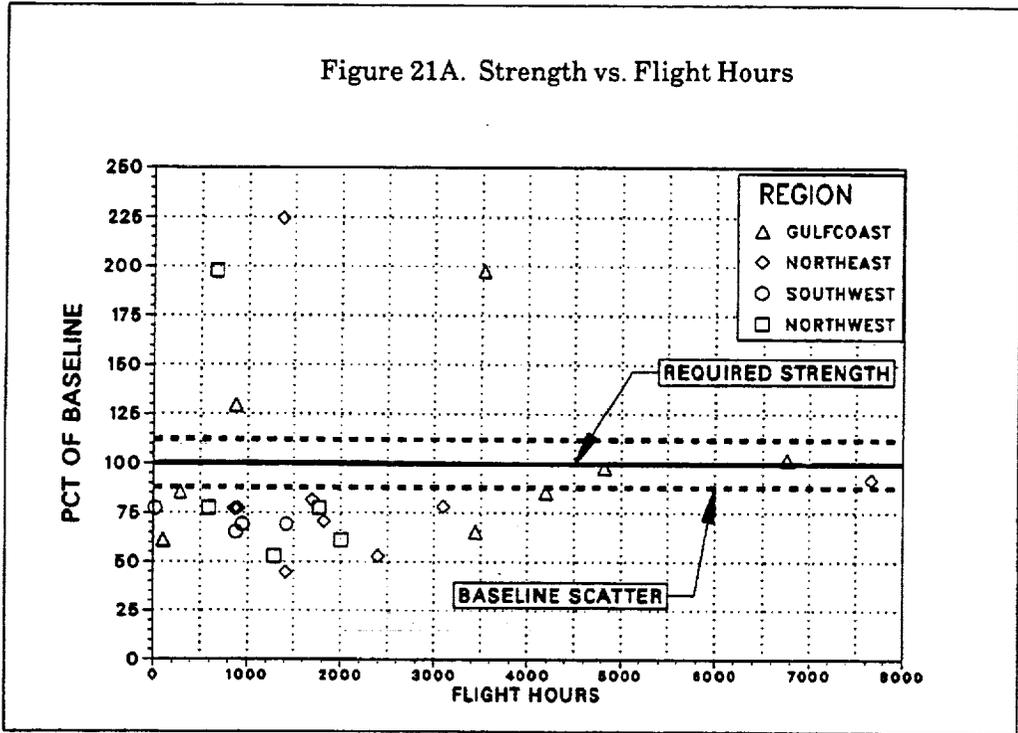
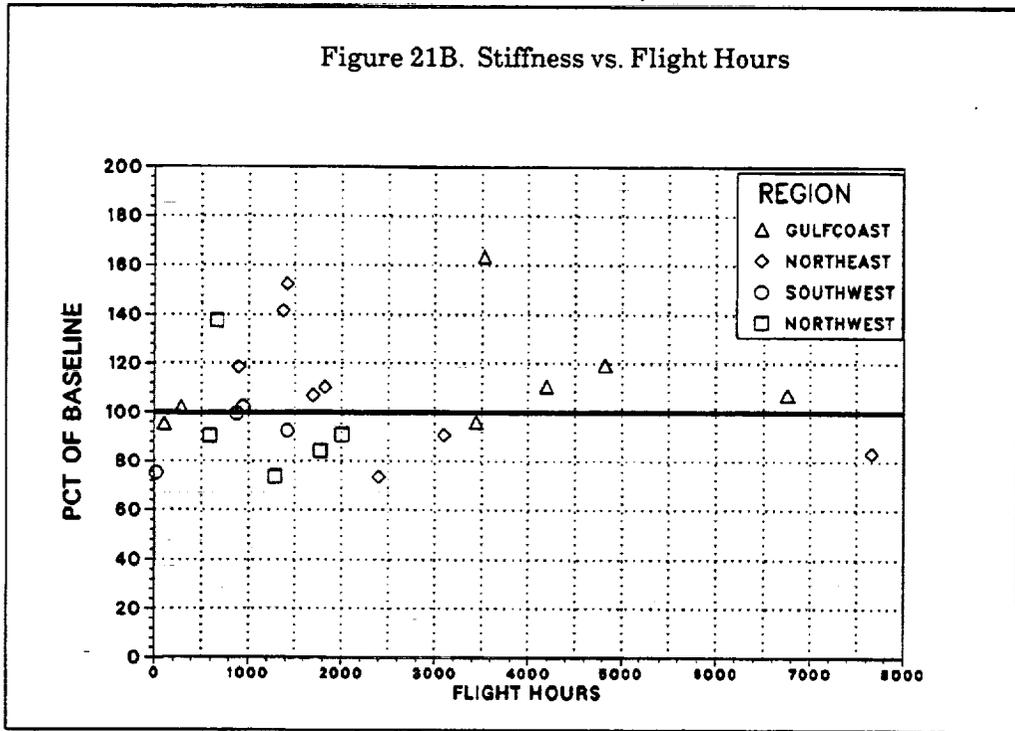
2-L545

Figure 21A. Strength vs. Flight Hours

Figure 21B. Stiffness vs. Flight Hours

Figure 21. Baggage Door Test Data

The problems associated with the matrix system used to manufacture the baggage doors with the Kevlar-49/LRF-277 material are apparent in both the component and coupon testing. The debonding of the facesheets and the core by the components, lead to degraded strength on almost every part. Similarly, the compressive and shear strengths (matrix-dominant properties) of the coupons for this system degraded a significant amount. The retention of properties by the coupons produced from the other material systems agrees with the property retention of the vertical fins, litter doors and fairings.

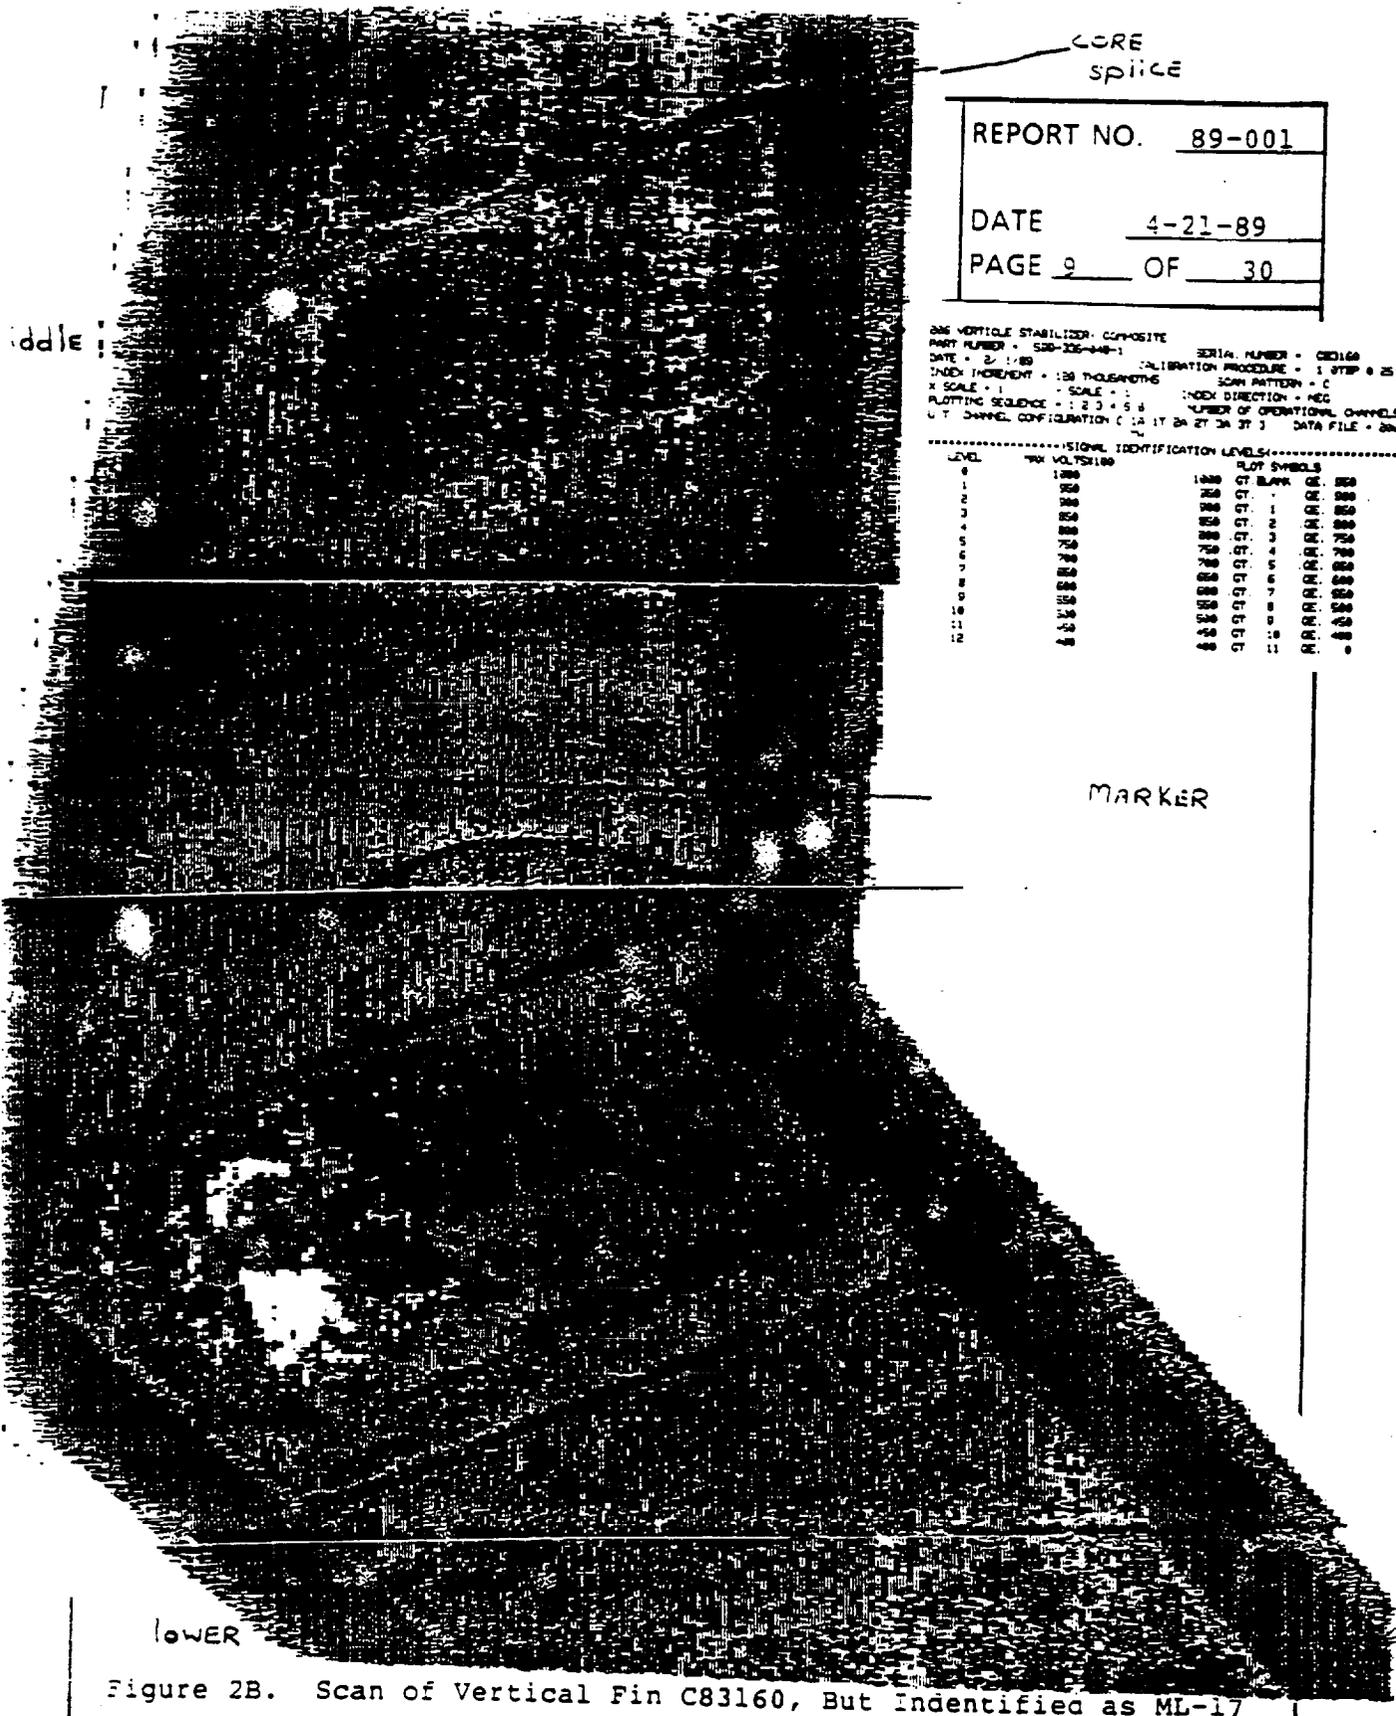
Figure 2A. Scan of Vertical Fin C83160, But Identified as ML-17

The vertical fin scans are shown in Figures 1 - 4. The vertical Fins ML-09, ML-17 and ML-23 show no field/service damage. The ML-22 scan (Figure 3A) shows field/service damage of 1,013 sq. in.
