TWR-64204

Final Postflight Hardware Evaluation Report 360T026 (RSRM-26, STS-47)

May 1993

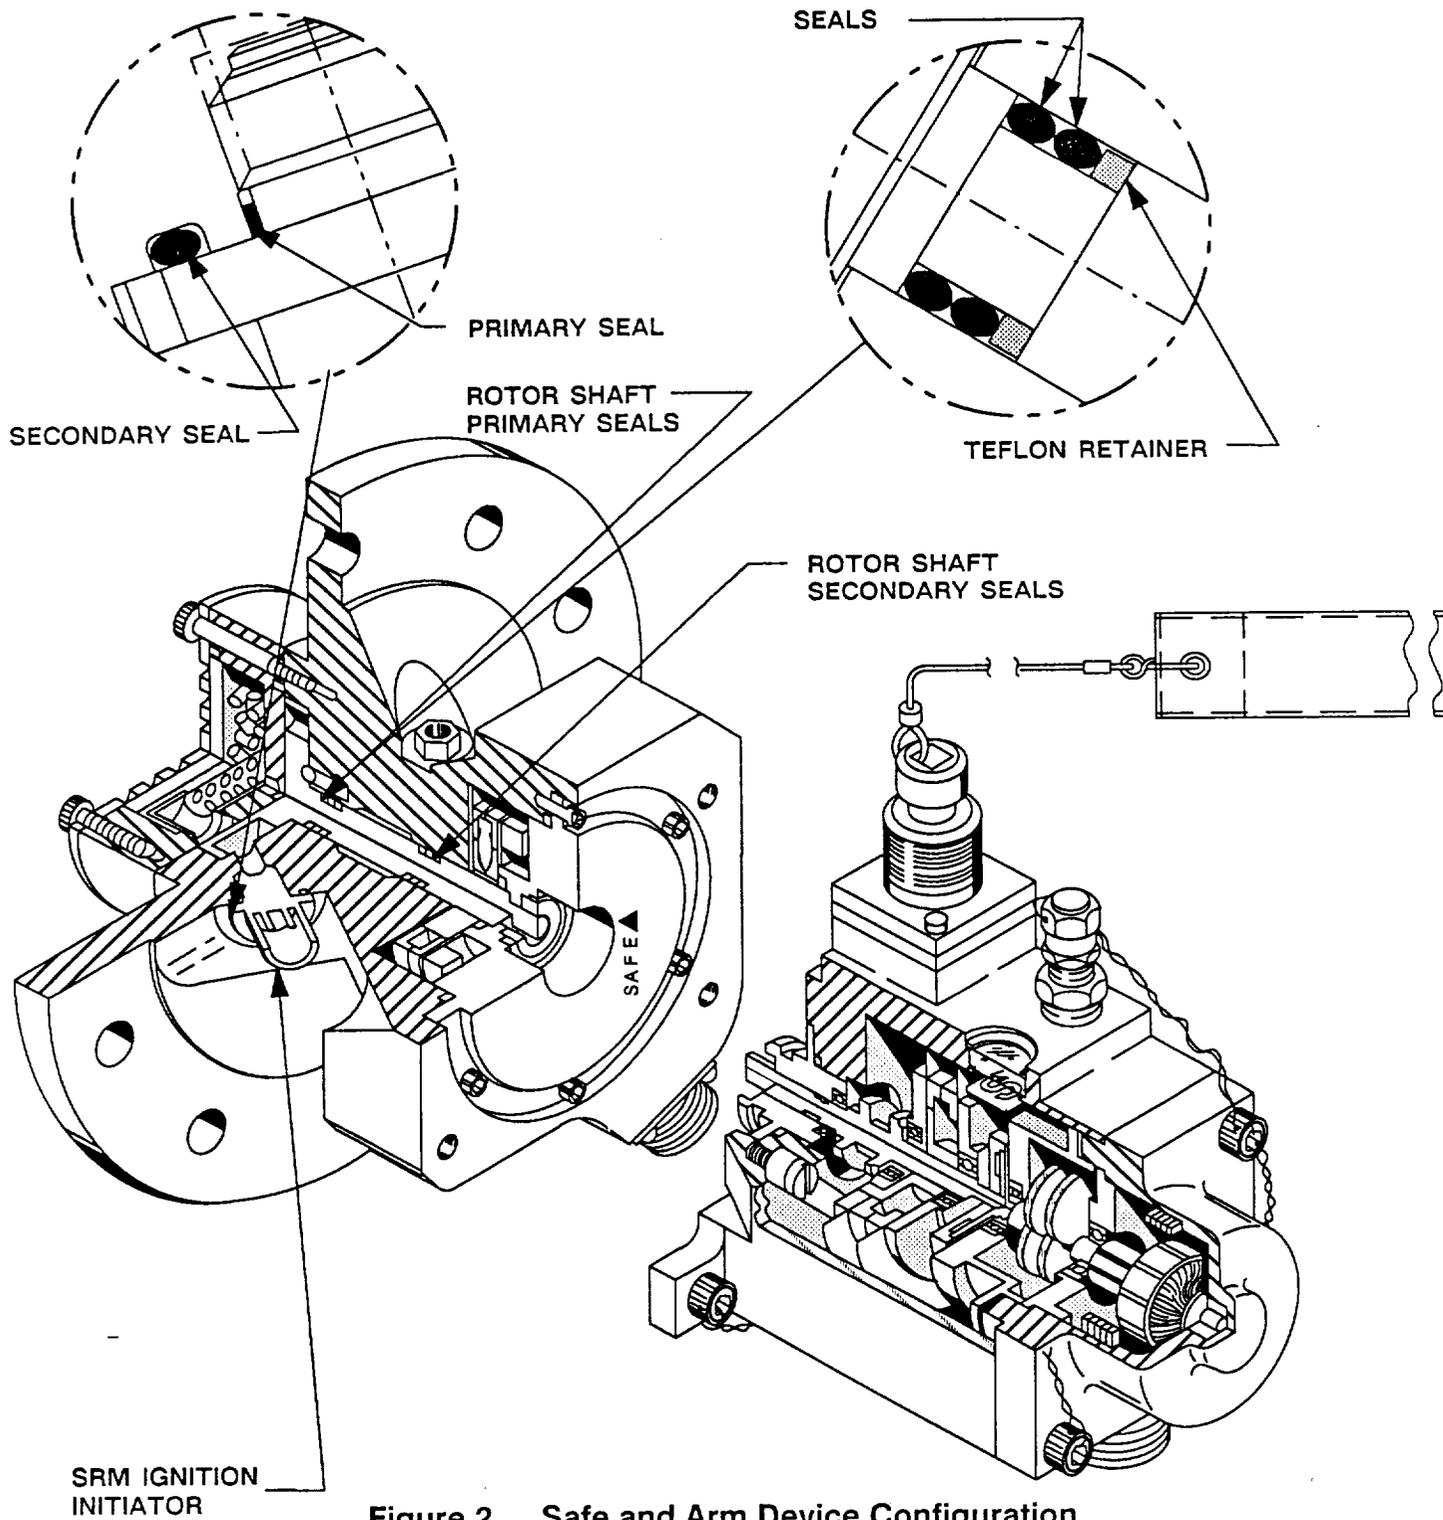
Figure 2. Safe and Arm Device Configuration

Typical soot was observed up to, but not past, the forward primary rotor shaft O-ring of both S&As. No O-ring or other seal surface damage was observed.

One anomalous condition was observed. A scratch was observed on the LH S&A 306 degree leak check plug. Preliminary PFAR 47C-14 was written on this condition. The scratch was "V"-shaped and oriented in a radial direction. The cause or time of occurrence was unknown. Typical galling on the land between the SII port primary and secondary seal surfaces was observed on both S&As. No other O-ring, plug or seal surface damage was observed.

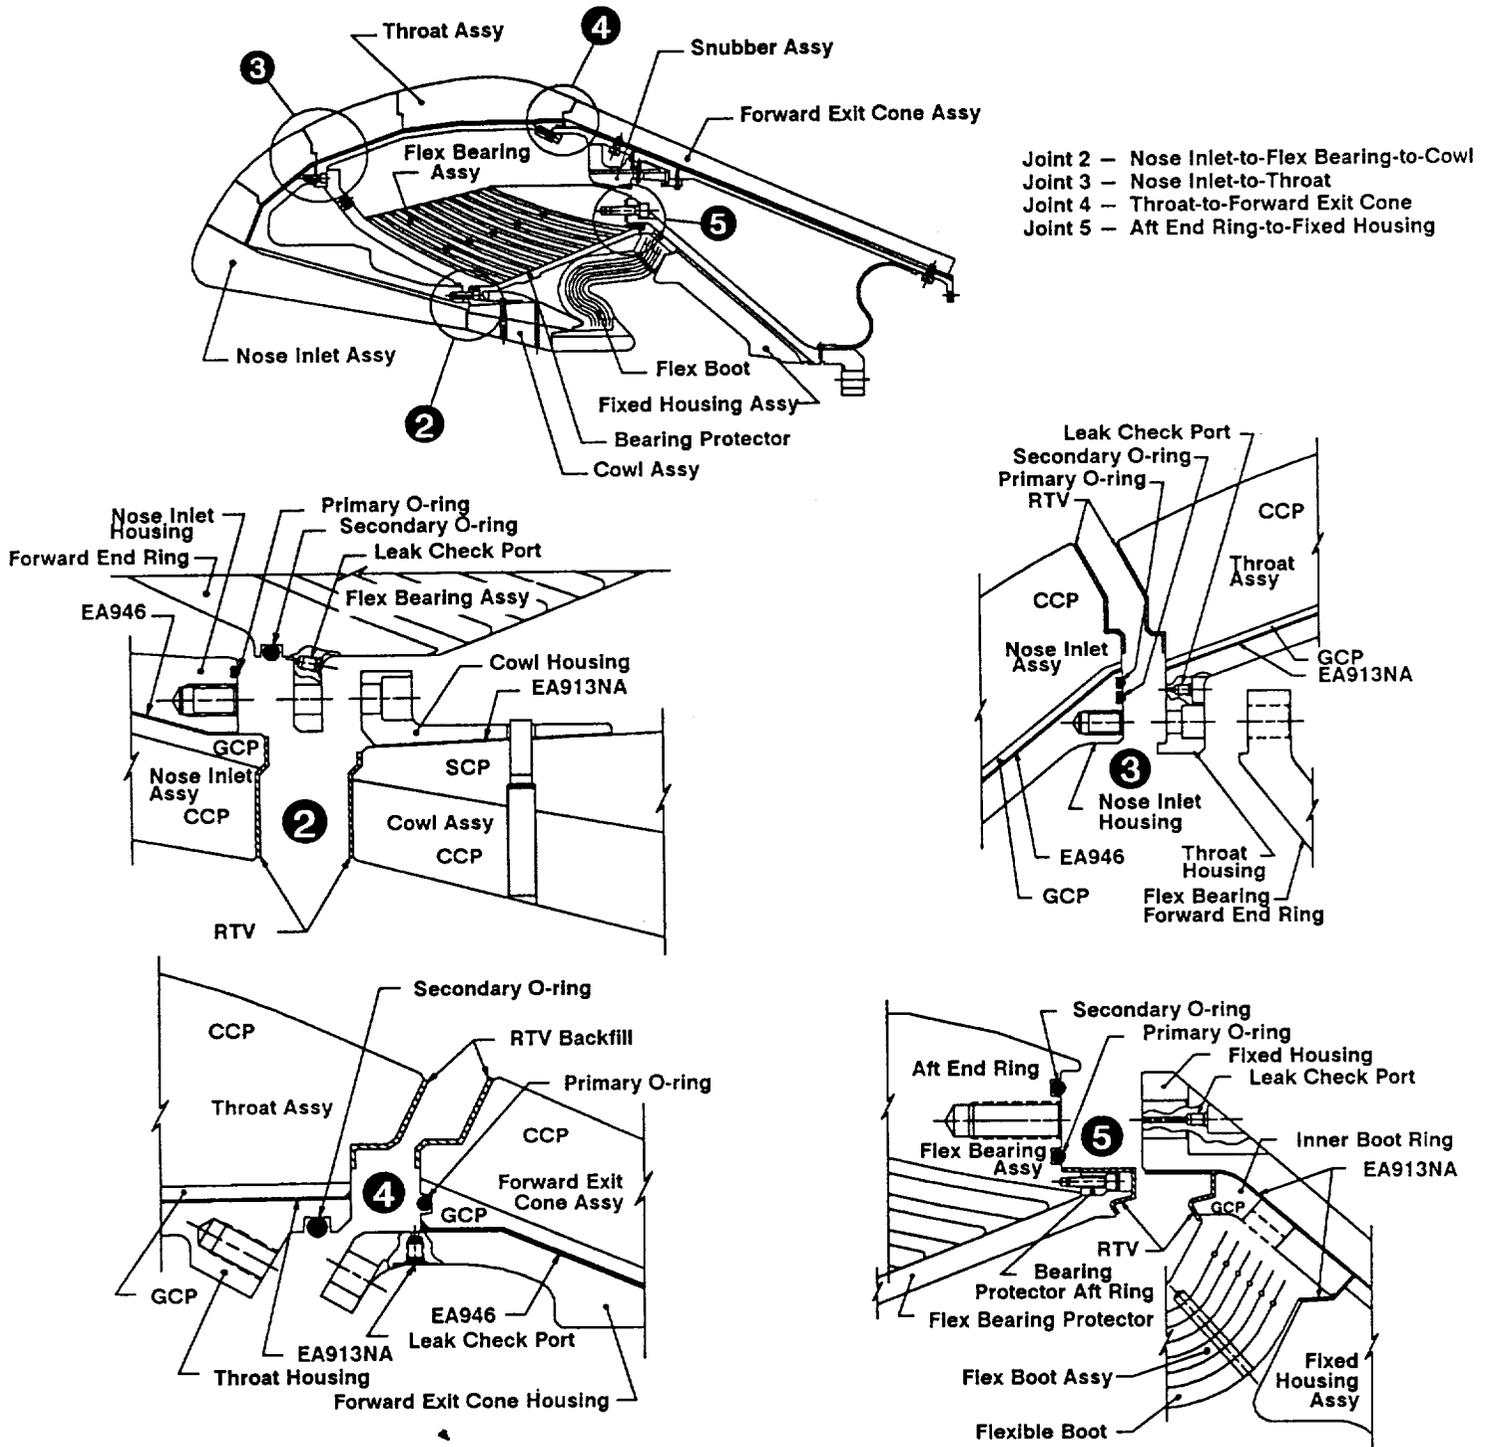
Figure 3. Internal Nozzle Joint Configuration

damaged phenolic liners at 352-0-5 degrees on the nose cap and forward end of the forward inlet ring. Preliminary PFA 47C-01 was written on this condition. The RH nozzle forward exit cone showed foreign material around three of the aft end shear pin screws in the CCP/GCP interface. Samples were taken and Preliminary PFA 47C-02 was written on this condition. Analysis of the foreign material shows it was grease.

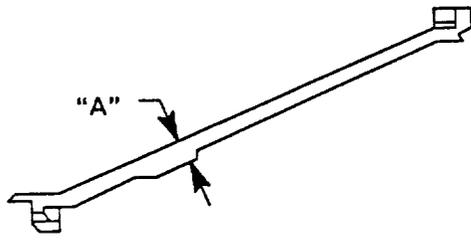
* "A" is the minimum thickness of the bearing protector in-line with the cowl vent holes. It corresponds to the deepest gas impingement location.

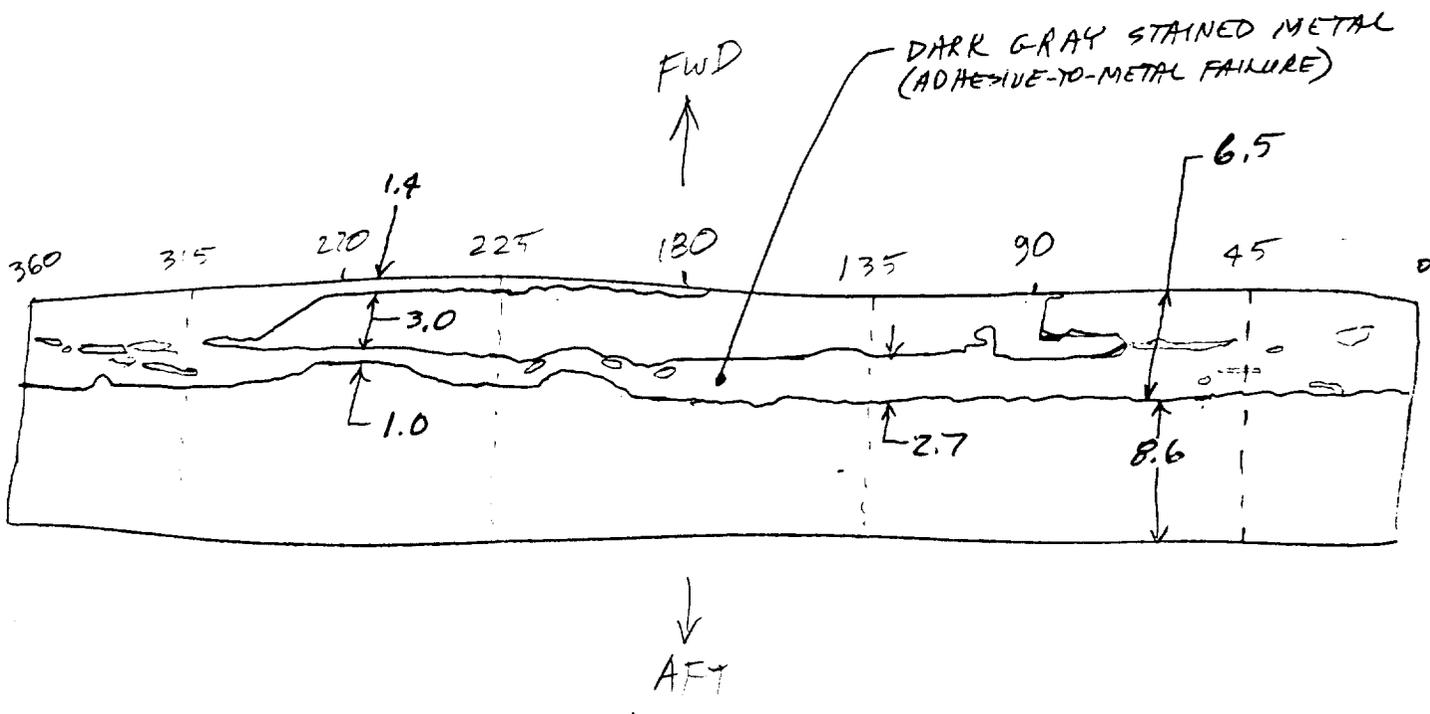
Motor No.: 360T026	Side: <input checked="" type="checkbox"/> Left (A) <input type="checkbox"/> Right (B)	Date: 10-2-92
Assessment Engineer(s)/Inspector(s): WILKES		
Description: FIXED HOUSING BONDLINE ADHESIVE STAIN MAP

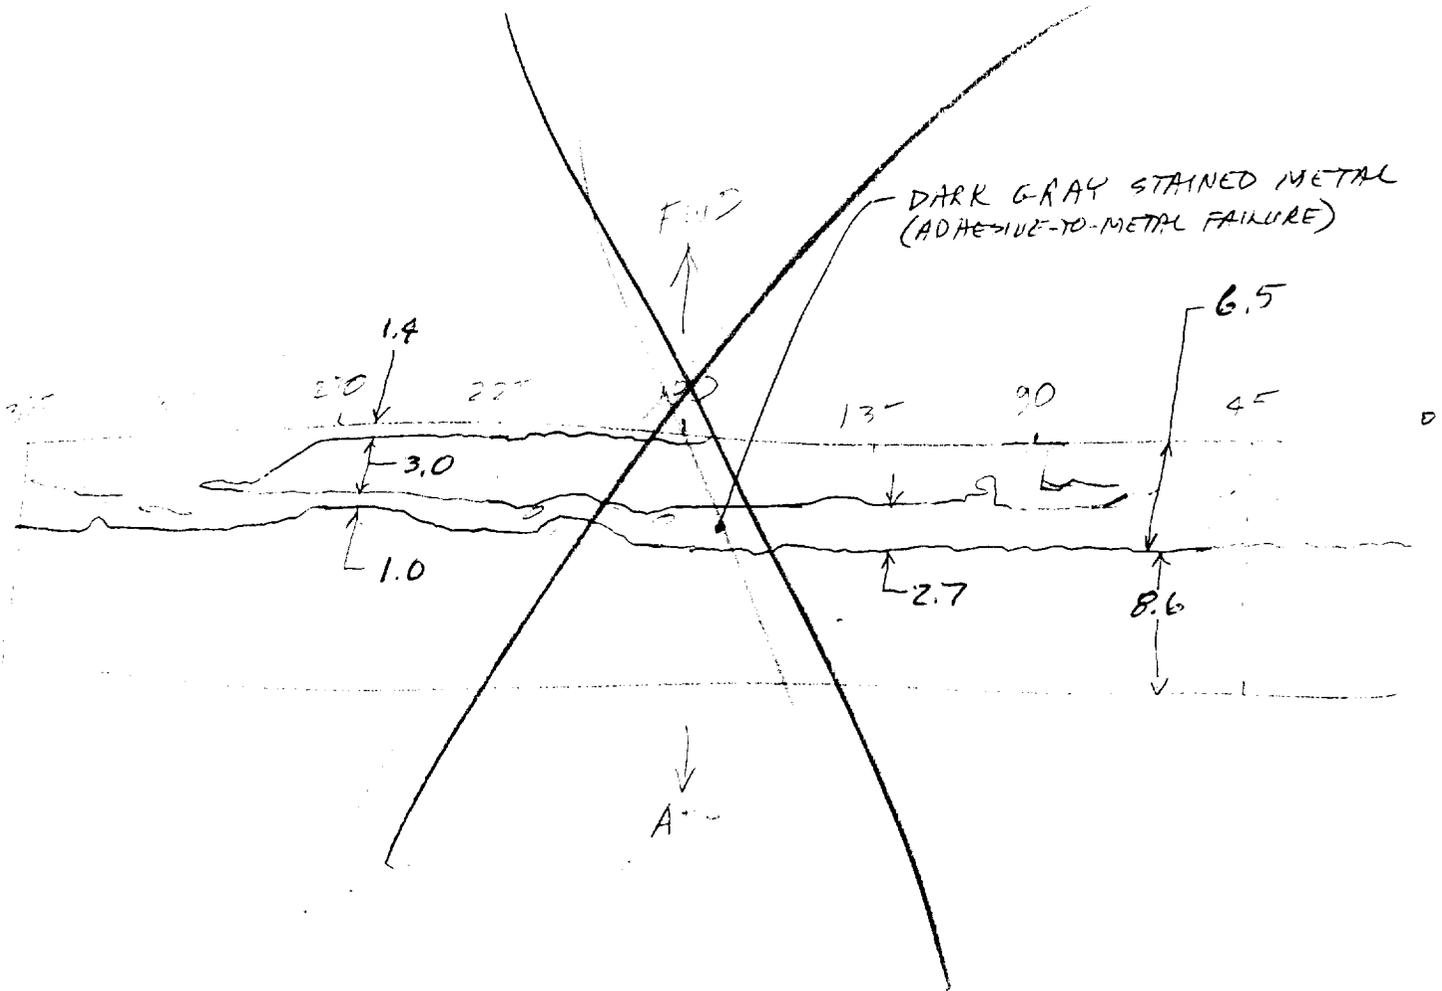
Motor No.: 360T026	Side: <input checked="" type="checkbox"/> Left (A) <input type="checkbox"/> Right (B)	Date: 10-2-92
Assessment Engineer(s)/Inspector(s): WILKES		
Description: FIRED HOLDING BONDLINE ADHESIVE STAIN MAP

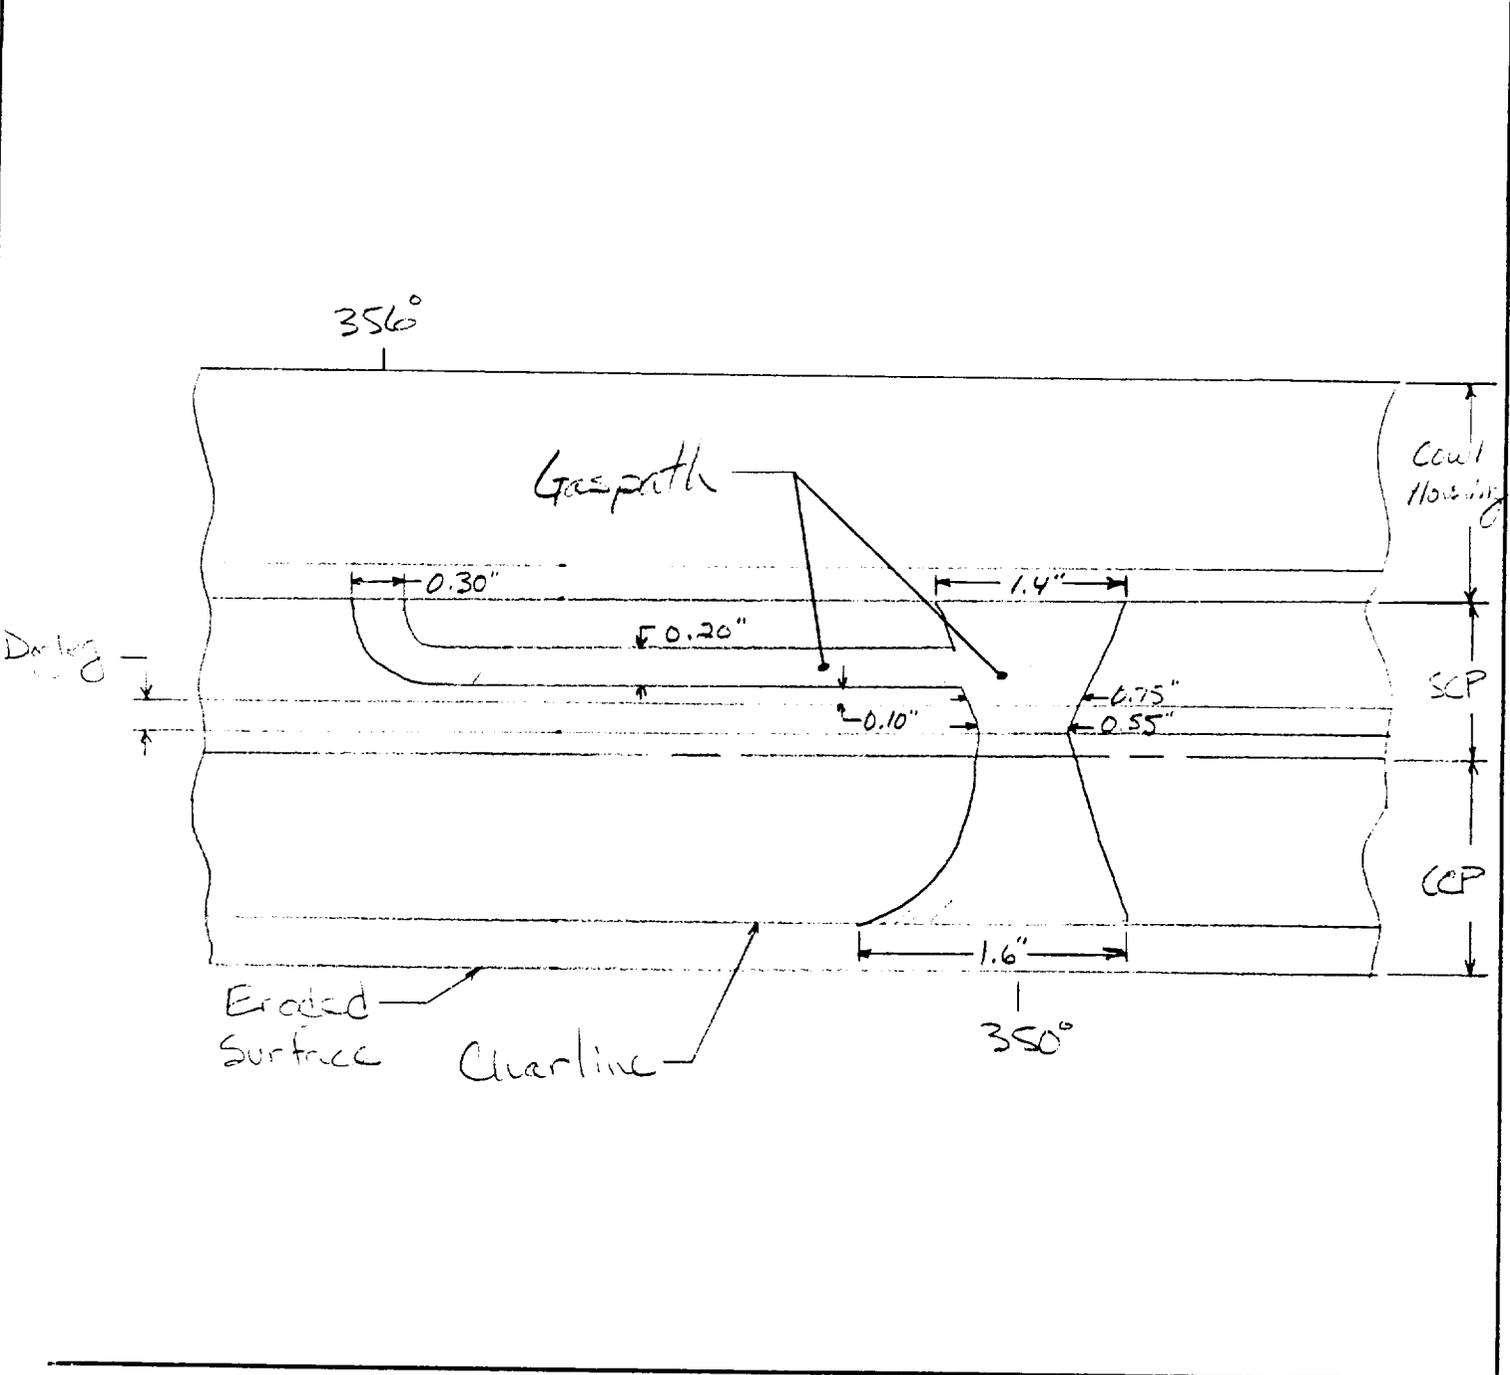
Motor No.: 360T026	Side: <input type="checkbox"/> Left (A) <input checked="" type="checkbox"/> Right (B)	Date: 10-1-92
Assessment Engineer(s)/Inspector(s): M. Clark, B. Quick, T. Freston		
Description: Joint 2 Gaspath

Corresponding Comment Number(s): 3

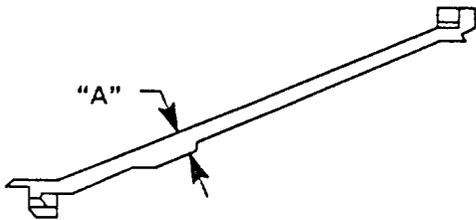
* "A" is the minimum thickness of the bearing protector in-line with the cowl vent holes. It corresponds to the deepest gas impingement location.

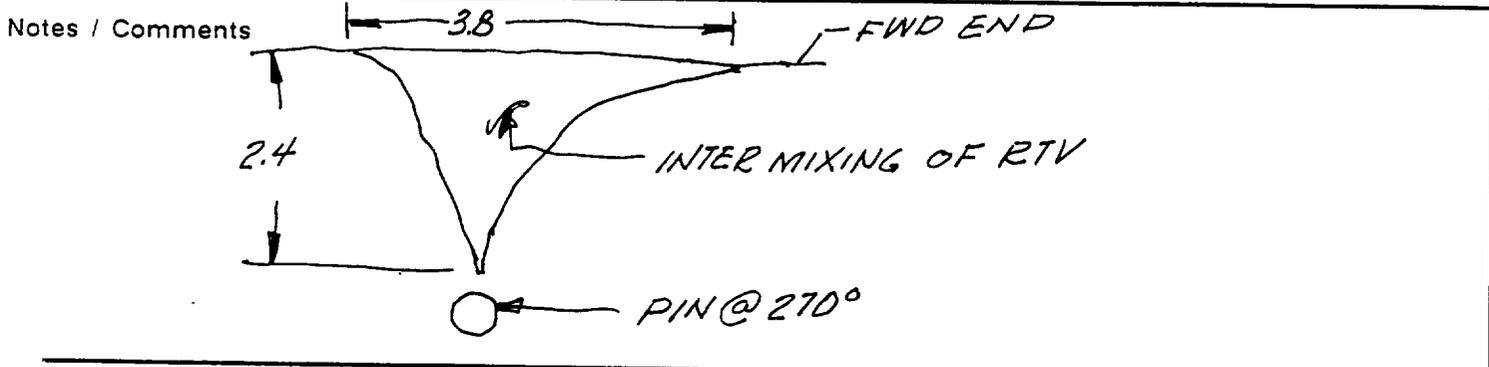
Nozzle Subassembly Bondline Adhesive Void Clarification Form

Notes / Comments: ① VERY FEW SMALL VOIDS 0.30 INCH MAXIMUM DIAMETER WERE OBSERVED.

Degree Location	Void Size		Location on Bonding Surface	
	Axial	Circ.	Distance From Fwd	Distance From Aft
<i>90°</i>	<i>.80</i>	<i>.28</i>	<i>.60</i>	
<i>282°</i>	<i>.58</i>	<i>.20</i>	<i>.20</i>

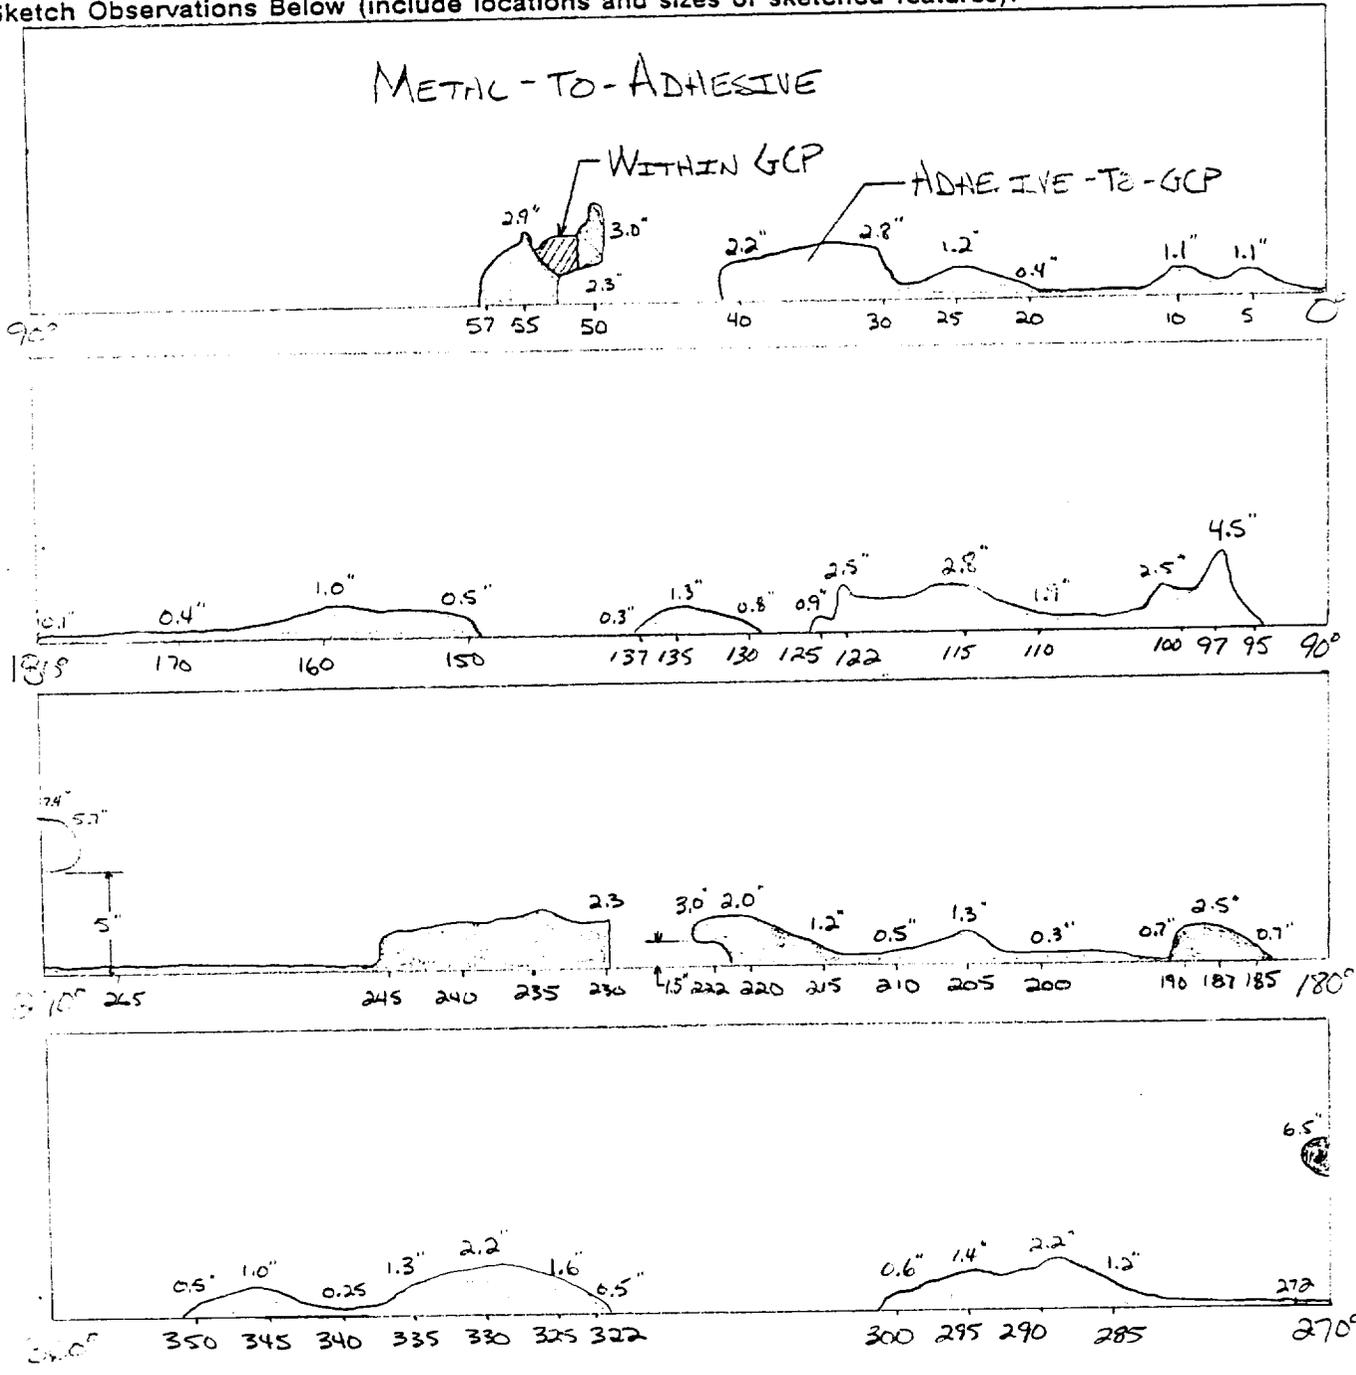
General Hardware Clarification Form

Motor No.: 360T026	Side: <input type="checkbox"/> Left (A) <input checked="" type="checkbox"/> Right (B)	Date: 10-2-92
Assessment Engineer(s)/Inspector(s): M. Clark		
Description: Fixed housing bondline separation (Fixed Housing Side)		
Sketch Observations Below (include locations and sizes of sketched features):

Corresponding Comment Number(s): 2

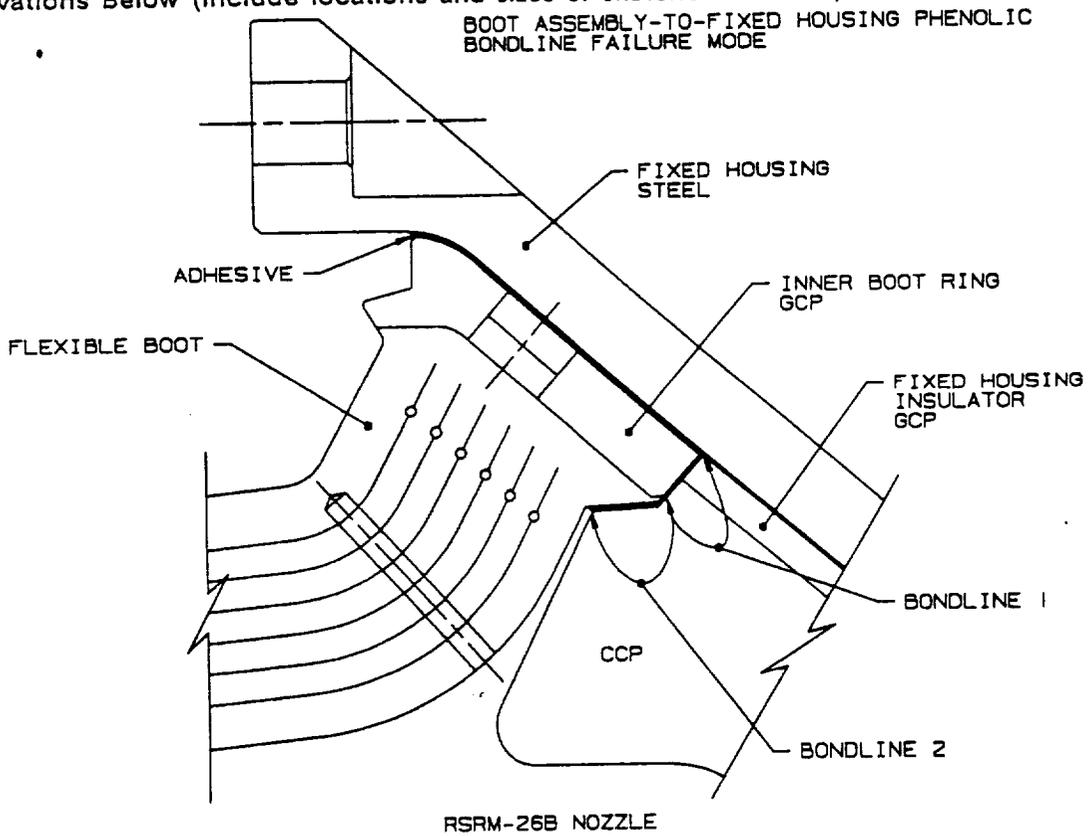
Description: BOOT ASSEMBLY-TO-FIXED HOUSING PHENOLIC BONDLINE

BONDLINE 1 FAILURE MODE IBR-TO-FIXED HSG PHENOLICS	PERCENT OF CIRCUMFERENCE
FIXED HSG-TO-ADHESIVE	5
WITHIN ADHESIVE	9
IBR-TO- ADHESIVE	86

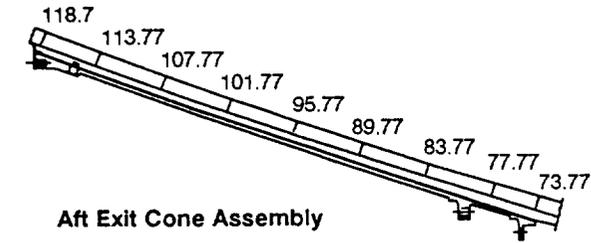
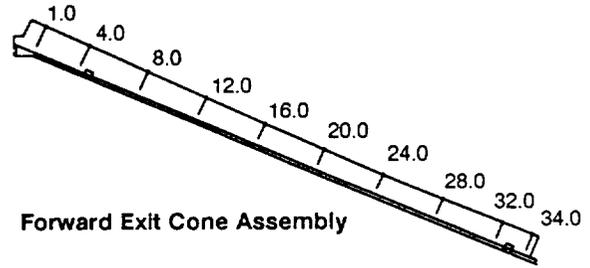
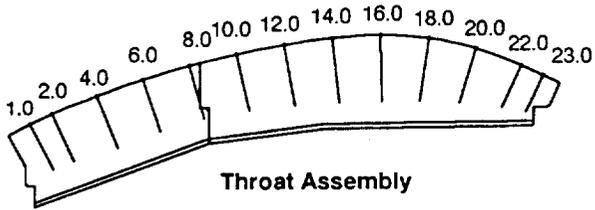
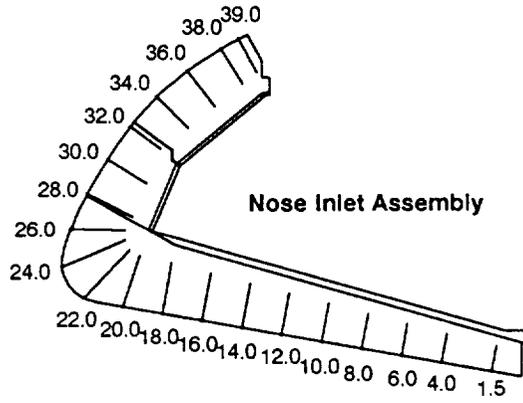
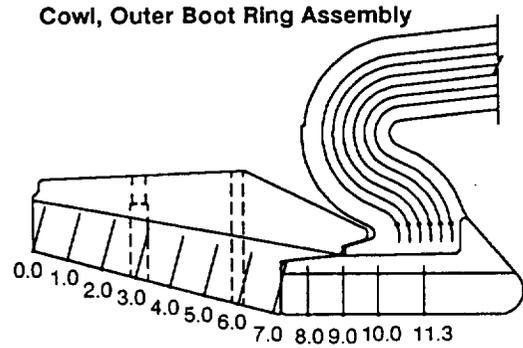
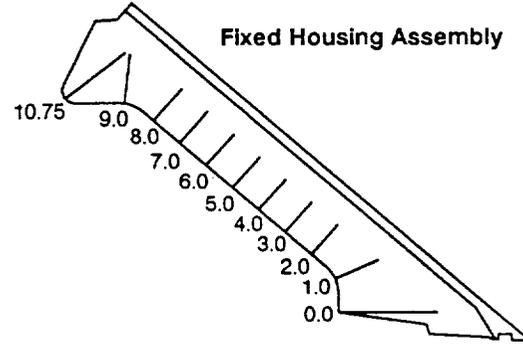
Figure 1
Nozzle Liner Char and Erosion Station Locations

Char and erosion margins of safety are summarized in Table 8. The char and erosion data tables for each component liner can be found in Appendix D. Measurement stations that contain an "N/A" means that data was not available due to missing material. The RH aft exit cone liner was not recovered and therefore is not included. Three large LH aft exit cone fragments were recovered from inside the motor at the KSC Hangar AF. Each fragment was sectioned in two places and evaluated. No plylifting or axial orientation features were present on the fragments. Therefore, erosion and char calculations could not be made. All stations showed positive margins of safety. The measurement stations can be found in Figure 1 of Appendix D.
