NASA Contractor Report 194439

A Review of Wiring System Safety in Space Power Systems

Mark W. Stavnes and Ahmad N. Hammoud
Sverdrup Technology, Inc.
Lewis Research Center Group
Brook Park, Ohio

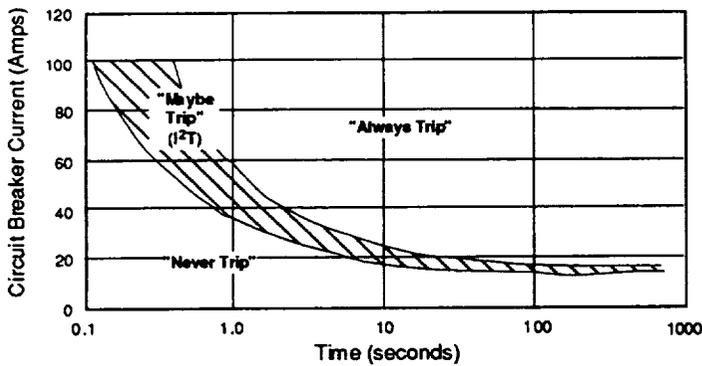
Figure 1. Thermal Circuit Breaker Trip Characteristics [6]

between conductors, averaged 30 Amps with spikes up to 50 amps [6]. Based on the total thermal energy in the circuit, current would have to flow through the breaker at a 30 Amp level for approximately 2.0 seconds to trip the circuit breaker, while a 50 Amp current would trip the circuit breaker after 0.5 second [9]. The teleprinter cable short did not trip the circuit breaker in this case because there was not enough thermal energy generated by the arc-tracking fault before it eventually extinguished itself [6].
