Debris/Ice /TPS Assessment and Integrated Photographic Analysis for Shuttle Mission STS-61

January 1994

DEBRIS/ICE/TPS ASSESSMENT
AND
INTEGRATED PHOTOGRAPHIC ANALYSIS
OF
SHUTTLE MISSION STS-61

December 2, 1993

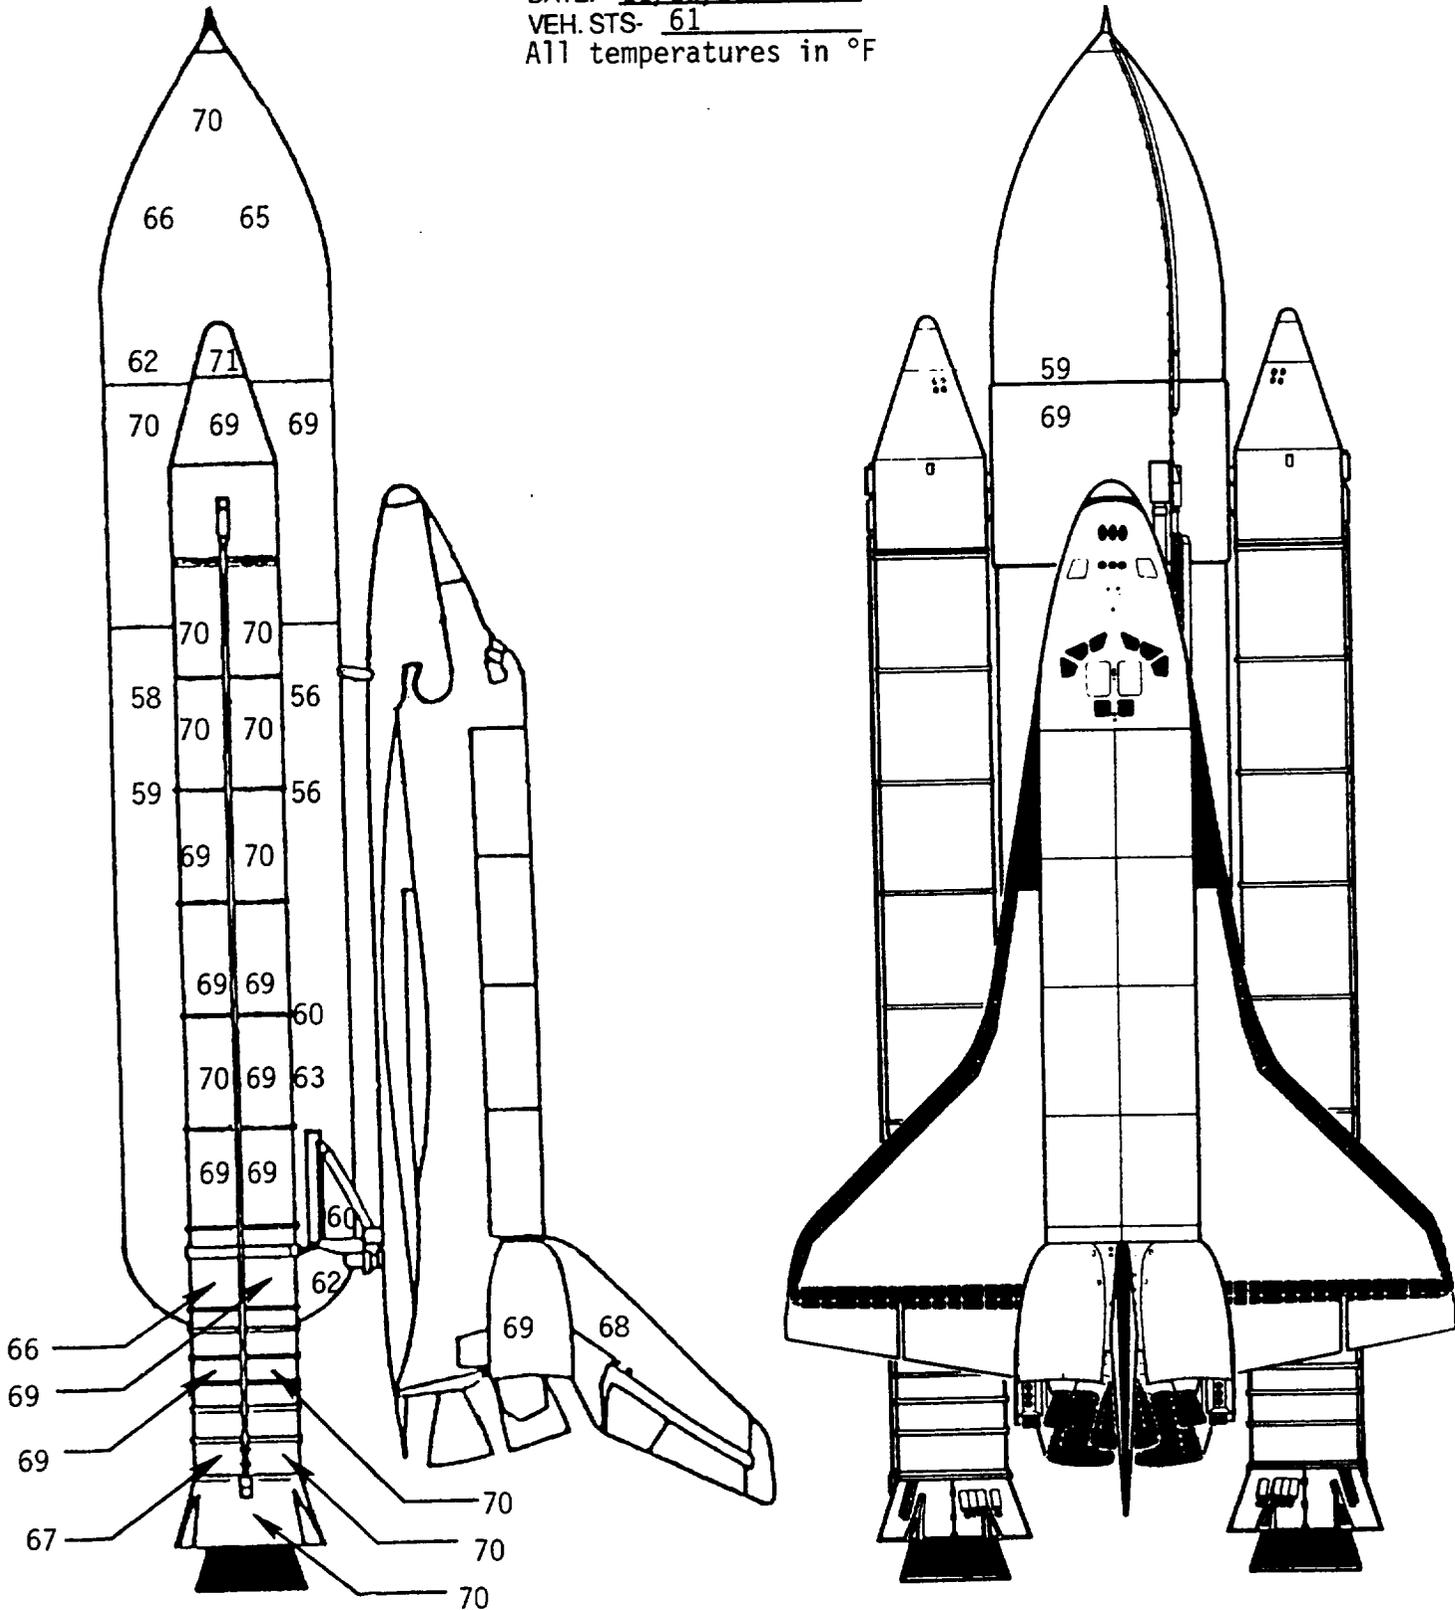
FIGURE 1. **SSV INFRARED SCANNER
SURFACE TEMPERATURE
SUMMARY DATA**

A portable Shuttle Thermal Imager (STI) was used to obtain vehicle surface temperature measurements (ref Figures 1 and 2) for a thermal assessment of the vehicle .

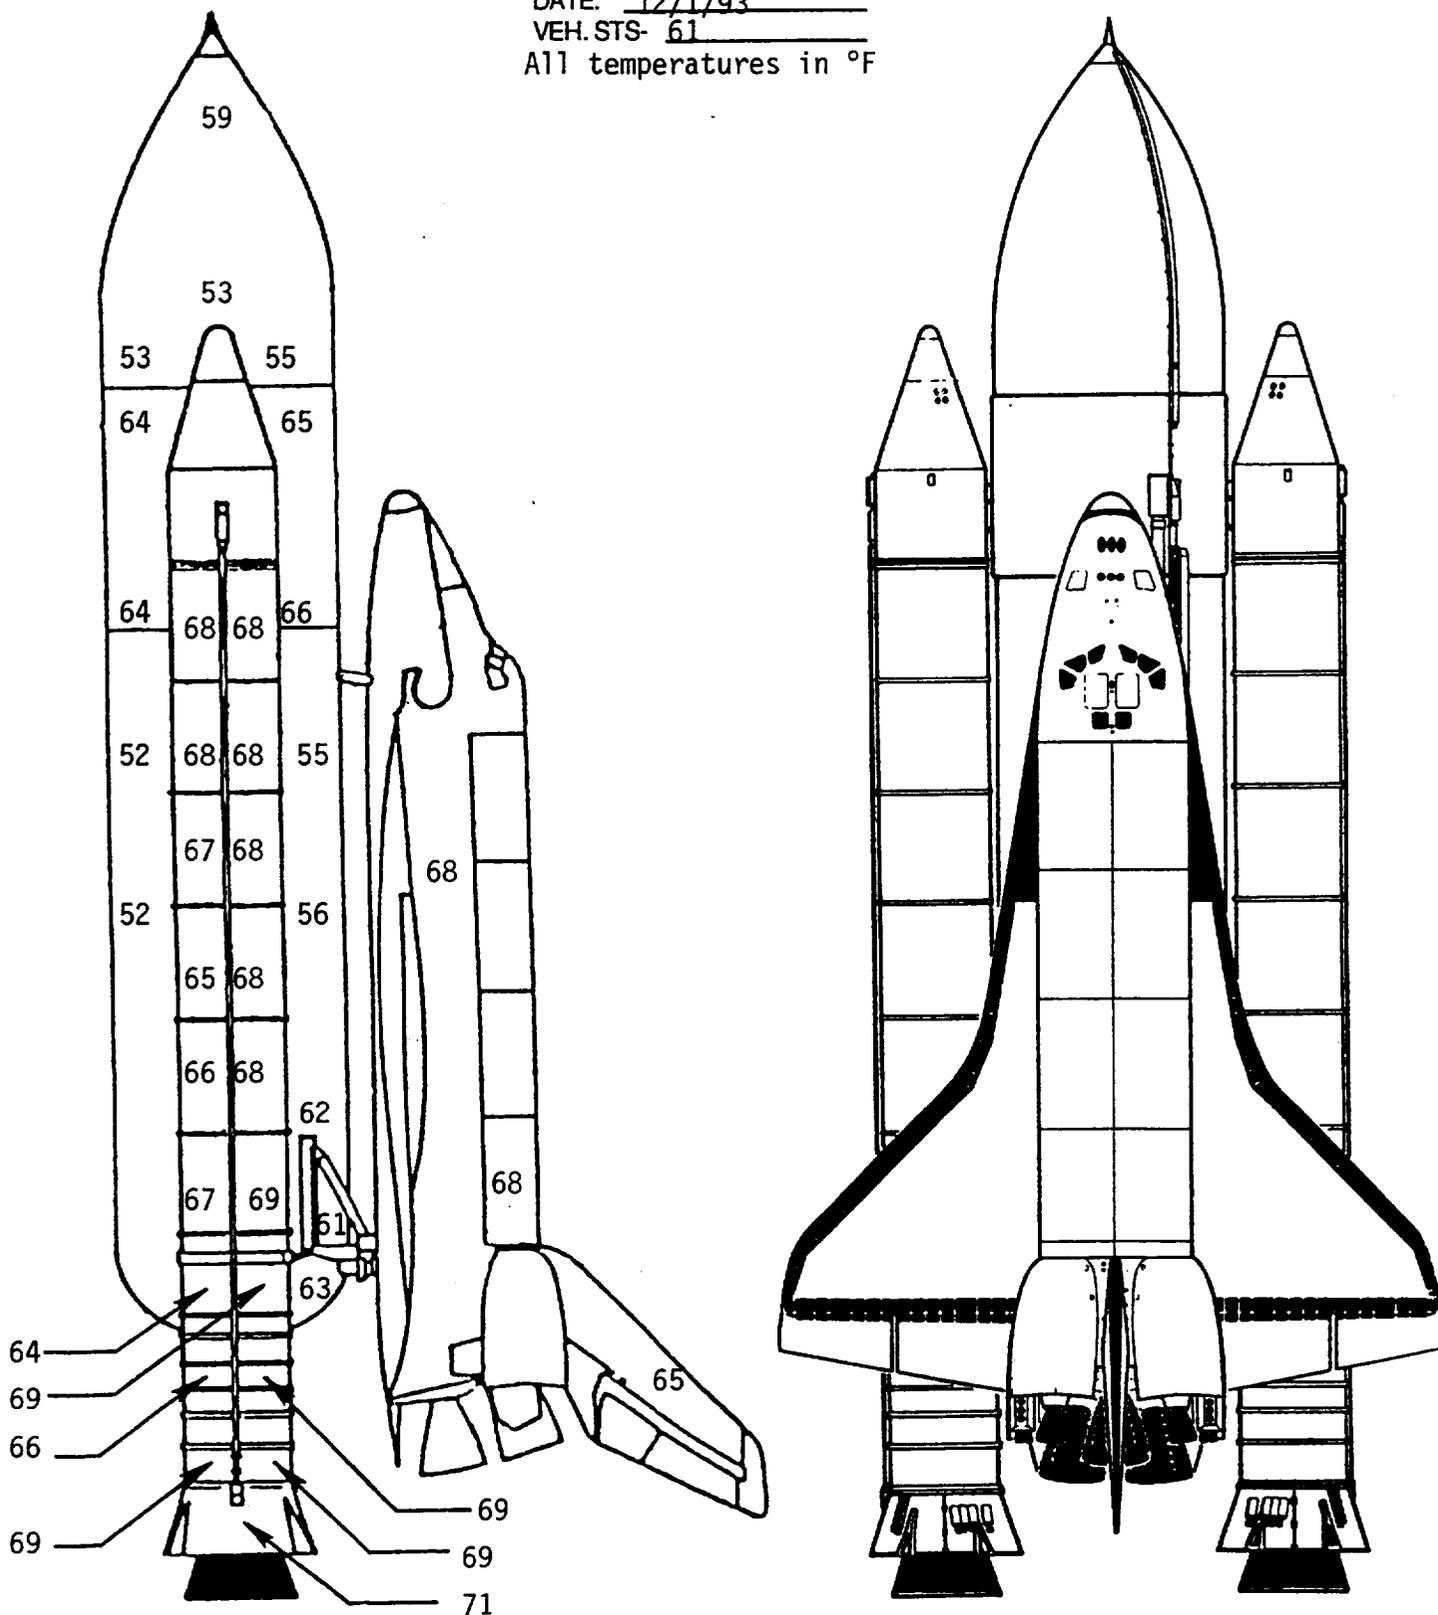
**FIGURE 4. SSV INFRARED SCANNER
SURFACE TEMPERATURE
SUMMARY DATA**

A portable Shuttle Thermal Imager (STI) infrared scanning radiometer was utilized to obtain vehicle surface temperature measurements for an overall thermal assessment of the vehicle, as shown in Figures 4 and 5.

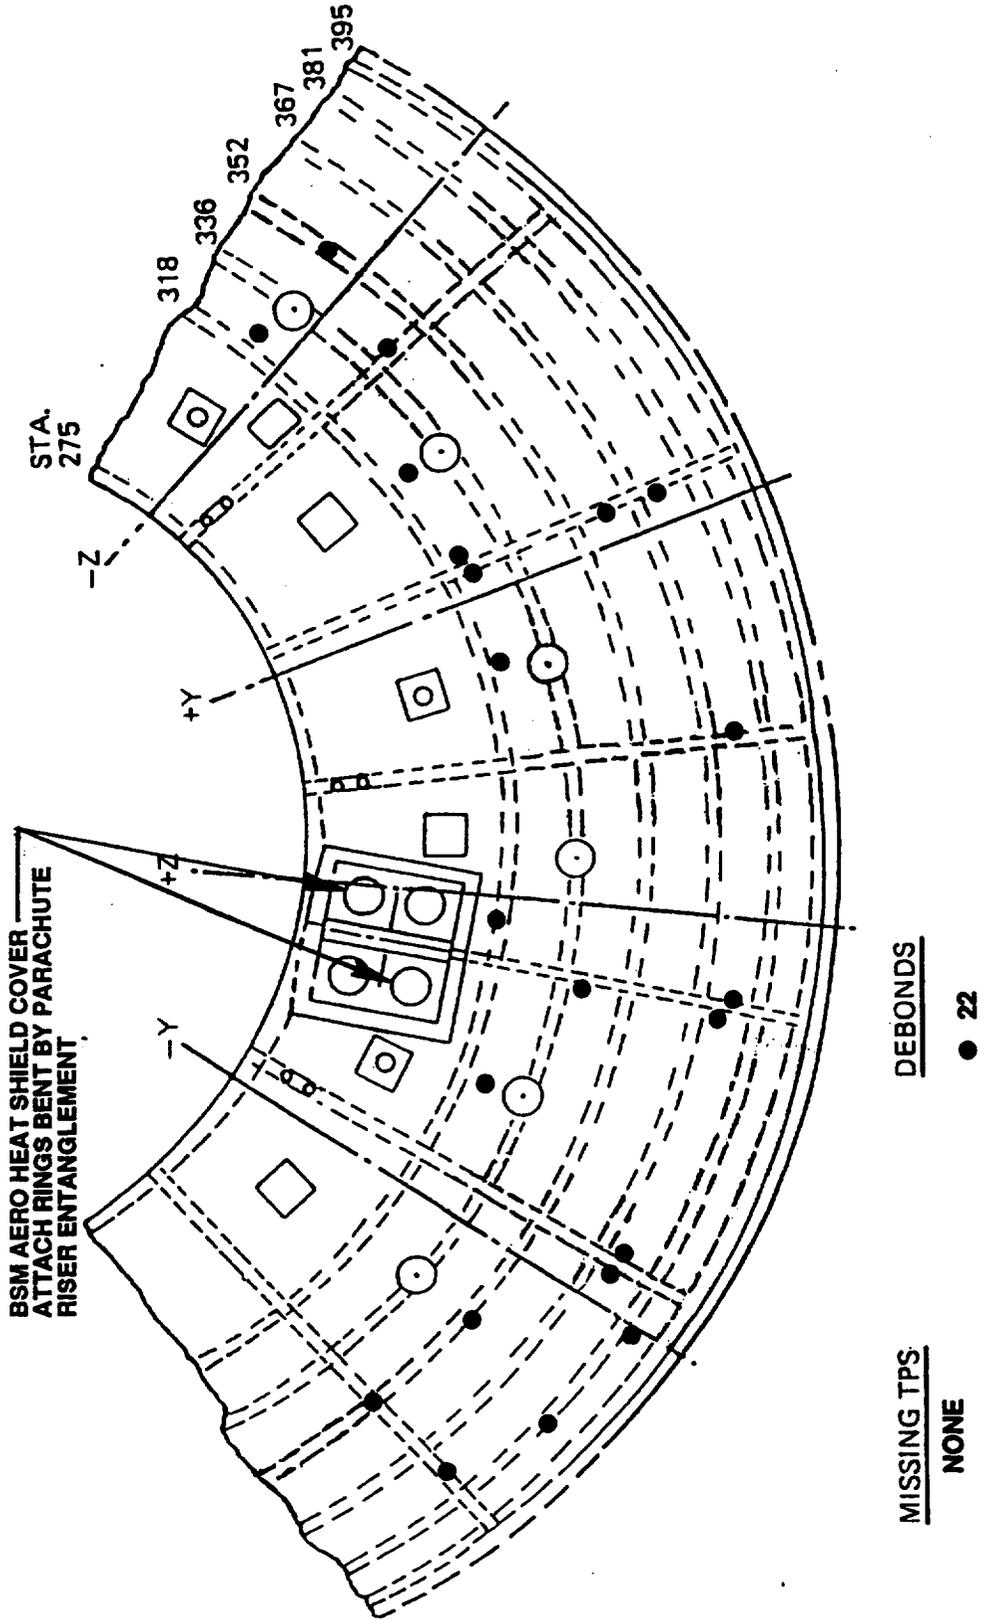
STS-61
FIGURE 7. RIGHT SRB FRUSTUM

The RH frustum was missing no TPS but had 22 MSA-2 debonds over fasteners (Figure 7). Minor blistering of the Hypalon paint had occurred in localized areas. The BSM aero heatshield covers were locked in the fully opened position, though the upper right and lower left cover attach rings had been bent by parachute riser entanglement.

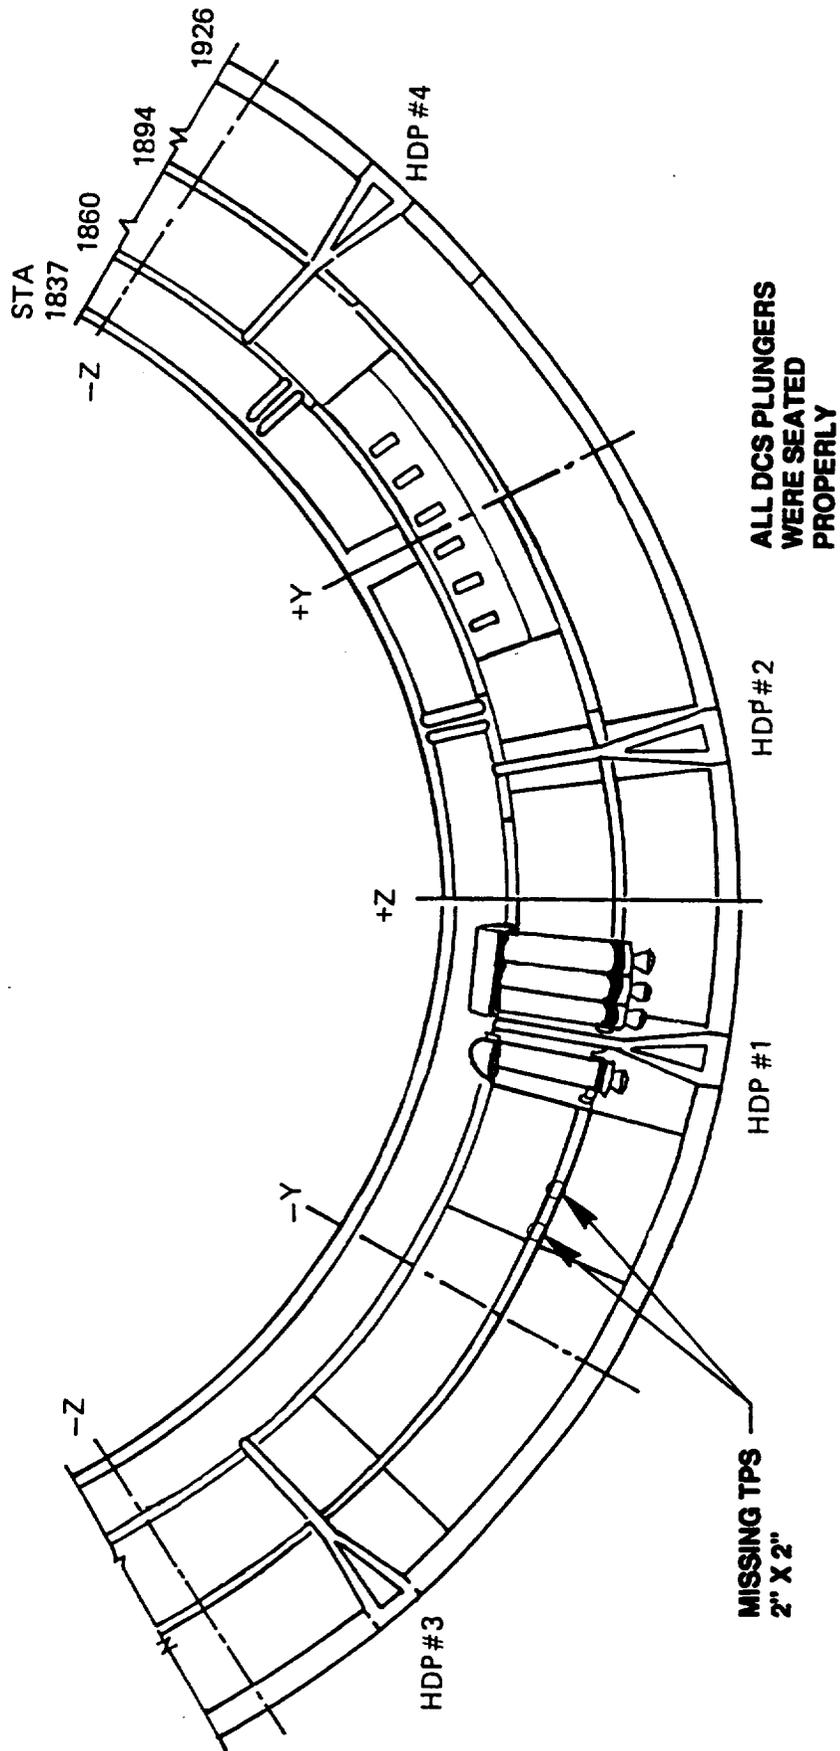
FIGURE 8.

All four Debris Containment System (DCS) plungers were seated and appeared to have functioned properly (Figure 8). EPON shim material is no longer bonded to the HDP #3 and #4 aft skirt structure.

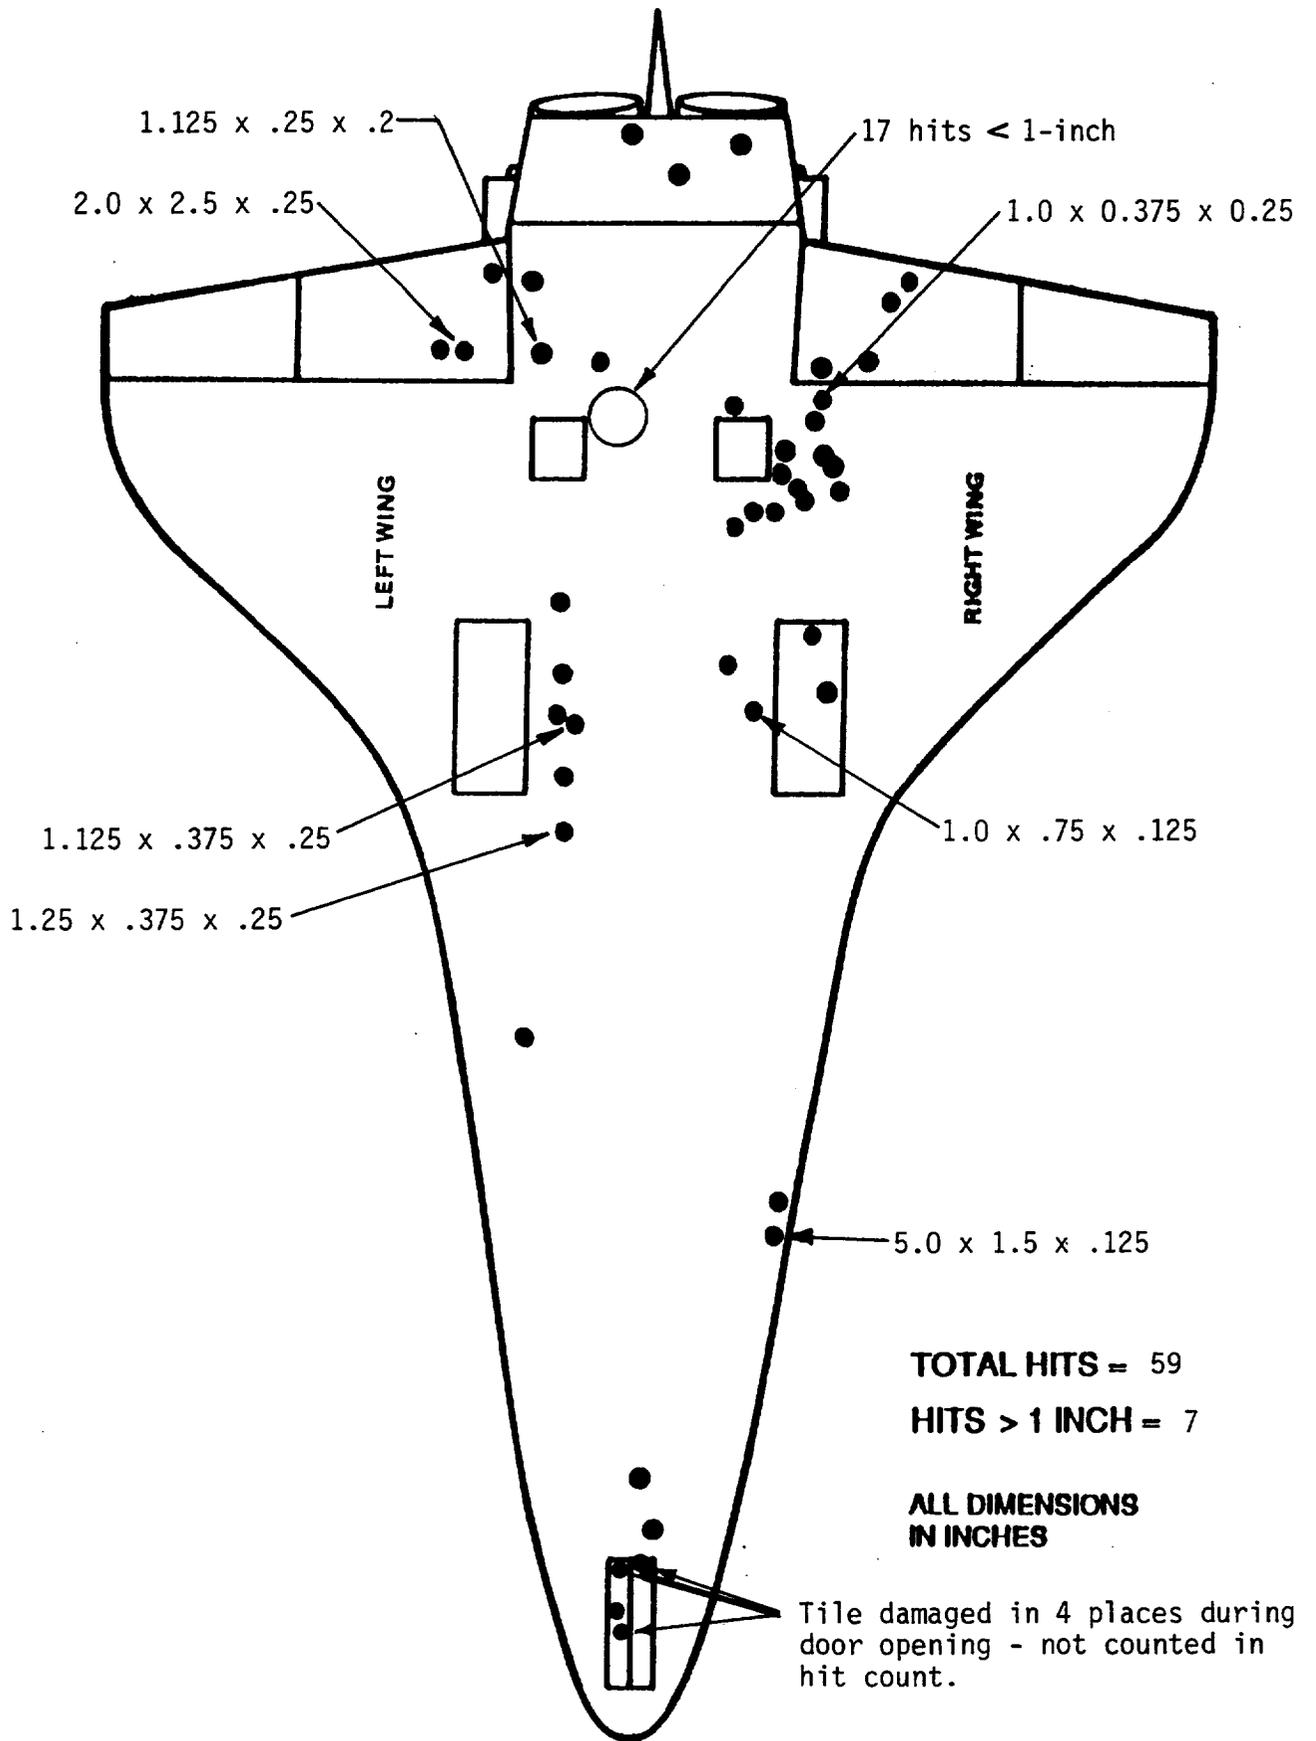
FIGURE 10. **DEBRIS DAMAGE LOCATIONS**

The Orbiter lower surface tiles sustained a total of 59 hits, of which 7 had a major dimension of 1-inch or greater. The largest tile damage site on the lower surface was on the RH wing chine and measured 5" x 1.5" x 0.125".

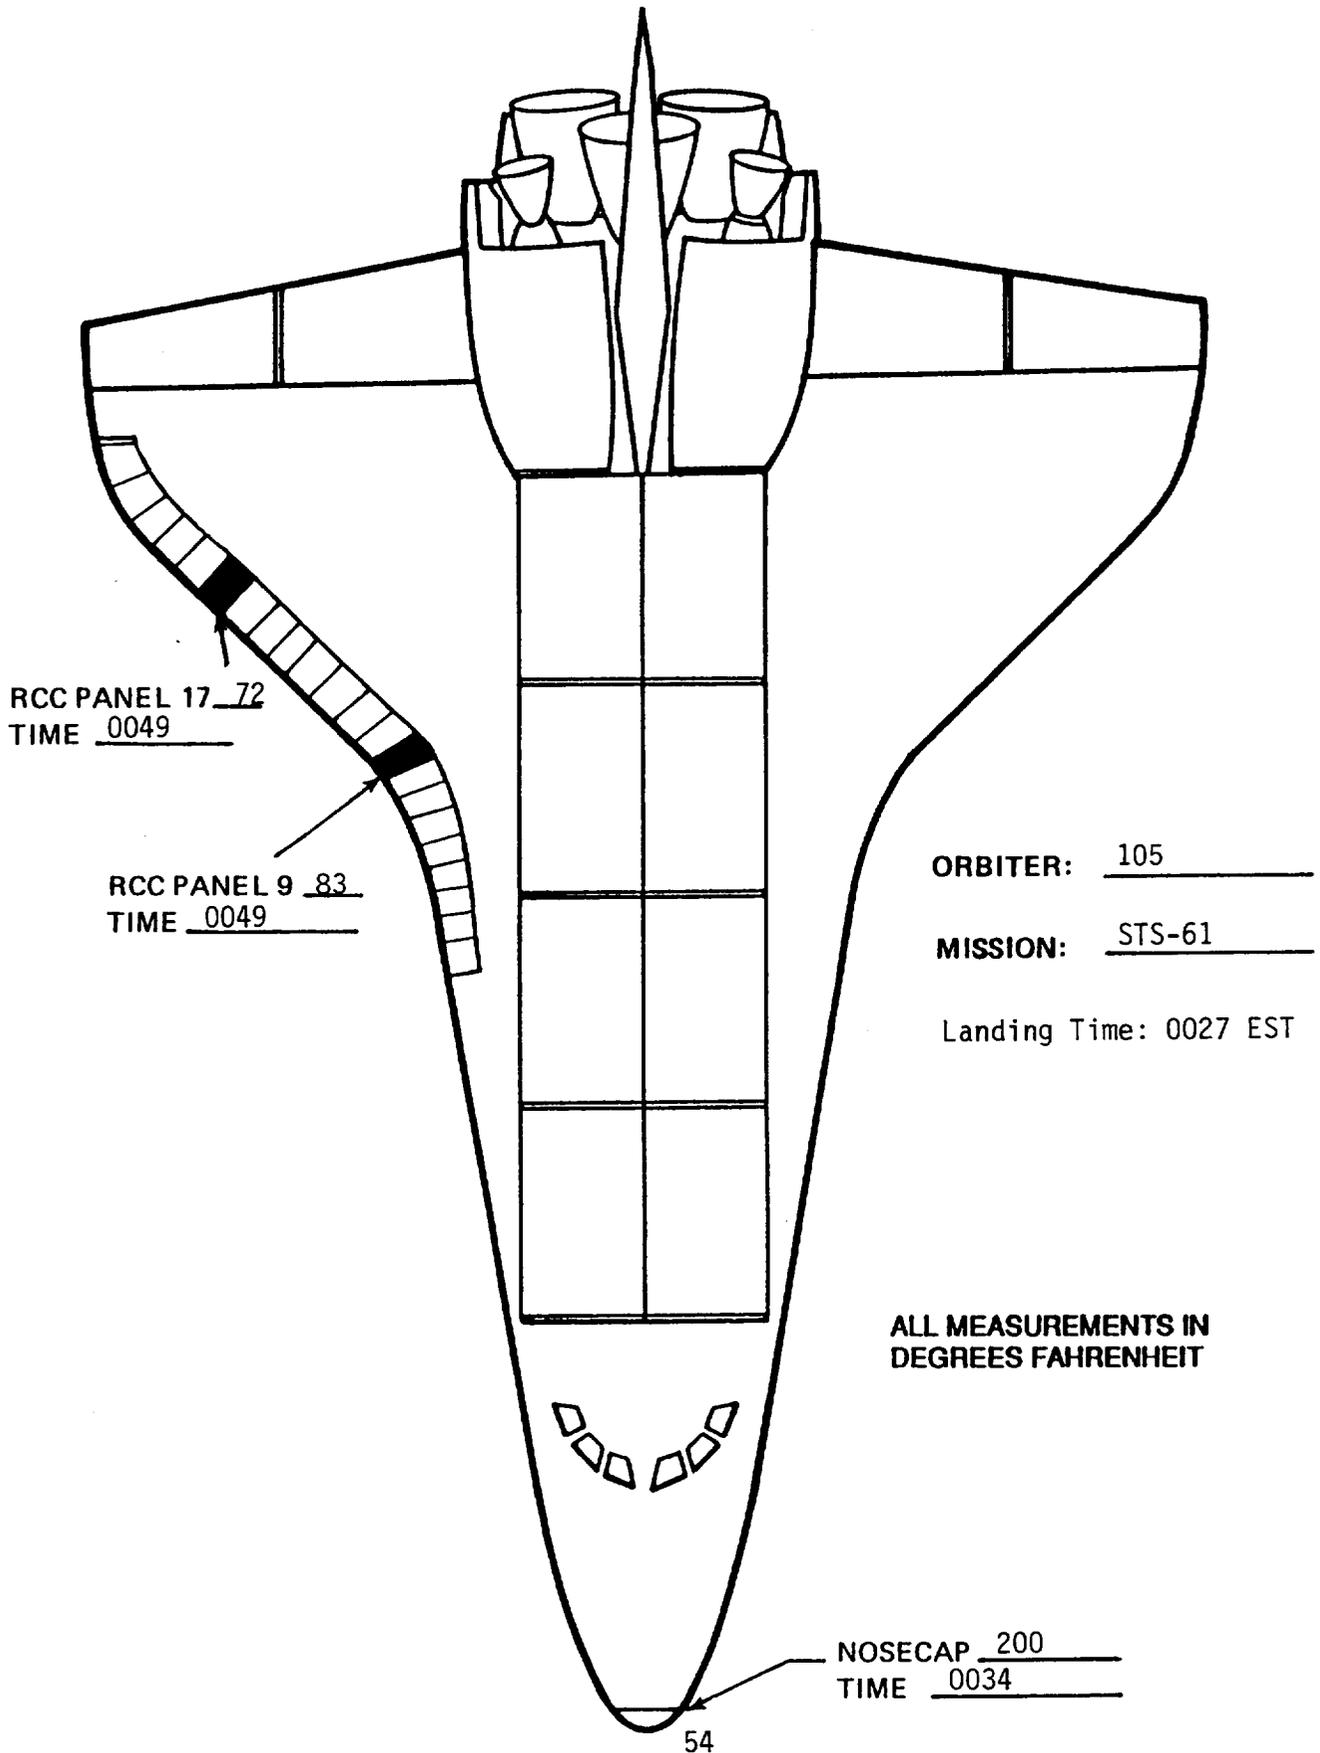
FIGURE 14. **STS-61 RCC TEMPERATURE MEASUREMENTS AS RECORDED BY THE SHUTTLE THERMAL IMAGER**

The Shuttle Thermal Imager (STI) was used to measure the surface temperatures of several areas on the vehicle (per OMRSD V09AJ0.095). Seven minutes after landing, the Orbiter nose cap RCC was 200 degrees F. Twenty-two minutes after landing, the RH wing leading edge RCC panel #9 was 83 degrees F and panel #17 was 72 degrees F (Figure 14).

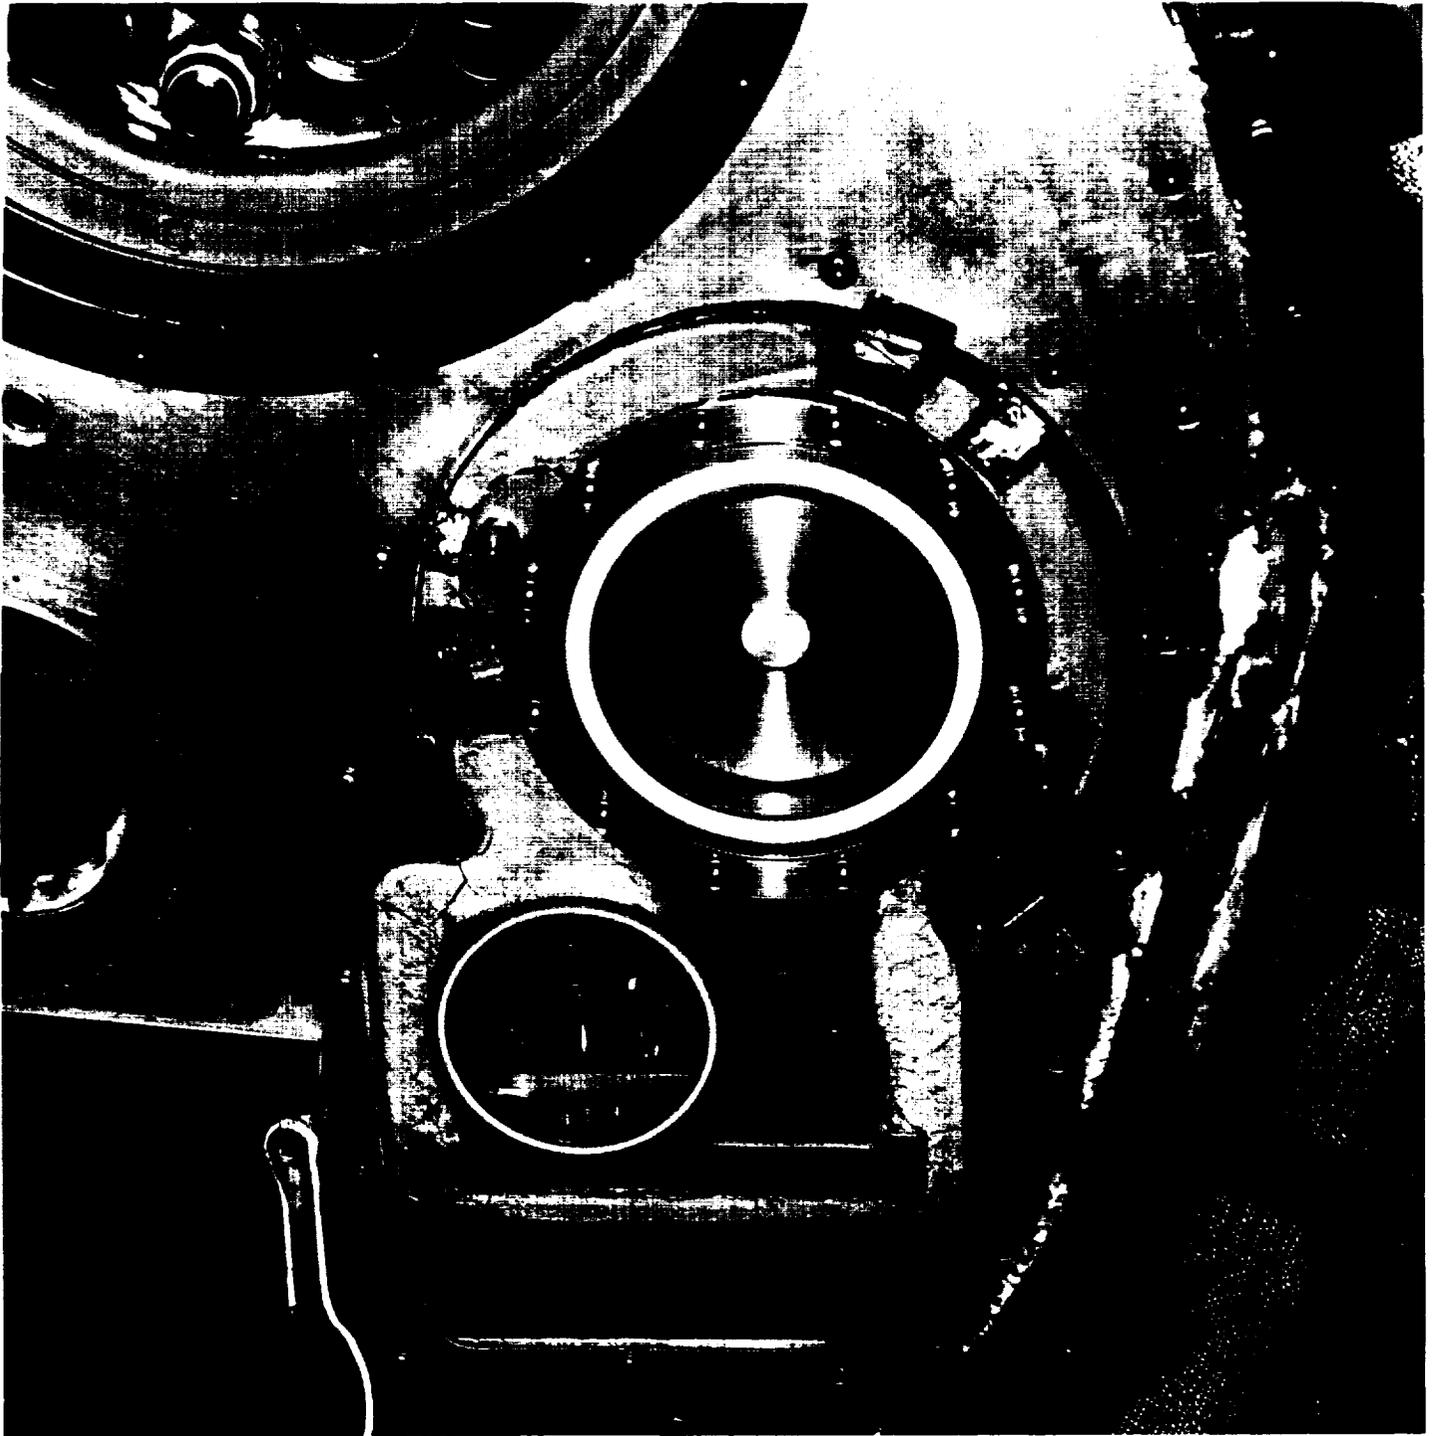
No significant amounts of ET foam or red purge seal adhered to the LH2 ET/ORB umbilical plate near the LH2 4-inch line flapper valve.

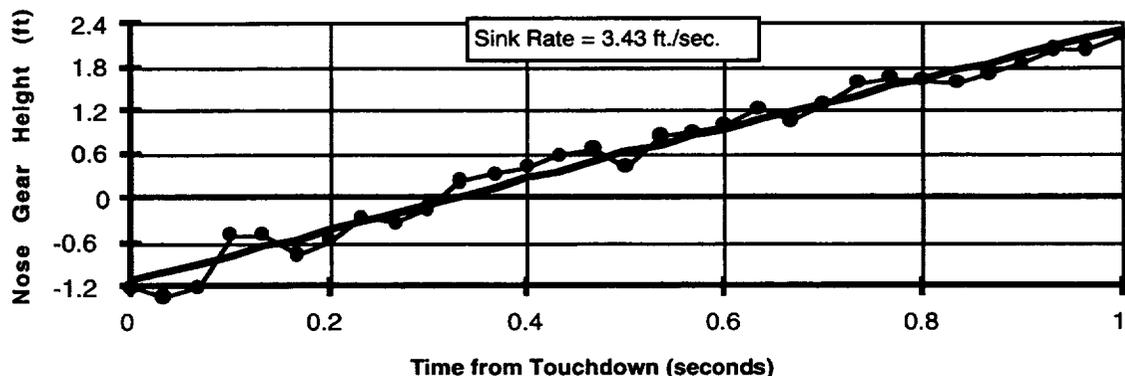
Video Nose Gear Height vs. Time

Camera KTV-33L was used to determine the sink rate of the nose gear. Data was gathered approximately 1 second prior to landing through touchdown at a rate of 30.0 frames per second. NOTE: The lack of light affected the resolvability of the nose gear throughout this time period. Scalar information was determined by using the distance between the right and left main landing gear struts. An assumption was made that the line of sight of the camera was perpendicular to the Orbiter's z-axis. The y distance between the nose gear and the main gear was then, multiplied by the scale to find the height of the nose gear. These heights were then regressed with respect to time, and the slope of the regression line was equal to the sink rate. The nose gear sink rate was determined to be 3.43 feet per second.

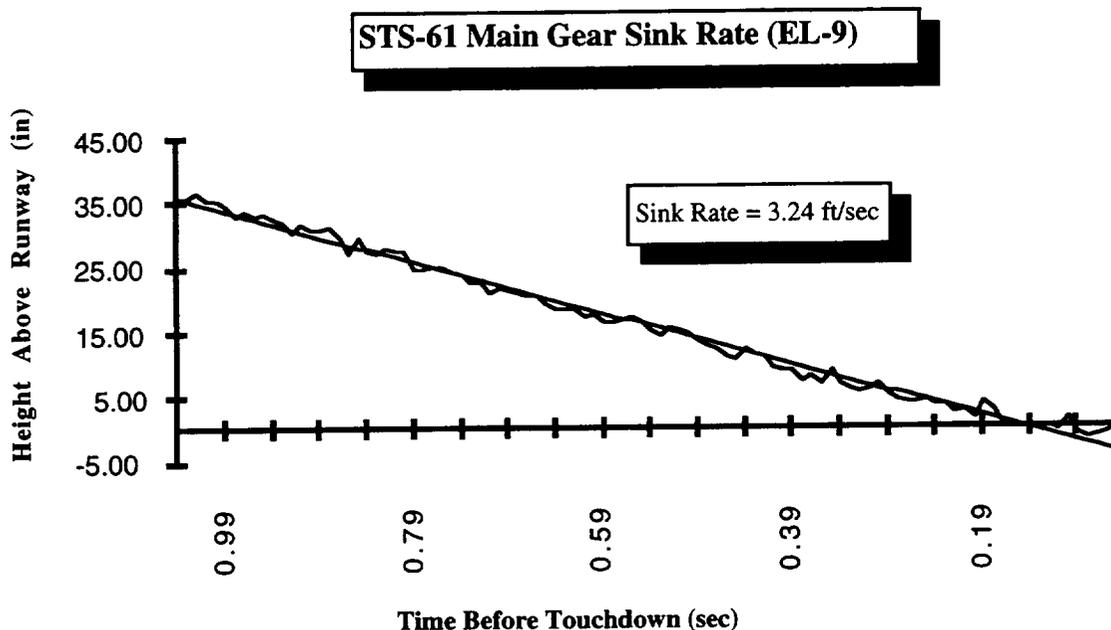
Camera EL-9 was used to determine the sink rate of the main gear. Data was gathered for approximately 1 second prior to landing at a rate of 100 frames per second. Scalar information was determined by using the distance between SSME bells #2 and #3. An assumption was made that the line of sight of the camera was perpendicular to the Orbiter's y-axis. Since the view was dark, and only the point of touchdown was visible, the motion of

each reference point was tracked for one full second. These heights were then regressed with respect to time, and the slope of the regression line was equal to the sink rate. The main gear sink rate was determined to be 3.24 feet per second.

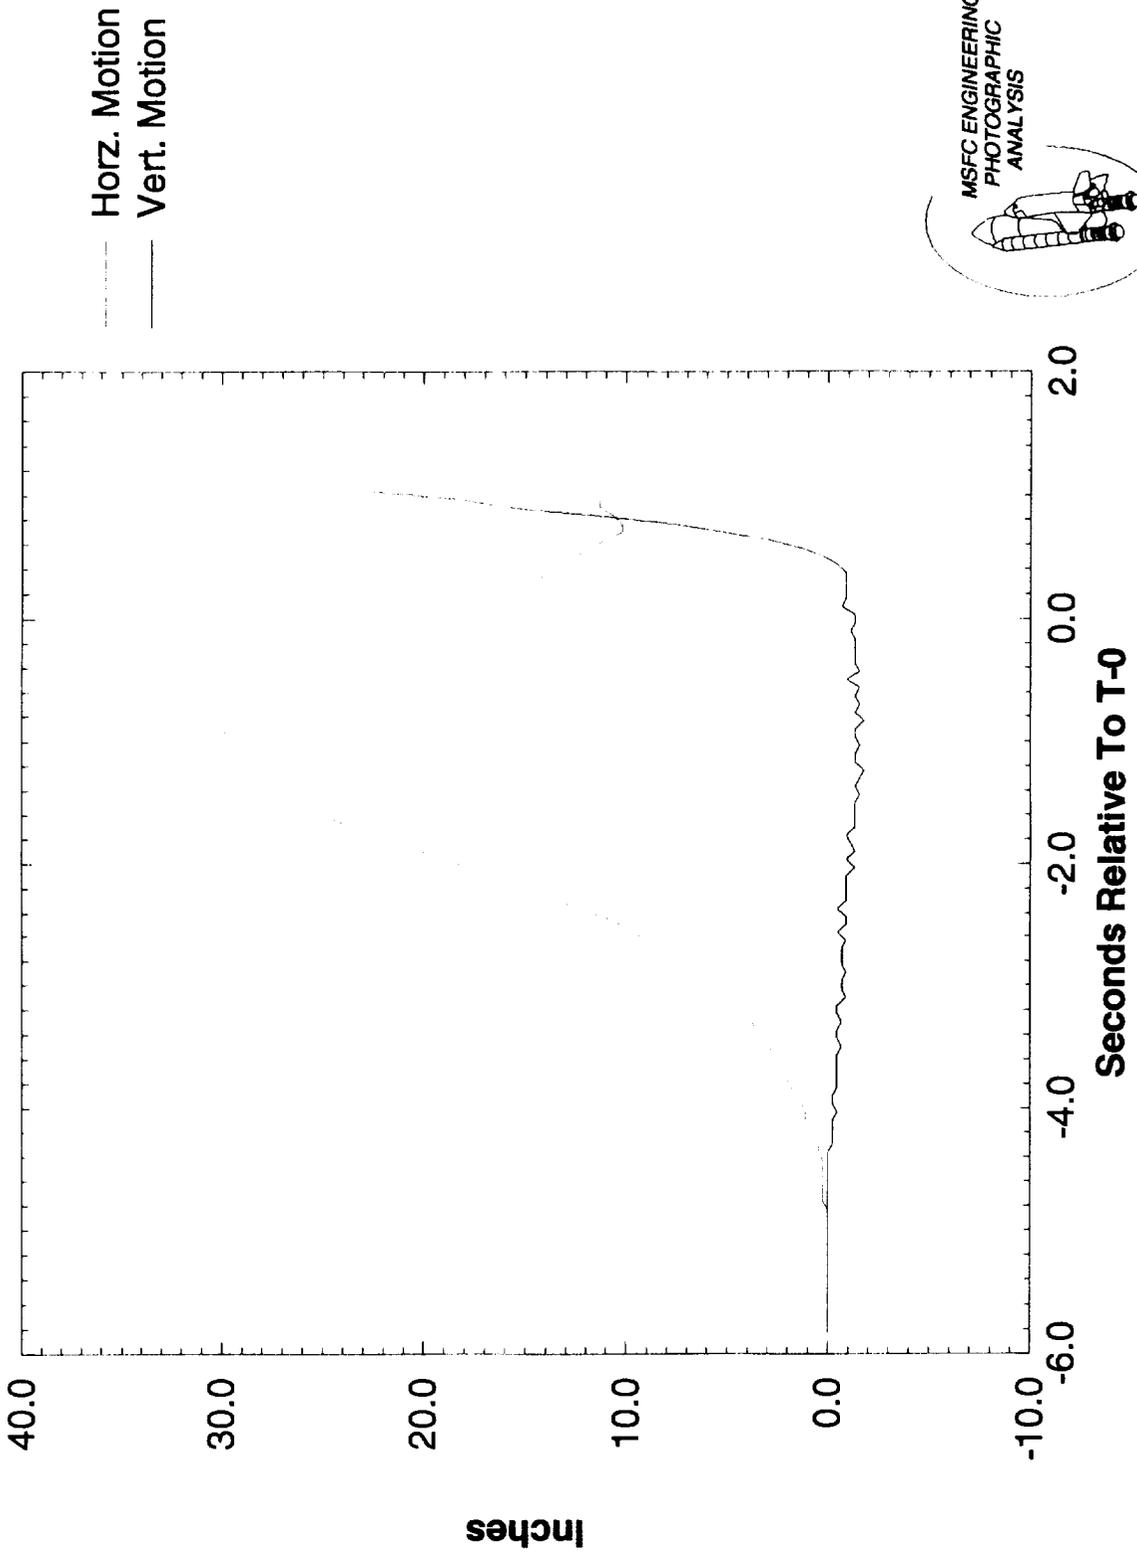
Maximum ET tip deflection for this mission was determined to be approximately 30 inches. Figure 3 is a data plot showing the measured motion of the ET tip in both the horizontal and vertical directions. These data were derived from camera OTV-161.

ET Tip Deflection
