THE CHARACTERIZATION OF WIDESPREAD FATIGUE DAMAGE 113056
IN FUSELAGE STRUCTURE

Robert S. Piascik
NASA Langley Research Center
Hampton, VA

Scott A. Willard
Lockheed Engineering and Science Company
Hampton, VA

Matthew Miller
Boeing Commercial Airplane Group
Seattle, WA

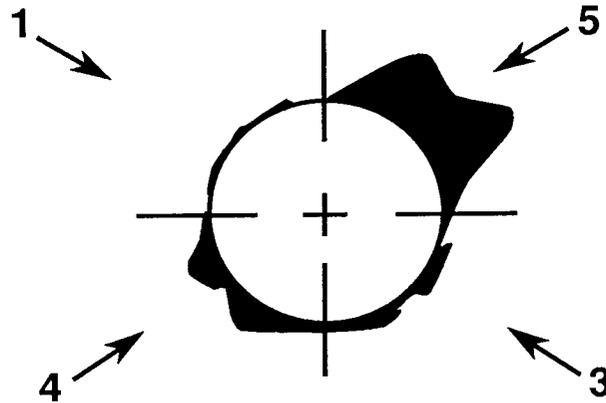
Upper rivet row fatigue cracking at the inner/outer skin interface shown in Figures 5c and 6 suggests that crack initiation is associated with localized damage due to fretting [8]. Evidence of fretting fatigue was noted by a black oxide deposit on the mating surface between the inner/outer skin around each rivet hole. Depicted in Figure 8 is the extent (area drawn to scale) of fretting debris (black oxide) observed on the inboard surface of bay #1 lap splice joint outer skin by estimating the area of fretting debris at each hole location. The amount of fretting was estimated by determining an arithmetic average of fretted surface area per the procedure shown in Figure 9. Here, a scaling factor was assigned to estimate the amount of fretting in each quadrant shown in Figure 9. The value 0 was assigned when no fretting was observed and 5 represented the highest degree of fretting. A "fretting Average" (FA) was calculated for each rivet position. A direct correlation of "fretting average" with rivet hole cracking was not conclusive, i.e., all fretting initiated cracks were observed in holes that exhibited a relatively high $FA > 3.00$, but, all holes that exhibited a $FA > 3.00$ did not contain fretting initiated cracks. Figure 10 is a plot of FA versus rivet hole location for the rows G, H, I and J. Here, a distinct correlation is observed for FA and rivet row, i.e., upper row J which contains the greatest number of fretting fatigue cracks, also exhibits the greatest evidence of fretting damage (highest FA level).

Figure 8. A schematic showing the interior surface of bay #1 lap splice outer skin. Illustrated is the location of black oxide film, the location of fretting initiated fatigue cracks and noted is the fretting average value determined by the procedure shown in Figure 9.
