# Orbital impacts and the Space Shuttle windshield

Karen S. Edelstein

NASA/Lyndon B. Johnson Space Center (JSC)  
ES2/Structures and Dynamics Branch  
Houston, TX 77058

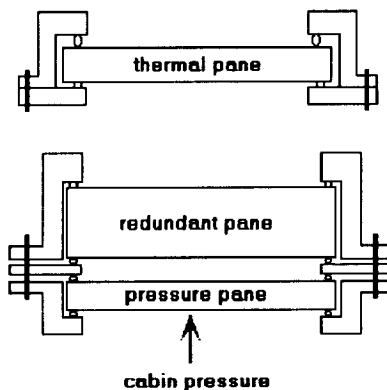
Figure 1

The outer pane, also called the thermal pane, is a .6 inch thick plate of fused silica glass, approximately 35" x 45". There are six thermal panes in the windshield, two in the overhead windows (observation windows) and one in the side hatch. These nine thermal panes have been our "experiment of opportunity" for evaluating the effects of the low earth orbit micrometeoroid and debris environment on the Shuttle program.

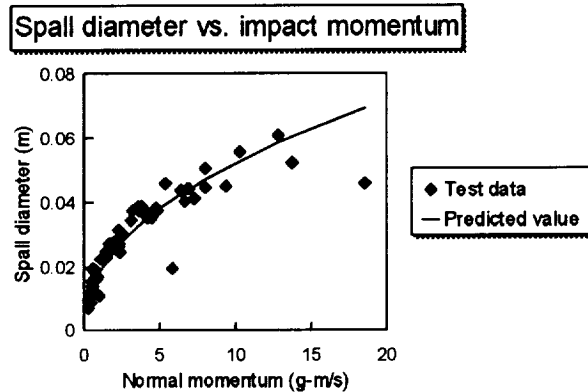
Figure 12

By using this well correlated relationship between impact momentum and spall diameter, an investigator can make certain deductions about the projectile source for any particular impact. The low-earth orbit projectile environment consists of natural material traveling through the solar system and man-made debris orbiting around the earth. The natural material can have velocities relative to the Space Shuttle ranging from 0 to 70 km/s, according to some scientists. The man-made debris is limited to a maximum velocity of two times orbital speed, or about 14 km/s. The two types of projectiles also have different densities in most cases; natural material is low density, and man-made debris is mostly alloy pieces, with densities ranging from aluminum to steel and denser metals.

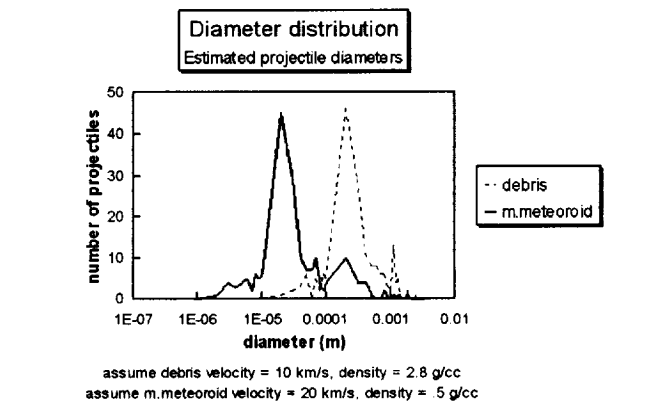
SEM analysis of the eleven windows described above has also indicated that the impact velocity range can be deduced from evidence of melted glass in the crater (see [4]). The properties of fused silica give a lower bound for material melting to occur at impacts around 6 km/s. Faster impacts will result in qualitatively different craters than slower, displaying more molten silica and less cracking and crazing under SEM examination. Figure 13 plots the distribution of the estimated projectile diameters, based on assumptions about the impact parameters of debris particles and micrometeoroids, and using equation (1).
