Debris/Ice/TPS Assessment and Integrated Photographic Analysis of Shuttle Mission STS-67

Gregory N. Katnik, Barry C. Bowen, J. Bradley Davis

Technical Memorandum 110651

April 1995

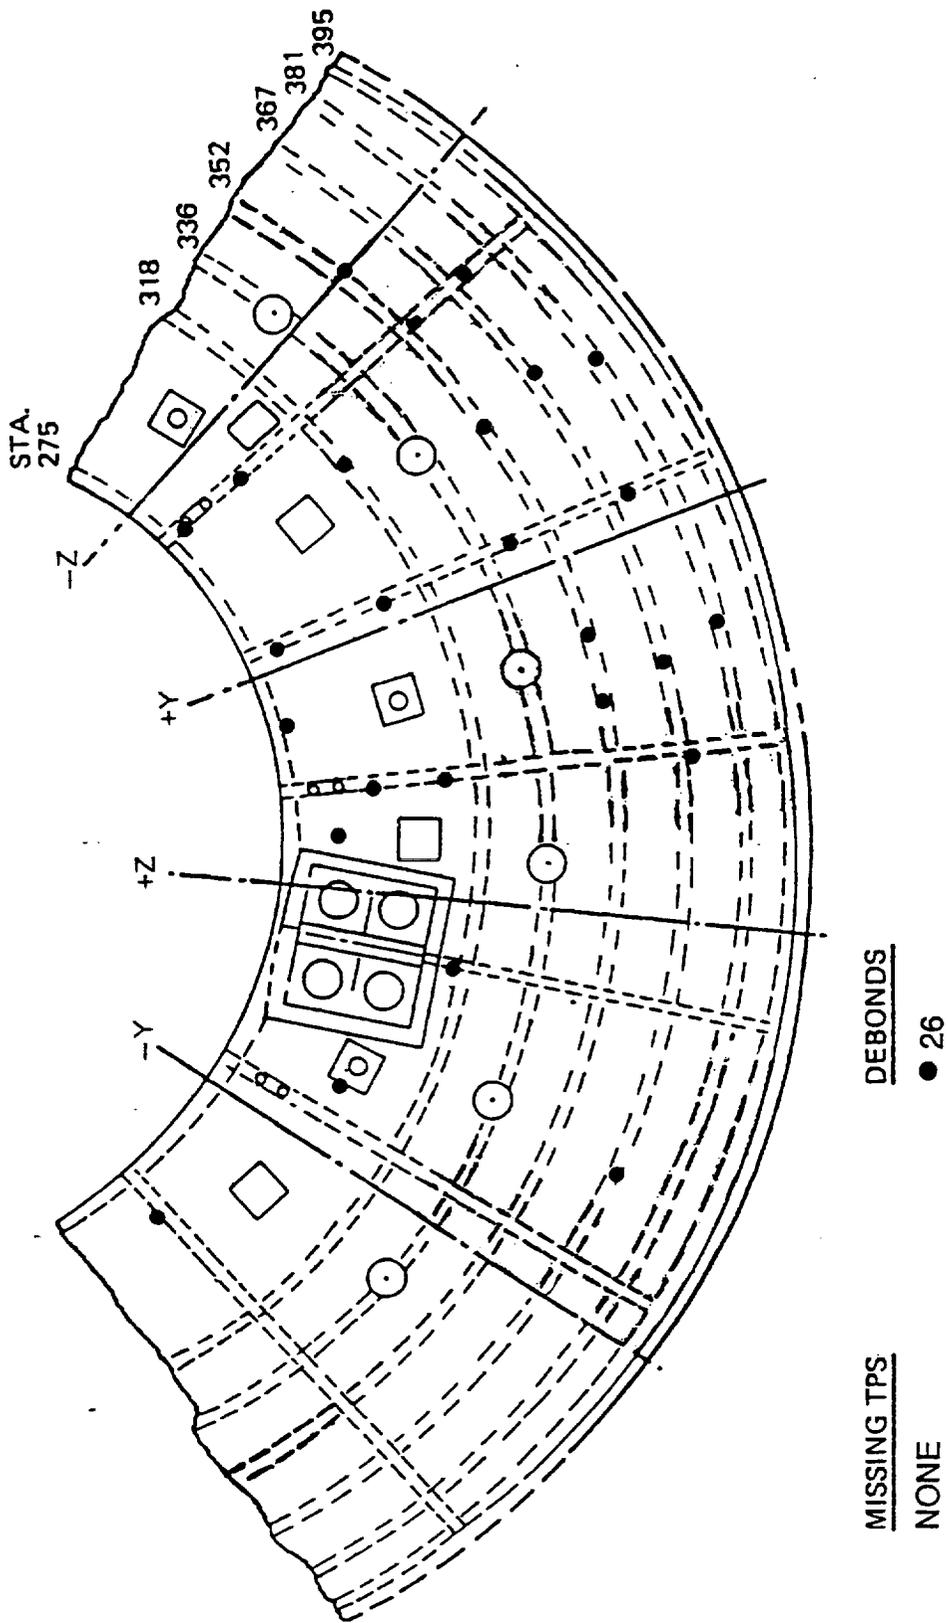
Figure 1 : RH SRB Frustum

The RH frustum was missing no TPS (Figure 1). The number of debonds over fasteners was average. Hypalon paint was blistered/missing along the XB-395 ring frame where BTA had been applied. Some of the underlying BTA was sooted. The BSM aero heat shield covers had locked in the fully opened position.

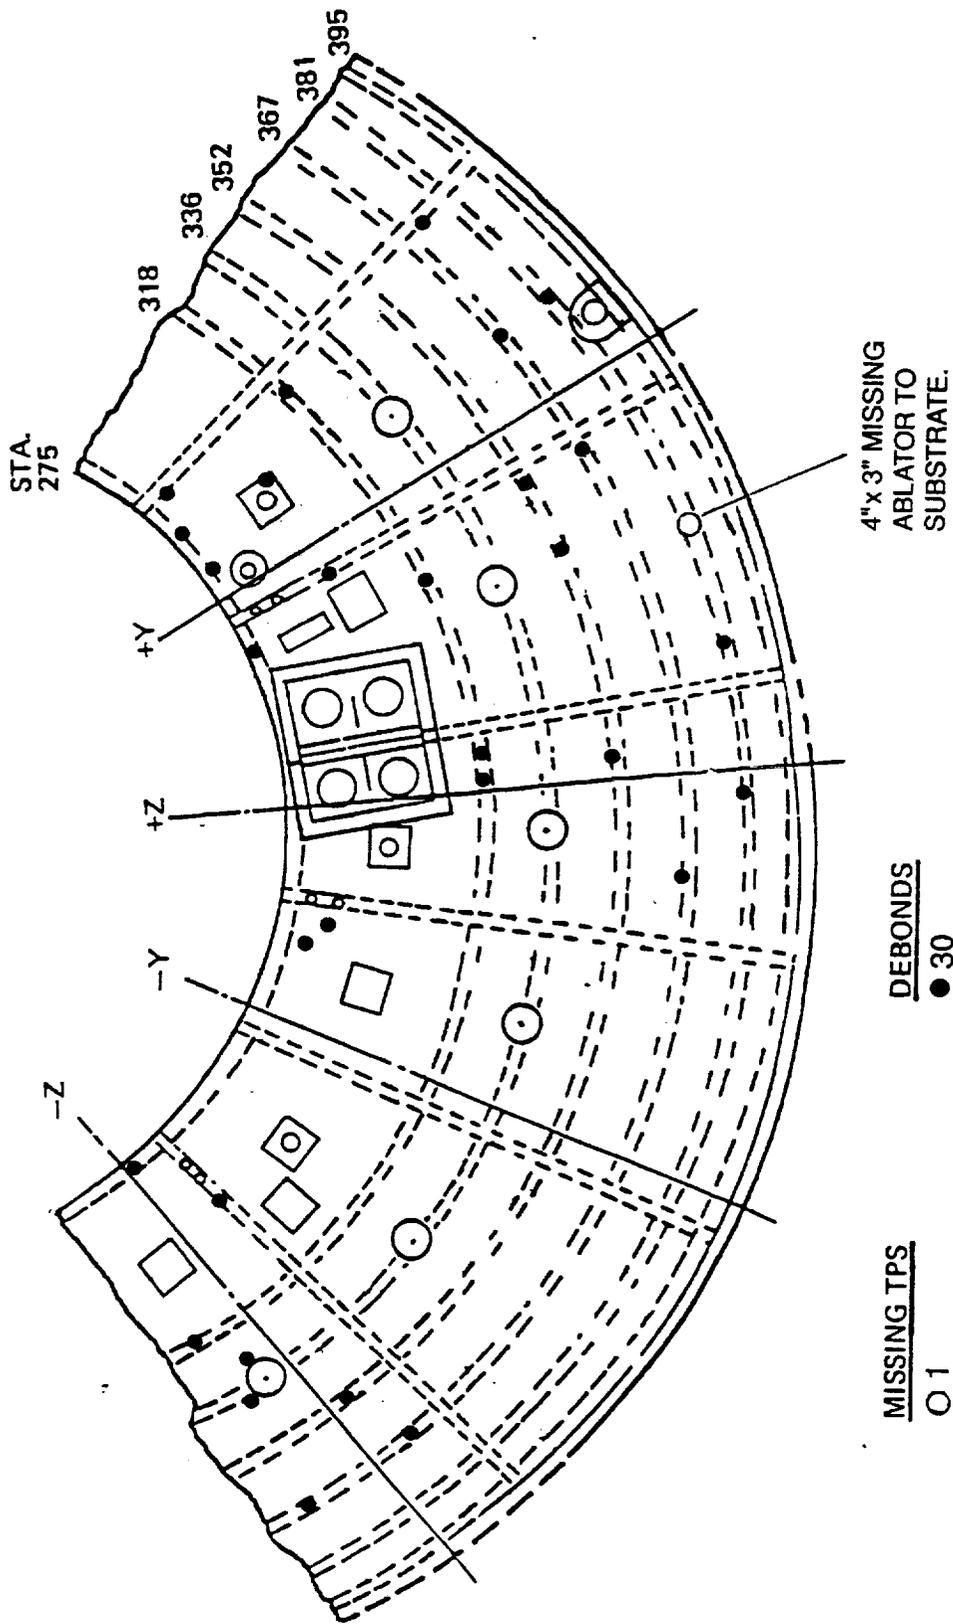
Figure 2 : LH SRB Frustum

The LH frustum was missing one 4-inch by 3-inch piece of TPS over three fasteners on the XB-381 ring frame between the +Y/+Z axes. The exposed substrate did not appear sooted. The number of MSA-2 debonds over fasteners was average (Figure 2). Hypalon paint was blistered/missing along the XB-395 ring frame where BTA had been applied. Some of the underlying BTA was sooted. The BSM aero heat shield covers had locked in the fully opened position.
