# Debris/Ice/TPS Assessment and Integrated Photographic Analysis of Shuttle Mission STS-80

*Gregory N. Katnik  
Jill D. Lin*

*Process Engineering/Mechanical System Division/ET-SRB Branch,  
Kennedy Space Center, Florida*

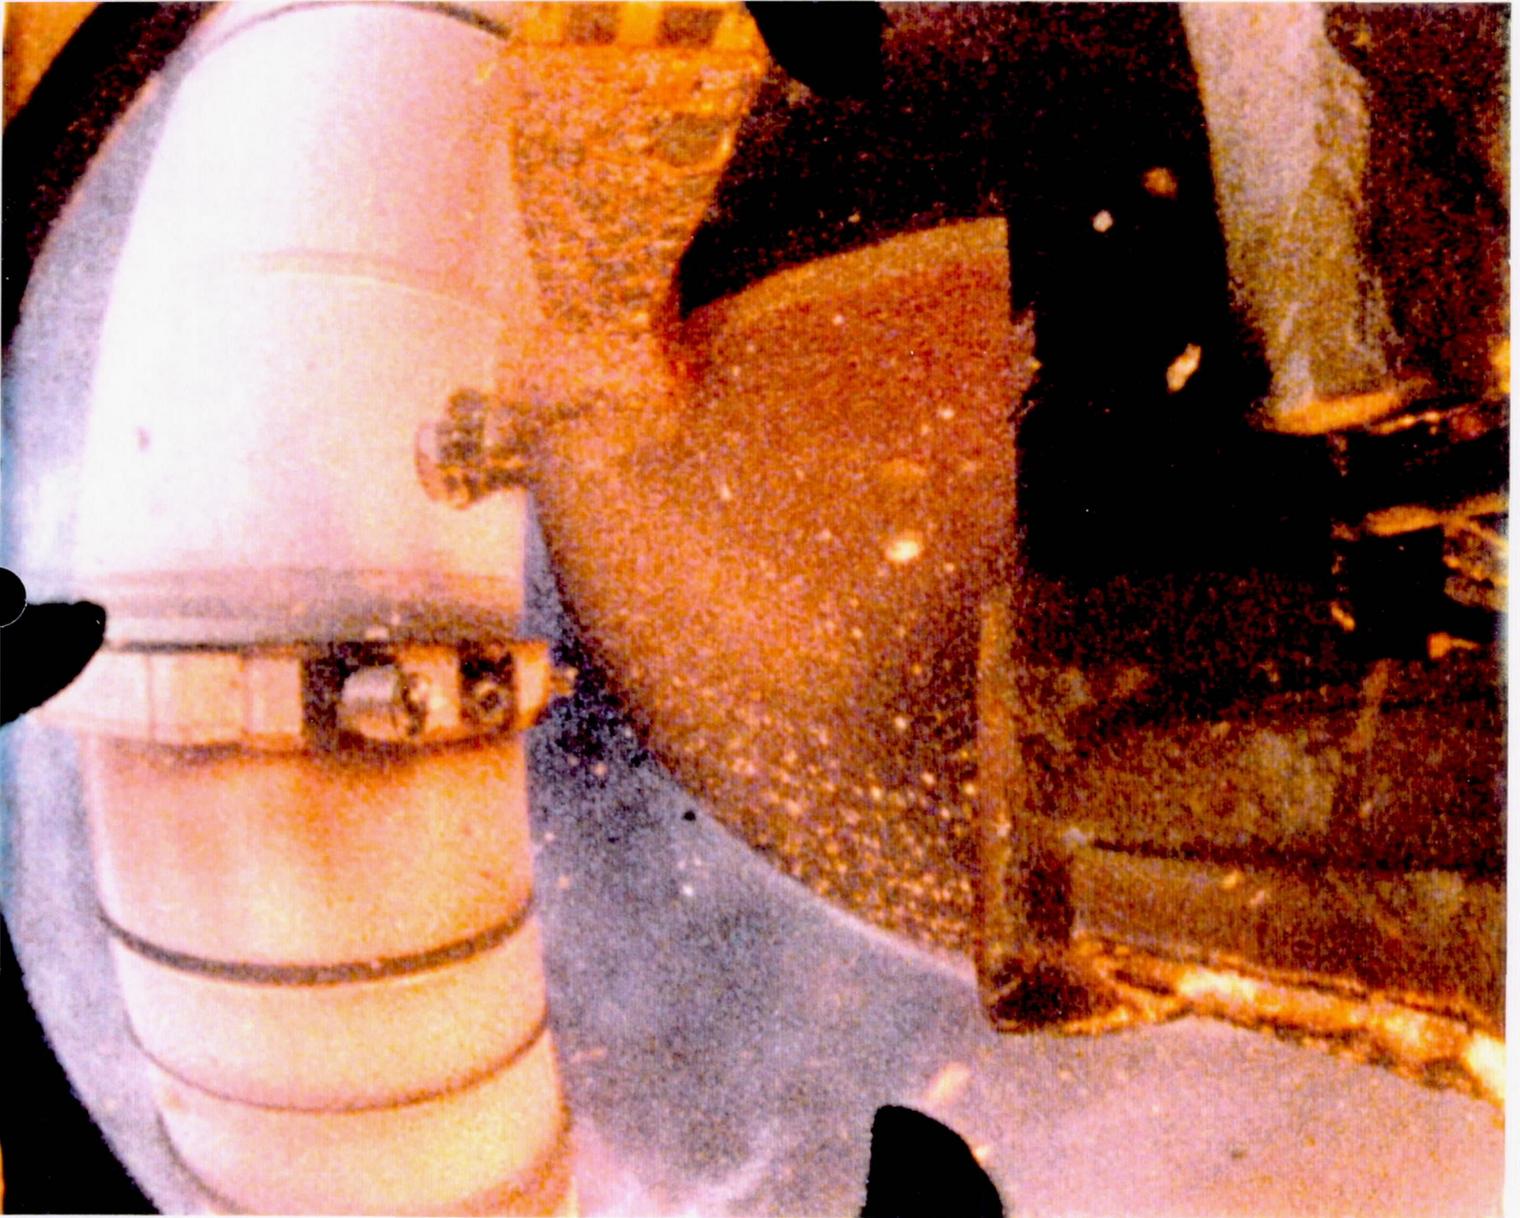
**Photo 10: SRB Separation**

SRB separation from the External Tank appeared nominal

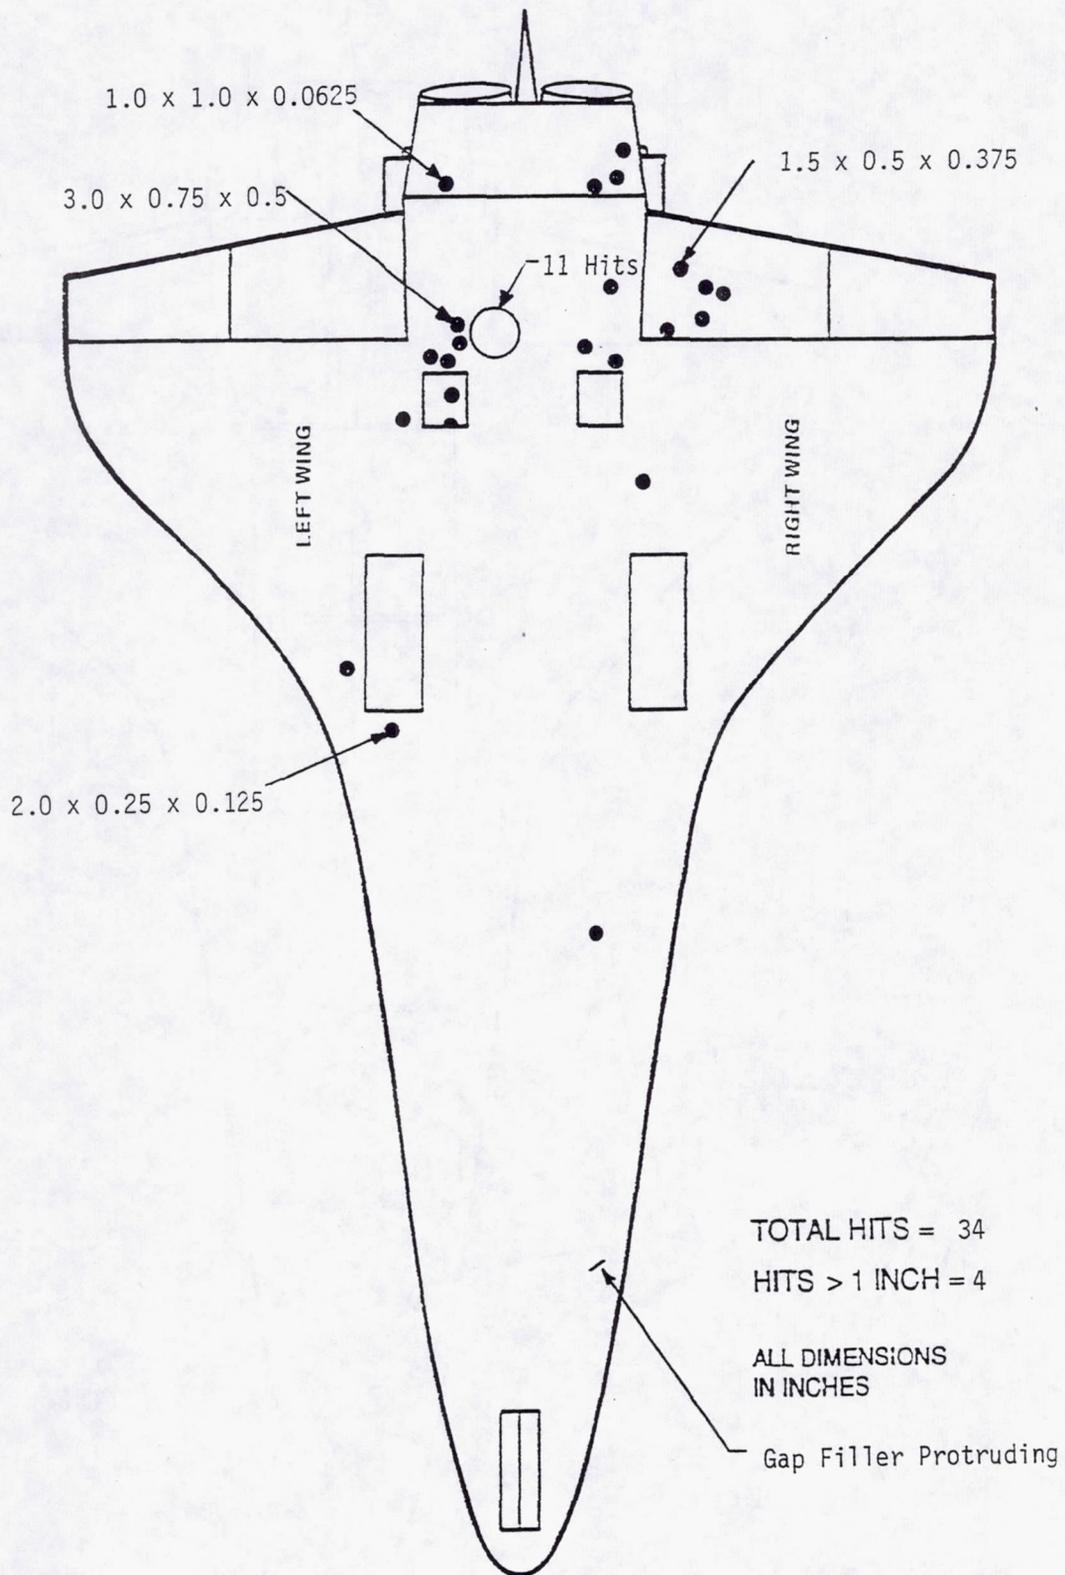
Figure 2: Orbiter Lower Surface Debris Map

The Orbiter lower surface sustained a total of 34 hits, of which 4 had a major dimension of 1-inch or larger. The largest lower surface tile damage site was located aft of the LH2 ET/ORB umbilical and measured 3-inches long by 3/4-inch wide by 1/2-inch maximum depth. The damage was most likely caused by an ice impact from the umbilical.

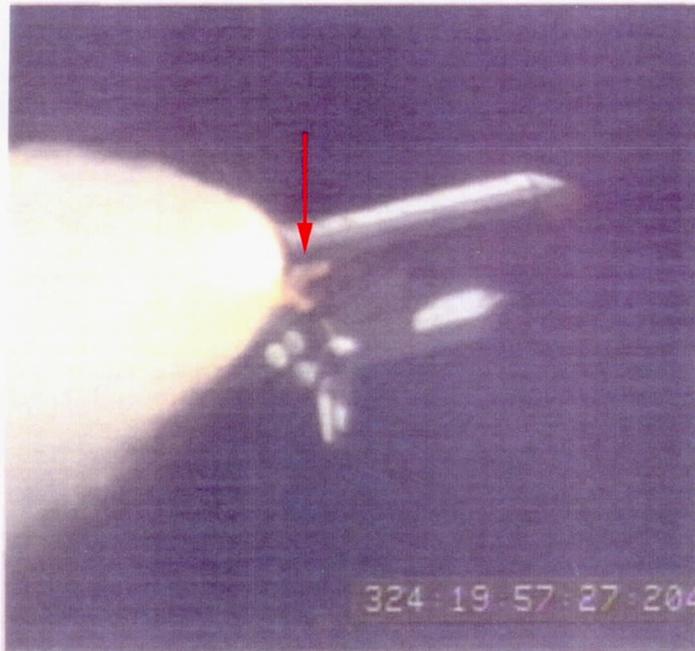
Figure 2.3 (A) Recirculation At Aft End Of Vehicle

Recirculation, or the expansion of burning gasses at the aft end of the vehicle, was seen during ascent (19:57:20 - 19:57:37 UTC). Recirculation during this time period has been seen on previous missions. (Cameras KTV13, ET204)

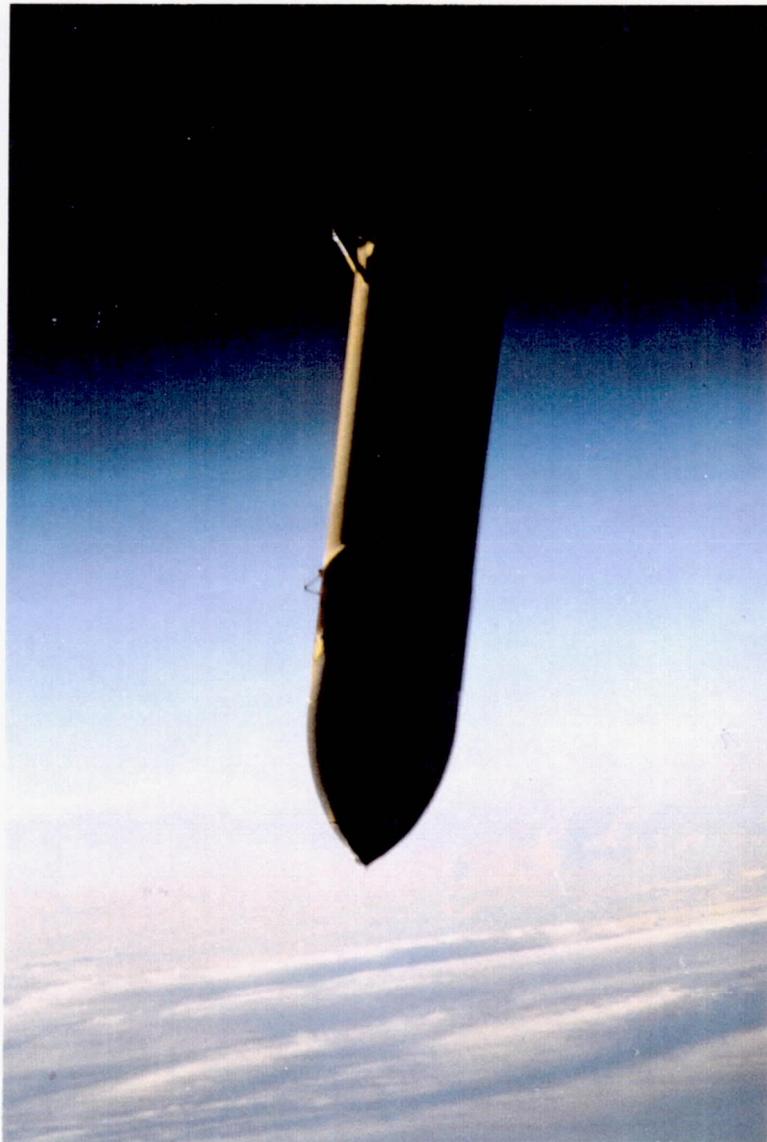
Figure 2.4.2 (A) Handheld View Of The External Tank

As can be seen above, back-lighting from the sun degraded the handheld views of the external tank. The previously used foam-covered intertank access door was flown on STS-80 (ET 80). The condition of the intertank access door could not be determined due to the poor lighting conditions.

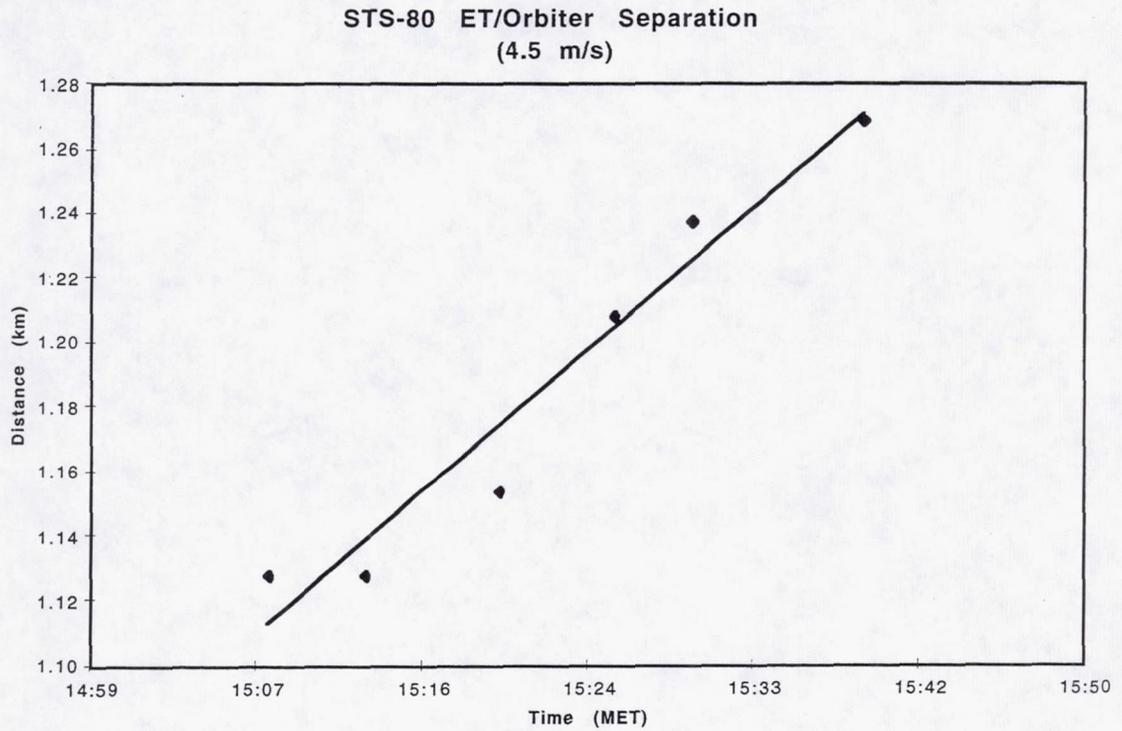
Figure 2.4.2 (B) ET Separation Velocity

The distance of the external tank was calculated over a six-frame sequence using the handheld photography. The external tank was calculated to be a distance of 1.1 km away from the Orbiter at 15:08 MET. The tank was calculated 31 seconds later (15:39 MET) to be at a distance of 1.3 km. The tank separation velocity was determined to be 4.6 m/s. The separation velocity was similar to previous mission measurements. The tank tumble and roll rates could not be determined due to the poor lighting conditions.

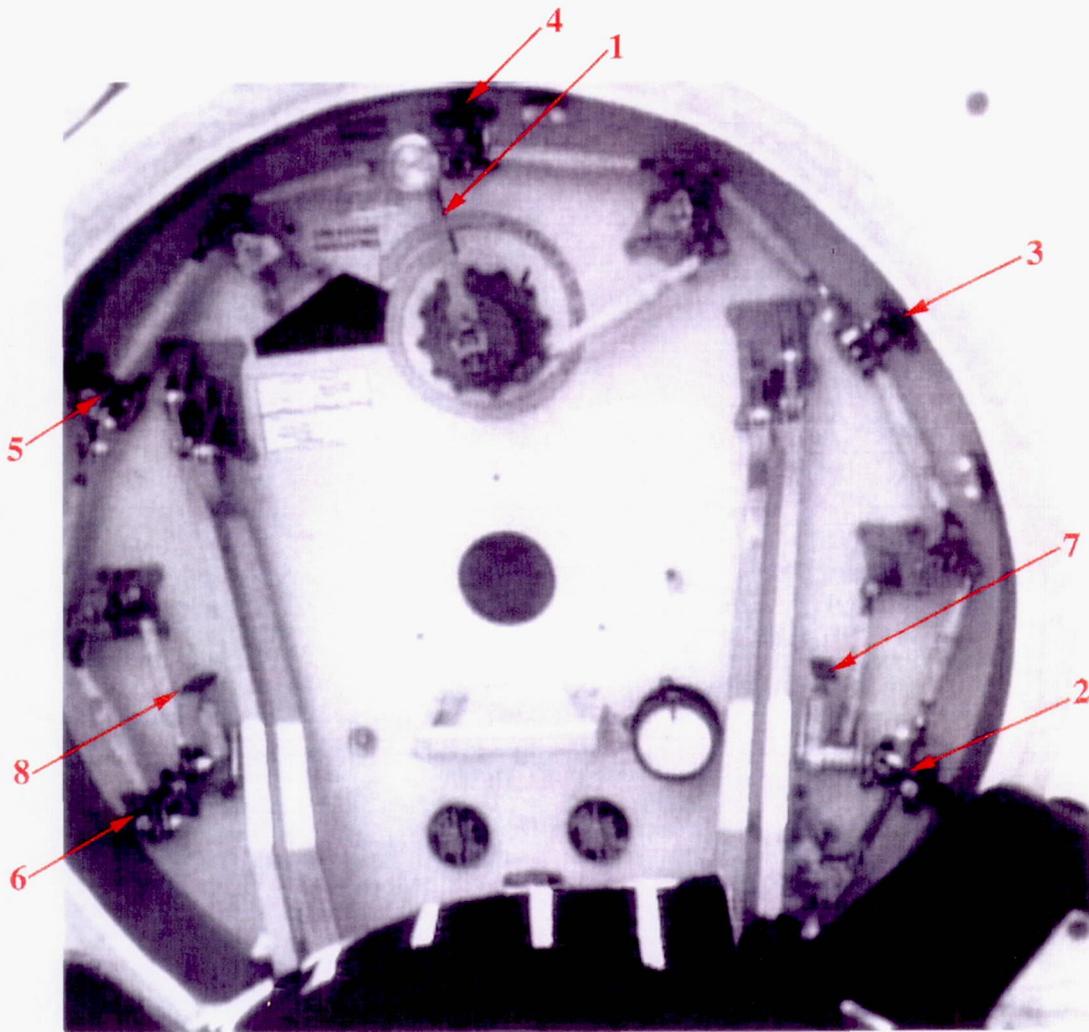
Figure 2.5.1 Airlock Hatch (Exterior)

The orientation of each latch link was measured relative to the deflection angle of each latch link using close-up views from video acquired with the end-effector camera positioned approximately face-on to each latch link (Figure 2.5.1, annotations 2-6). The total rotation of a latch link from fully latched to its dead-on-center (DOC) perpendicular orientation was approximately 2.15 degrees. At the maximum jammed position, latches 1, 2, 3, and 4 were definitively observed to rotate beyond DOC in the unlatched direction (total rotations from fully latched of 5.5, 4.9, 5.8 and 7.5 degrees respectively). Latches 5 and 6 were observed to probably rotate beyond DOC in the unlatched direction, but the observations were not definitive due to uncertainty in the measurements.

Video of the simultaneous motion of both deployable legs was analyzed (Figure 2.5.1, annotations 7 and 8). Both legs reached their jammed position within one video frame of each other, corresponding to a time difference of less than approximately 0.03 seconds. The starboard leg reached its jammed position first.

During the post-flight inspection conducted by engineers at KSC, a loose screw was found lodged in the actuator gearbox (Figure 2.5.1, annotation #1). This loose screw jammed the handle preventing the crew from opening the hatch on orbit.

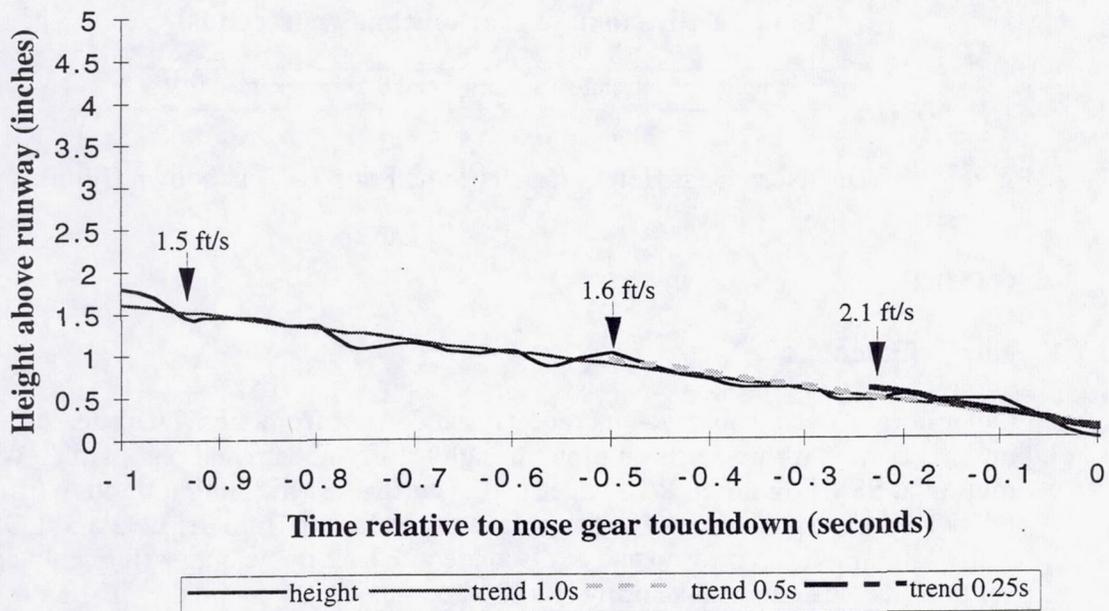
Figure 2.6.1 (A) Main Gear Height Versus Time Prior To Touchdown (Video)

The measured main gear sink rate values were found to be below the maximum allowable values of 9.6 ft/sec for a 211,000 lb. vehicle and 6.0 ft/sec for a 240,000 lb. vehicle (the landing weight of the STS-80 Orbiter was reported to be 227,523 lb.). The sink rate measurements for STS-80 are given in Table 2.6.1. In Figure 2.6.1(A), and 2.6.1(B), the trend of the measured data points for the image data is illustrated.
