Final Report
STUDY METHODS TO CHARACTERIZE AND IMPLEMENT THERMOGRAPHY
NONDESTRUCTIVE EVALUATION (NDE)

Contract Number: NAS8-97095
Task: H-28166D

James L. Walker
Center for Automation and Robotics
University of Alabama in Huntsville
Huntsville, AL 35899
(256)-890-6578*207

October, 1998

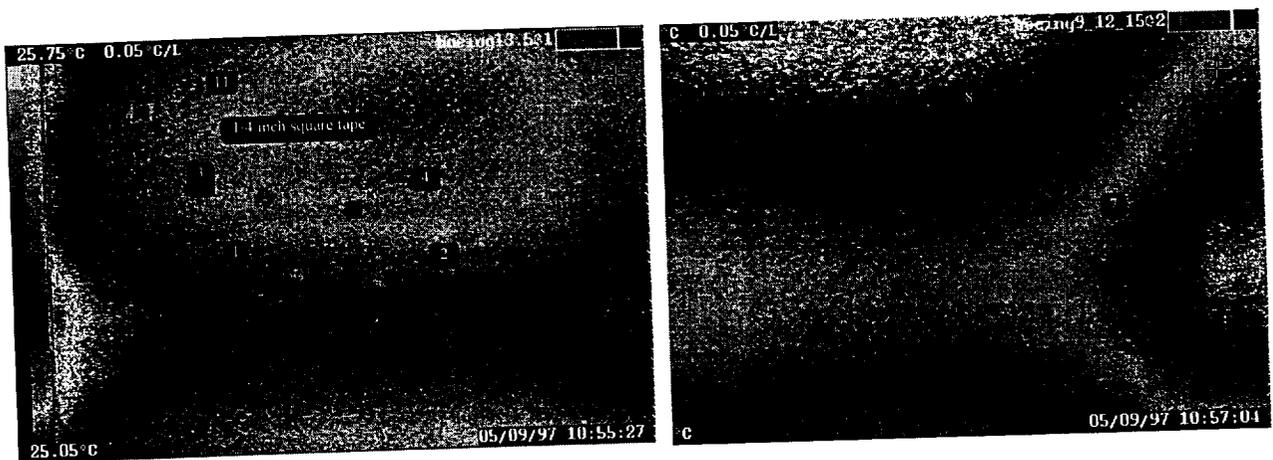
Figure 2. Thermograms of impact damage.

The impacted panel was thermographically inspected using flash heating from the impact side. The coverage area for the imager dictated that the panel be inspected in two passes, each covering an area of the panel 18 inches wide by 12 inches tall. As evident in Figures 4 and 5, all thirty impact locations were identified thermographically. The extent of the damage between impact points as viewed by the thermography system remained fairly constant even though the visual measurements varied greatly between positions (Table 2). The thermograms indicate that the maximum damage area is approximately 0.25 inch square as seen by comparison with the foil

tape square in each image. As expected, yet not apparent in the two thermograms shown, the damage appeared to enlarge with depth away from the impact point.

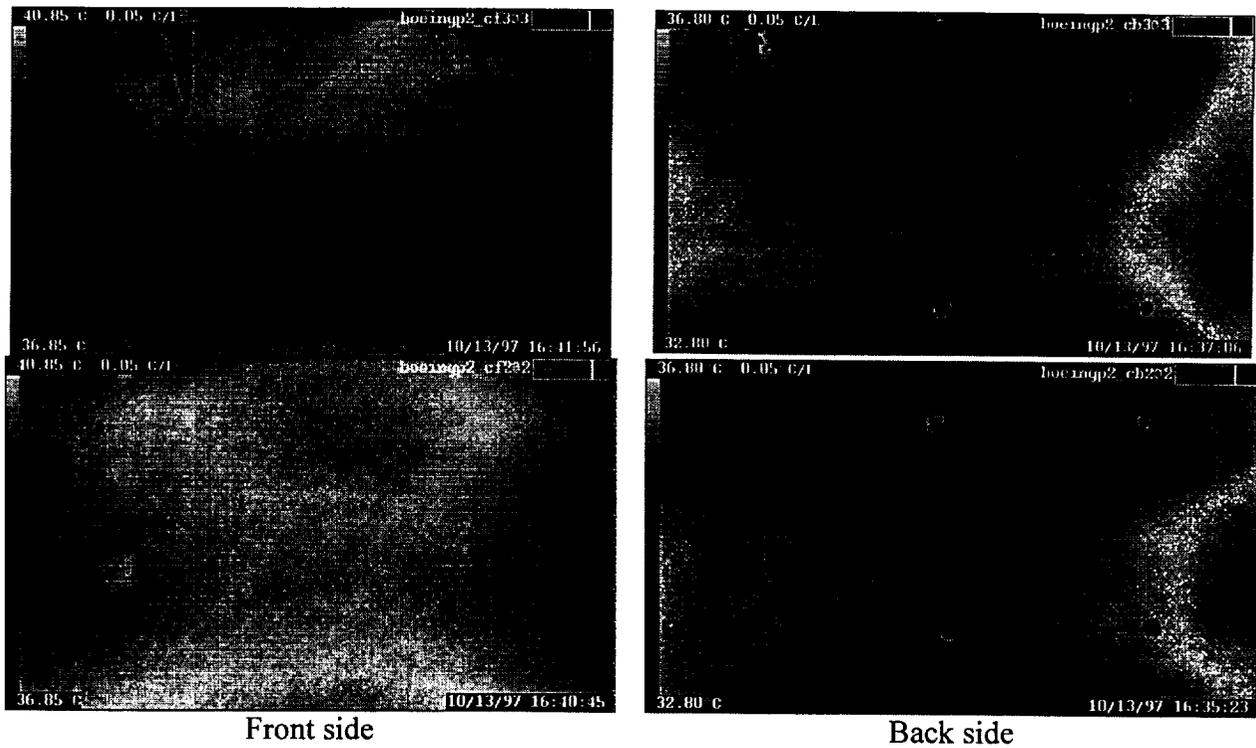
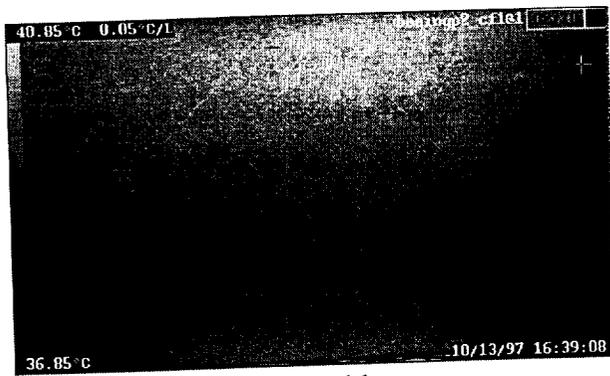
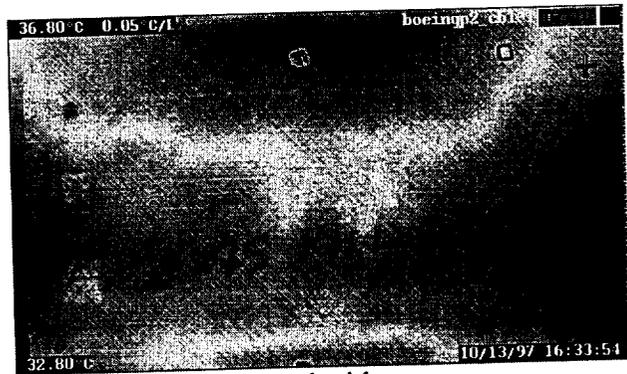
Figure 10. Bales TIP results.

For comparison, the Bales Thermal Image Processor was also used to inspect the panel. The imager was set 16 inches from the test panel and flashed with a power setting of 1400V (≈ 1.4 kJ)

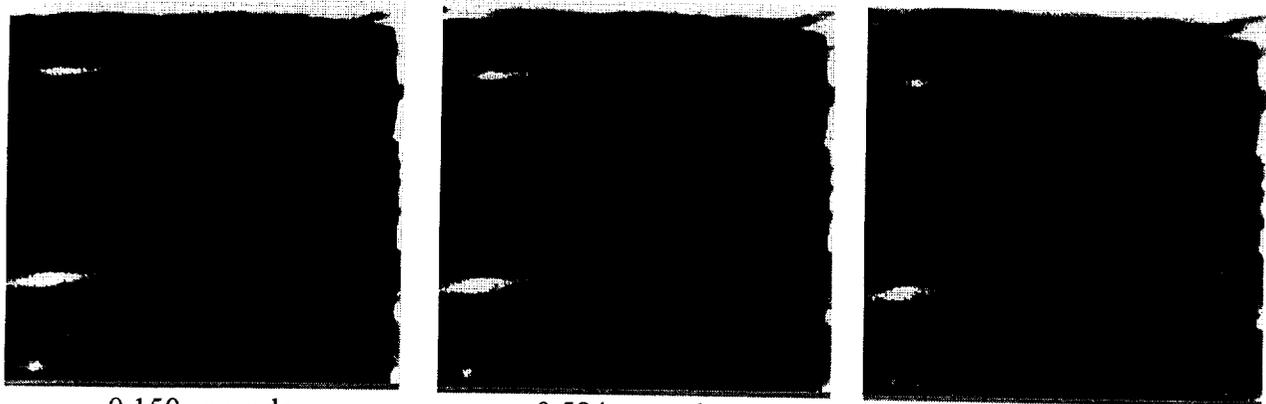
Figure 13a. No Surface Treatment

- **Figure 13a.** Obtained by viewing the unaltered jacket surface.
 - The dark (cold) spot is the thermal reflection of the cooled infrared camera.
 - The distinct horizontal bright (hot) “flares” are the thermal reflections of the residual heat in the lamps after flash.
 - The faint horizontal bright (hot) lines are the interstitial gaps between the coolant tubes and the jacket.
 - The faint horizontal dark (cold) lines are the regions where the coolant tubes are in contact with the jacket.
 - The diagonal bright (hot) line is a feature of unknown classification which is visible to the unaided observer on the coupon surface.
 - The vertical bright (hot) line is a feature of unknown classification which is not visible to the unaided observer on the coupon surface.
 - The extremely faint bright (hot) spot near the lower left “flare” is the thermal signature of the programmed defect.

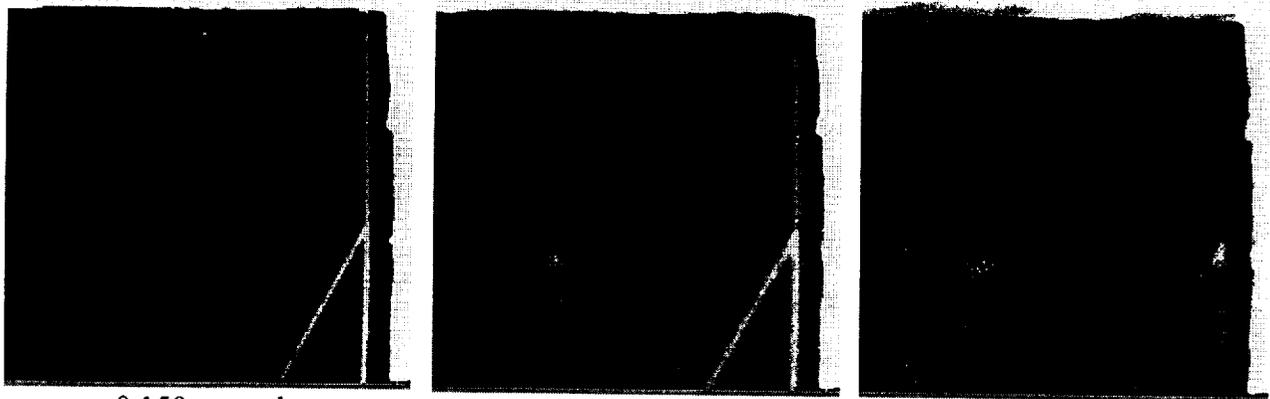
Figure 13c. Painted Flat Black (Water washable paint)

- **Figure 13c.** Obtained by painting the jacket surface flat black.
 - The distinct bright (hot) spot is the thermal signature of the programmed defect.
 - The somewhat distinct horizontal bright (hot) and dark (cold) lines are the tubes and gaps.
 - The diagonal and vertical bright (hot) lines are the features of unknown classification.

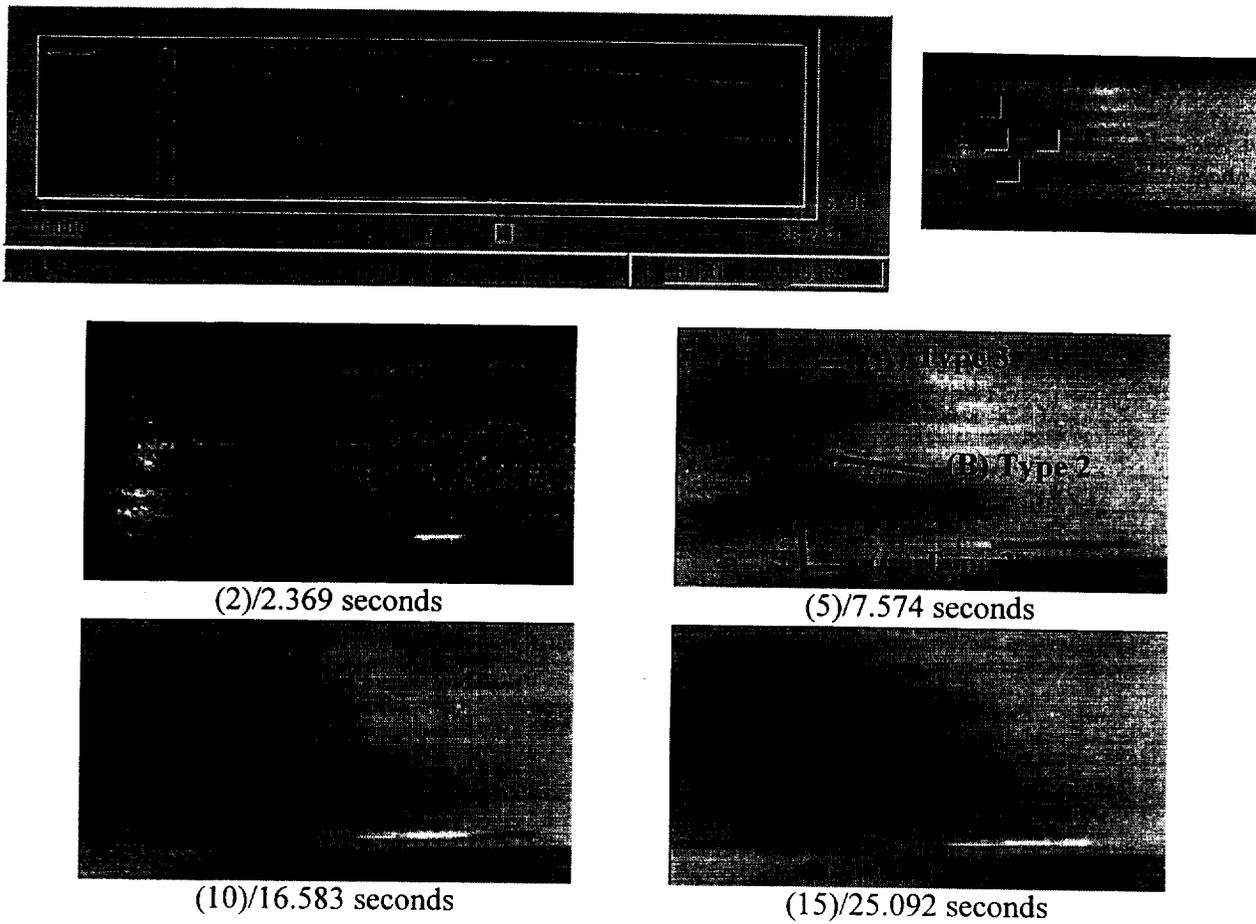
Figure 20. Region 1.

Figures 20 and 21 show the resulting thermograms over 4 (gate)/time intervals. Also included in the figures are the Time-Temperature plots which provide an indication of the degree to which the defects can be detected.

Defect number	Pressurized tube	Interstitial Leak location	Leak type
C	2	2-3	3
B	4	4-5	2
A	6	6-7	3

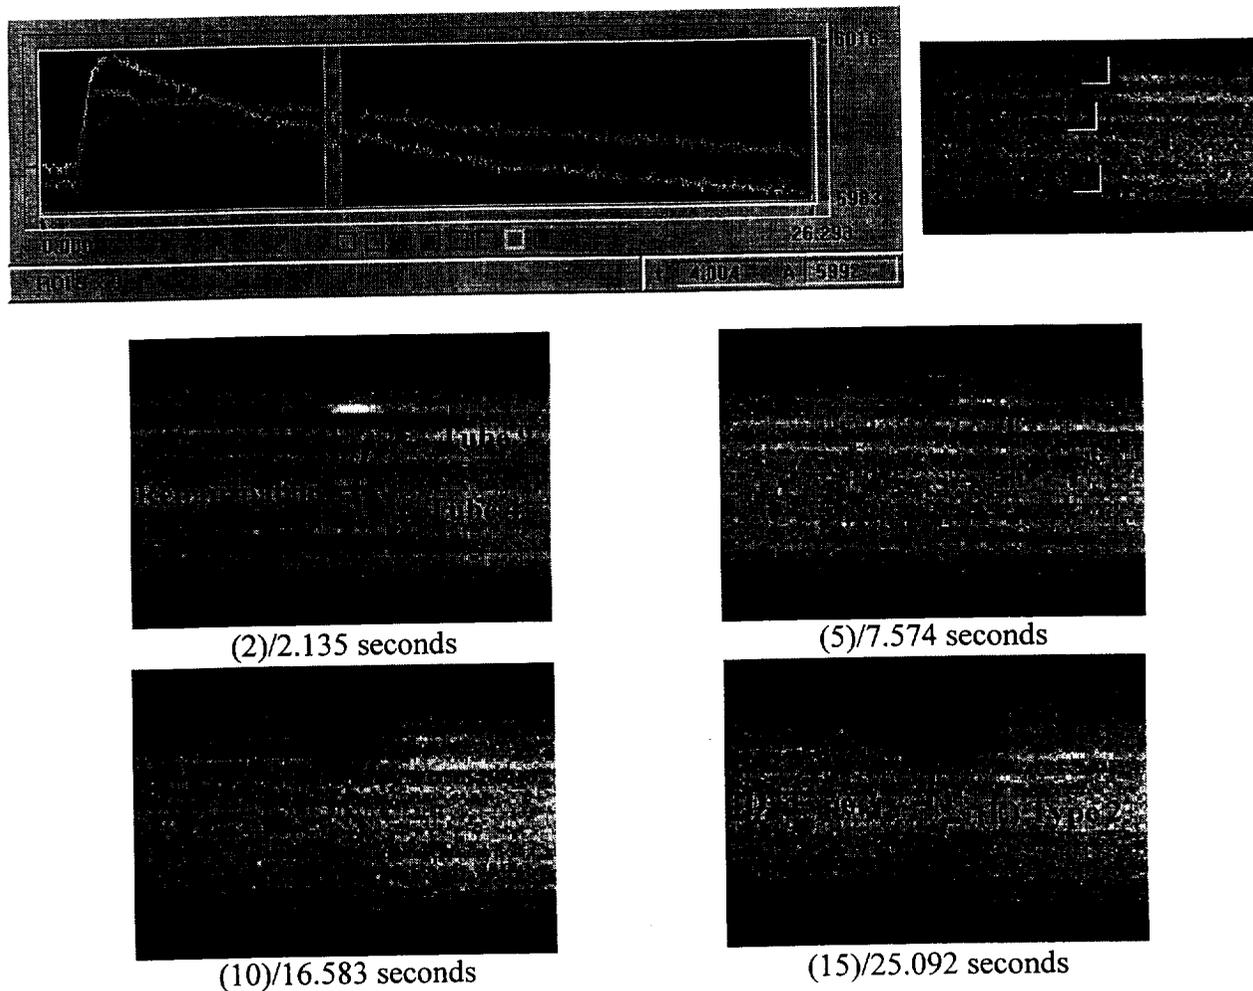
Figure 21. Region 2.

Defect number	Pressurized tube	Interstitial Leak location	Leak type
E	4	4-5	1 - 2
D	9	9-10	3

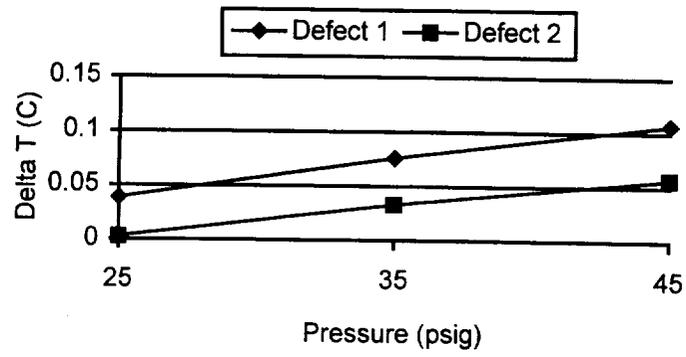
Figure 22. Thermal response at three pressures.

One question that arose from the previous testing was how much of an effect does the amount of pressure have on the ability to detect a leak. This question was answered by computing the delta temperature based upon maximum difference in IR camera values between defect region and acreage region assuming a conversion factor of 203 levels/°C. The results are given in Table 6 and Figure 22. All tests were conducted in region 2 of SSME4.

Defect	Pressure (psig)		
	25	35	45
1	.039 Δ°C	.076 Δ°C	.107 Δ°C
2	.003 Δ°C	.033 Δ°C	.057 Δ°C

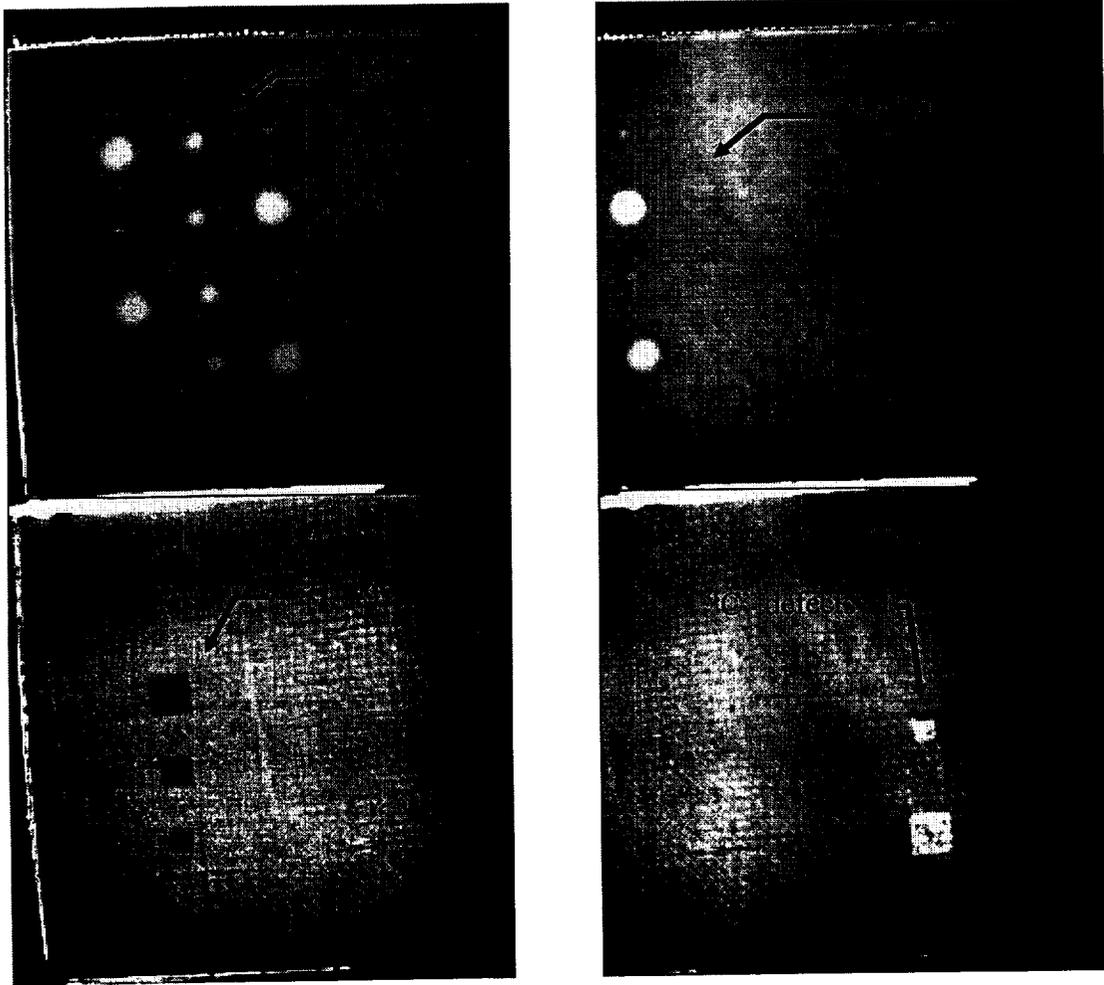
Figure 27. Foil Side of panel H1.

The finished panel was inspected using the Amber Radiance 1 camera and front side flash heating before being sent to KSC. The heat source for this inspection was supplied by the Thermal Wave Imaging flash hood. The thermograms are given in Figures 27 and 28.

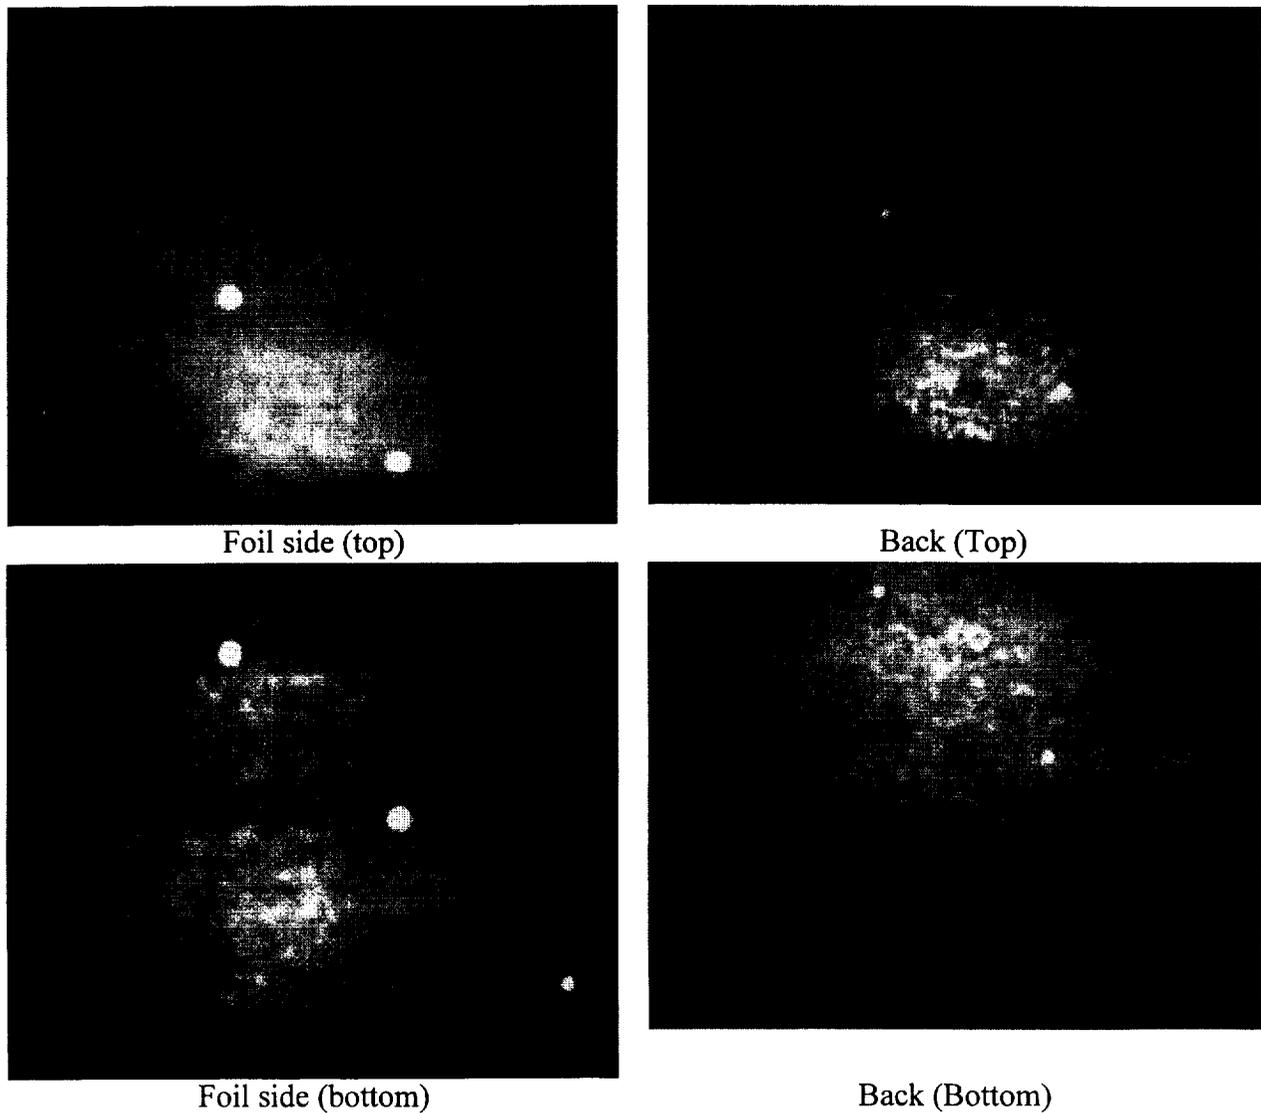
Figure 30. Thermograms for panel H2.

Panel H2 was fabricated in a manner similar to H1 except the defects were formed by precuring sections of cobond adhesive on the core as given in Table 8 and Figure 29. The resulting thermograms are given in Figure 30.

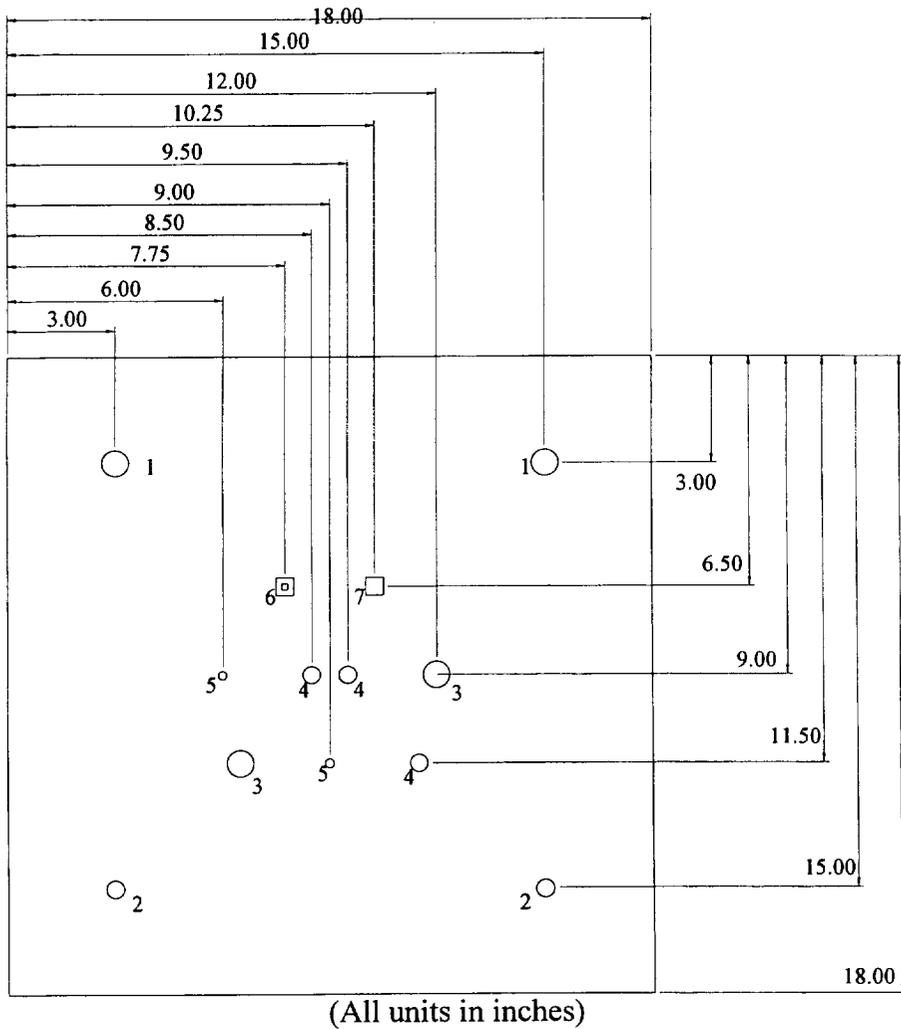
Figure 31. Defect map for Panel H3.

Panel H3 was constructed using the lessons learned from building and testing the first two panels. Due to physical constraints imposed by the shearographic system at KSC it was desired on panel H3 to group the main defects within a 9 inch box in the center of the panel. Milled core defects would be placed on the corners of the plate for thermographic inspection. The defect descriptions are given in Table 9 with a defect map given in Figure 31. The resulting thermograms are provided in Figure 32.

Defect Number	Characteristics
1	Milled core, 3/4 inch diameter, 0.2 inch deep
2	Milled core, 1/2 inch diameter, 0.2 inch deep
3	Missing cobond adhesive, 3/4 inch diameter
4	Missing cobond adhesive, 1/2 inch diameter
5	Missing cobond adhesive, 1/4 inch diameter
6	Doubled 0.001 inch thick plastic film with single ply tissue paper insert, 1/2 inch square film, 1/4 inch square paper
7	Doubled 0.001 inch thick plastic film, 1/2 inch square
6*	Doubled 0.001 inch thick plastic film with single ply tissue paper insert, 3/4 inch square film, 1/4 inch square paper
7*	Doubled 0.001 inch thick plastic film, 1/4 inch square

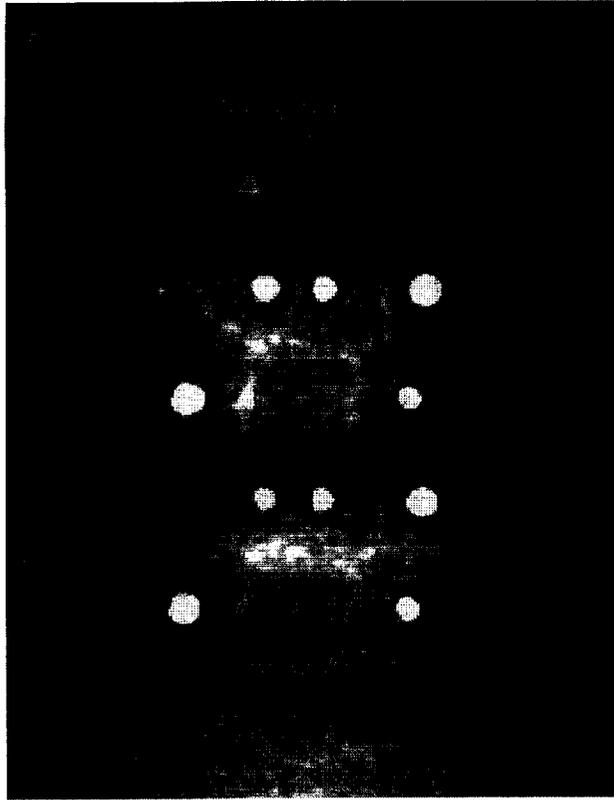
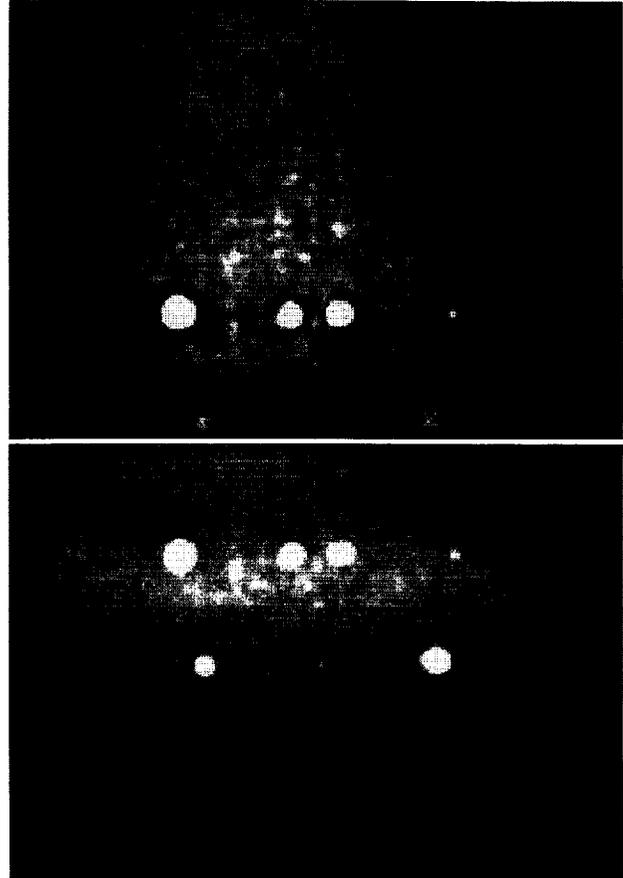
Figure 32. Thermograms for panel H3.

1. The milled core defects are just barely visible. It appears that the ability of the core to conduct heat away is very similar to the ability of air to radiate the heat away.

2. One milled defect looks very similar to a missing cobond tape defects. It may be that the cobond tape on that milled core pulled away from the face plate.

3. The only insert defect that was clearly visible was number 6. Defects 6* and 7 are just barely visible. The insert defects were placed between the core and cobond tape. It is possible that a better defect would be made by placing the inserts between the cobond tape and the face plate. In this manner the inclusion, and air, would be trapped between the cobond tape and face plate. As the panel was built, the only thing one would expect to see is the lack of bond between the cobond tape and the core and the difference in thermal conductivity of the inclusion. The tightness to which the insert is held between the core and face plate may be helping the flow of heat through that region, i.e. making the region look “thermally” bonded.

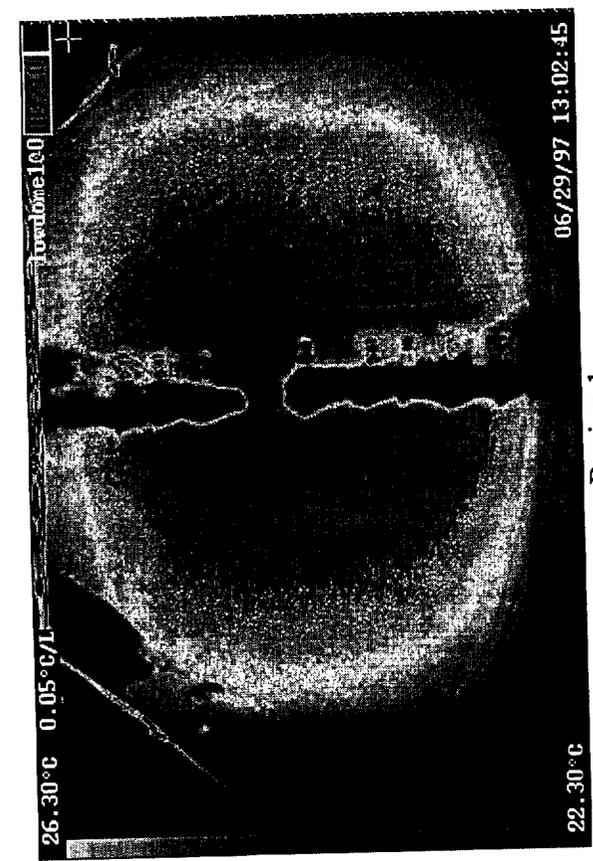
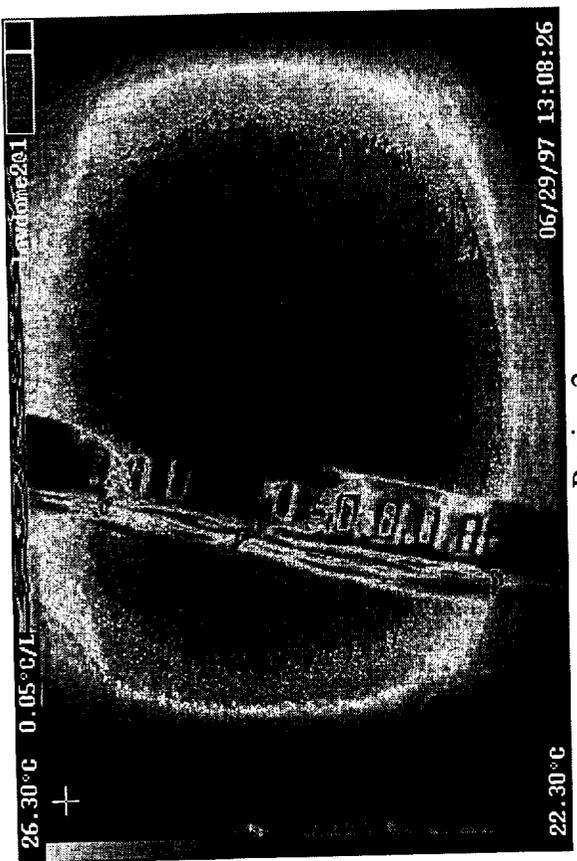
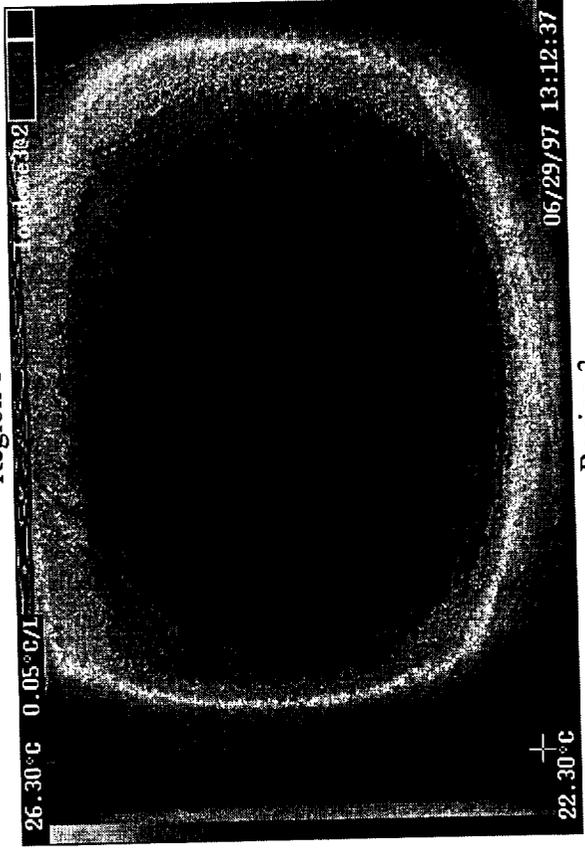
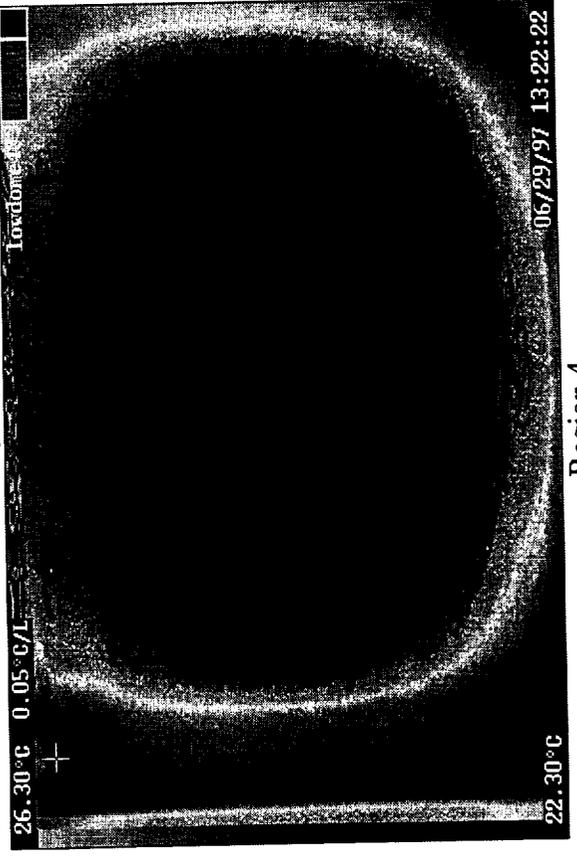
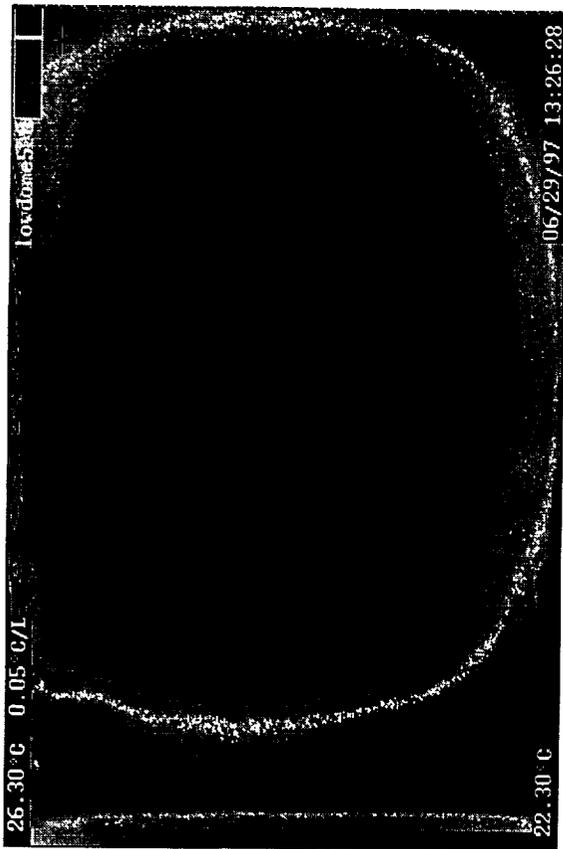
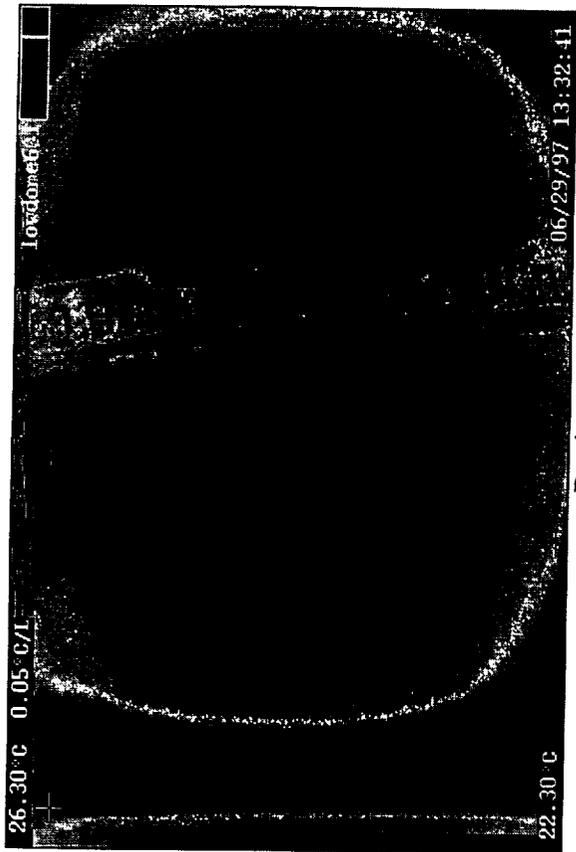
Some thermal abnormalities were found at visible surface wrinkles as shown in the following thermograms. Due to the severity of the visible surface features it is difficult to identify individual subsurface defects.

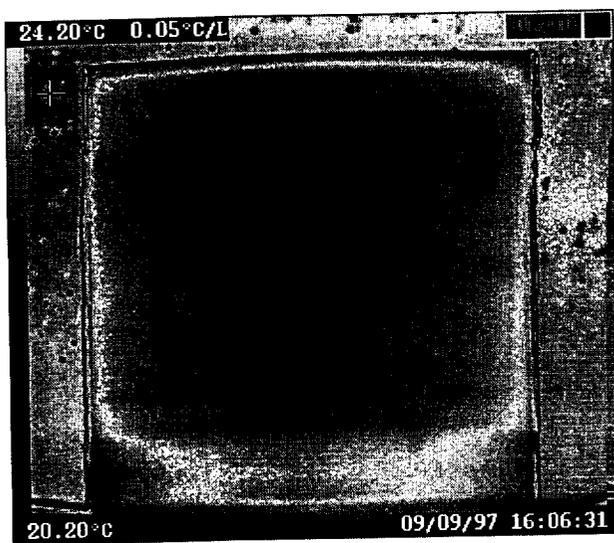
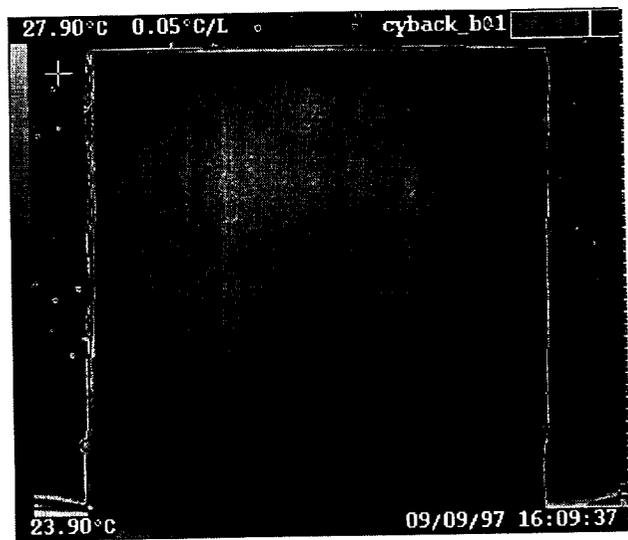
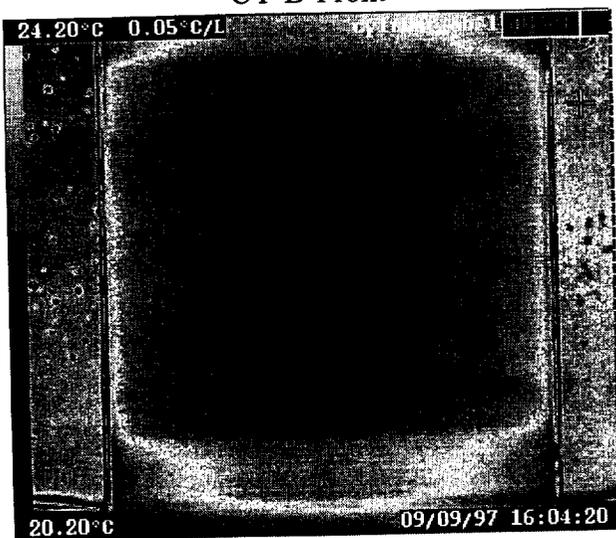
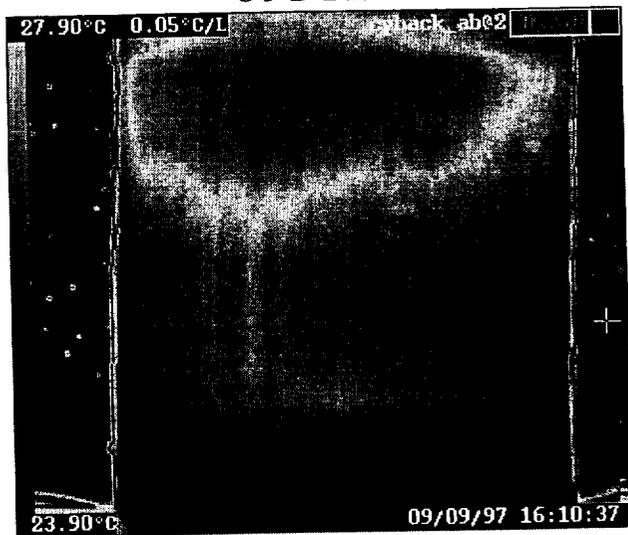
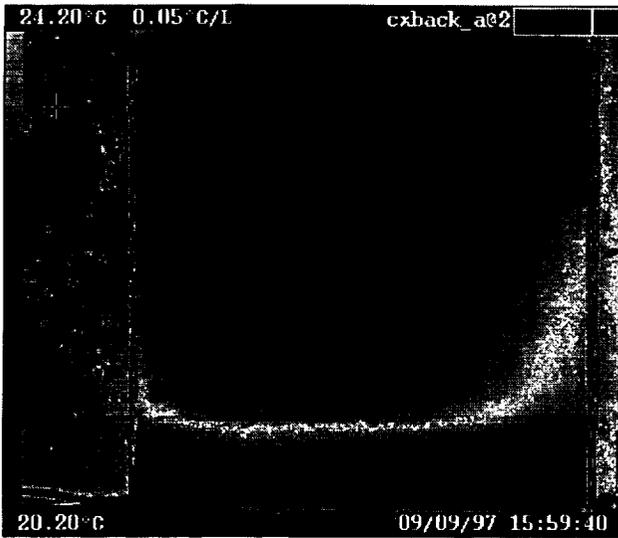
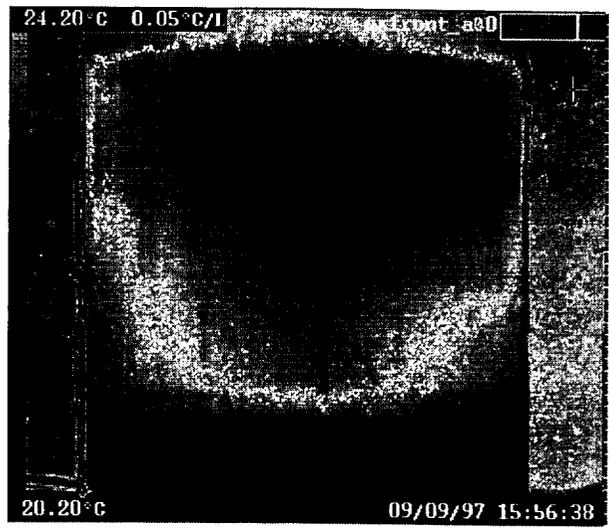
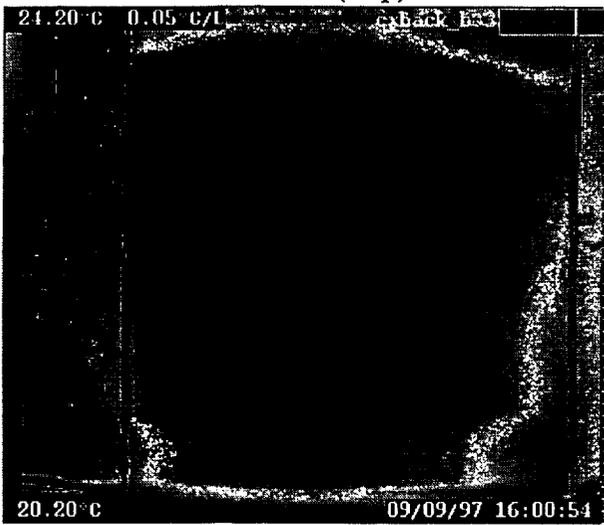
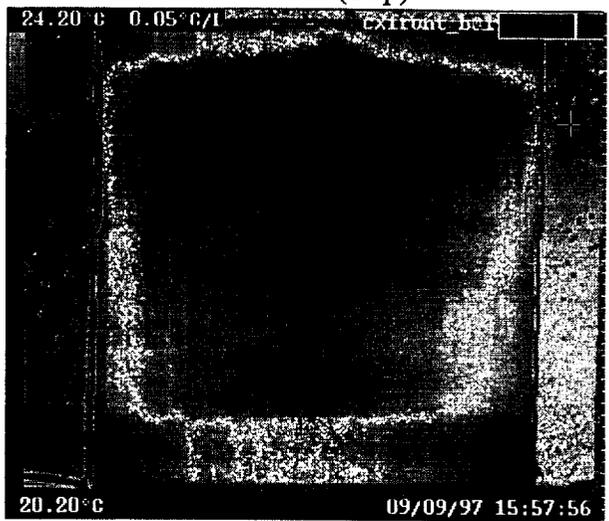
- Project description: Test panels built by THIOKOL.
- Material: Graphite/epoxy
- Lay-up schedule: Unknown
- Critical defect size: Unknown
- Inspected using flash thermography (Bales TIP)
- Imaged at a distance of 32 inches
- Power setting of 1400V
- Results: Several thermal abnormalities found. See thermograms.

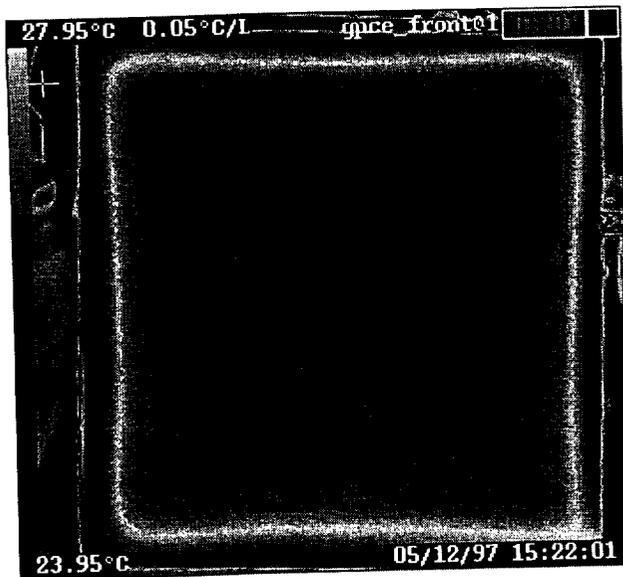
Front

The only thermal abnormality found was a small spot on the right side of the front face of the panel. This defect acts as a small void “delamination” at the edge of a bolt hole. No indications were found using through transmission heating (1000W heat lamp). A defect standard panel is needed to verify the depth of penetration of the flash heating

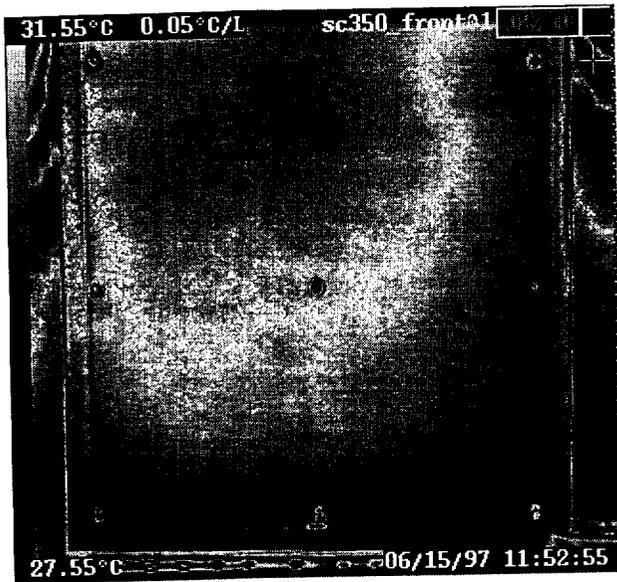
SC350 Front

Thermal abnormalities marked on images

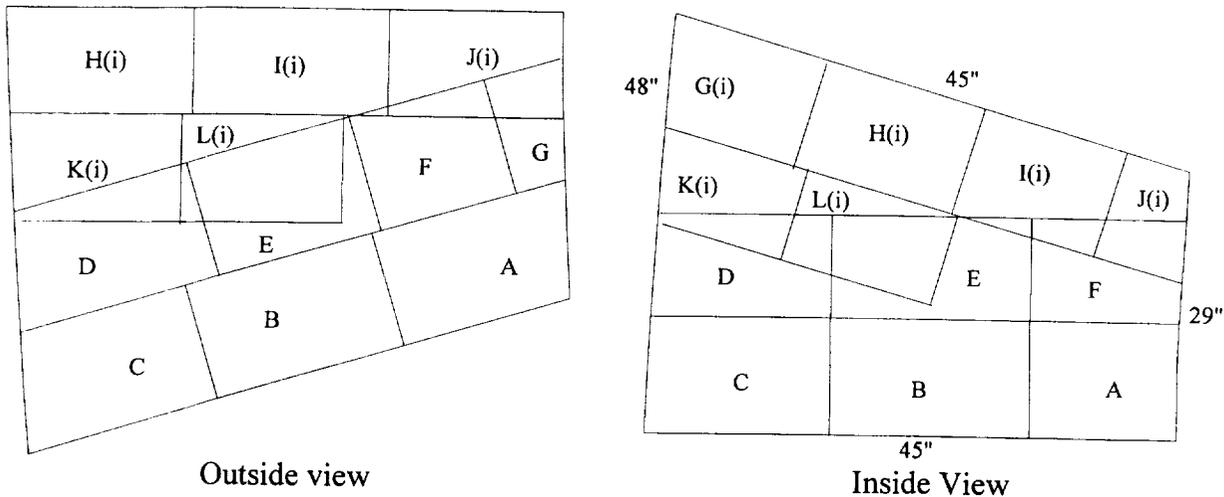
Figure 37. X-38 Panel.

The panel was inspected using flash thermography from both sides. A single sided inspection was not possible as determined by the inability to detect lead foil tape on the back side of the panel during inspections. The panel was imaged at a distance of 32 inches using a Amber Radiance 1 thermal camera running under Thermal wave Imaging software. Flash heating was provided by a Bales Scientific Flash Unit set to a power setting of 1400V. With this arrangement the nominal inspection size was 12 inch tall by 18 inch wide and required 24 stations to provide complete coverage of the panel (Figure 37).

Note: The label (i) indicates that the panel was inverted to acquire thermograms.

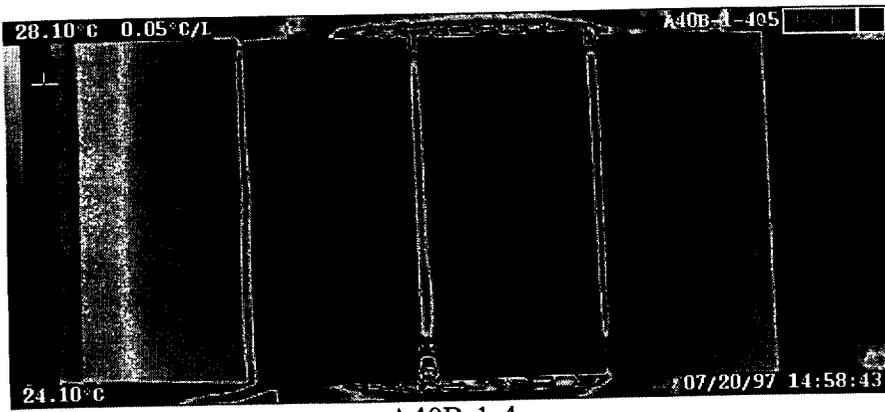
A40B-1-4

Out of the 192 inspections performed, only 10 anomalies were detected. These anomalies are identified in the following table and shown on the thermograms. The defect regions were identified on the samples with a white marker.
