Debris/Ice/TPS Assessment and Integrated Photographic Analysis of Shuttle Mission STS-93

*Gregory N. Katnik
Process Engineering/Mechanical System Division/ET-SRB Branch,
Kennedy Space Center, Florida*

23 July 1999

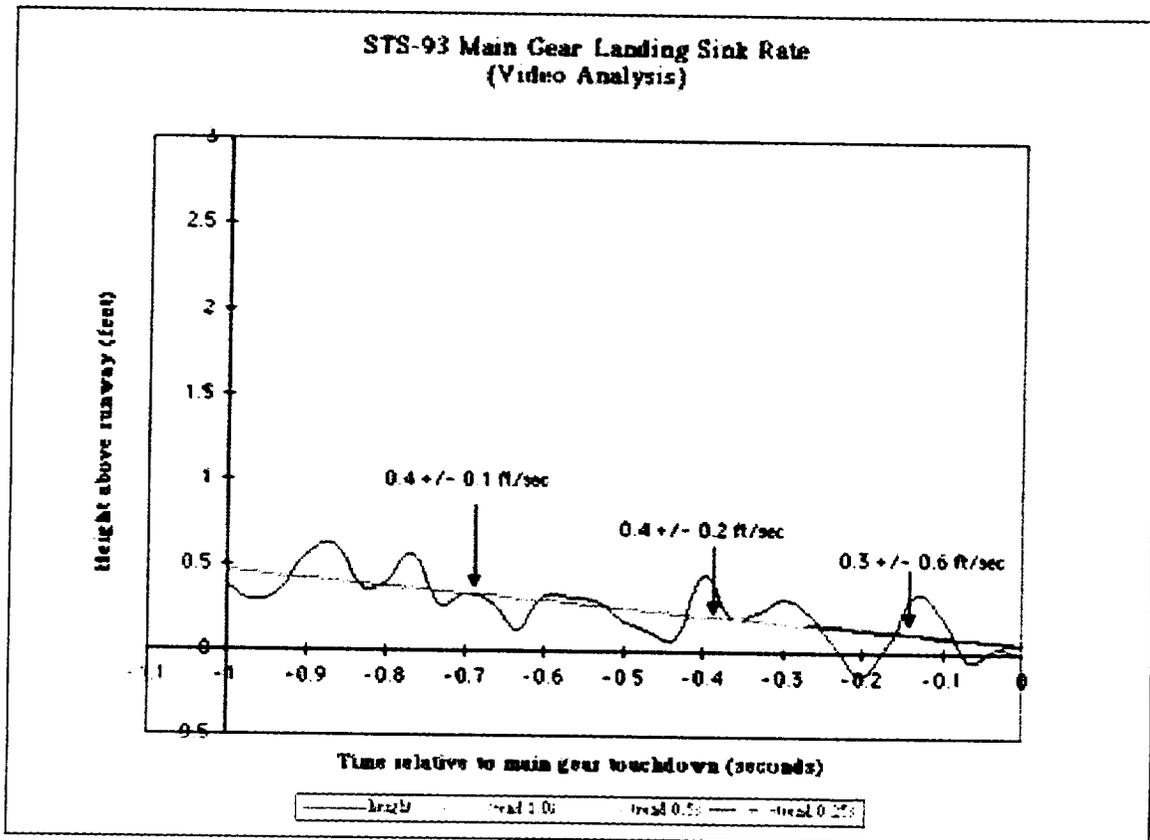
Figure 2.7.1 Main Gear Landing Sink Rate

The left main gear sink rate for STS-93 landing at one second, at half a second, and at a one quarter of a second are provided in the following table. A plot describing these sinkrates is enclosed. Due to the night landing resulting in dark images and the degraded resolution of video compared to film, the sink rate estimates for STS-93 are not as accurate as in previous missions. No significant correlation could be determined for the regression of the data during the last 0.25 seconds of the landing. Error estimates during this time are imprecise at best.

The maximum allowable main gear sink rate values are 9.6 ft/sec for a 212,000 lb vehicle and 6.0 ft/sec for a 240,000 lb vehicle. The landing weight of the STS-93 vehicle was estimated to be 202,721 lbs.
