Debris/Ice/TPS Assessment and Integrated Photographic Analysis of Shuttle Mission STS-103

**DEBRIS/ICE/TPS ASSESSMENT
AND
INTEGRATED PHOTOGRAPHIC ANALYSIS
OF
SHUTTLE MISSION STS-103**

19 December 1999

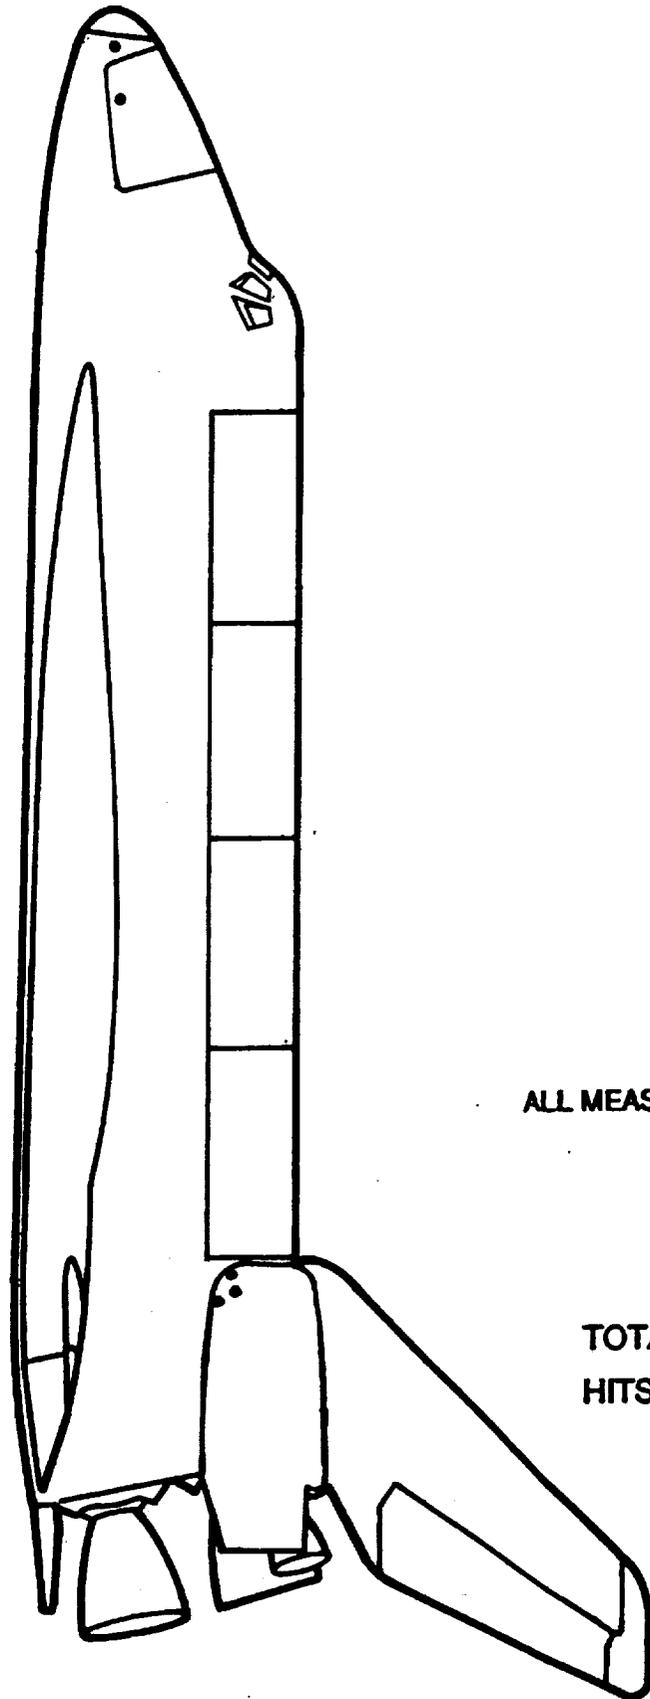
Figure 2: Orbiter Left Side Debris Damage Map

TOTAL HITS = 5

HITS > 1 INCH = 0

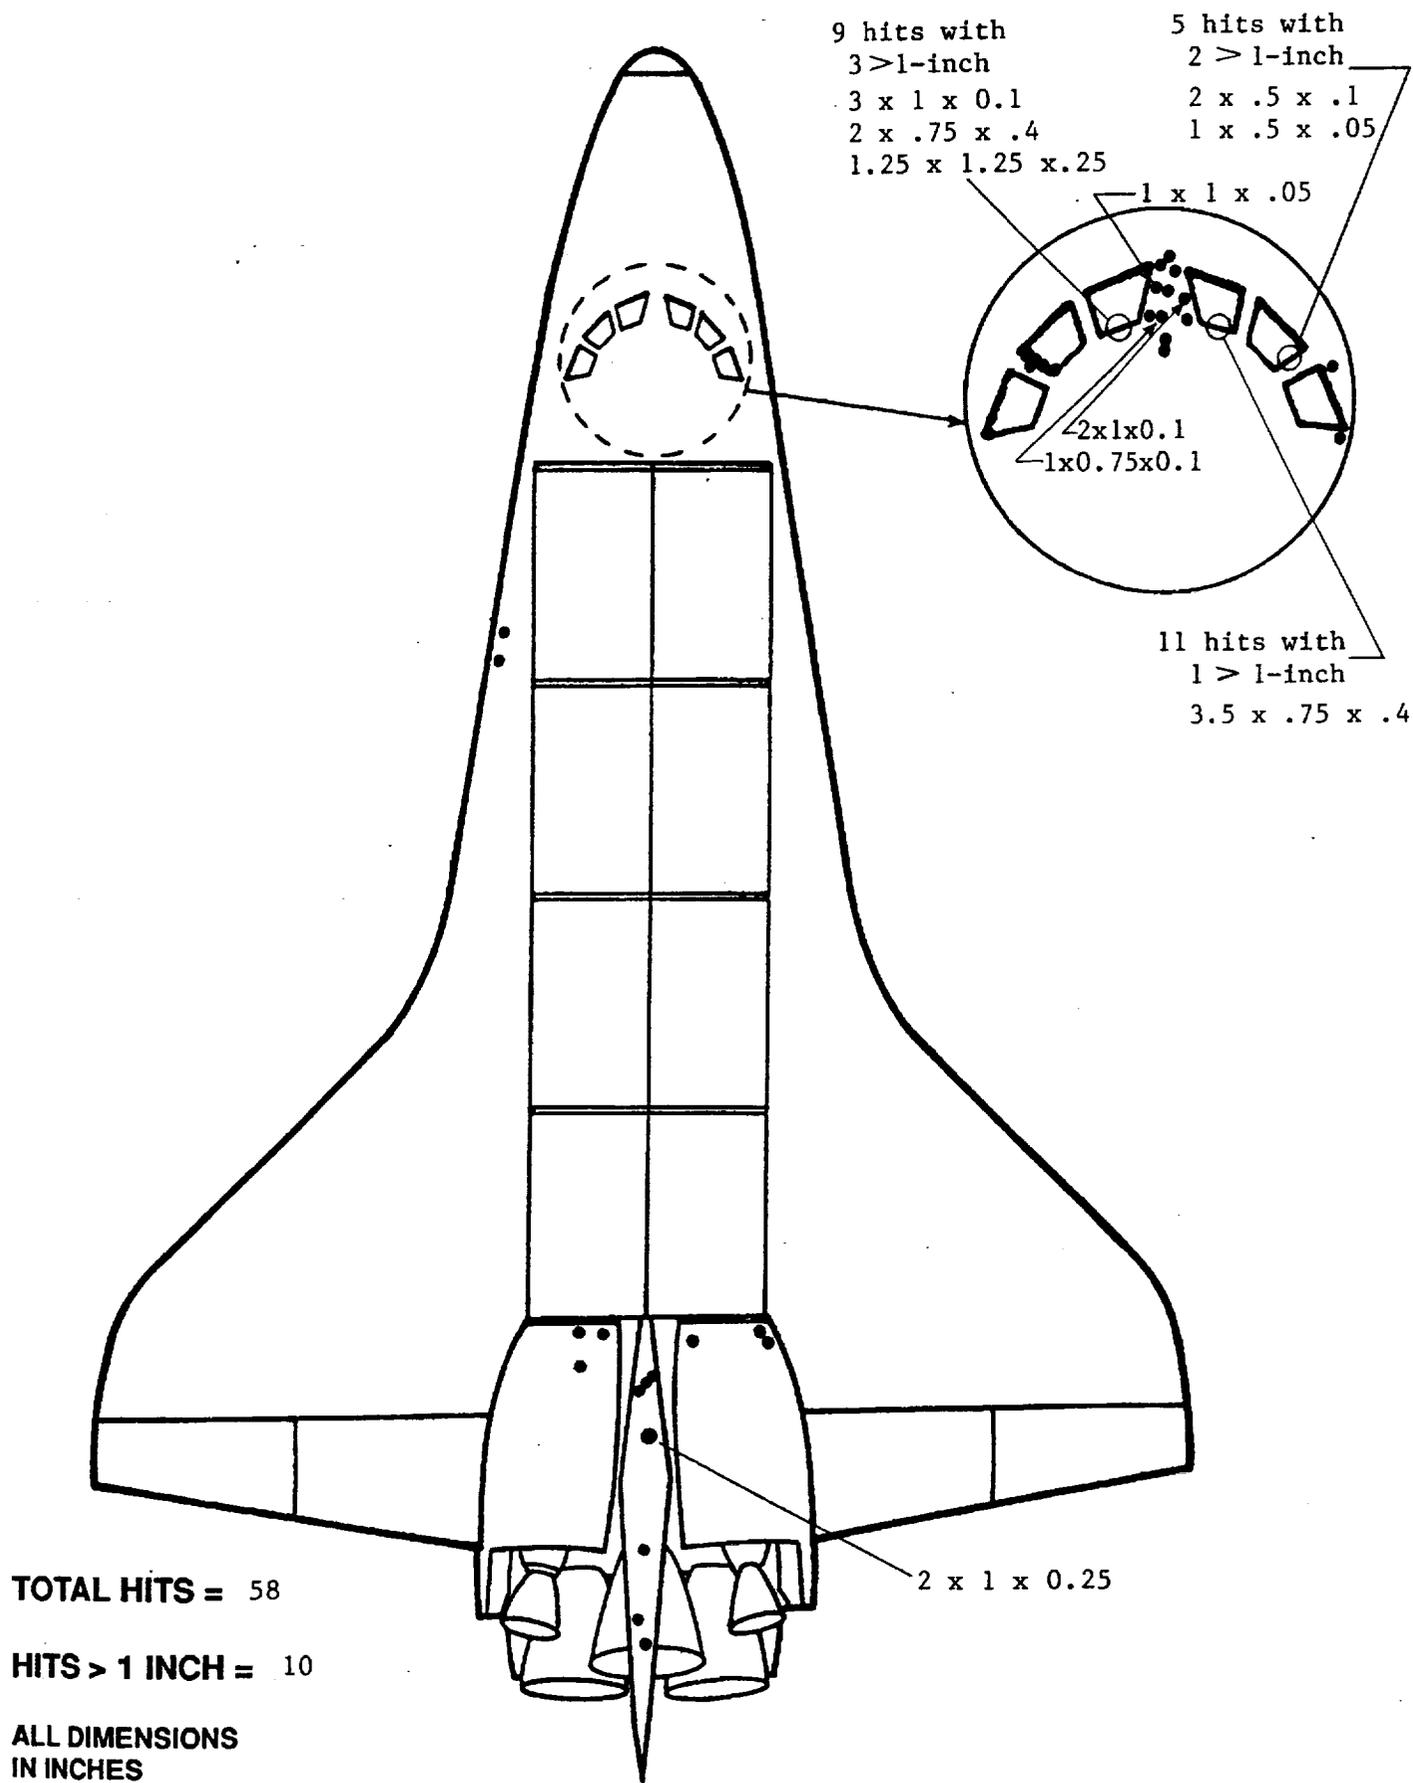
Figure 4: Orbiter Upper Surface Debris Damage Map

The Orbiter TPS sustained a total of 153 hits, of which 24 had a major dimension of 1-inch or larger. This total does not include the numerous hits on the base heat shield attributed to SSME vibration/acoustics and exhaust plume recirculation (Reference Figures 1-4. Figure 5 shows fleet averages prior to the loss of ET thrust panel foam starting at STS-86).

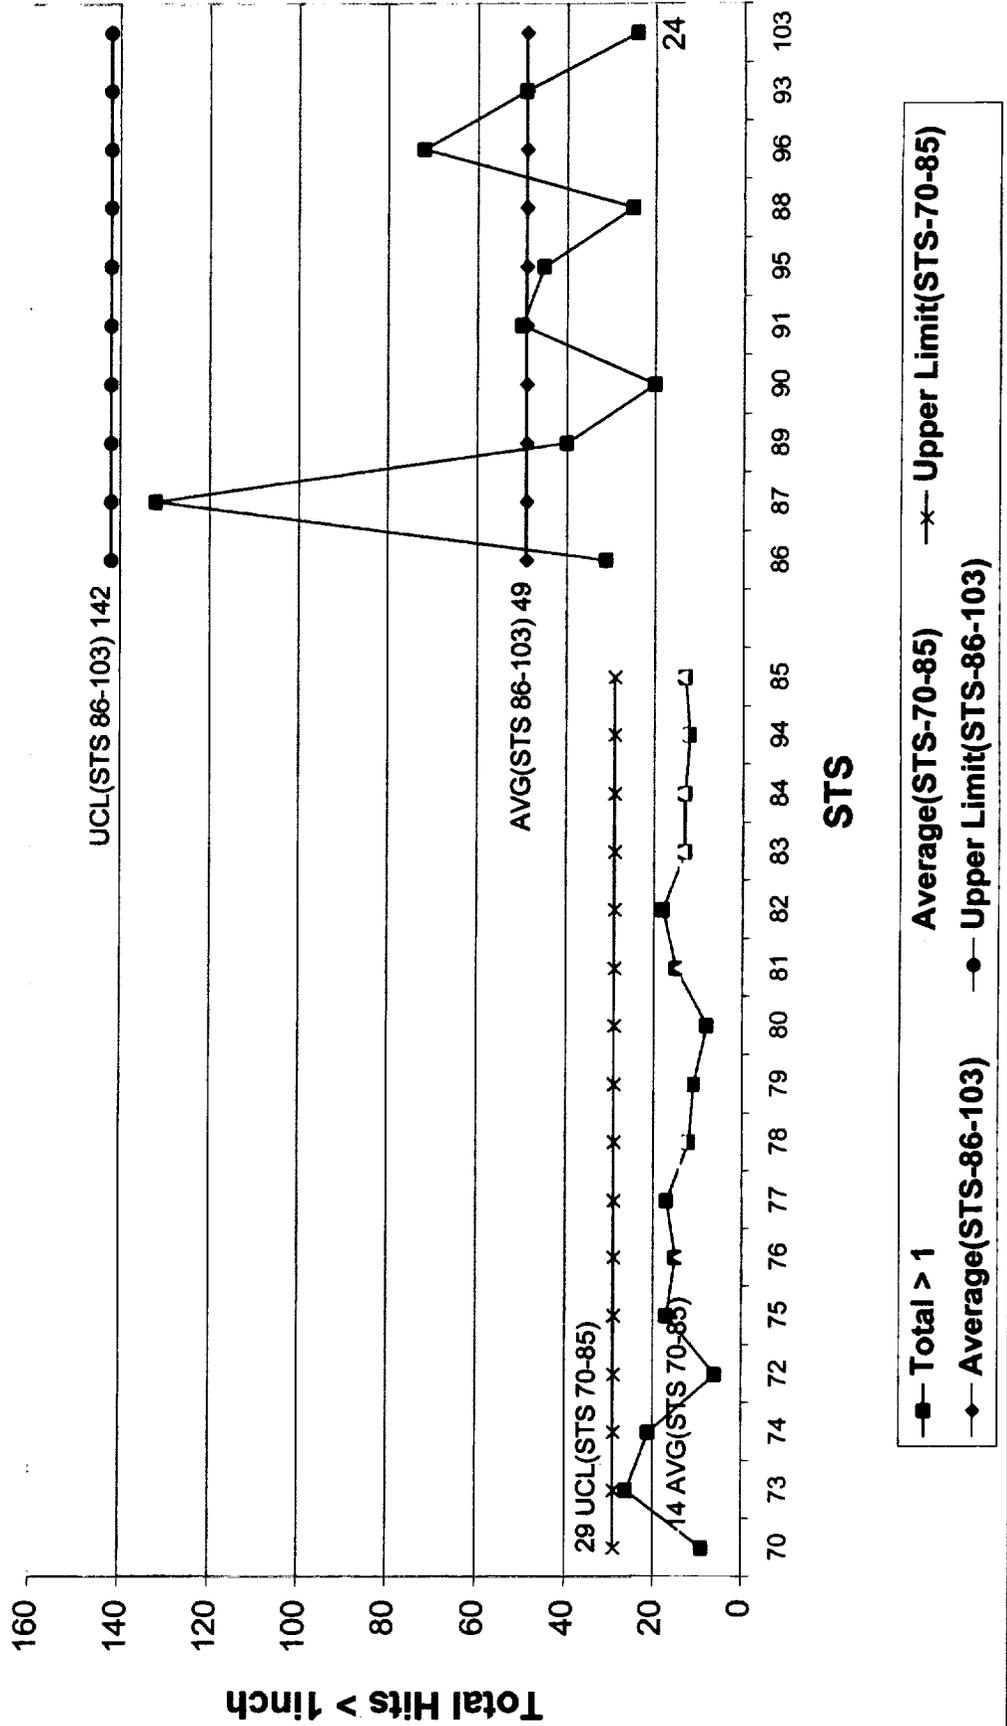
Figure 9: Control Limits for Total Hits > 1-inch

In summary, both the total number of Orbiter TPS debris hits and the number of hits 1-inch or larger were significantly reduced compared to the number and size of damage sites on previous missions since STS-86. IFA STS-87-T-01 documenting loss of ET foam will be closed. A Technical Directive-type plan to test and apply a replacement TPS will be presented to the Program by the External Tank Project.

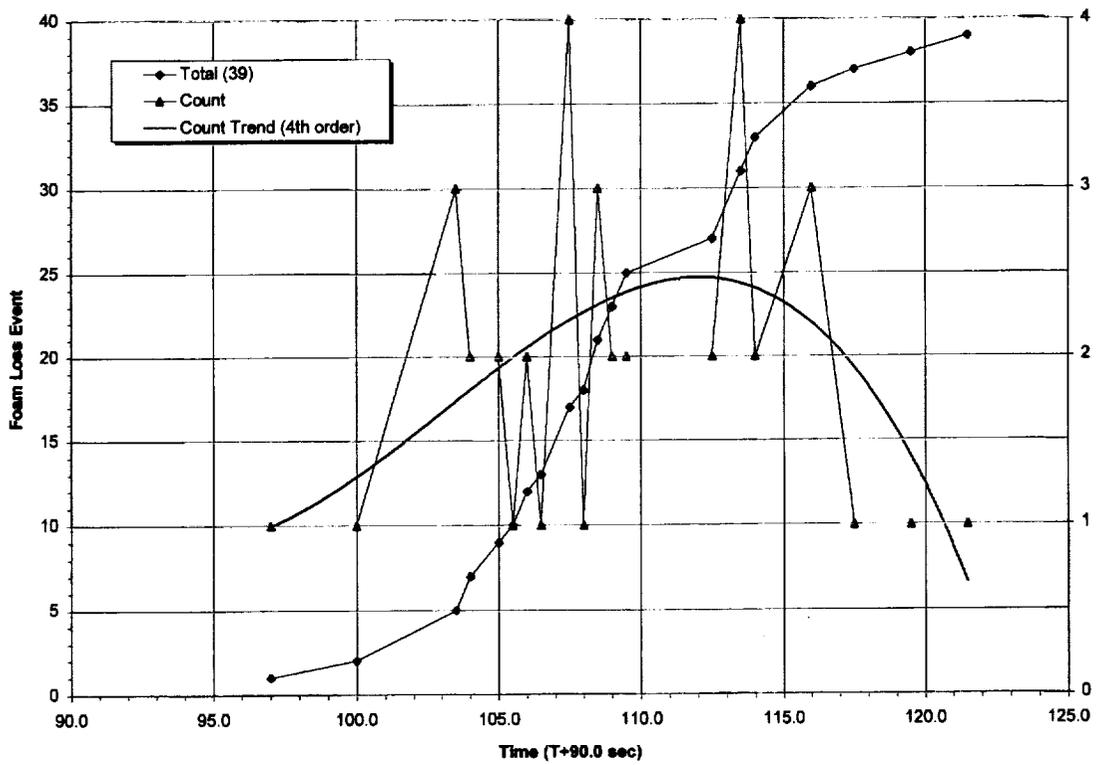
Figure 13. STS-103 -Y Thrust Panel: Foam Loss Event Timeline

In the first chart, the frequency and cumulative number of events recorded during each 0.5 second time interval from approximately T+90.0 seconds are shown. Using a fourth order polynomial approximation to trend the count data, the maximum foam loss activity appears to peak just after T+ 110.0 seconds. The maximum number of events recorded during any 0.5 second time interval was four.

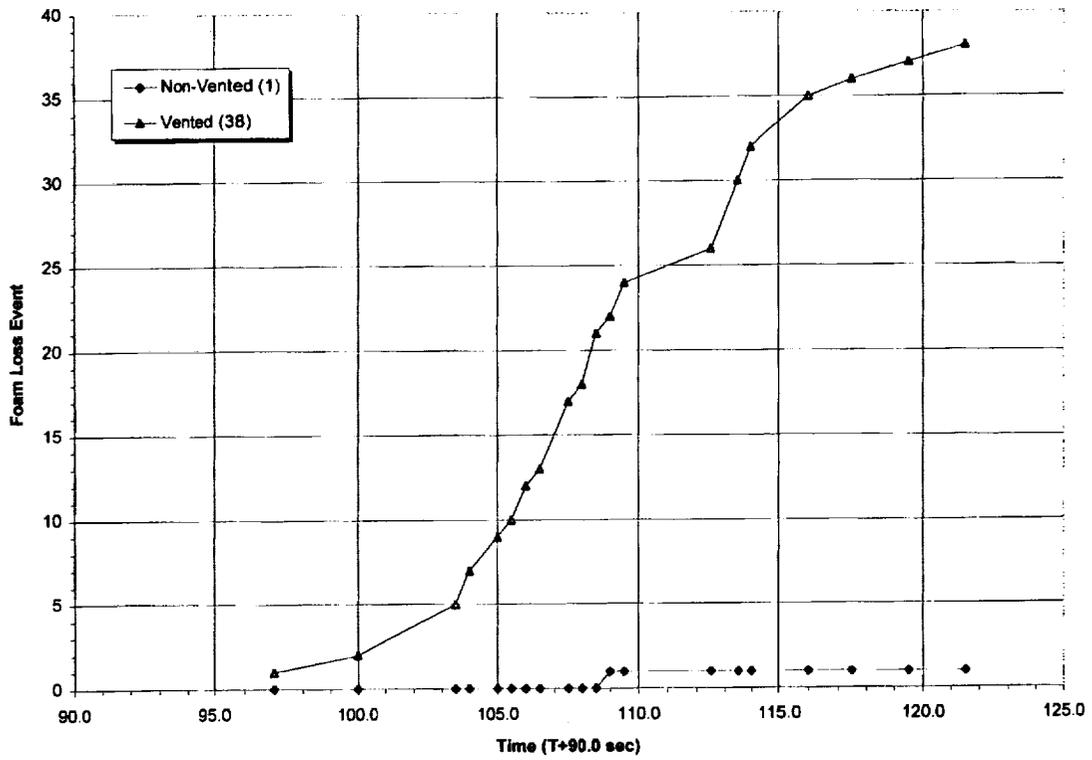
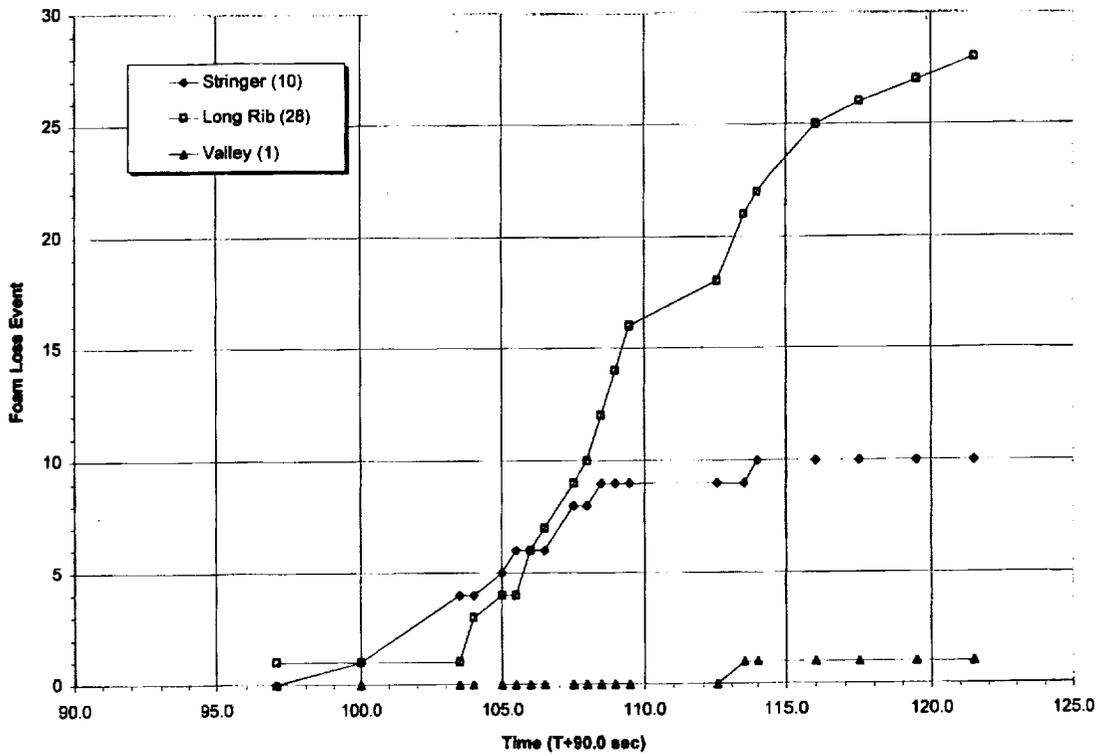
The second and third charts illustrate the timeline of events for vented/non-vented, and ET surface categories of foam loss events.

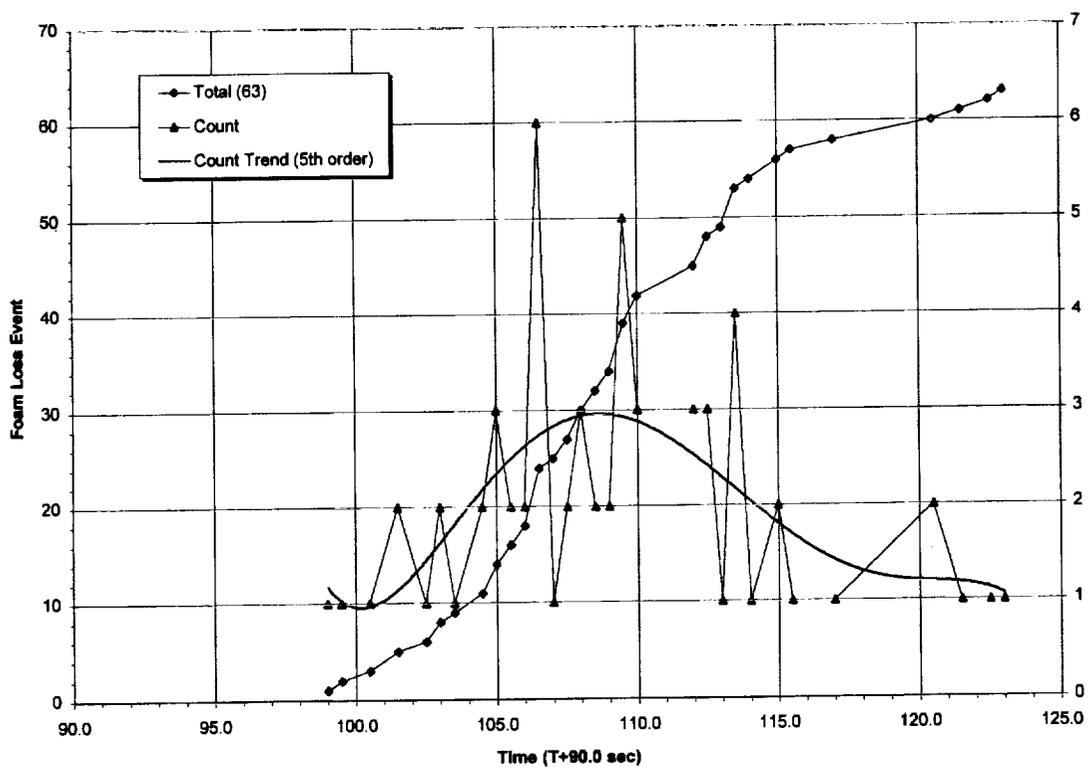
Figure 19. STS-103 +Y Thrust Panel: Foam Loss Event Timeline

In the first chart, the frequency and cumulative number of events recorded during each 0.5 second time interval from approximately T+90.0 seconds are shown. Using a fifth order polynomial approximation to trend the count data, the maximum foam loss activity appears to peak just before T+ 110.0 seconds. The maximum number of events recorded during any 0.5 second time interval was six.

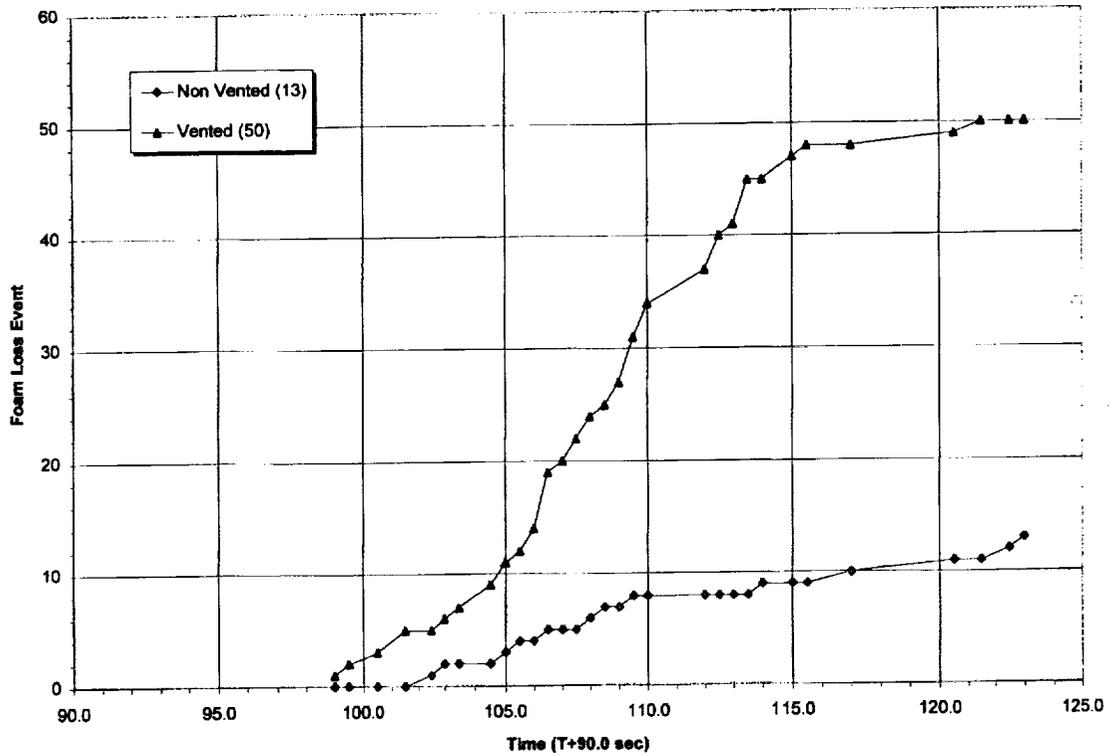
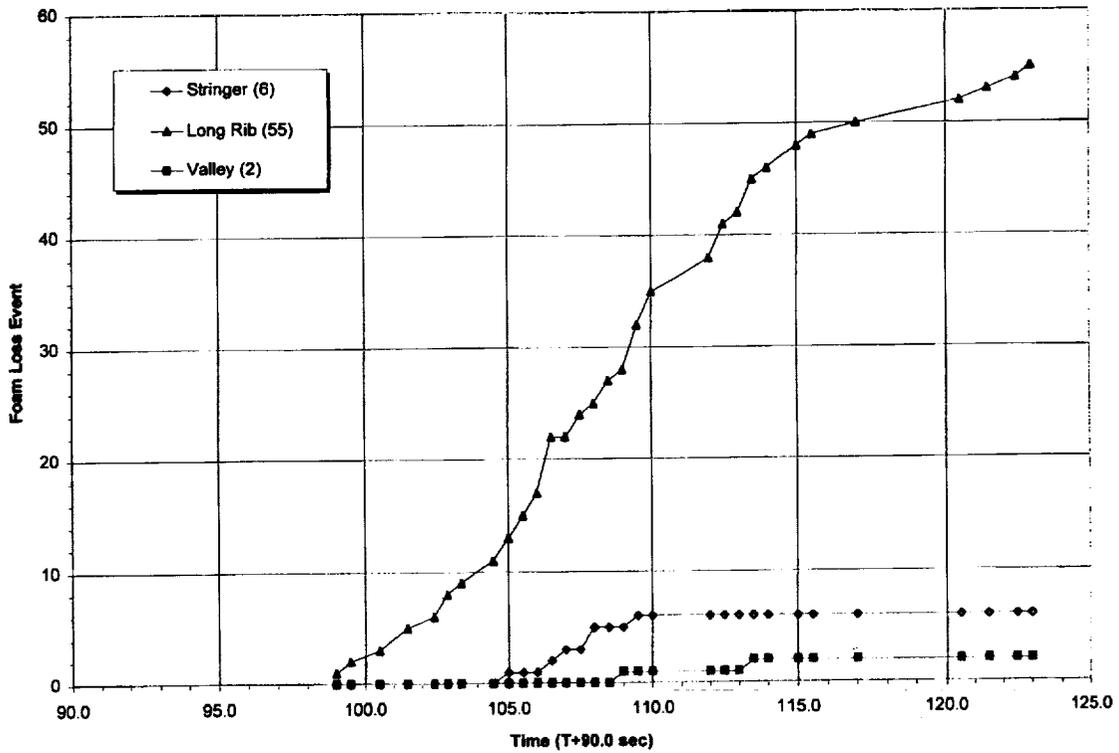
The second and third charts illustrate the timeline of events for vented/non-vented, and ET surface categories of foam loss events.
