Debris/Ice/TPS Assessment and Integrated Photographic Analysis of Shuttle Mission STS-99

**DEBRIS/ICE/TPS ASSESSMENT
AND
INTEGRATED PHOTOGRAPHIC ANALYSIS
OF
SHUTTLE MISSION STS-99**

11 February 2000

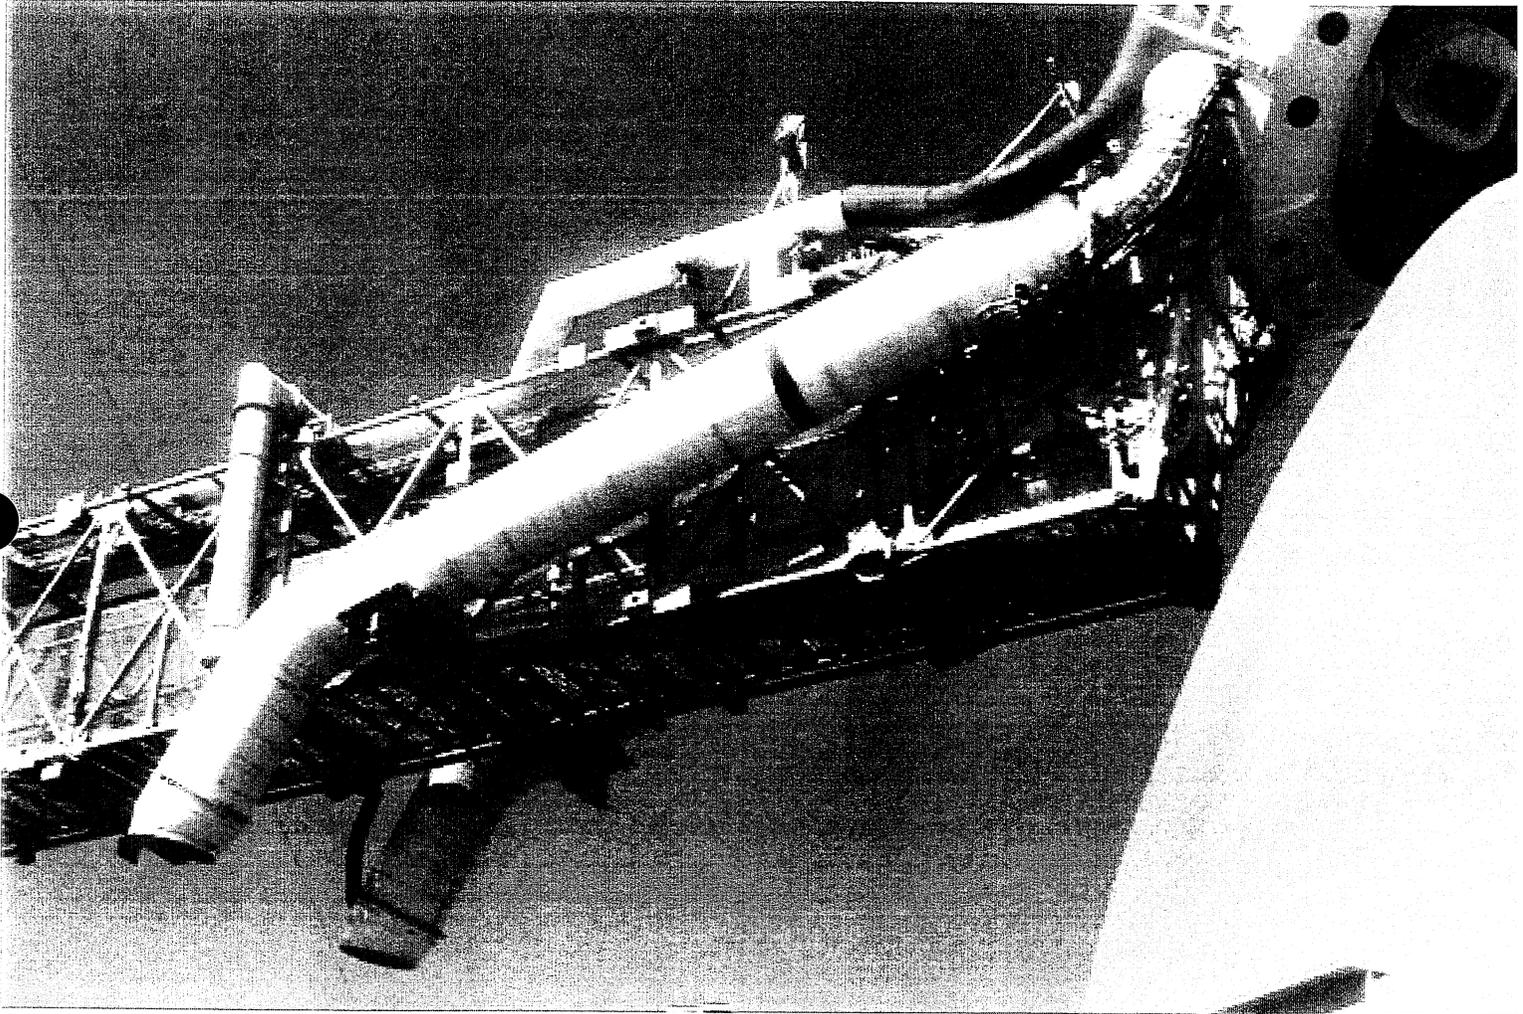
Photo 4: Side View of GOX Vent Ducts

At 12:25 GMT (0725 local), the Final Inspection Team on the FSS 255-foot level detected icicles on the exit planes of the GOX vent ducts: five on the south duct and four on the north duct. The largest icicles were estimated to be 8 inches long by 1 inch in diameter and approximately 40 pounds per cubic foot density. The weather conditions at the time – relatively cool temperatures, strong northwesterly 14-knot winds, and light rain/mist – were causing the icicles to grow in size as well as create new icicles. These conditions were expected to continue until 1200 hours local. The Final Inspection Team made a determination the icicles would eventually break loose and the falling pieces of ice pose an impact threat to Orbiter left wing tiles. The Launch Team in the LCC was notified accordingly. Disposition of the IPR included a report from Launch Accessories that the GOX vent duct heated nitrogen purge was operating with specification at 180 degrees F.

The Final Inspection Team on the FSS 255-foot level detected icicles on the exit planes of the GOX vent ducts: five on the south duct and four on the north duct. The largest icicles were estimated to be 8 inches long by 1 inch in diameter and approximately 40 pounds per cubic foot density.

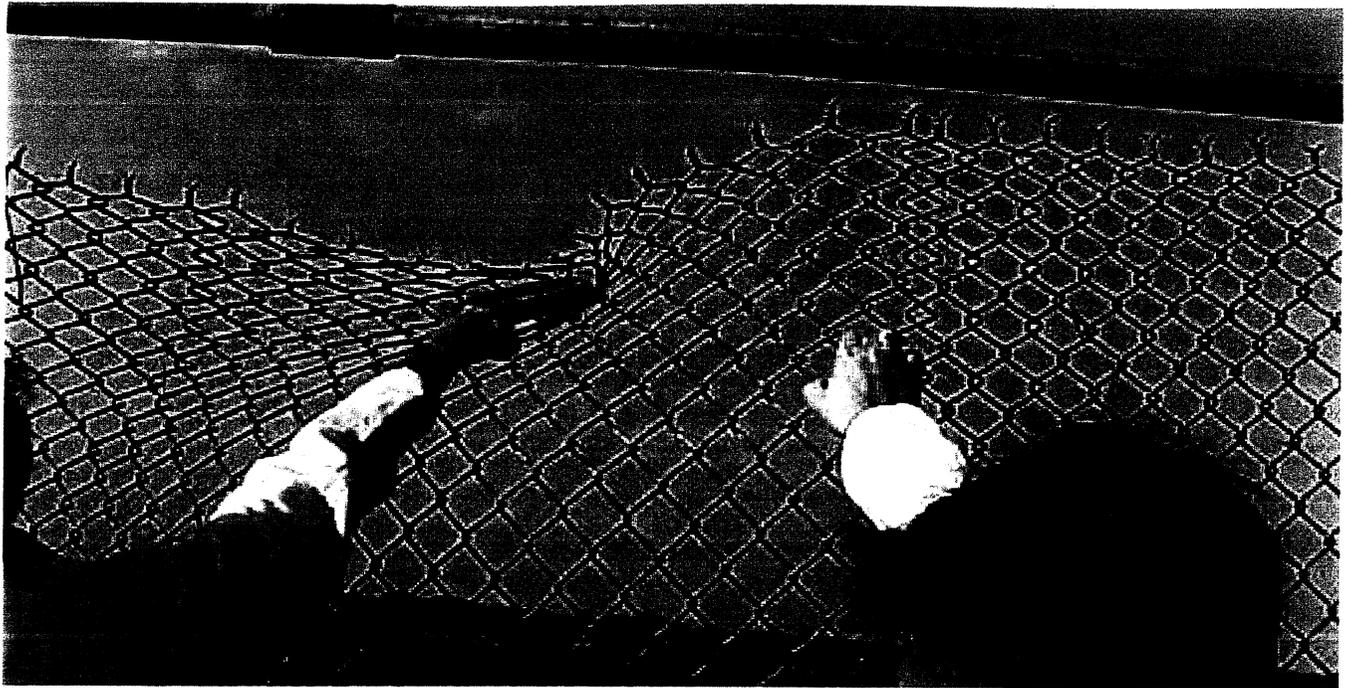
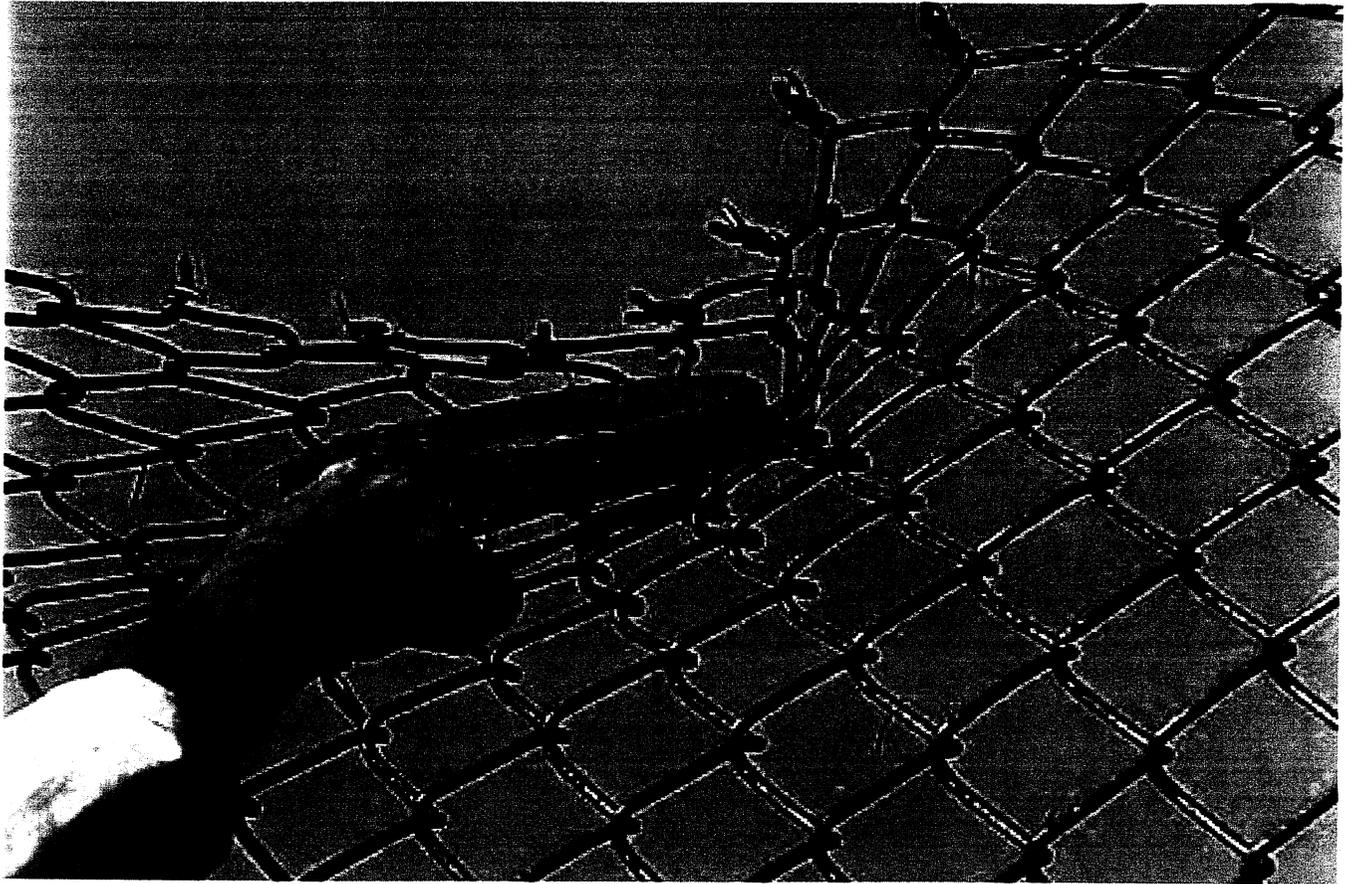
Photo 15: Metal Disk Embedded in Perimeter Fence

Two flame-cut steel disks, approximately 4 inches in diameter by 1 inch thick, were found in the south trench. A similar 8-inch diameter disk was found embedded in the north perimeter fence. The three disks did not pose a threat to flight hardware since no objects of this size were observed near the vehicle in the launch films. Debris emanating from the flame trenches, such as brick and mortar, are commonly transported by the exhaust plumes to outlying acreage areas of the pad without incident to the vehicle.

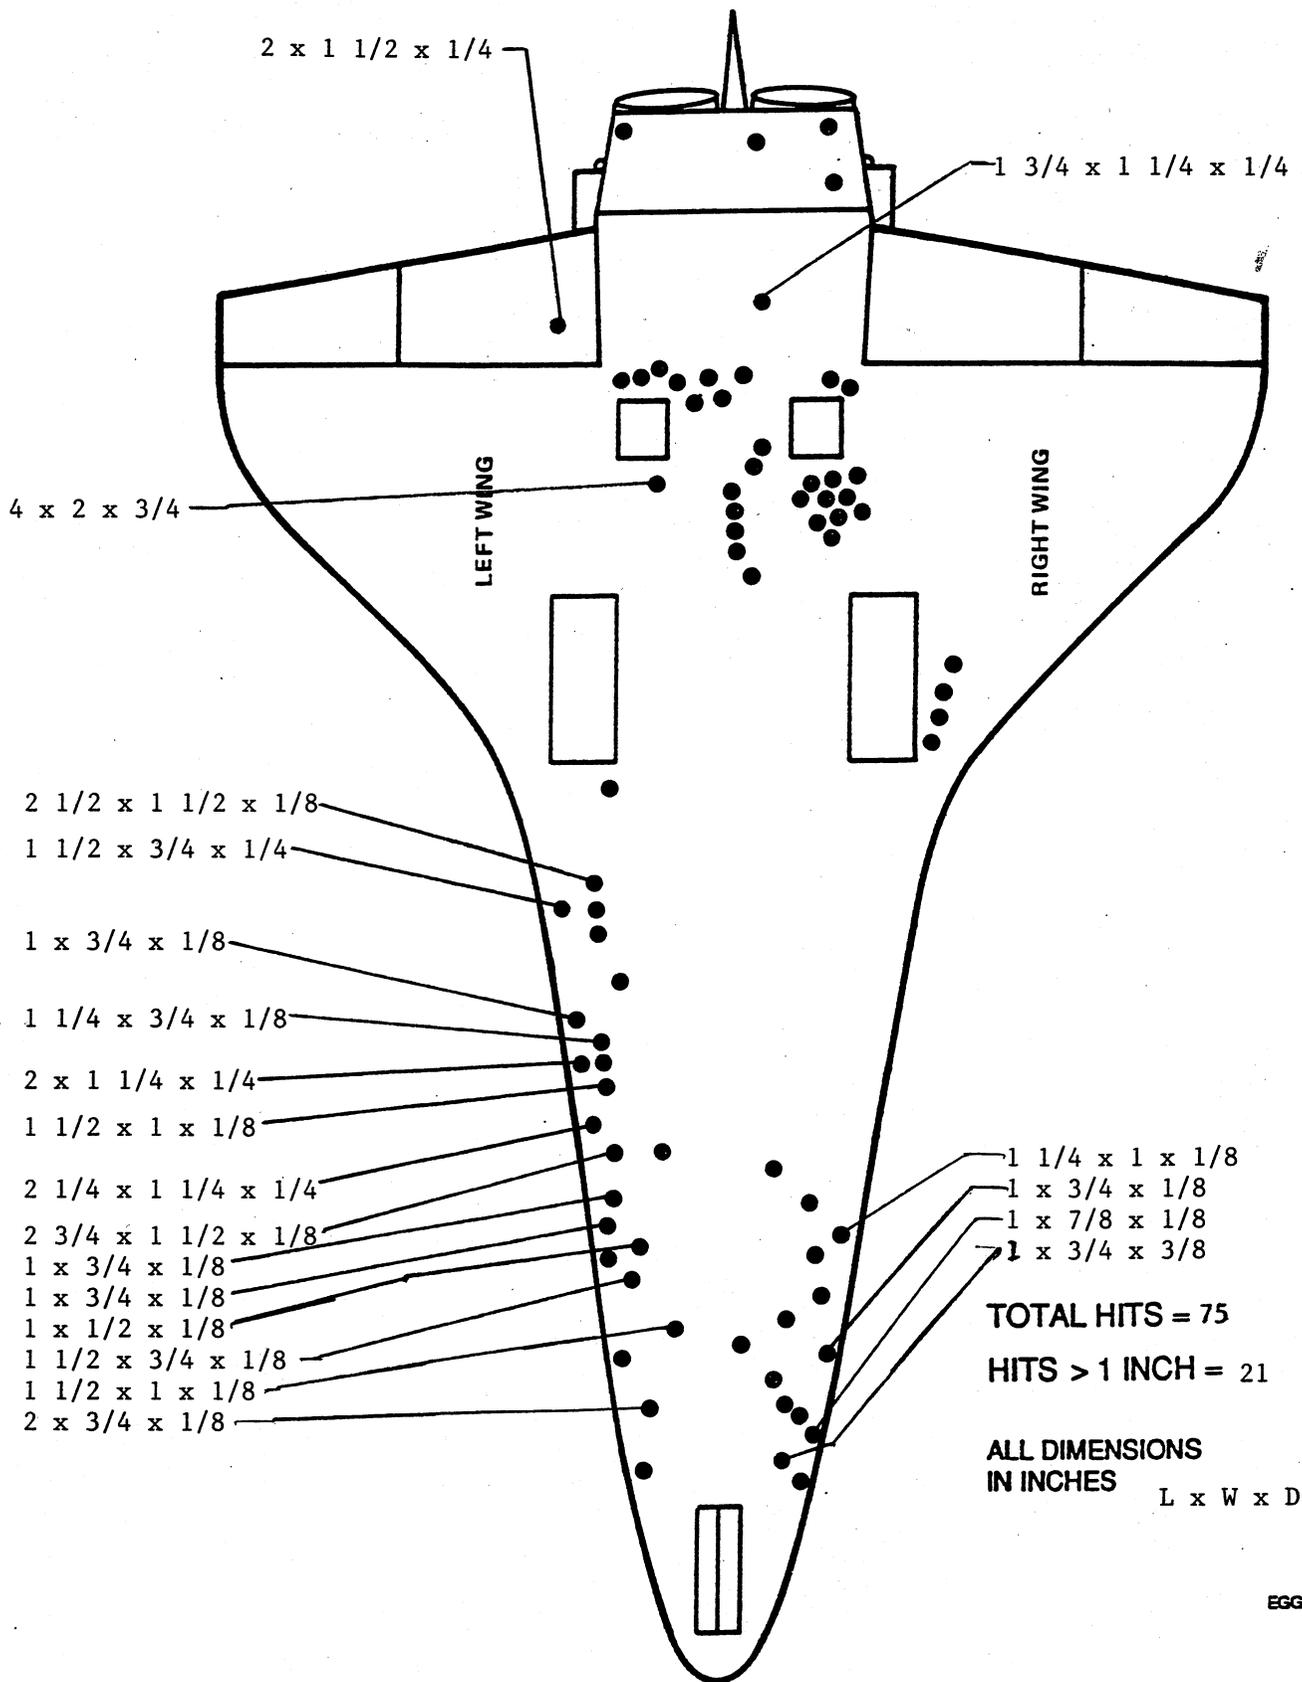
Figure 1: Orbiter Lower Surface Debris Damage Map

The Orbiter TPS sustained a total of 88 hits, of which 25 had a major dimension of 1-inch or larger. This total does not include the numerous hits on the base heat shield attributed to SSME vibration/acoustics and exhaust plume recirculation (Reference Figures 1-3. No hits occurred on the left side of the Orbiter and the associated figure has been omitted. For comparison purposes, Figure 4 shows fleet averages prior to STS-86 when loss of ET thrust panel foam began).

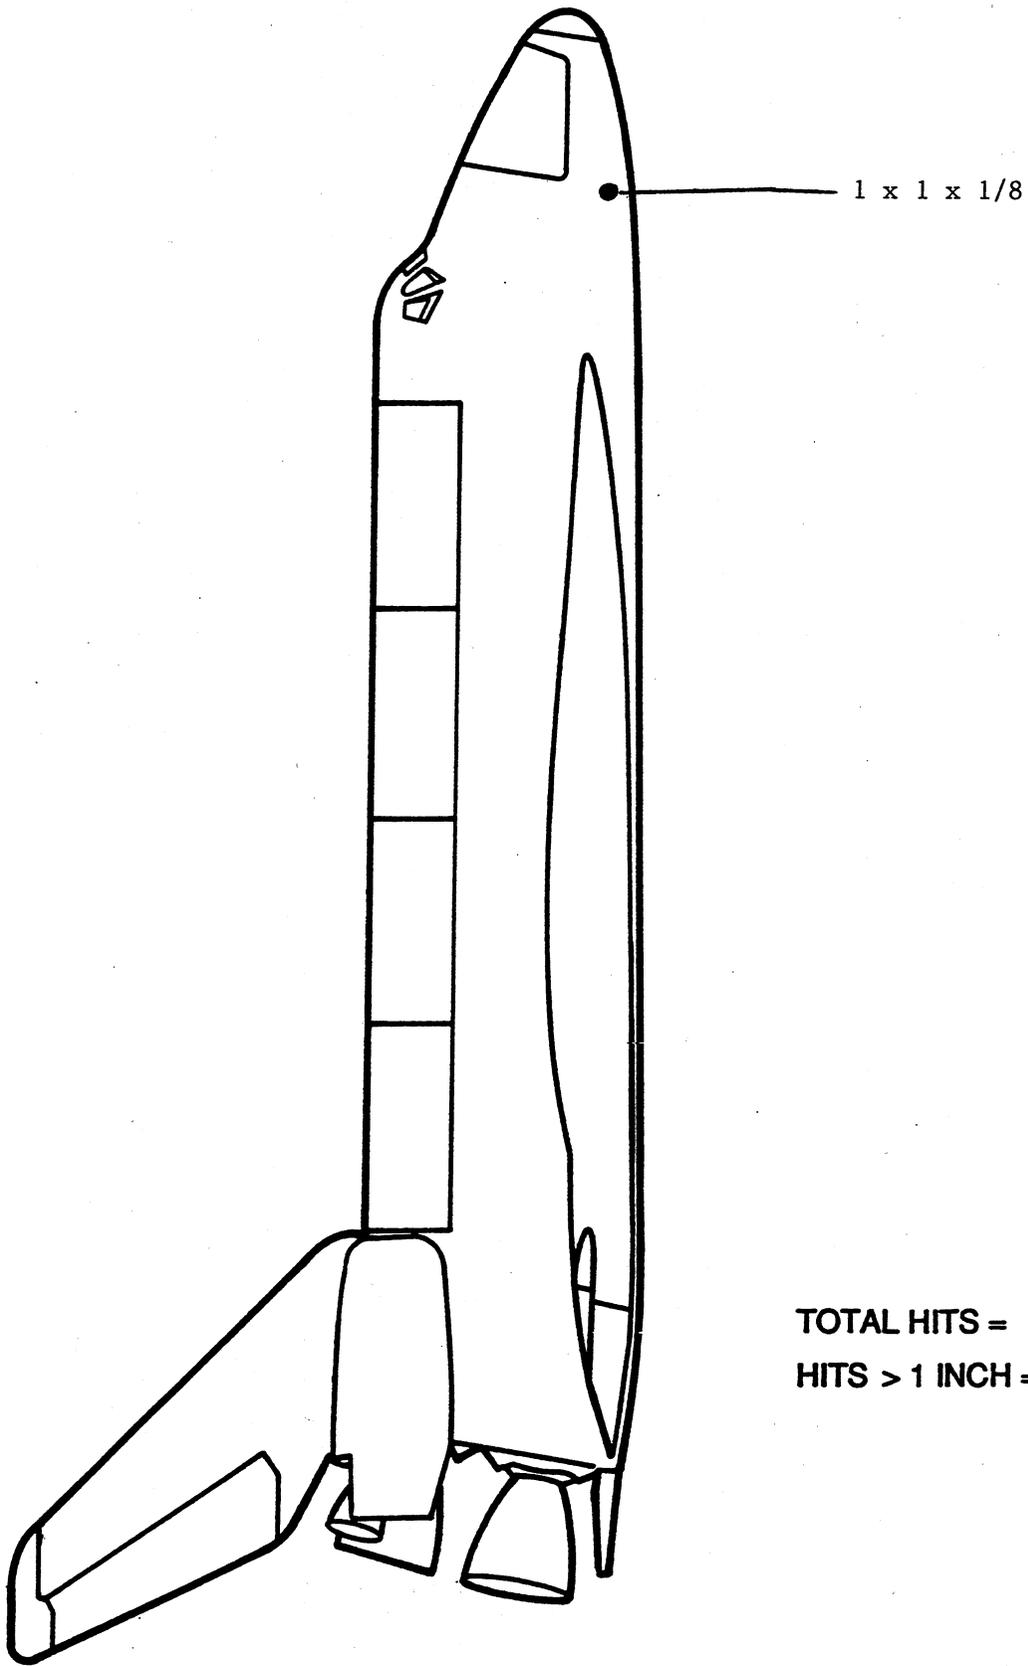
Figure 2: Orbiter Right Side Debris Damage Map

TOTAL HITS = 1
 HITS > 1 INCH = 1

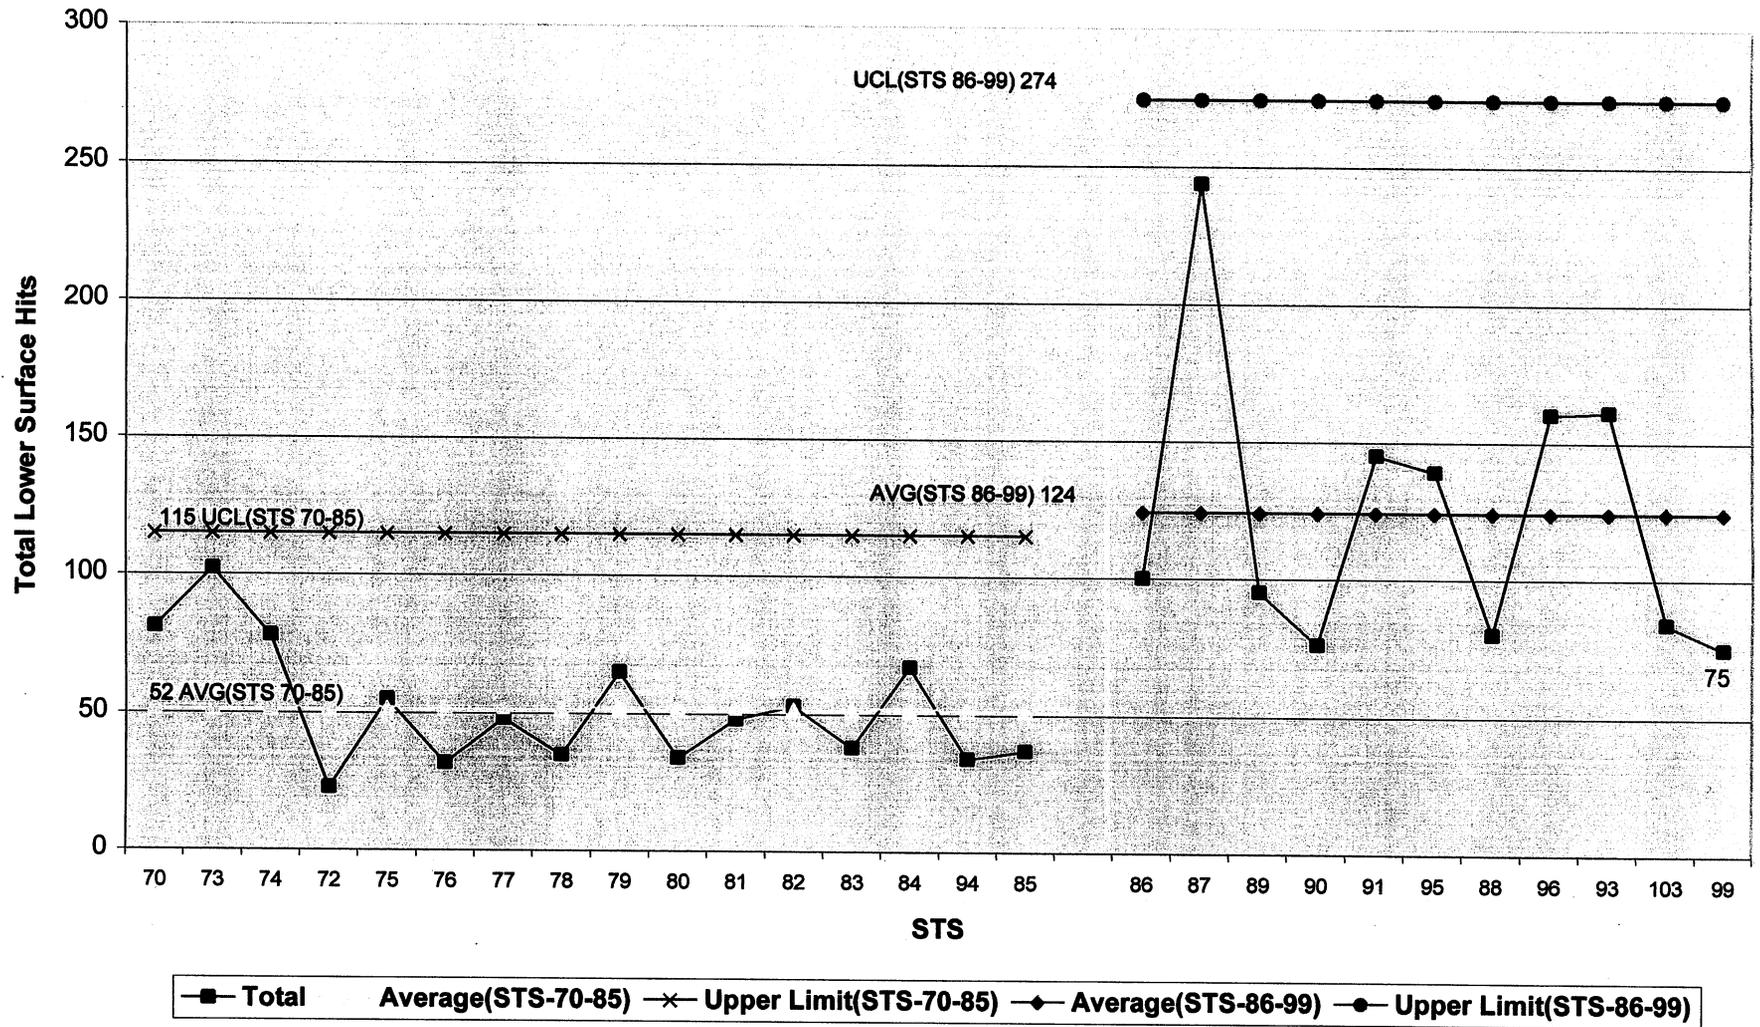
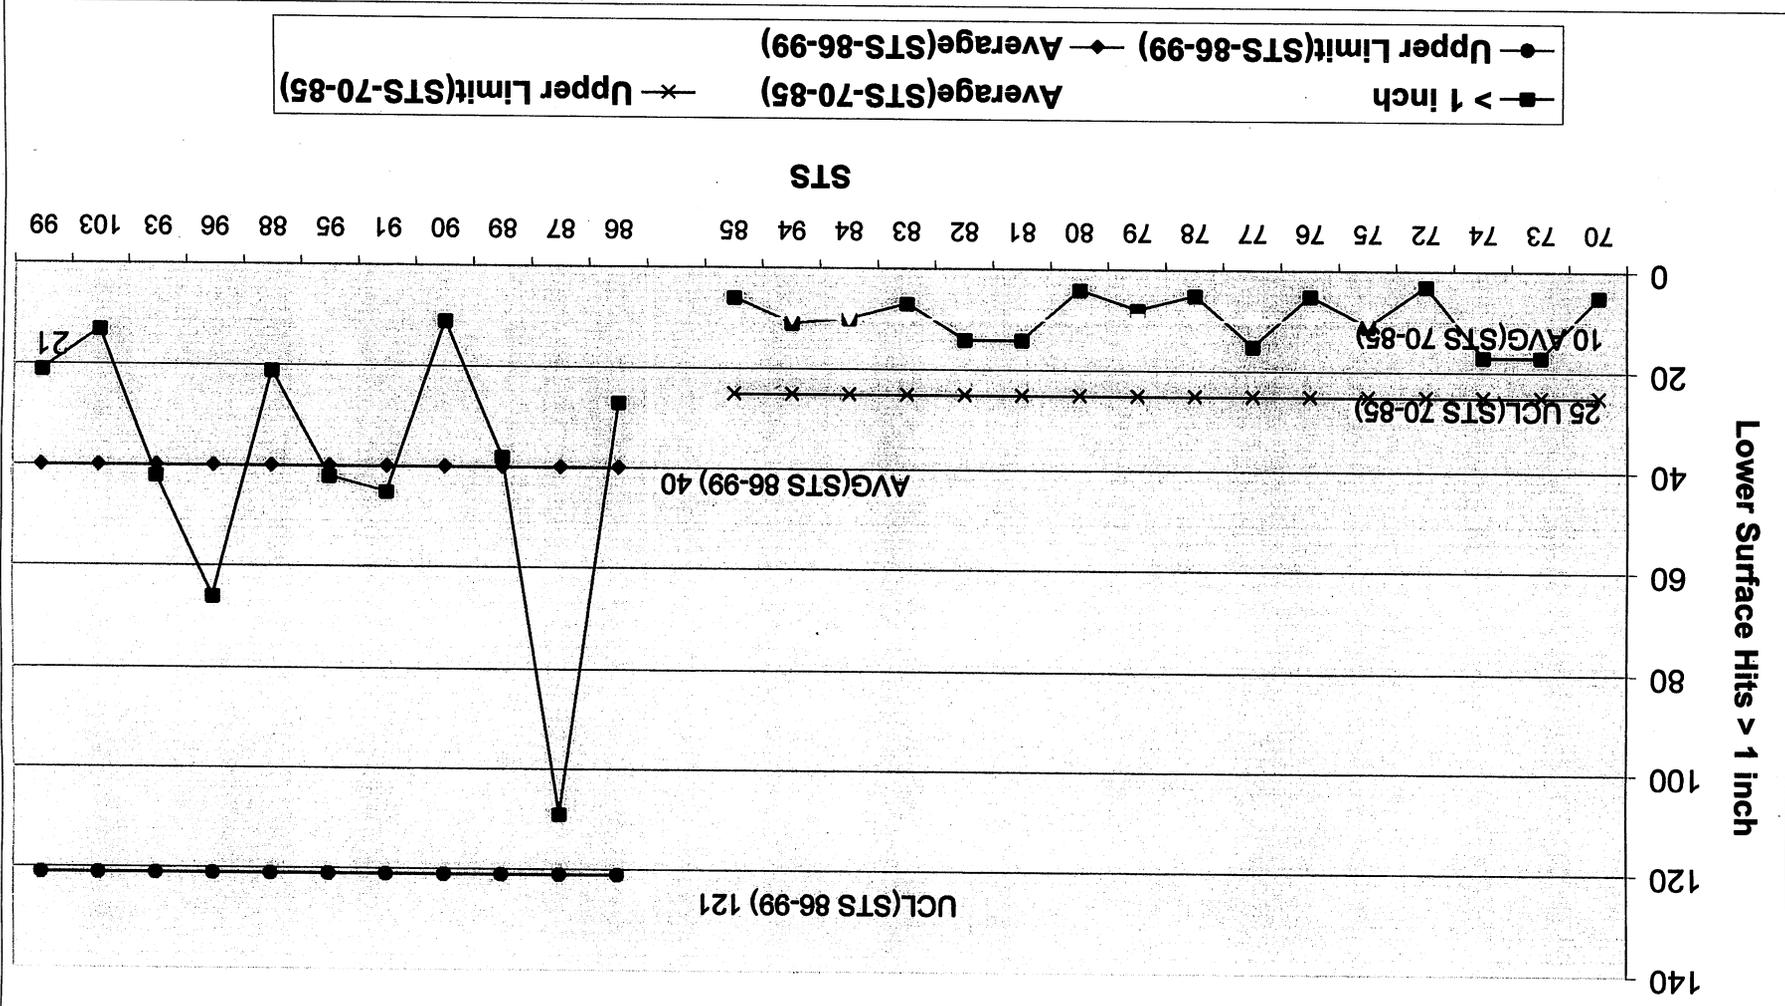
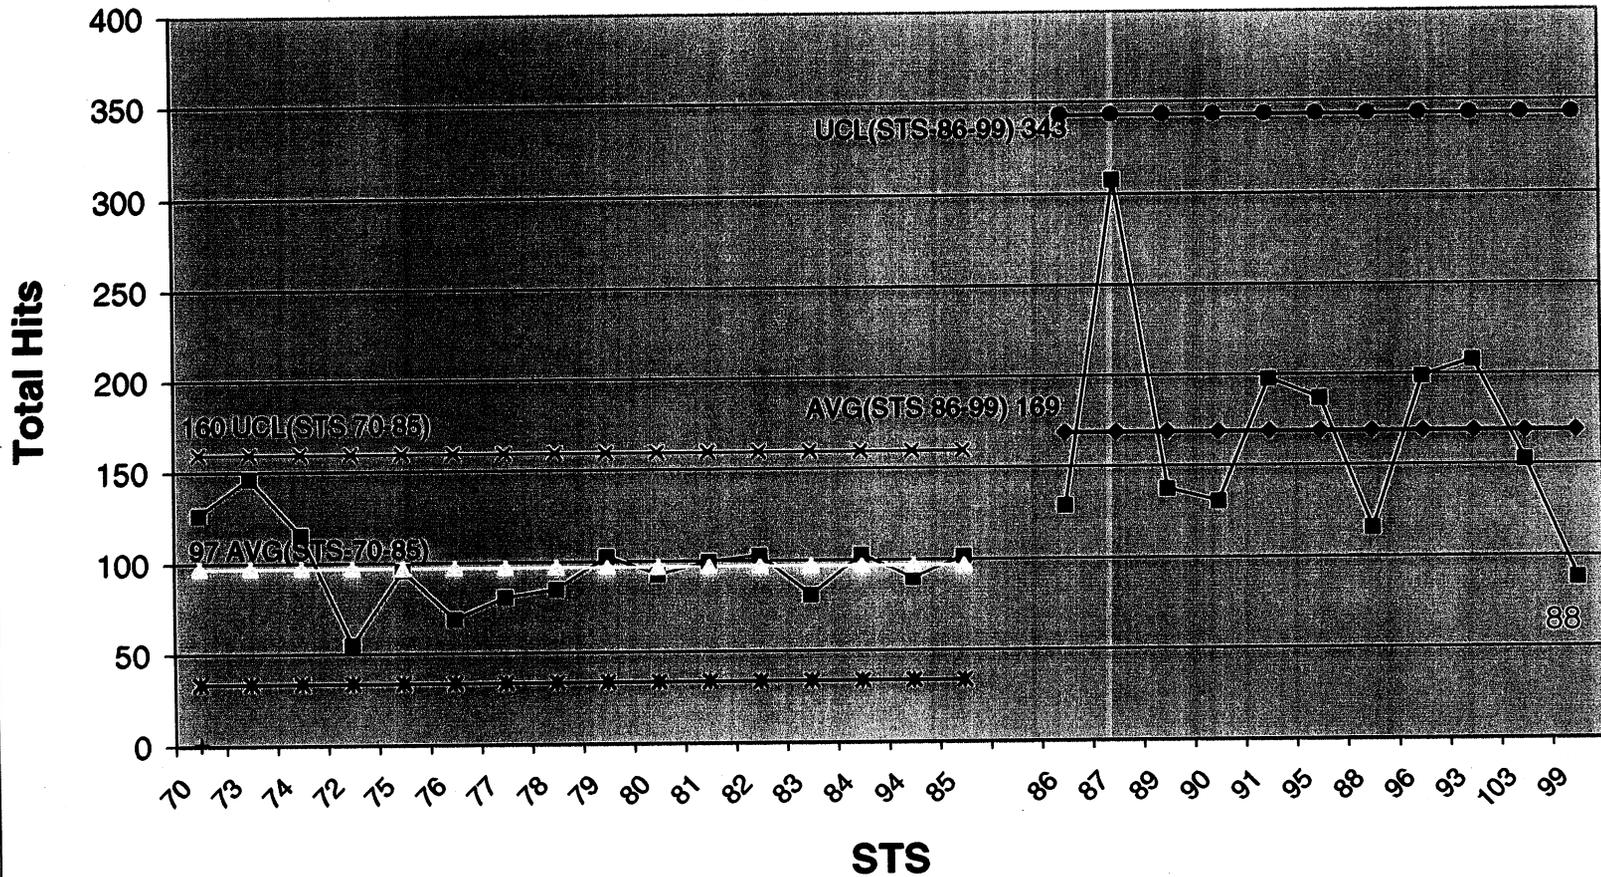
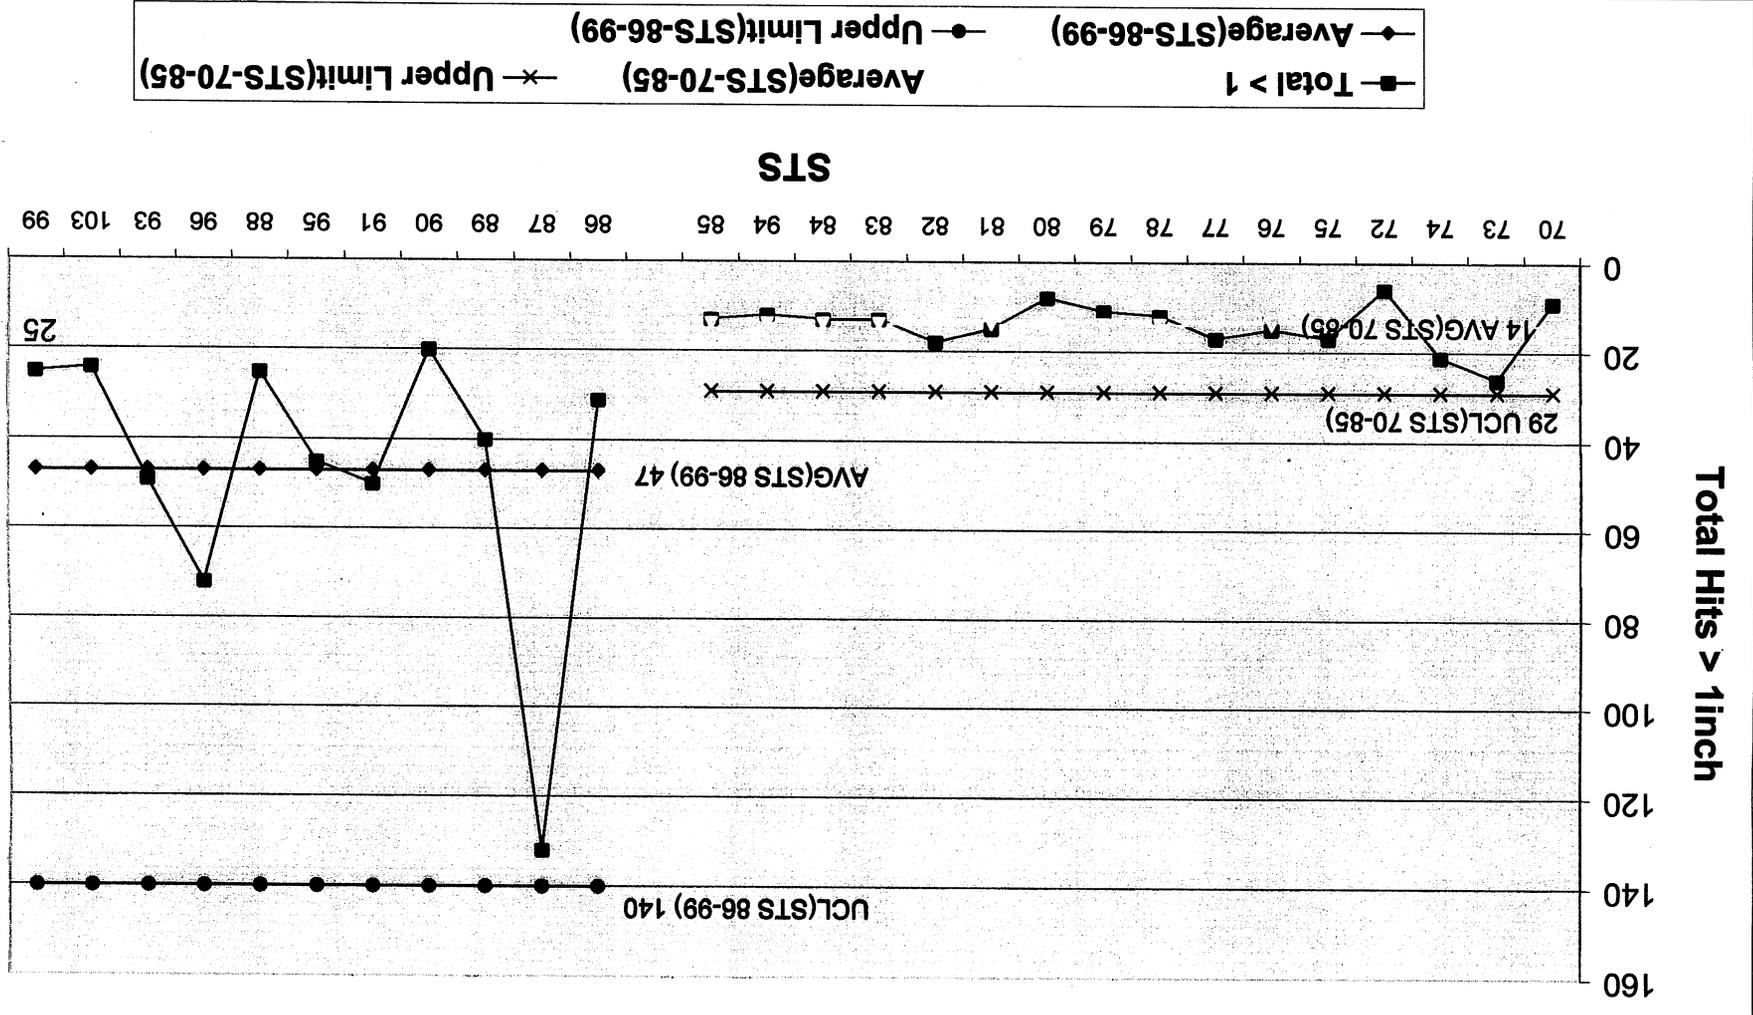
In summary, the total number of Orbiter TPS debris hits and the number of hits 1-inch or larger were "in family". However, the twenty-five lower surface hits 1-inch or larger were close to the 3-sigma upper control limit of 29 (Figures 5-8). The control charts reflect a comparative family from STS-70 through STS-85 where debris control measures had been optimized and debris damage sites on the Orbiter minimized to a family of flights beginning with STS-86 and the loss of foam from ET thrust panels.

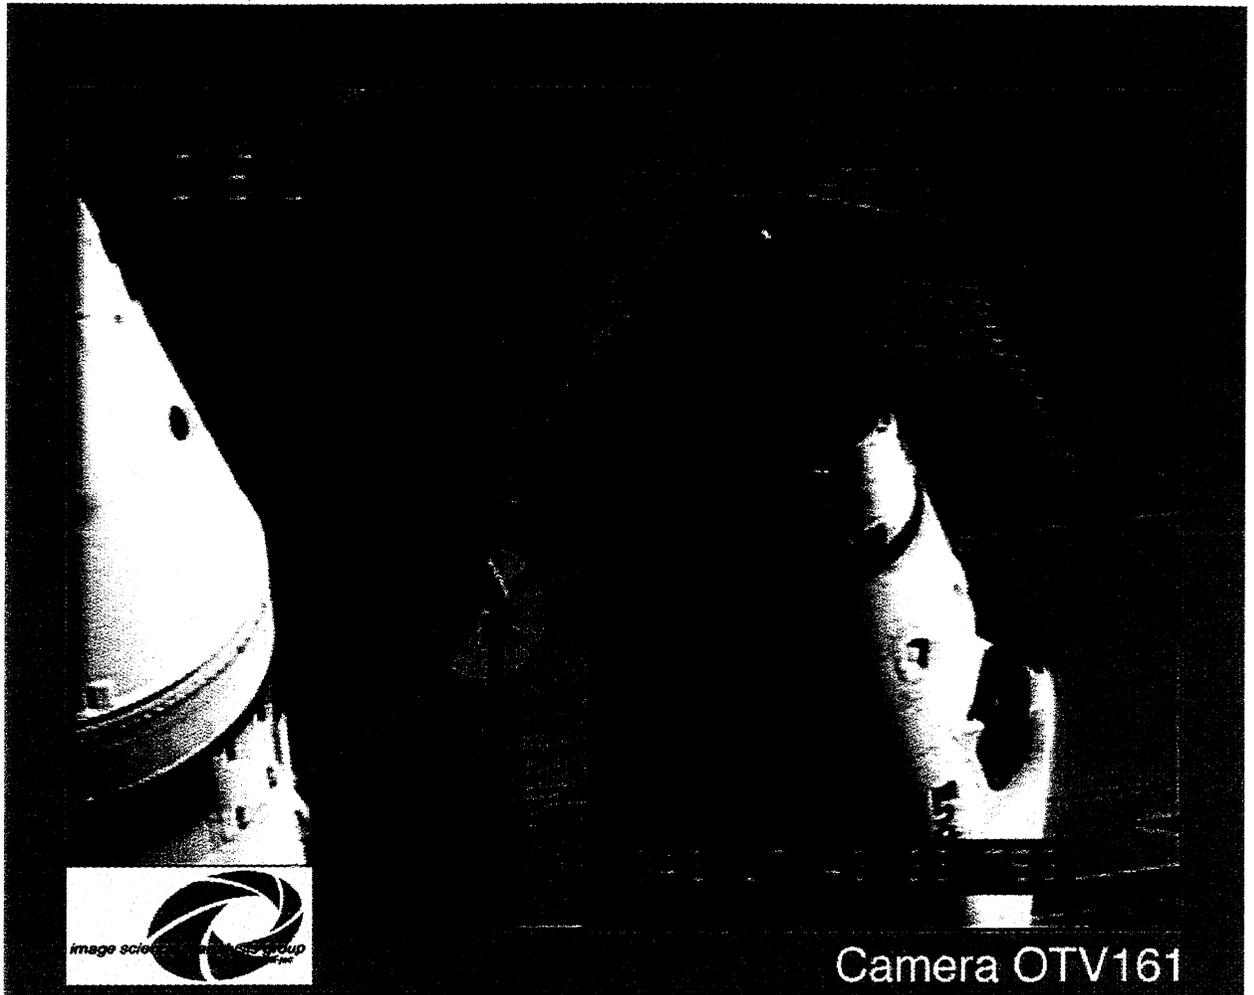
Figure 2.3(B) Vapor Near Left Foot of ET/Orbiter Forward Bipod

A faint, white-colored vapor (reported as a thermal short by KSC) was seen at the left foot of the ET/Orbiter forward bipod prior to liftoff (17:43:33.75 UTC). (Camera OTV061)
