# SUBSCALE COMPOSITE LIQUID OXYGEN TANK TESTING

Lockheed Martin Space Systems Company – Michoud Operations  
New Orleans, LA 70129

## ABSTRACT

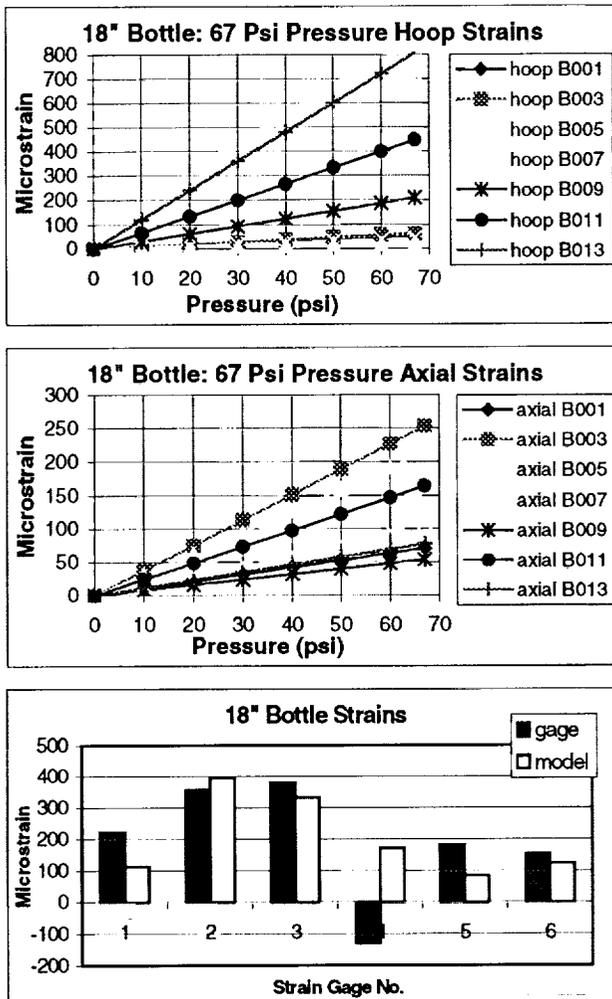
Figure 6: Test bottle strains and comparison with predicted

helium to 1.5 times the test pressure (67 psig/0.46MPa x 1.5 = 100 psig/0.69MPa). The pressure was stepped up at 20 psig/0.14MPa increments, with soap bubble checks at each increment. No leaks were detected at any increment for either bottle. Also, the strains in the tanks approximated the strains predicted by analysis. (Strain gage #4 was wired backwards; the true positive value approximates the model.) Figure 6 shows plots of the strains as well as a comparison to predicted values. Each bottle was then subjected to a 24-hour helium decay test at test pressure. Neither bottle showed any indication of pressure loss.

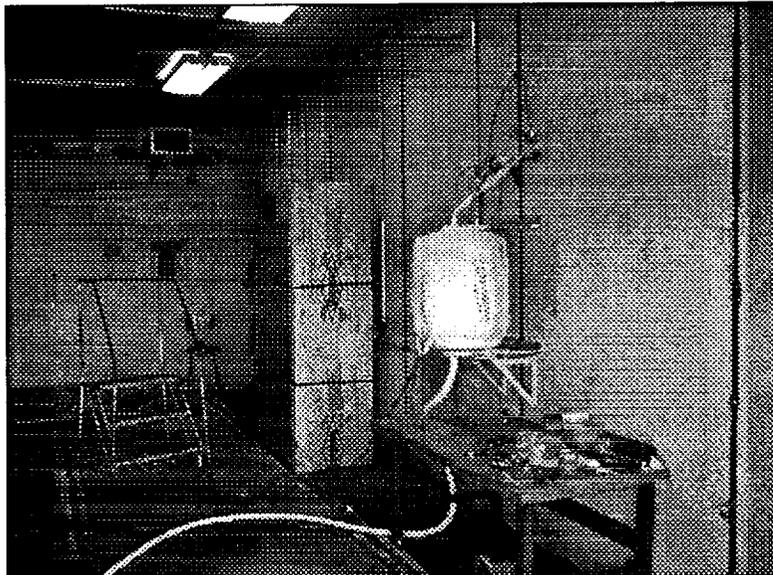
Figure 7: Bottle undergoing cryogenic conditioning

the decay tests. There was no build-up of ice on the foam, which indicated that the foam applied was sufficient. There was also no visible damage to the bottle. Figure 7 is a photograph of the bottle during a cryogenic cycle.
