## The IRAC Shutter Mechanism: Residual Magnetism and the Rotary Solenoid

### Abstract

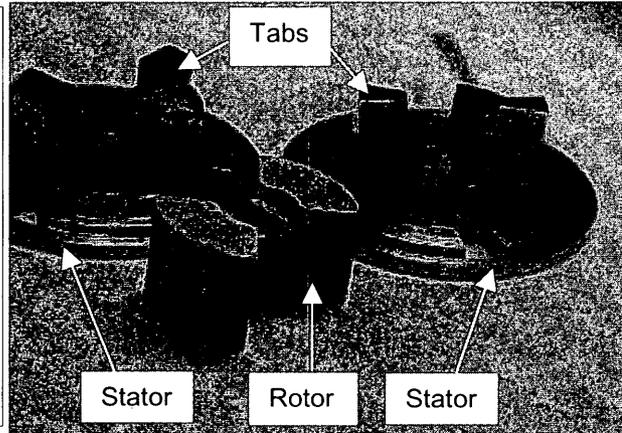
Figure 5. Shutter rotor and stator

Considerable frustration was endured during initial post failure testing which showed very little effect of magnetics on the ability of the shutter to remain closed with zero current. Upon examination of the rotor and stator parts, a slight burnishing of the rotor where it contacted the stator tabs was revealed (Figure 8). Clearly the majority of the tab surface was not in intimate contact with the rotor. Only when the contacting surfaces of a set of actuators were lapped together (Figure 8) did it become apparent that our initial suspicions were most likely correct. Approximately 12  $\mu\text{m}$  (0.0005 in) of material was removed during the lapping process. When these components were assembled into a spare mechanism, the unit consistently failed to open with zero current applied. This was a breakthrough in the testing program. It showed that small variations in the nature of the contact between the rotor and the stator have a significant impact on residual magnetism and, therefore, the residual torque that the actuator could exhibit.
