NASA/TM-2002-211732

Thermal Nondestructive Evaluation
Report - Inspection of the Refurbished
Manipulator Arm System in the
Manipulator Development Facility of
Johnson Space Center 10-12 January 2001

*K. Elliott Cramer
Langley Research Center, Hampton, Virginia*

July 2002

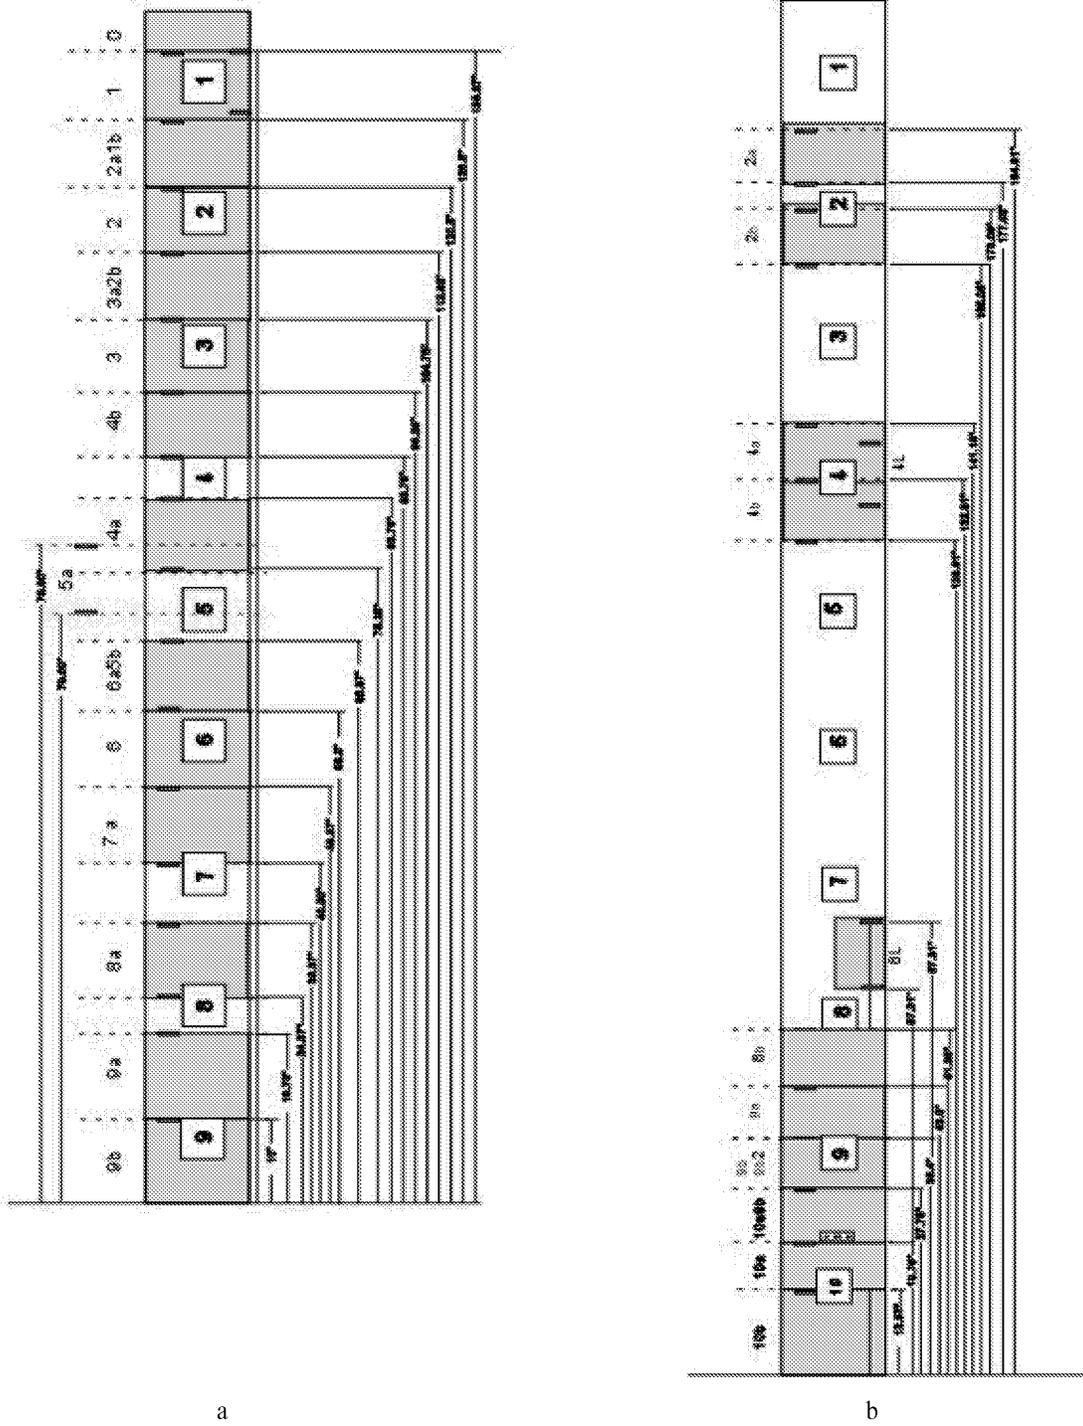
Figure 4 -- Inspection Areas on the (a) Upper and (b) Lower Arm

Figure 4 shows all of the inspection areas for both the upper and lower arm as well as the numbers for mounting pads located along the arm. Composite time derivative thermal images for Locations 1-9, as defined in Figure 5, are shown on pages 9-13 of this report. In many of the images where inspections were performed close to the mounting pads a darkening of the image occurs on either side of the pad. This darkening is the result of both the changes in heat flow in the composite and nonuniformities in the application of heat due to the presence of the pad. These areas are not as pronounced above and below the pads because of the orientation of the quartz heat lamps relative to the pads (see Figure 2).
