GT2002-XX

Characterization of Ceramic Matrix Composite Fasteners Exposed in a Combustor Liner Rig Test

Michael Verrilli and David Brewer
NASA Glenn Research Center
Cleveland, OH

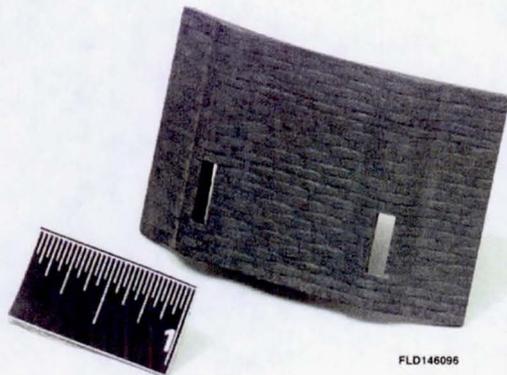
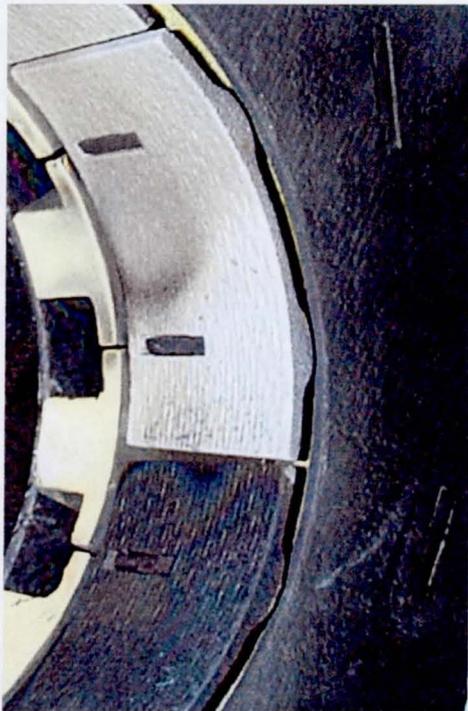
Figure 9 – Lean Transition Liners, a) as-manufactured part, b) installed in the sector rig.

The effect of exposure time can be seen by examining data for fasteners that attached one combustor liner part, the lean transition liner (LTL). The RQL sector rig liner set consisted of twelve LTL's, each held in place with two Miller fasteners, Fig. 9. The exposure temperatures of the different liner parts in the sector rig varied. In addition, combustion gas chemistry and flow rate varied in different regions of the rig. Examination of fastener data for only one part can eliminate potential failure load differences due to varying exposure conditions. During the course of the 260 hours of rig operation, several of the LTL's and their fasteners were removed for reasons described earlier, resulting in the largest number of fasteners exposed for different times from a single part type. To eliminate the effect of failure mode on failure load, only data for LTL fasteners that failed via shear of the “ears” is shown as a function of exposure time in Fig. 10. Data for the as-manufactured fasteners is shown as well. Exposure of 50 hours reduced failure loads by

50% relative to the as-manufactured fasteners. The average fastener failure load of about 900 N was the same for all exposure times, up to the maximum of 260 hours. Note that during sector testing, LTL fasteners reached a maximum temperature of about 1200 °C at the head surface subjected to combustion flow.
