Title: *Failure Investigation & Design Optimization of a Photo-Multiplier Tube Assembly Under Thermal Loading.*

Abstract: Analysis of GLAST ACD Photo-Multiplier Tube (PMT) assembly under thermal loading demonstrates that the glass tube experiences high stresses due to Coefficient of Thermal Expansion mismatch, as well as increased stress due to high stiffness and incompressibility of potting compound. Further investigation shows adverse loading effects due to the magnetic shield, a thin piece of steel wrapped around the PMT. This steel, Mu Metal, contained an overlap region that directly attributed to crack propagation in the outside surface of the tube. Sensitivities to different configurations were studied to reduce the stress and provide a more uniform loading throughout the PMT to ensure mission success. Studies indicate substituting a softer and more compressible potting compound and moving the Mu metal from the glass tube to the outside wall of the aluminum housing yields lower stress.

Glasm Large Area Telescope: AntiCoincidence Detector (ACD) PhotoMultiplier Tube Glass Failure

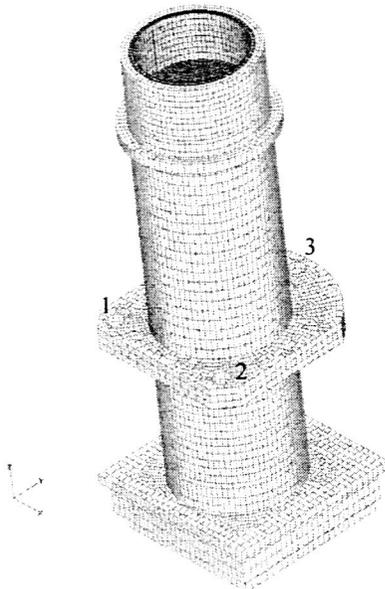
PMT Detailed Stress Analysis

- Composed completely of solid elements.
- Constrained with pure kinematic conditions. (1-XYZ, 2-YZ, 3-Z).
- Threads for PMT Cap not modeled. Assumed nominal OD.
- Model does not include R/N (Resistor Network) & R/N housing.
- Assumed worst case is cold temperature of -40 deg C.

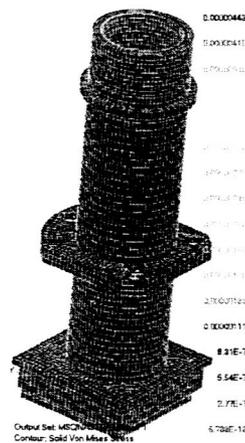
Full assembly shows approximate stress free conditions.

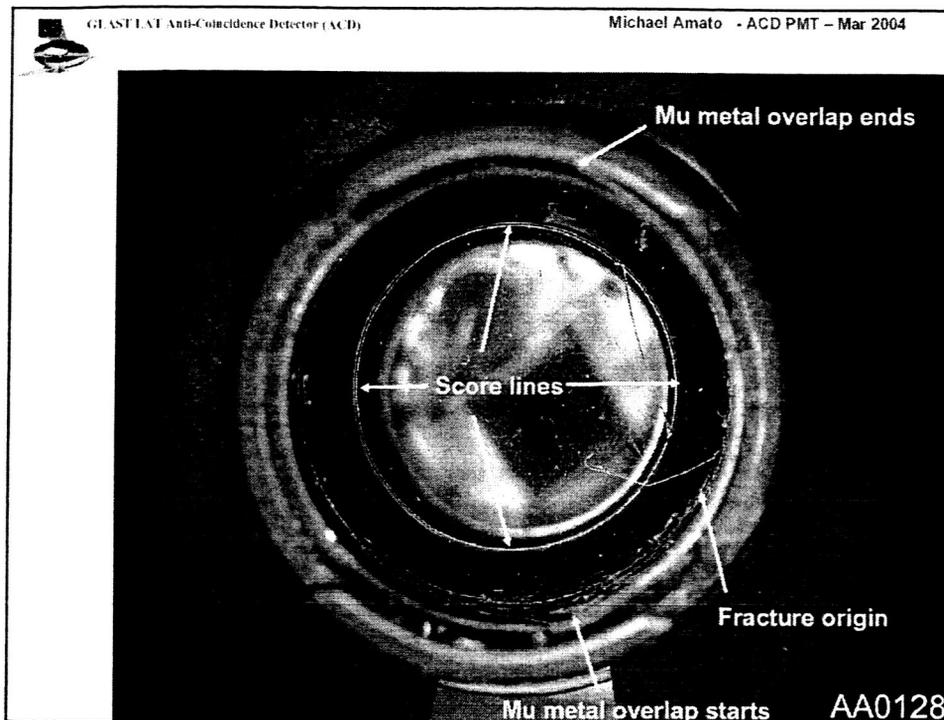
Path 2 – Defects on the outer surface of PMTs

- Predicted stress on outside surface in region of Mu metal overlap is not 4300 psi but around 3200 psi.
- Inspected outer surfaces of 8 NG PMTs. Scores/pits/scratches were found, but are small in size compared to scores on inner surface. NG tubes handled very little at GSFC
- No new strength tests have been performed on the outer surfaces of the PMT.
 - More difficult to test the strength of outer surface.
 - Time constrain
 - PMTs better used for qualification of new designs.
 - The data we have: failed 4 of 23, in an area with calculated stress around 3200 psi

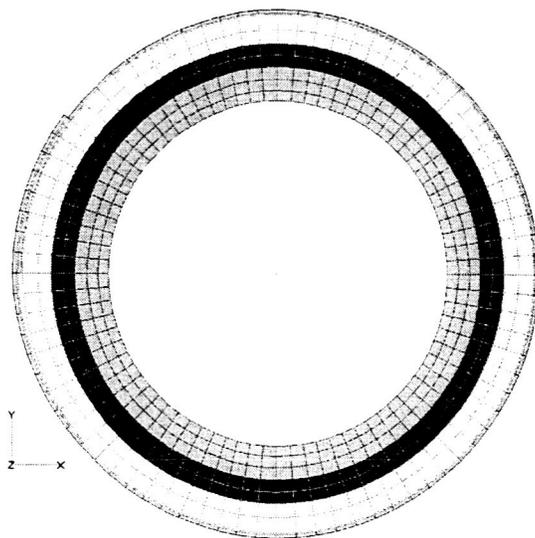
Mu Metal tacked to outside wall of housing, RTV-566 potting (Case 7)

Mu Metal tacked to outside wall of housing with y966, RTV-566 potting.

| GLAST LAT Anti-Coincidence Detector (ACD) | | Kevin Dahya - ACD PMT - April 2004 | | | |
|---|---|---|---|---|---|
| 7 | MU METAL ATTACHED TO OUTSIDE WALL OF HOUSING, NOT CONTINUOUSLY ATTACHED. Using RTV 566 potting. | 419.14 | 384.34 | -90 | -86 |
