Debris/Ice/TPS Assessment and Integrated Photographic Analysis Of Shuttle Mission STS-98

**DEBRIS/ICE/TPS ASSESSMENT
AND
INTEGRATED PHOTOGRAPHIC ANALYSIS
OF
SHUTTLE MISSION STS-98**

February 7, 2001

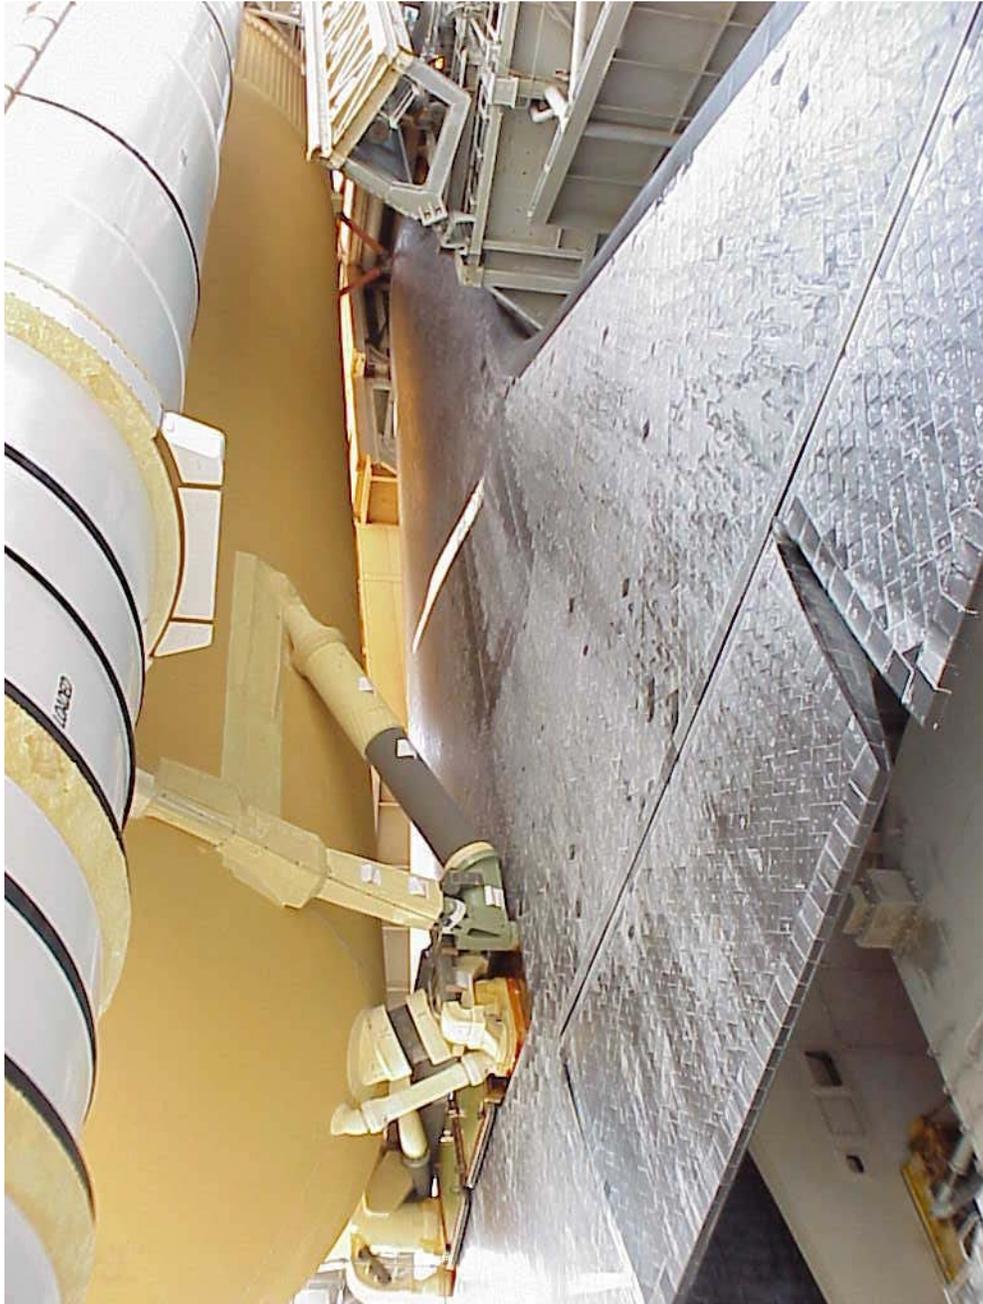
Photo 2: Pre-Launch Debris Inspection

The only facility discrepancy noted was a broken pip pin discovered at the Rotating Service Structure (RSS) 207 foot level on the Left Hand Forward Reaction Control System (FRCS) access retractable platform. A piece of the pin was forwarded to the Pad shop personnel, who were found to have the remaining portions. Pin replacement was in work.

A crack-like material surface observation was found on the aft side of the External Tank LH2 recirculation line and was discovered to be a serration cut in the ablator material for substrate shrinkage.

No unresolved issues from this inspection were noted.

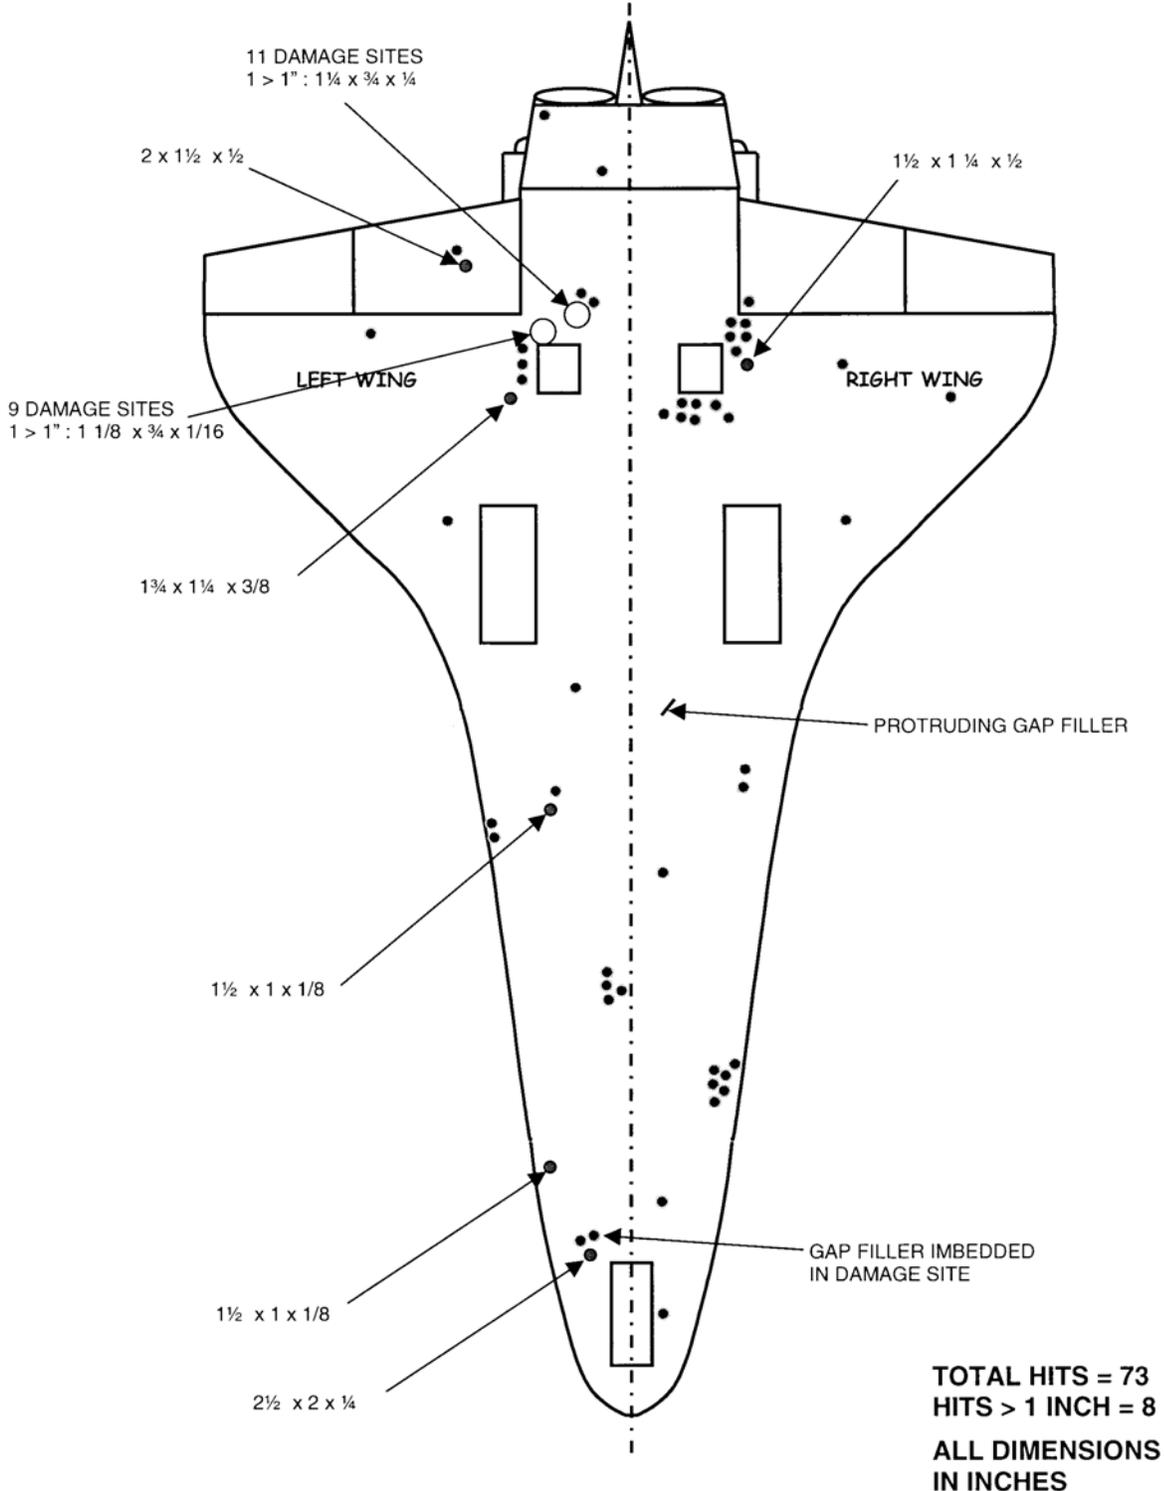
Figure 2: Orbiter Lower Surface Debris Damage Map

Post landing inspection of Orbiter tiles showed a total of 102 hits, of which 13 had a major dimension of 1-inch or larger. The Orbiter lower surface sustained 73 total hits, of which 8 had a major dimension of 1-inch or larger. Some of these damage sites (23 total hits with three larger than 1-inch) were located in the area from the nose gear to the main landing gear wheel wells on both left and right chines, which is consistent with the loss of foam from ET thrust panels. But the overall quantity and average size of the damage sites compared to previous flights was consequently reduced as a result of the pre-launch TPS venting modification. Some of the hits in this area may also be attributed to impacts from LO2 feedline bellows ice particles, with one hit just aft of the nose gear on the left side having material imbedded in the damage site.

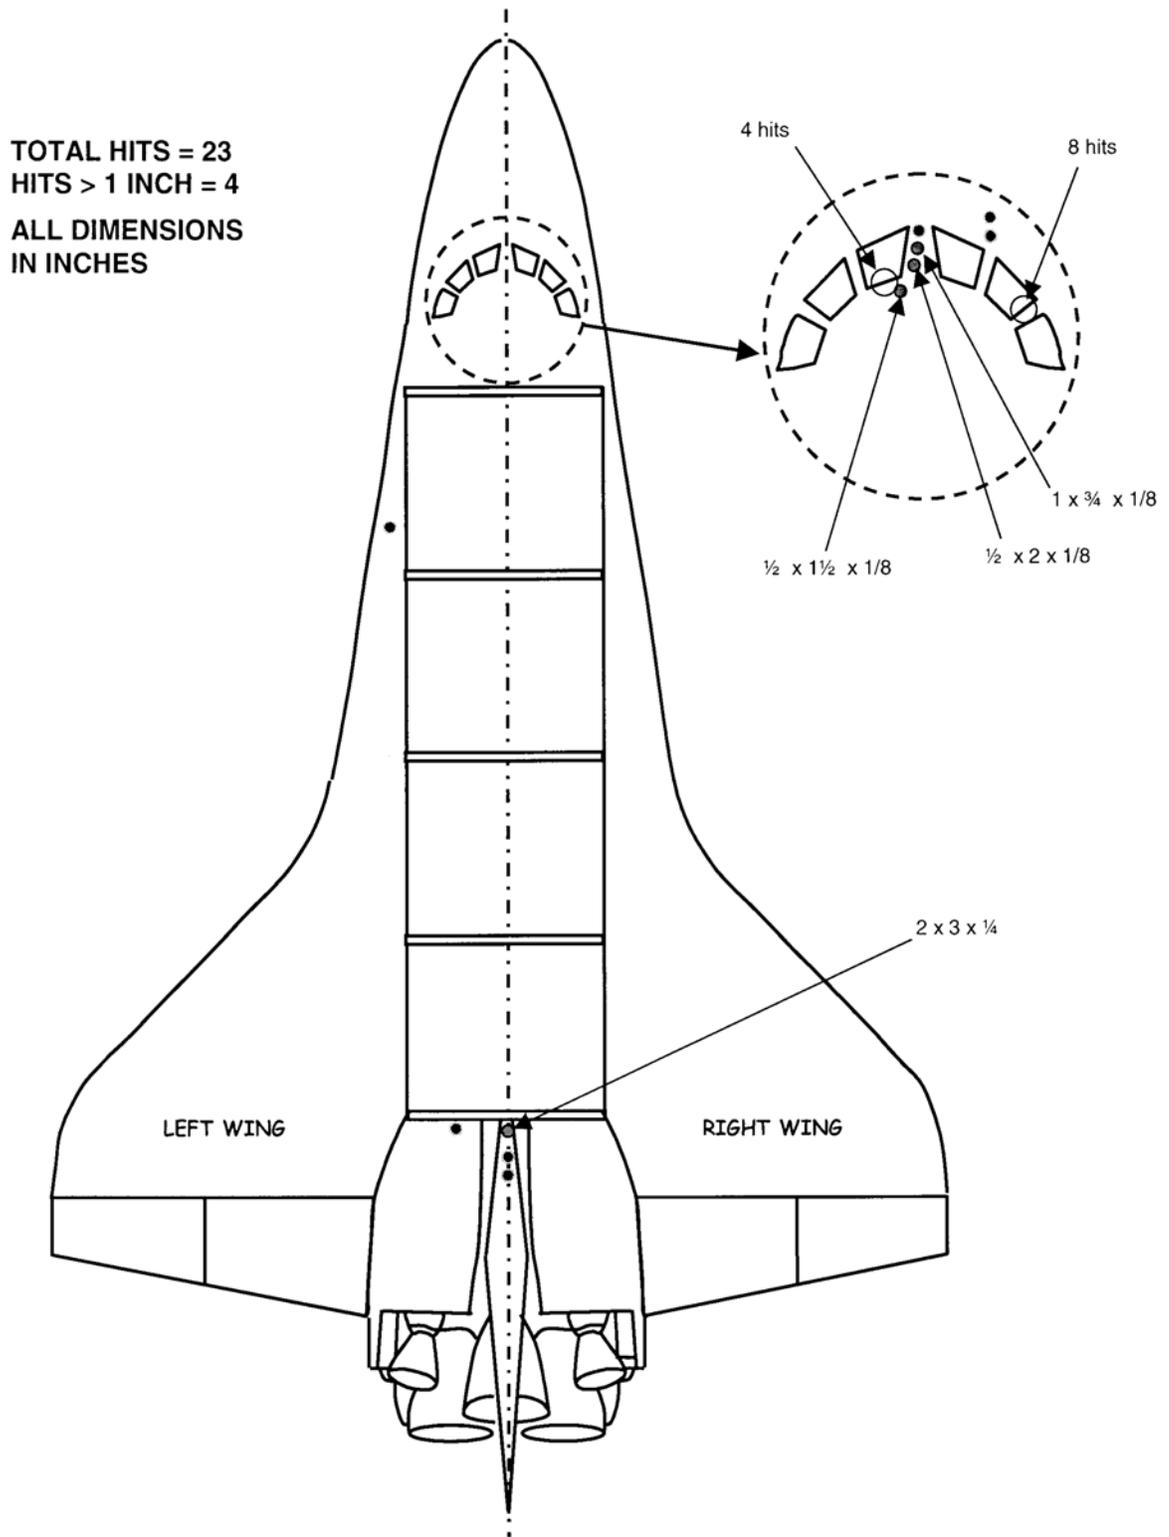
Figure 4: Orbiter Upper Surface Debris Damage Map

A 2 inches by 3 inches by 0.25 inch, tile damage area at the base of the vertical stabilizer was observed during on-orbit operations.

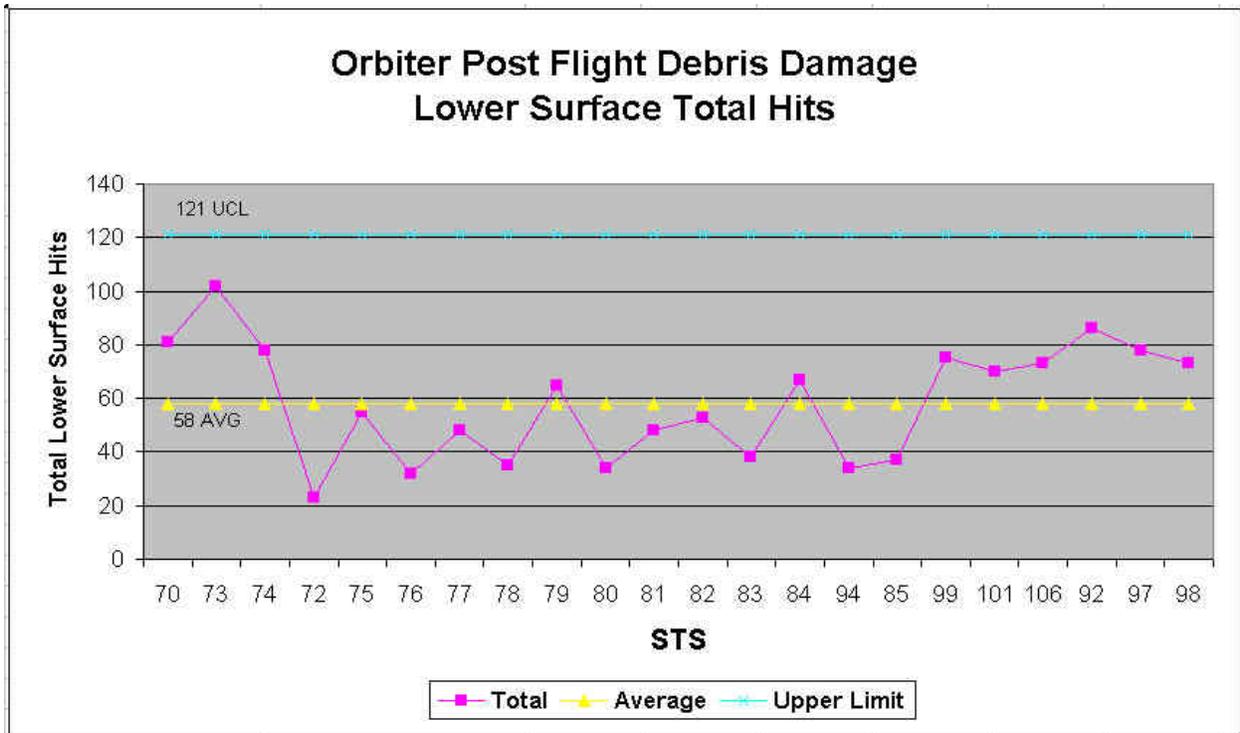
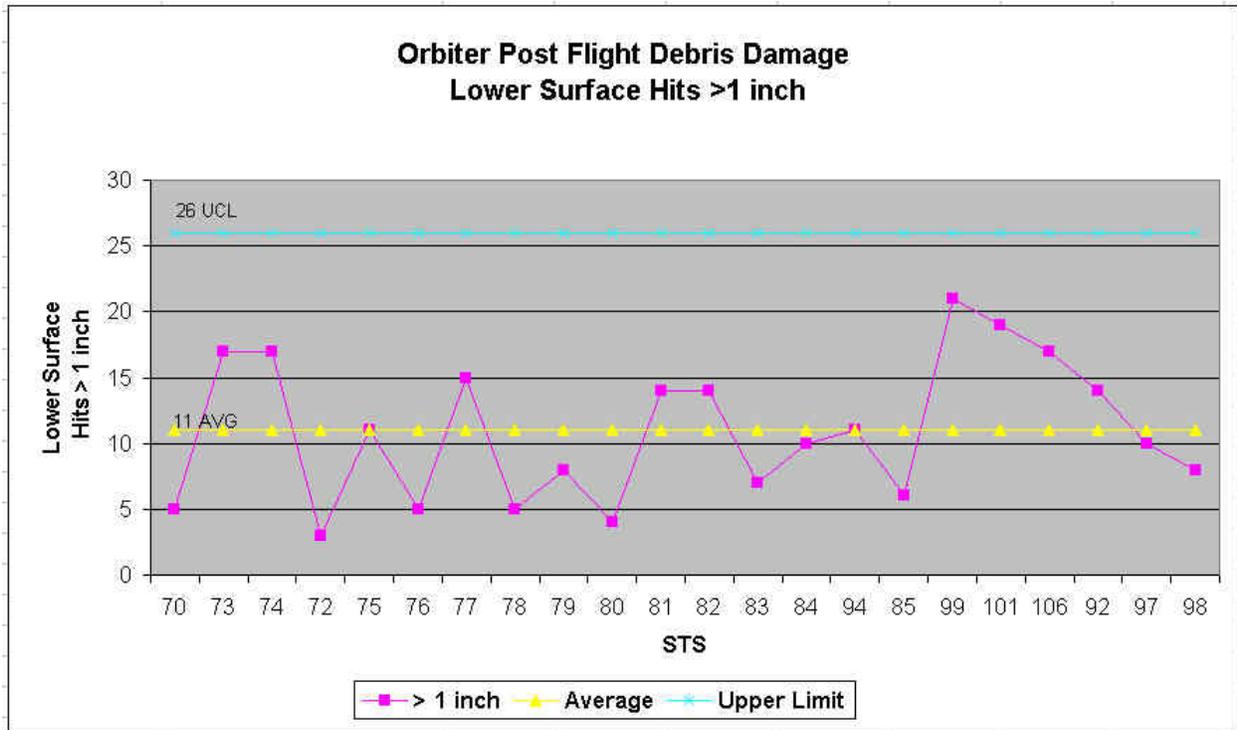
Figure 6: Control Limits for Lower Surface Hits

In summary, both the total number of Orbiter TPS debris hits (102) and the number of hits one-inch or larger (13) were within the established family totals (family average 103 total hits and 16 one-inch or greater). The total number of Orbiter TPS debris hits, and the number of hits 1-inch or larger, were "in family" when compared to the statistics generated from previous Shuttle missions. These comparisons are shown in table and graphic form in figures 5, 6 and 7.

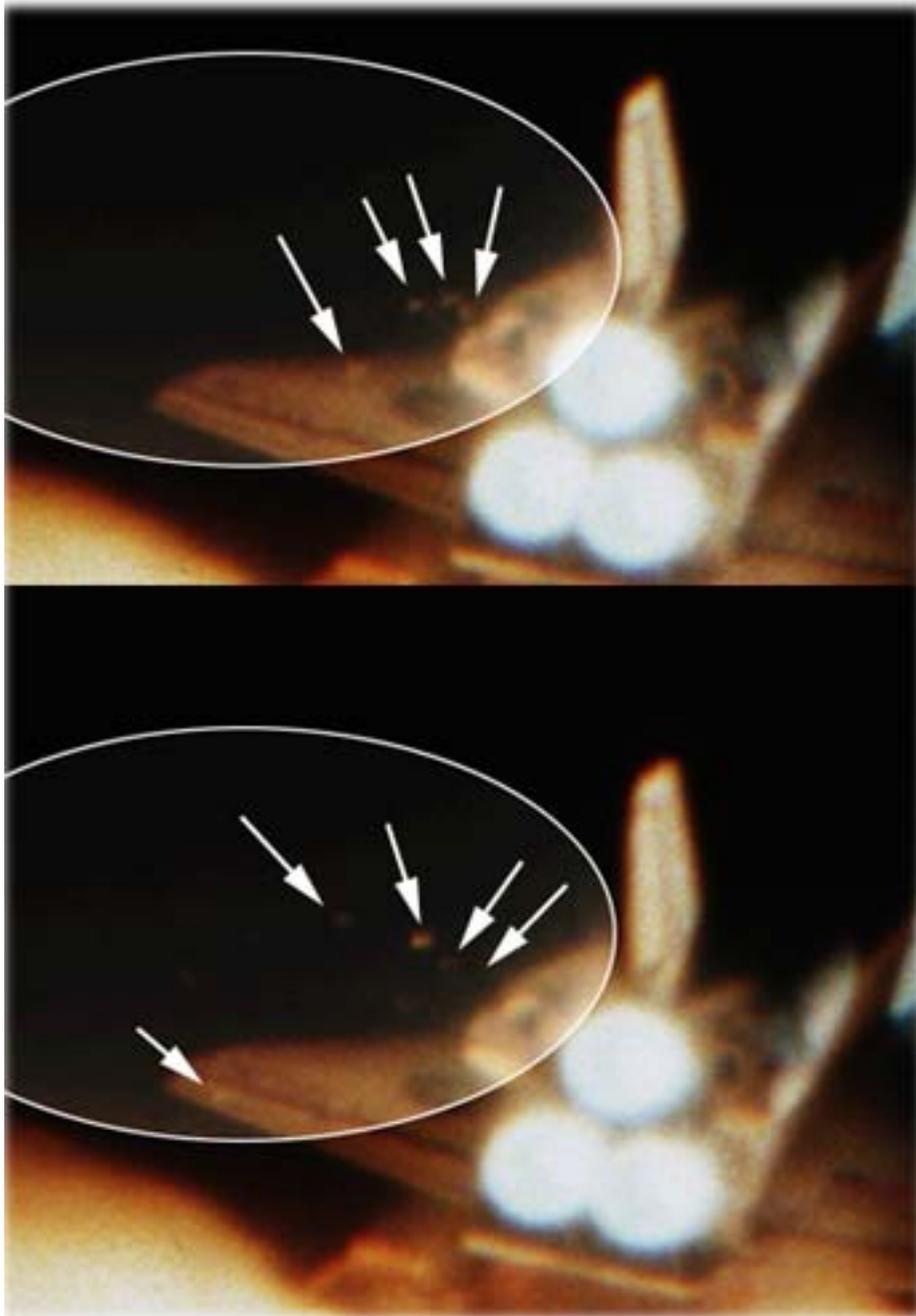
Figure 2.1 Debris Near Left OMS Pod (Camera E207)

Tracking films provided view of debris in the region of the vertical stabilizer and left OMS pod prior to SRB separation. The debris was observed to have a profile similar to that of RCS cover paper. This observation was listed on the STS-98 Consolidated Film/Video Report. Subsequently, a damage site on the vertical stabilizer leading edge was observed during on-orbit operations. At Orbiter landing, the damage site had not changed significantly in size and measured 2 by 3 by 0.25 inches in depth. Sample from this damage site provided evidence of tile materials only when processed in the laboratory, as shown in the analysis report and summary. There were no tiles, blankets or components missing from the vertical stabilizer or OMS pod areas, as might have caused the observed damage.

CFVR-98-01: Unusual Debris at ~ 4.5 Seconds Prior to SRB Separation

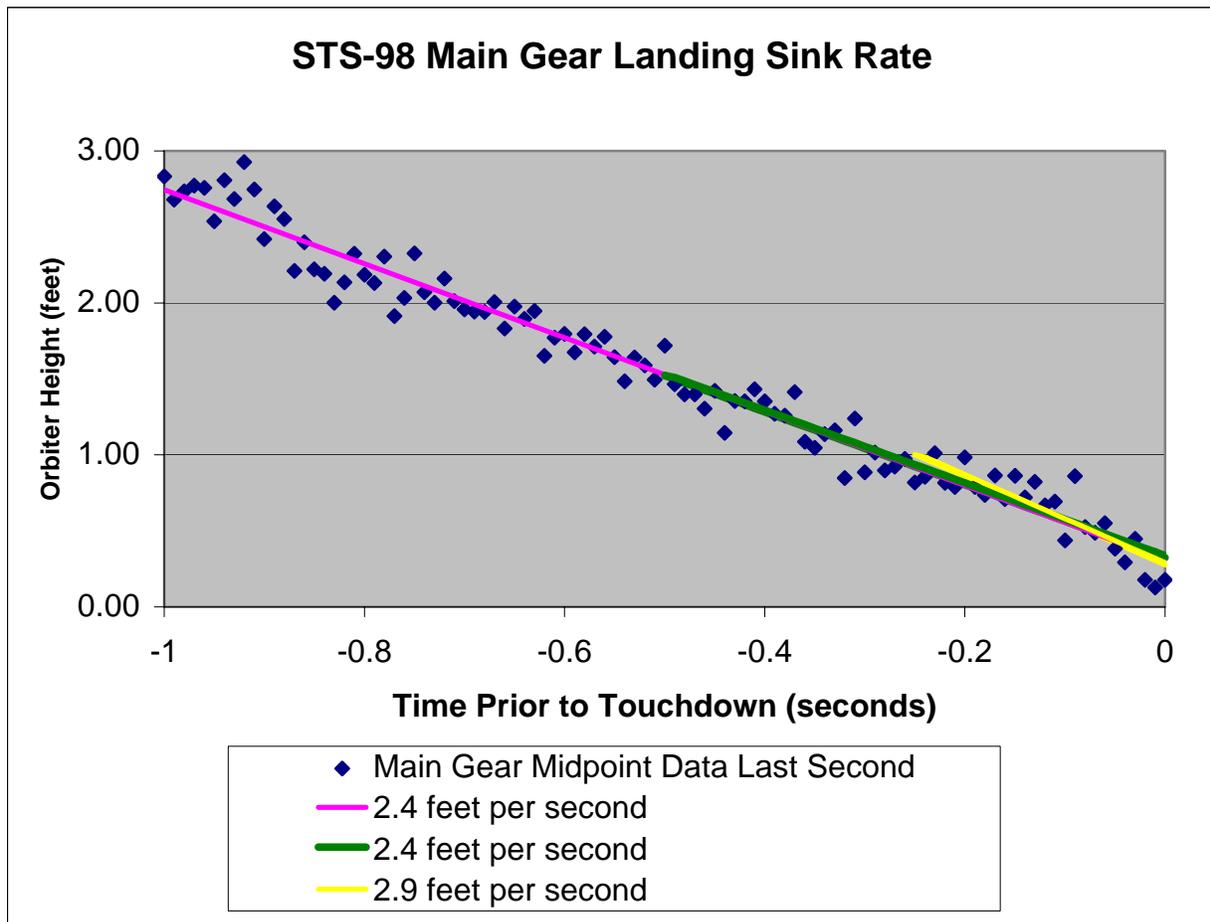
Figure 2.5. Main Gear Landing Sink Rate

The maximum allowable main gear sink rate values are 9.6 feet / second for a 212,000 lb. vehicle and 6.0 feet/second for a 240,000 lb. vehicle. The landing weight of the STS-98 vehicle was reported to be 197,581 lbs.

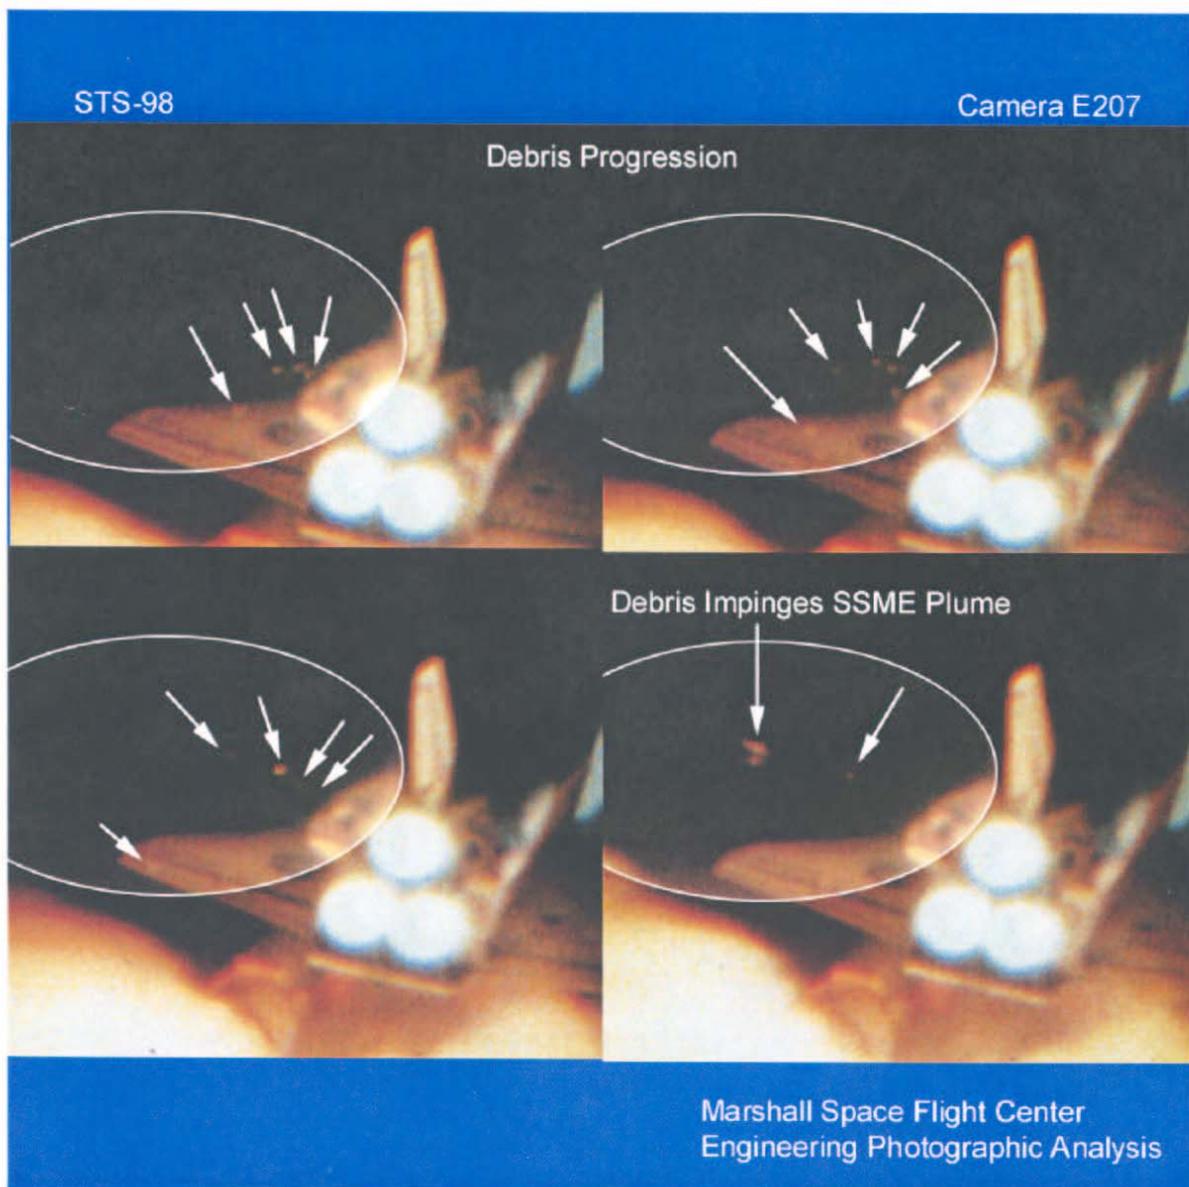
Figure 1. Debris Observed on Left Side of Orbiter

Several trails of light-colored debris were observed, on film from camera E207, emanating from the vicinity of both the left, Fig. 1, and right, Fig. 2, sides of the aft portion of the Orbiter just prior to SRB separation. The first observance of this debris was at 038:23:15:02.470 UTC, approximately five seconds prior to SRB separation. The debris trails aft of the vehicle and some particles are noted to impinge onto the SSME plume. The debris appeared to change the reflectivity of the orbiter structure in the vicinity of the perceived ejection site.

This observation was listed on the STS-98 Consolidated Film/Video Report. A movie highlighting the debris as it travels away from the Orbiter is available on the website.

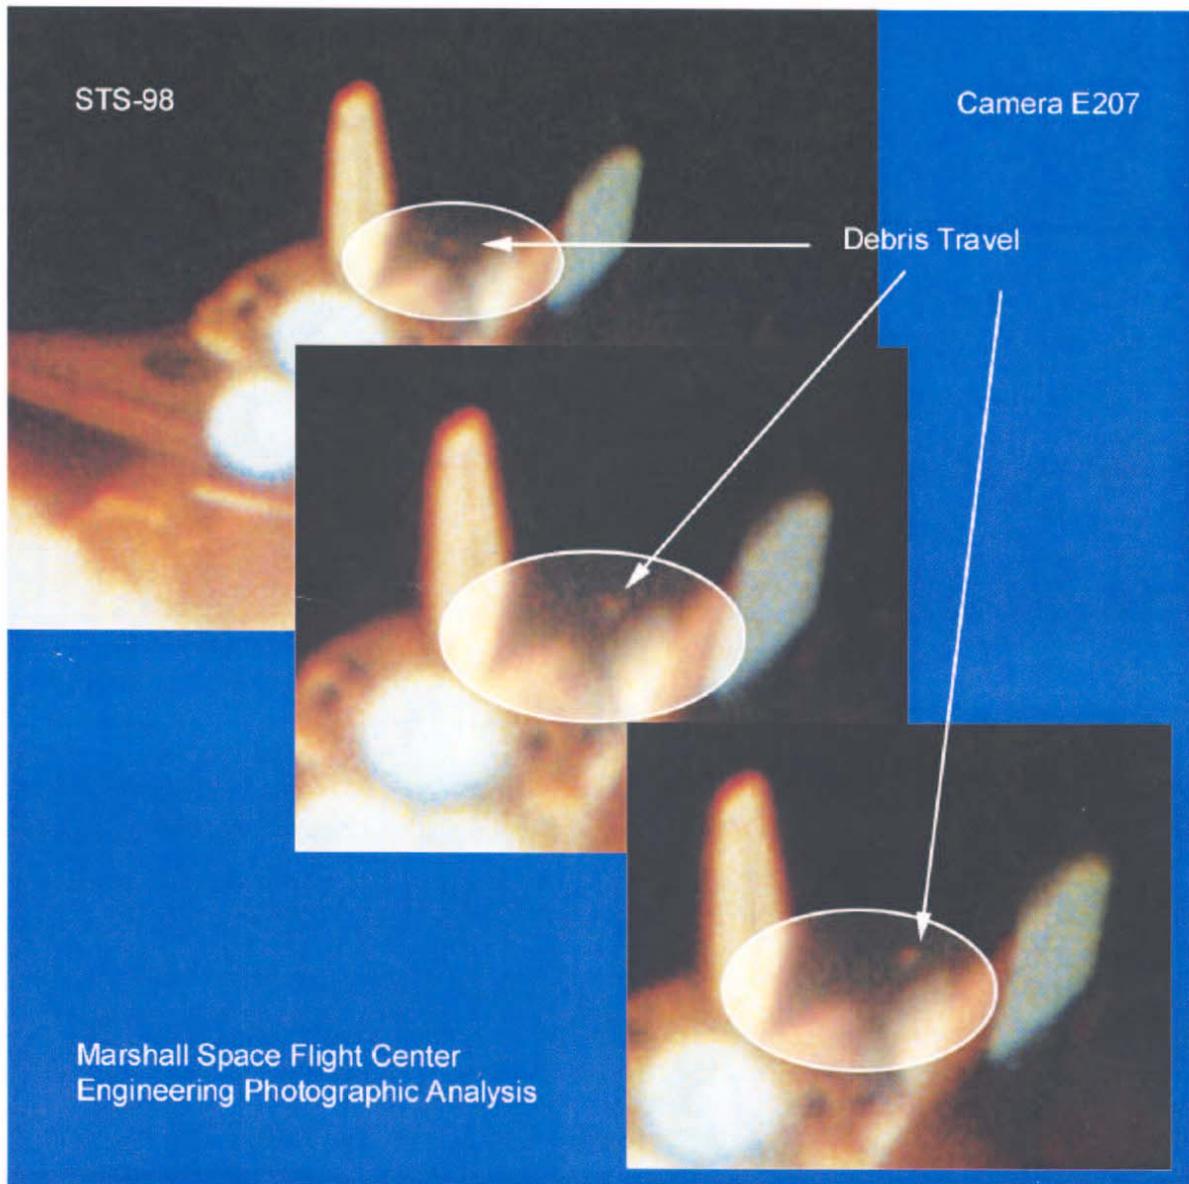
Figure 2 Debris Observed on Right Side of Orbiter

Debris emanated from the right side of the orbiter at approximately the same time as it became visible on the left. The following figure illustrates the direction of travel of the debris from the right side of the Orbiter.

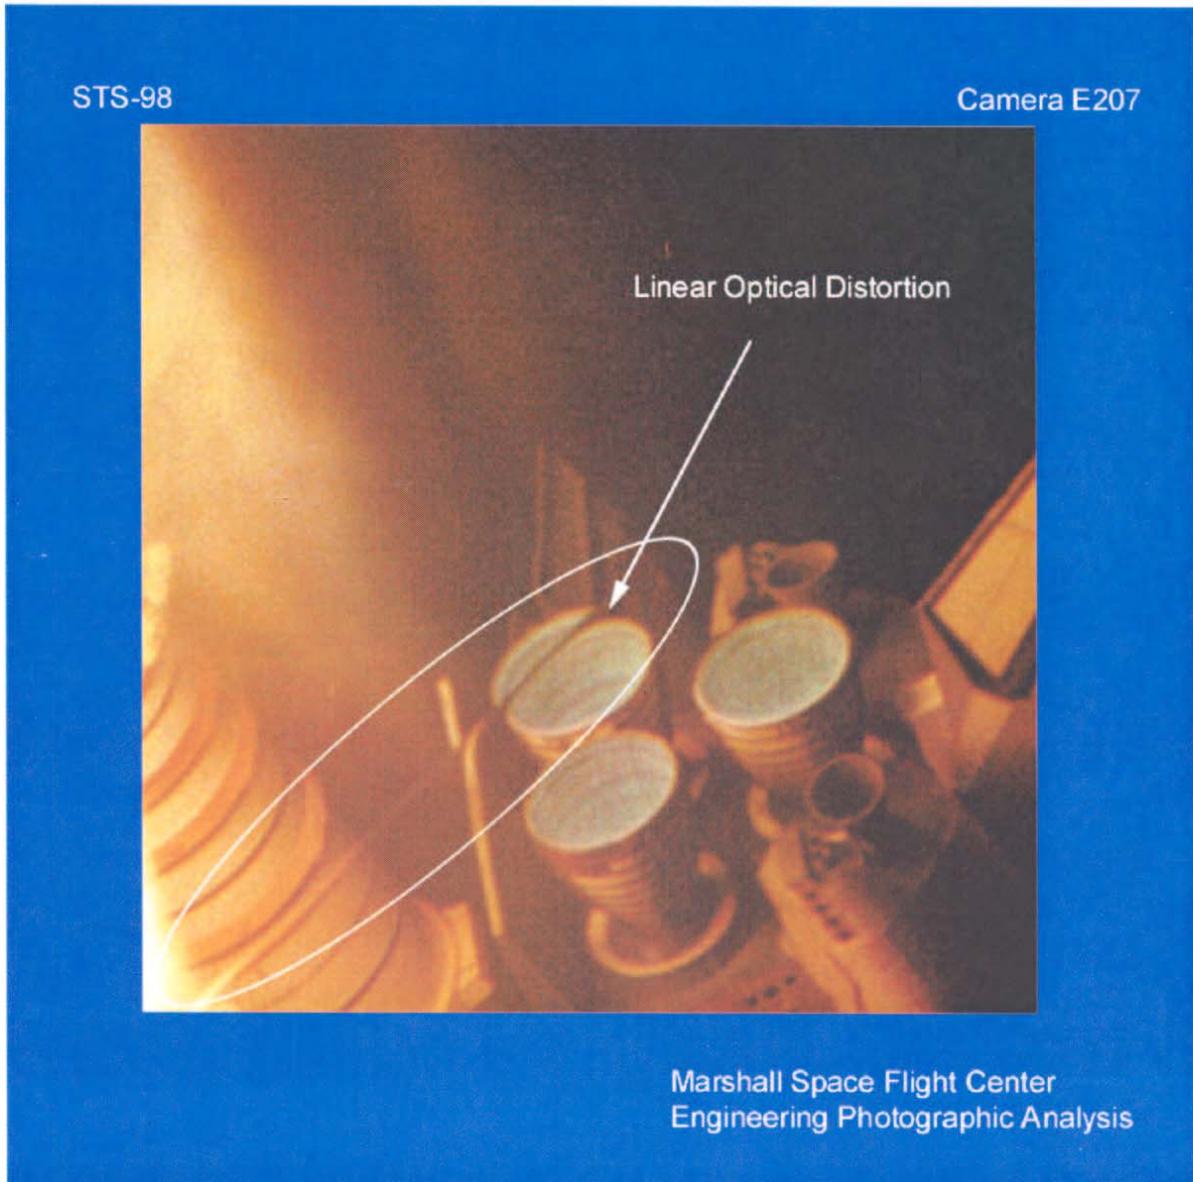
Figure 5. Linear Optical Distortion

Linear optical distortions are observed on most flights. An enlarged image from Film Camera E207 illustrates the distortion as it passes in front of SSME number two.

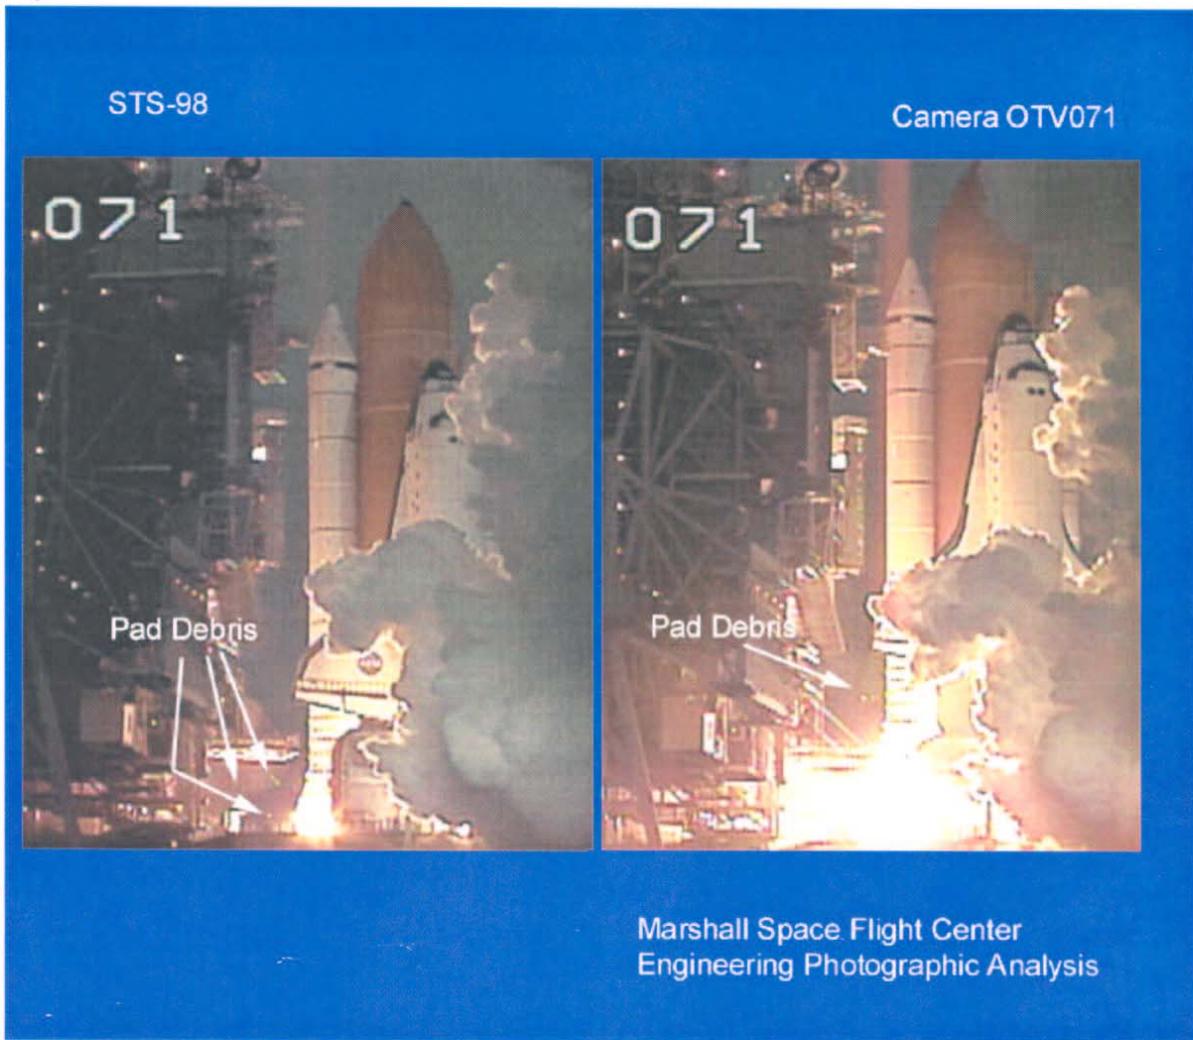
Figure 7. Pad Debris (OTV071)

Typical pad debris was observed to the left side of and moving away from the Orbiter at SRB ignition.

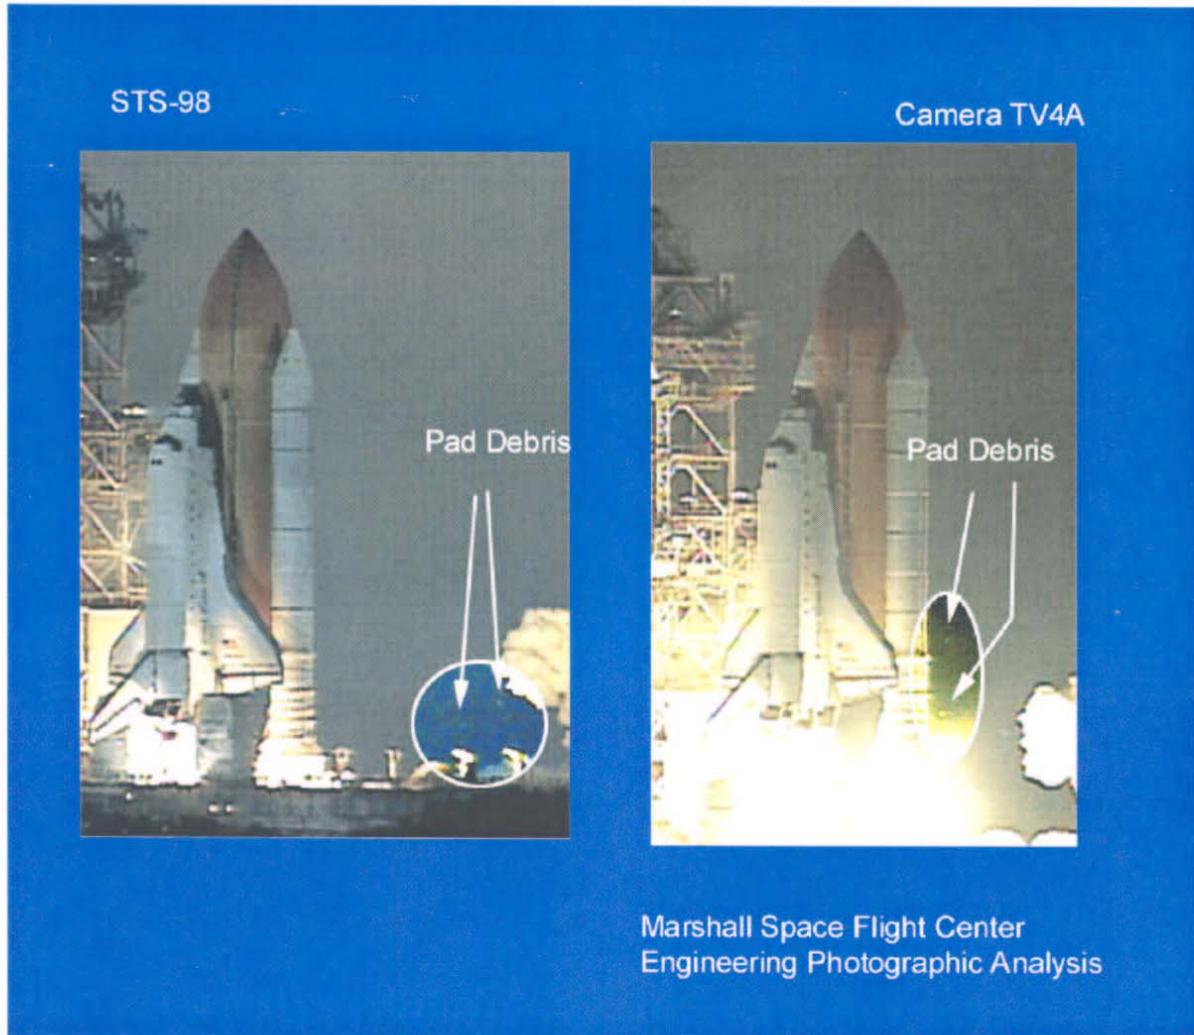
Figure 8. Pad Debris (TV4A)

Typical pad debris observed to the right side of and moving away from the Orbiter at SRB ignition is highlighted in the following figure.

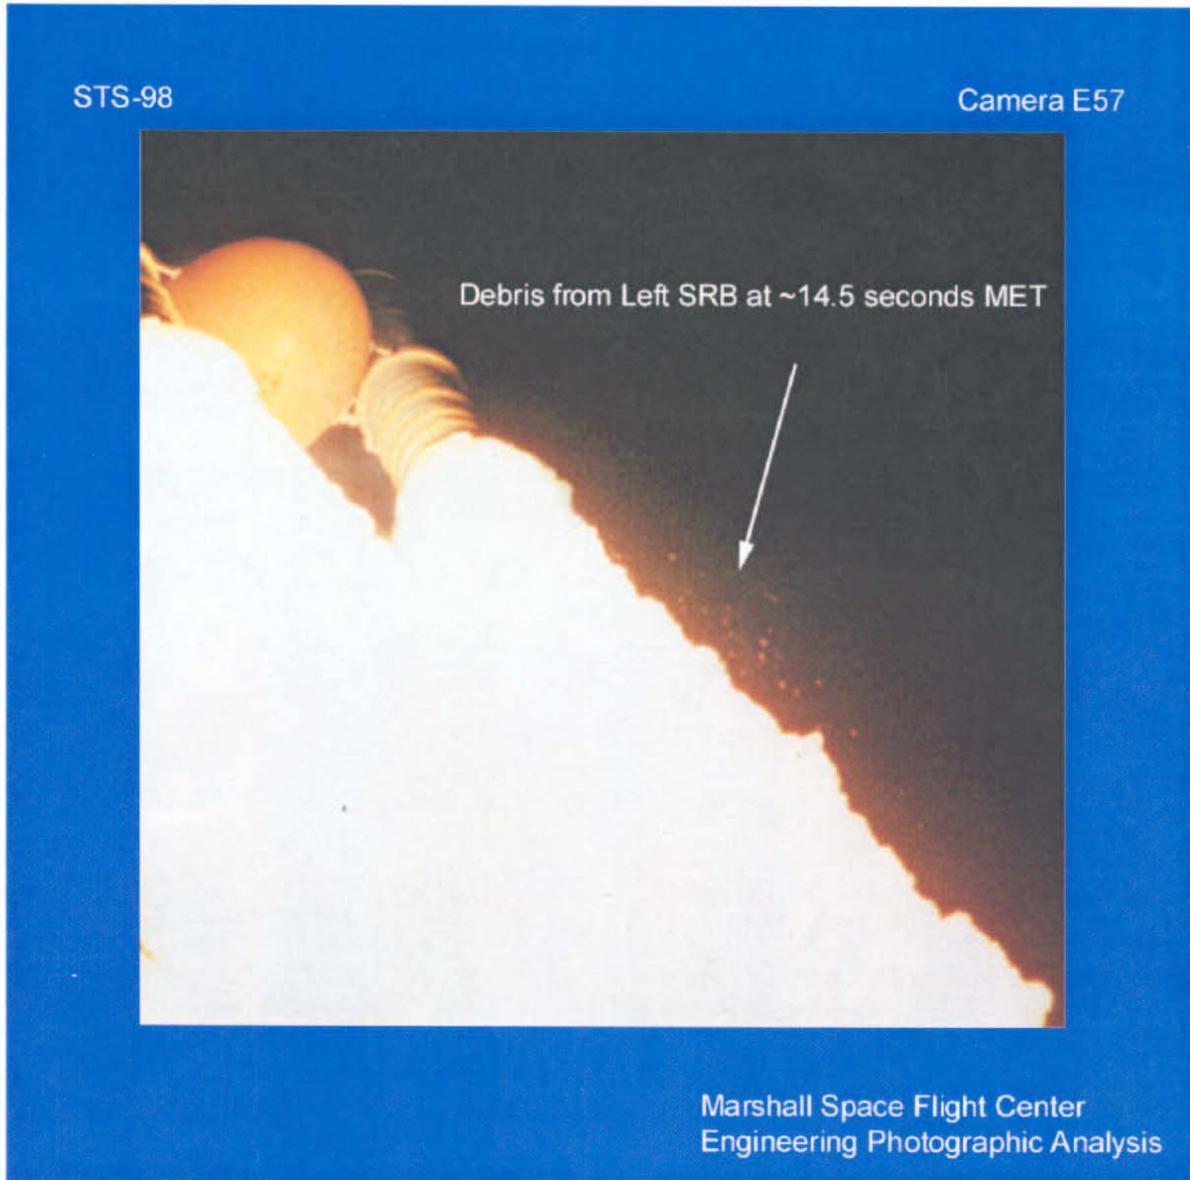
Figure 12. Debris from Left SRB Plume

Debris was ejected intermittently from the left SRB plume starting at approximately 14.5 seconds MET and ranging for a period of about eight seconds. Figure 10 depicts a large shower of debris that was observed during this time period. Figure 10 was taken at approximately 038:23:13:16.46 UTC.

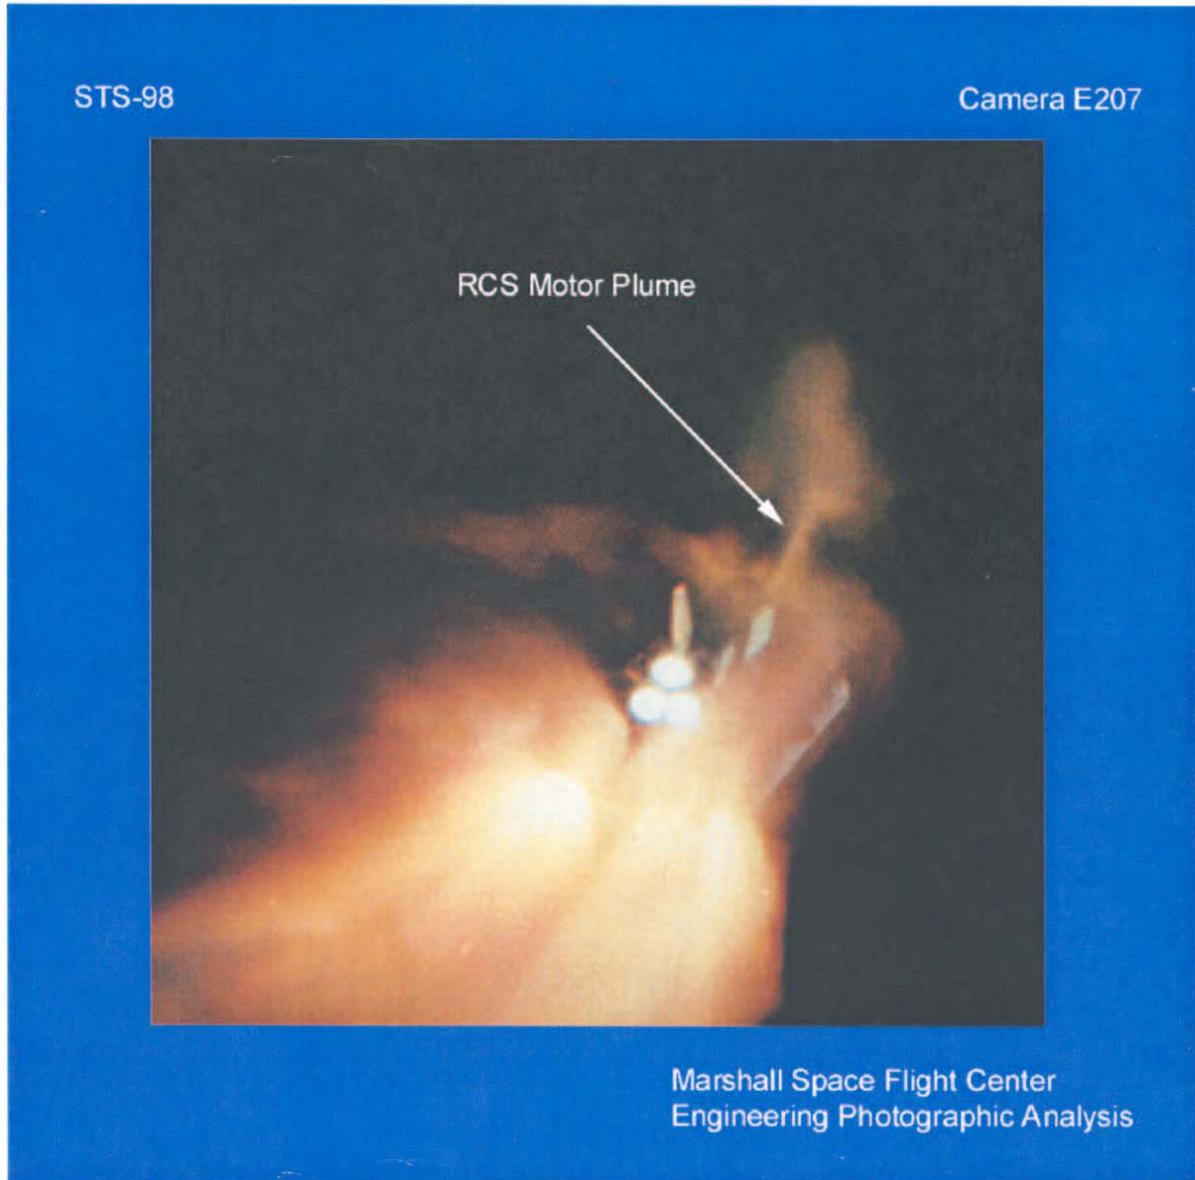
Figure 13. RCS Motor Firing at SRB Separation

A procedure to fire the forward RCS thrusters during SRB separation in order to help keep the Orbiter windows free of exhaust particle hazing was initiated on this mission. RCS motor plumes were observed near the forward end of the Orbiter.
