# RESEARCH MEMORANDUM

ALTITUDE-WIND-TUNNEL INVESTIGATION OF A 4000-POUND-THRUST

AXIAL-FLOW TURBOJET ENGINE

II - OPERATIONAL CHARACTERISTICS

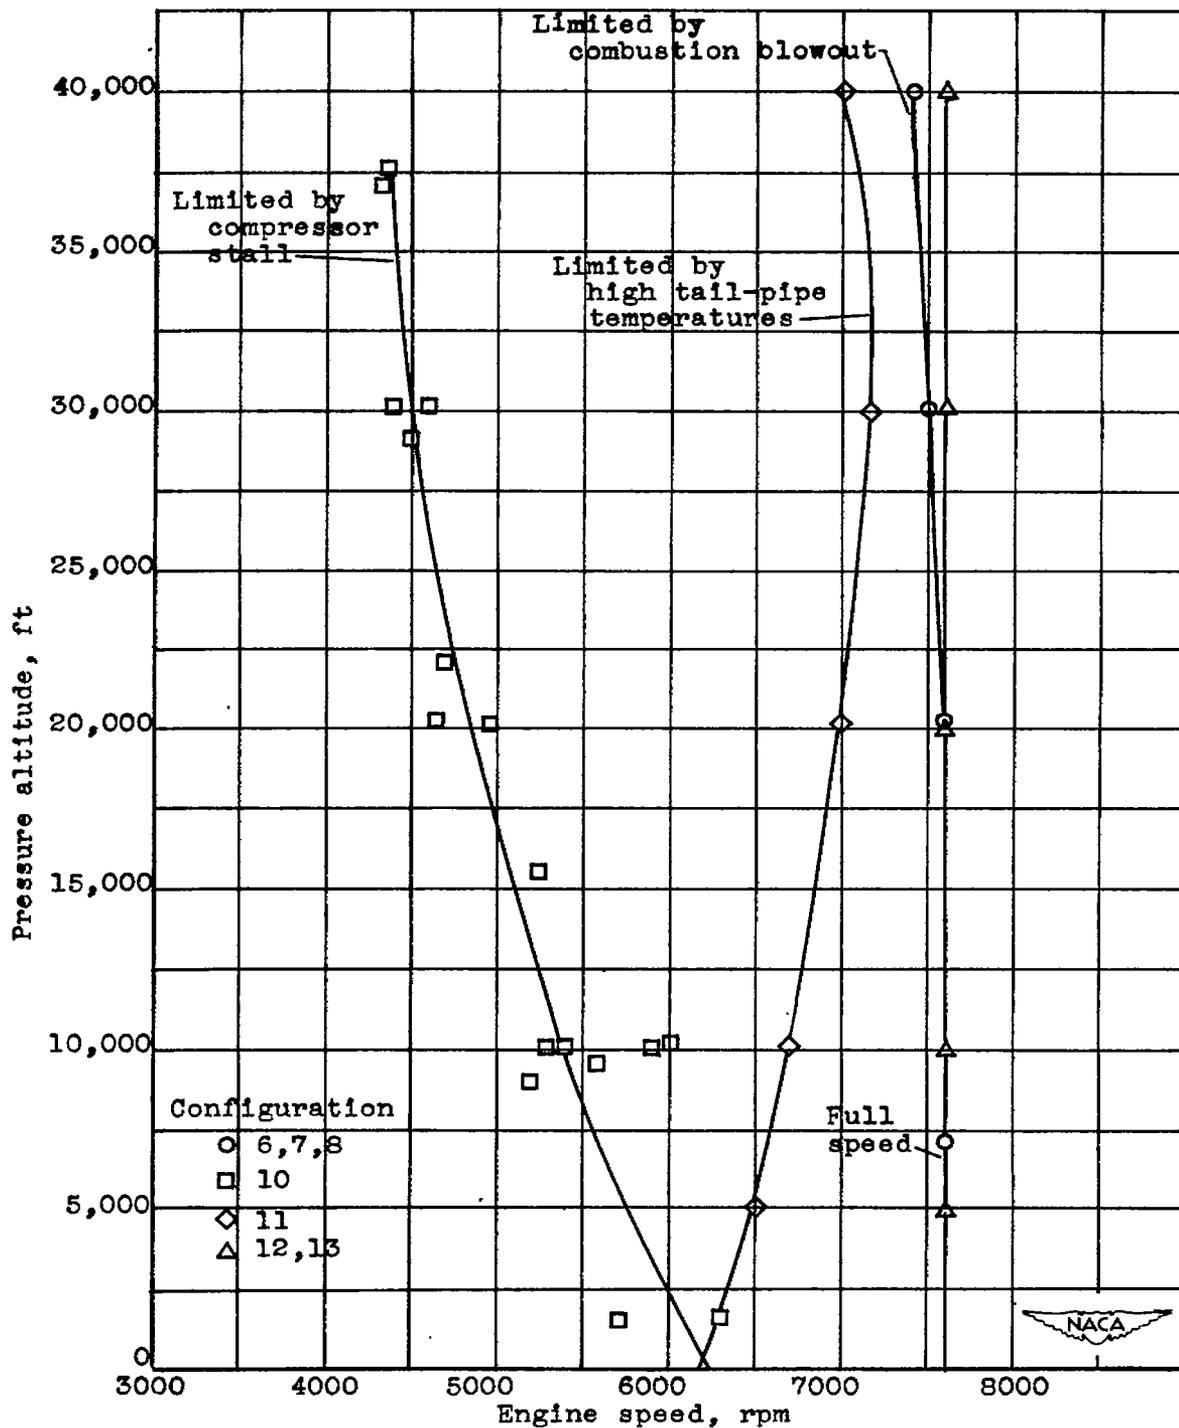
Replacement of the small turbine nozzles with the large nozzles (configuration 11) made possible operation of the engine at higher speeds. (See fig. 7.) Static tests were made with this configuration at pressure altitudes from 5000 to 40,000 feet. The maximum speed of the engine with this configuration was limited by high tail-pipe temperatures resulting from excessive fuel flow. The maximum engine speed at 5000 feet was 6500 rpm, with tail-pipe temperatures between 1150° and 1300° F. A maximum engine speed of 7000 rpm was reached at 40,000 feet with a tail-pipe temperature of 1300° F. Slow acceleration to the maximum engine speed was required in order to avoid blow-out of the combustion chambers. Combustion blow-out was encountered at 5400 rpm with a pressure altitude of 30,000 feet and at 6400 rpm with a pressure altitude of 40,000 feet during rapid accelerations.

Replacing the 18-inch-diameter jet nozzle with a 19 $\frac{1}{2}$ -inch-diameter nozzle and replacing the turbine wheel having excessive radial clearance with one having proper radial clearance (configurations 12 and 13) made possible operation of the engine at full speed. (See fig. 7.) Configuration 12 was investigated at indicated airspeeds from 250 to 300 miles per hour and configuration 13 was investigated at static conditions. Both configurations were investigated over a range of pressure altitudes from 5000 to 40,000 feet. With these configurations, the tail-pipe temperature at full speed was between 1000° and 1100° F at all altitudes.

Figure 7.- Effect of pressure altitude on maximum engine speed with high-flow compressor installed on configurations 6, 7, 8, 10, 11, 12, and 13.

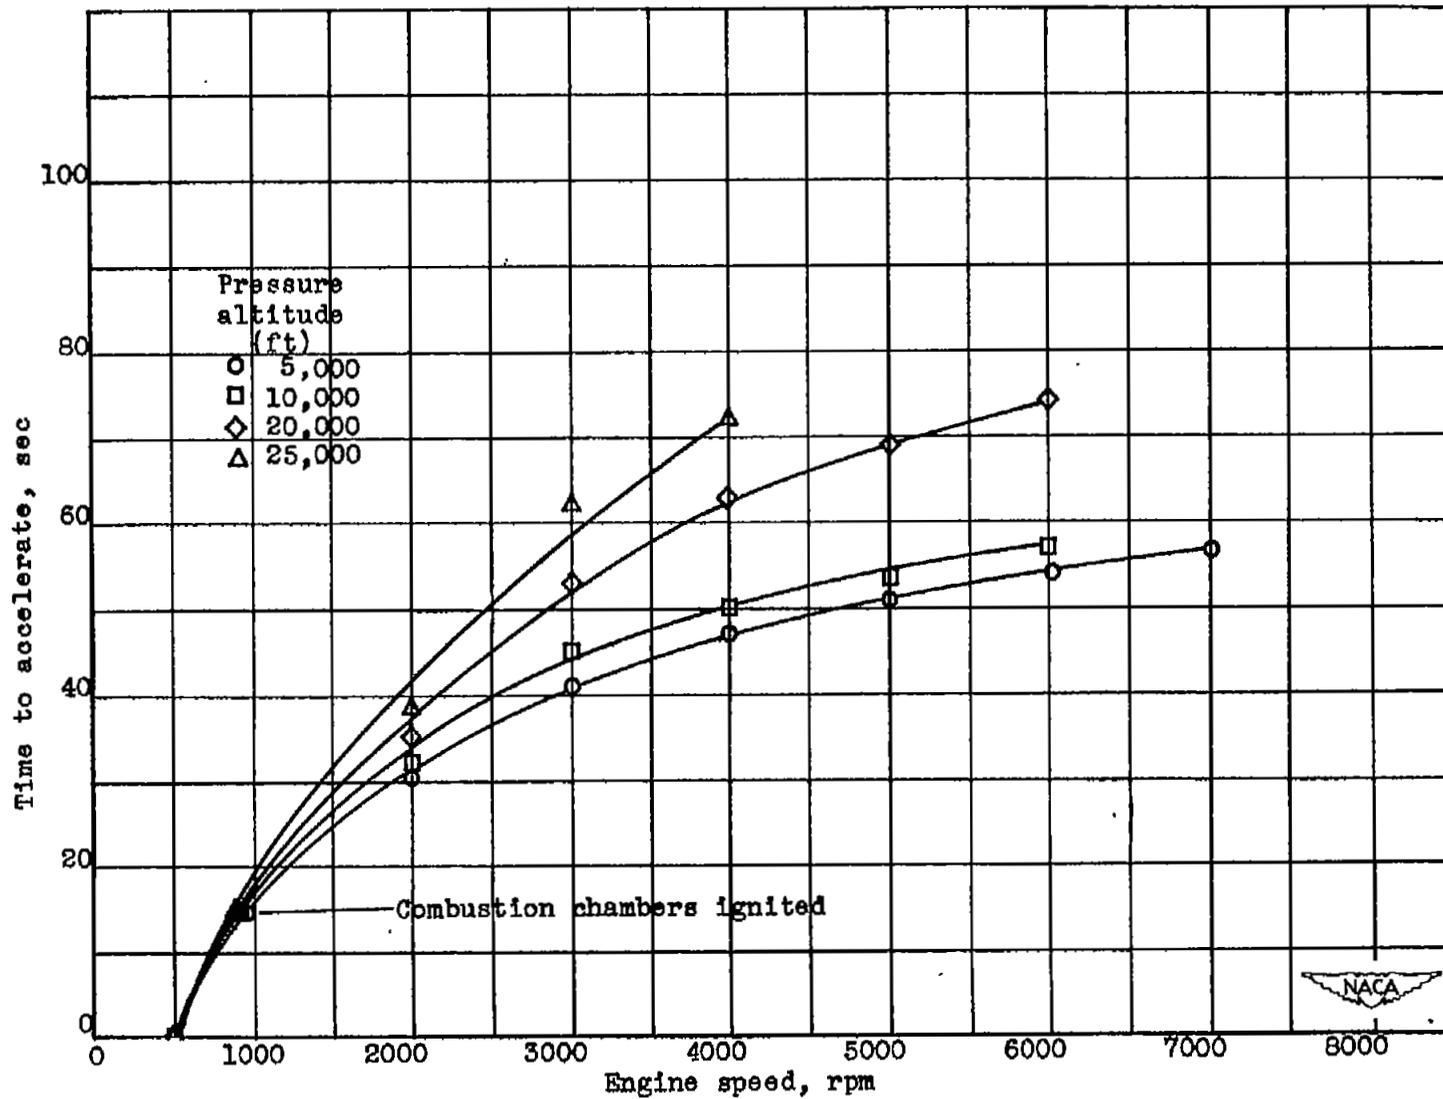
Low-flow compressor. - With the low-flow compressor (configurations 1 and 5) at pressure altitudes from 5000 to 25,000 feet and temperatures from 29° to -41° F, the engine was started and accelerated to a normal operating speed. The time required to start the engine from a windmilling speed of approximately 500 rpm and accelerate to 4000 rpm increased from 47 seconds at 5000 feet to 72 seconds at 25,000 feet. (See fig. 9.) The time required to accelerate from 3000 to 6000 rpm increased from 13 seconds at 5000 feet to 44 seconds at 30,000 feet (fig. 10). Between 12 and 18 seconds were required to ignite the combustion chambers at all altitudes. The increase in acceleration time with altitude resulted from the decreased accelerating force exerted on the turbine blades by the low-density gases at high altitude. The results of experimental and calculated data to determine the ratio of the time to accelerate at altitude to the time to accelerate at sea level are shown in figure 11. In order to determine the calculated curve, the assumption was made that the turbine-inlet temperature was the same at all altitudes during acceleration. The ratio of time to accelerate at altitude to time to accelerate at sea level was then found to be inversely proportional to the ratio of the respective densities of the inlet air.

Figure 9.- Effect of pressure altitude on time required to start and accelerate with low-flow compressor, configurations 1 and 5.

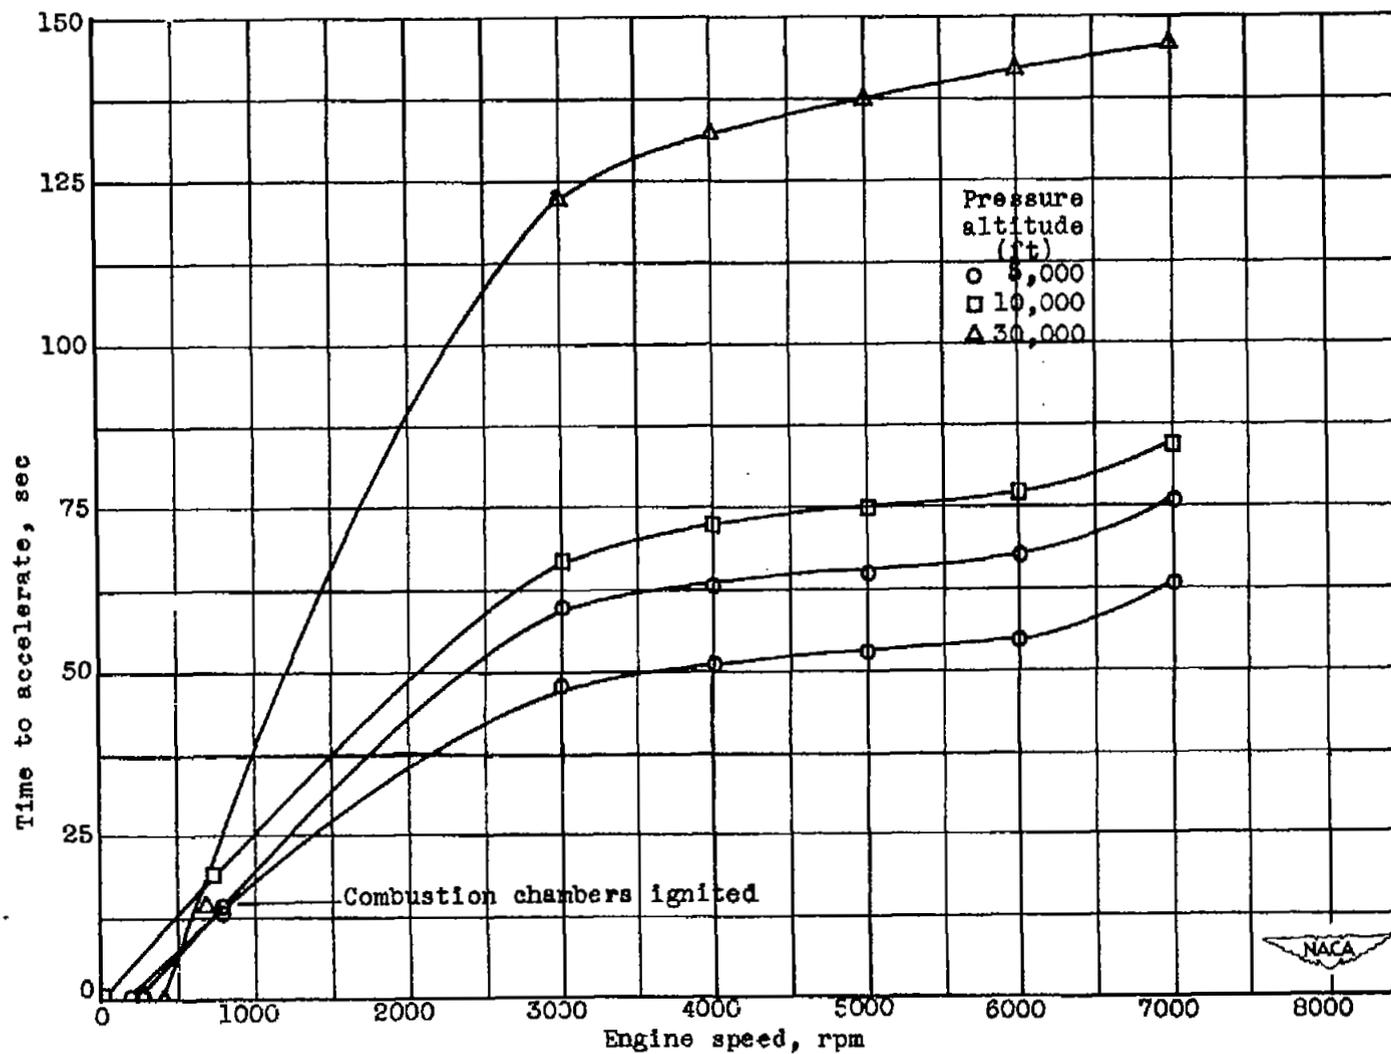
Starting and acceleration tests were made with the large turbine nozzles and a  $19\frac{1}{2}$ -inch-diameter jet nozzle (configuration 13) at pressure altitudes from 5000 to 40,000 feet and inlet temperatures from 25° to -34° F. Combustion blow-out was not encountered below a pressure altitude of 20,000 feet during rapid accelerations. The revised fuel regulator contained a restricting orifice that limited the rate at which the fuel flow could be increased. During accelerations a tail-pipe temperature of 1500° F could be maintained until the engine speed reached approximately 5500 rpm. From this point the fuel regulator controlled the rate at which the fuel flow was changed to such an extent that the acceleration from 6000 to 7000 rpm with the throttle wide open was only from one-third to one-half as fast as the acceleration from 5000 to 6000 rpm. This restricting orifice was responsible for a greater accelerating time from 6000 to 7000 rpm than would normally be encountered. (See figs. 12 and 13.) The variation in the two acceleration curves at a pressure altitude of 5000 feet is attributed to an excess of fuel sprayed into the burners during the run represented by the upper curve. The excess of fuel caused very high tail-pipe temperatures and considerable burning of fuel in and behind the tail pipe, which resulted in a slower acceleration below 3000 rpm.

Modified fuel regulator. - The modified fuel regulator, which replaced the original fuel regulator when the high-flow compressor was installed in the engine, so restricted the fuel flow during acceleration that above 6000 rpm acceleration was very slow (figs. 12 and 13). The original fuel regulator controlled the fuel flow up to an engine speed of approximately 6800 rpm where the variable-speed governor began to control the fuel flow. The modified regulator, however, controlled the fuel flow up to an engine speed of about 7000 rpm at a pressure altitude of 5000 feet. With the modified fuel regulator an increase in altitude resulted in an increase in the engine speed at which the governor took control of the fuel flow. At pressure altitudes above 20,000 feet the revised fuel regulator controlled the fuel flow up to 7600 rpm. The maximum small-slot fuel pressure obtainable when starting was 90 pounds per square inch with the modified fuel regulator as compared with 120 pounds per square inch with the original fuel regulator.

Figure 12.- Effect of pressure altitude on the time required to start and accelerate with high-flow compressor, configuration 13.

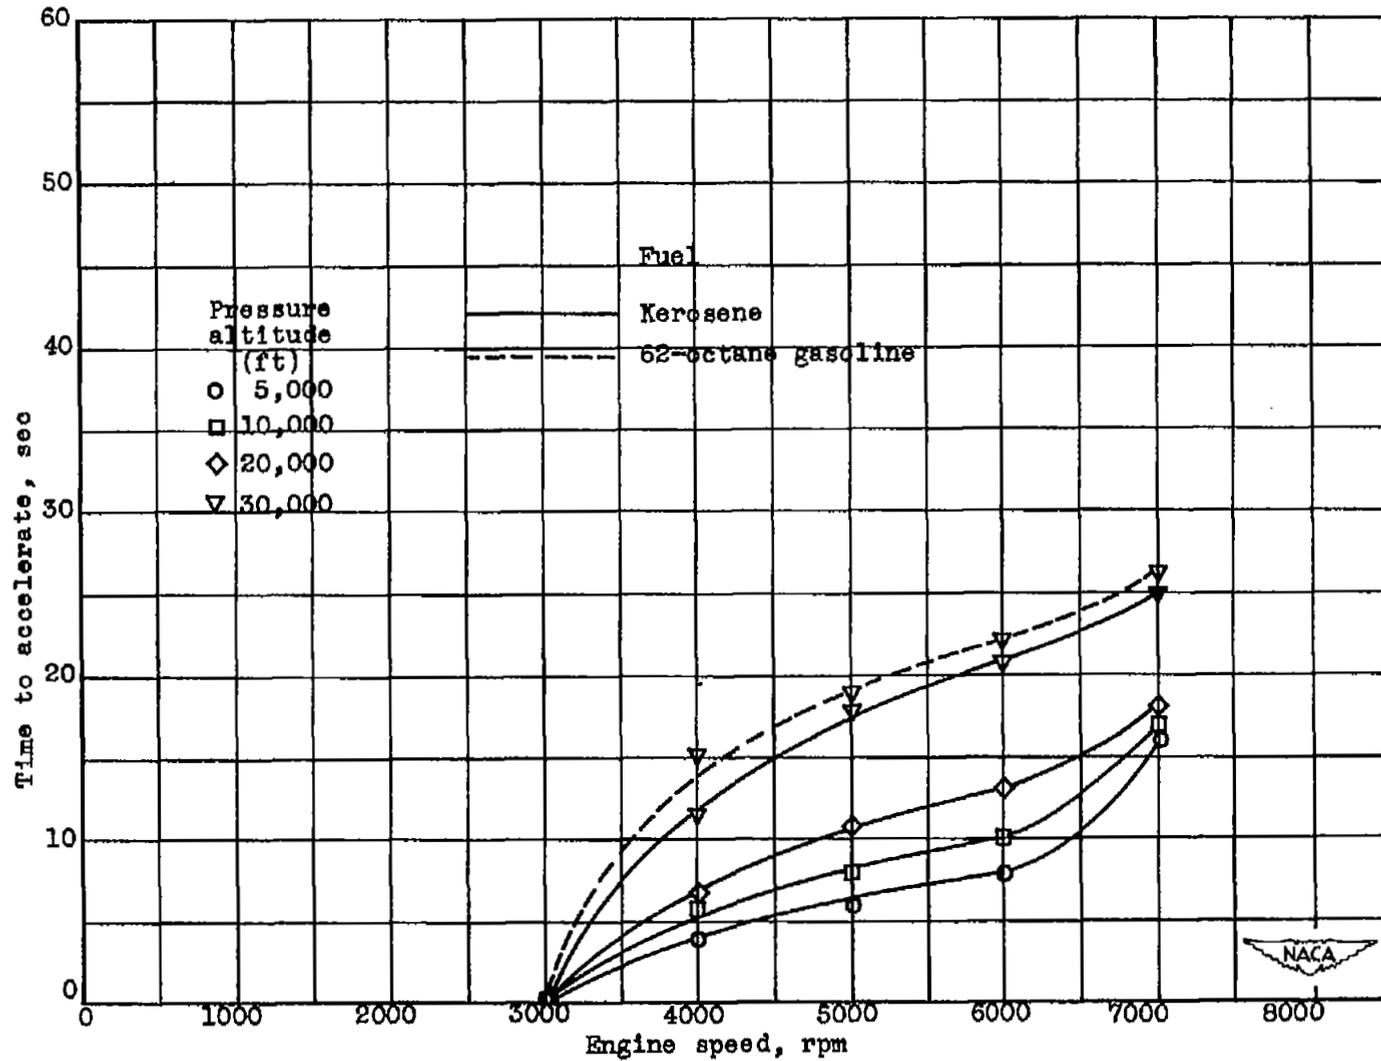
Figure 13.- Effect of pressure altitude on the time required to accelerate from an idling speed of 3000 rpm with high-flow compressor, configuration 13.

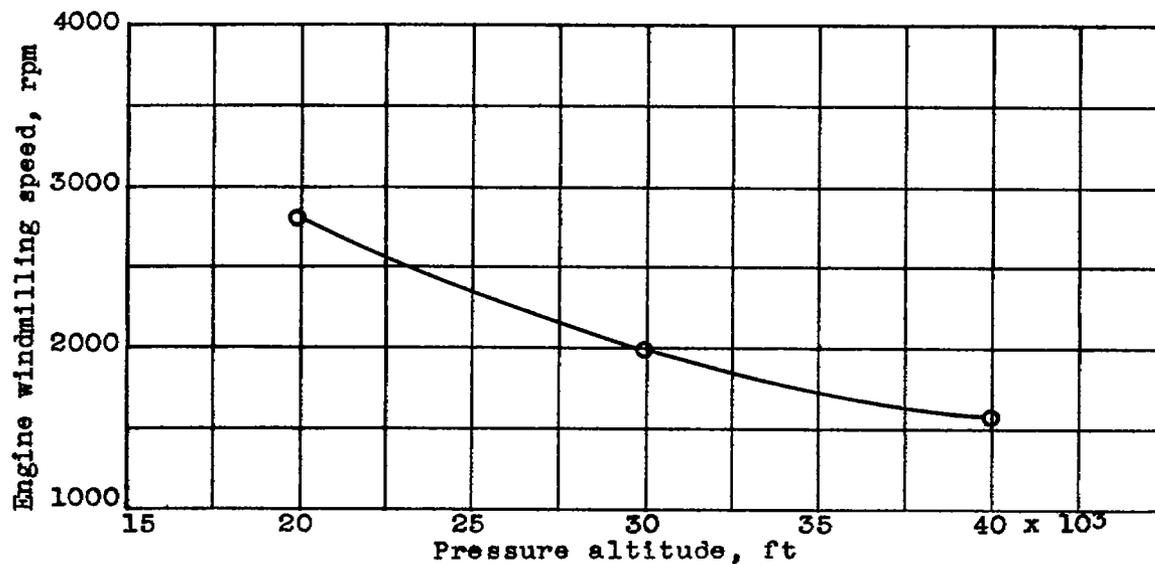
A summary of the conditions at which windmilling starts were attempted is given in table III and the maximum windmilling speeds and true airspeeds at which the engine could be started at each altitude are shown in figures 14 and 15. Acceleration of the engine was more rapid in starts at high airspeeds.

Figure 14. - Variation with altitude of maximum engine windmilling speed at which engine could be started.

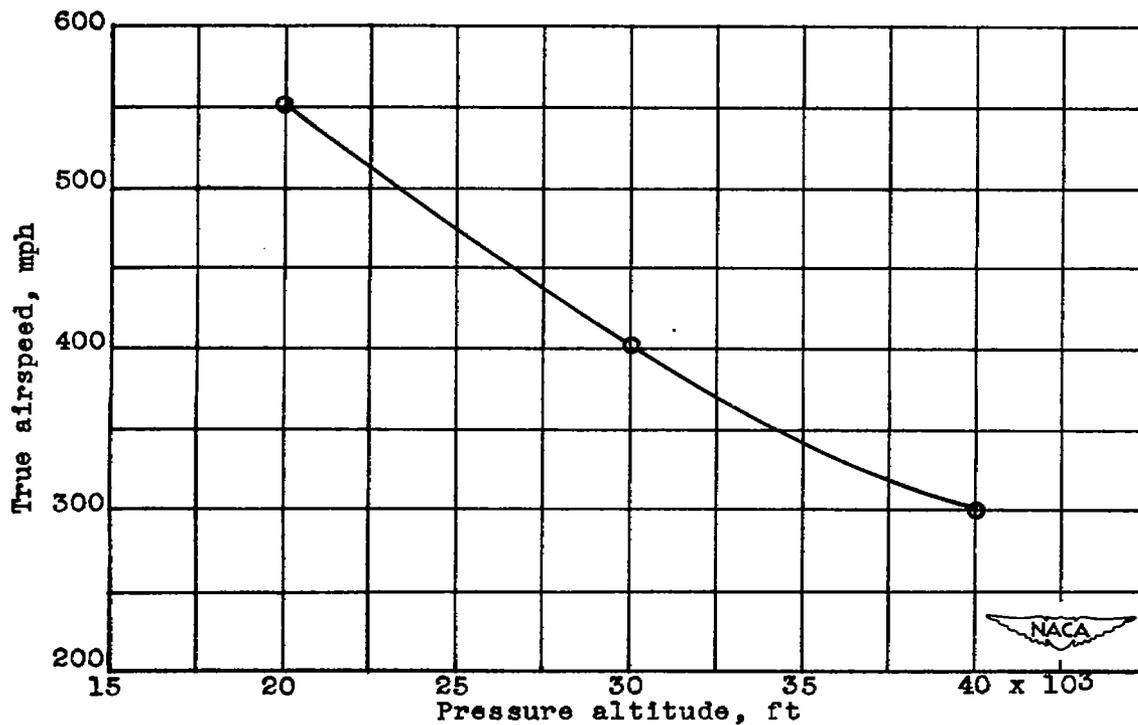
Figure 15. - Variation with altitude of maximum true airspeed at which engine could be started.

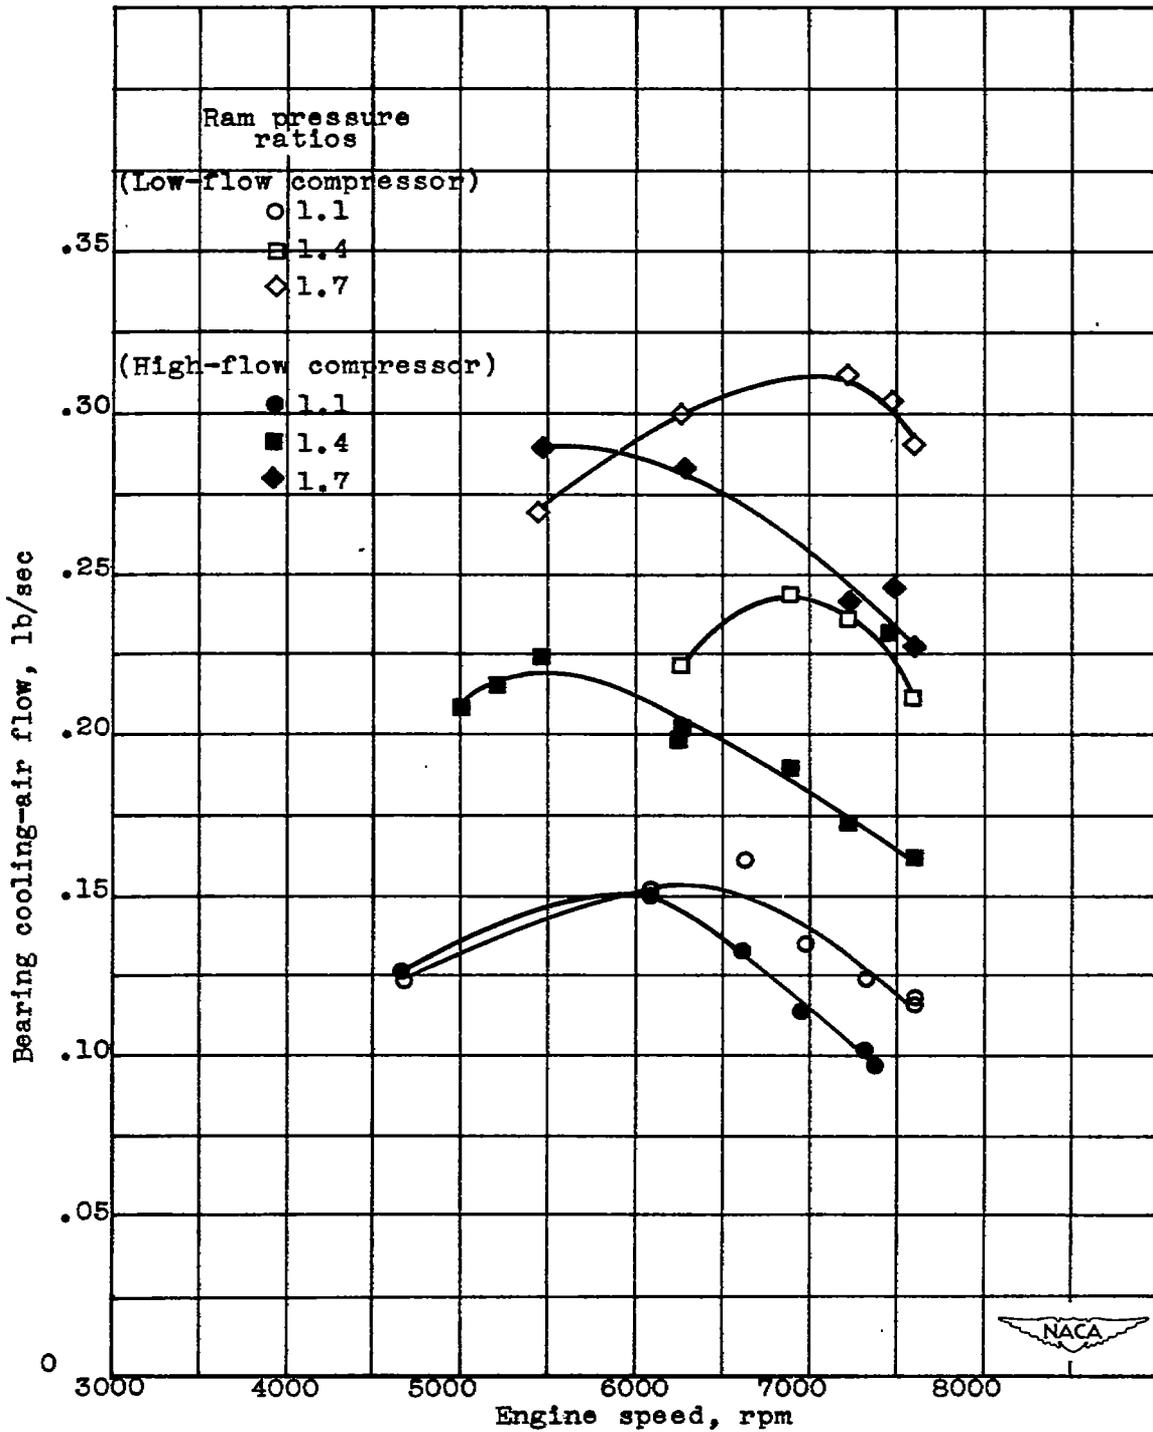
Failure of the bearings to cool properly at high pressure altitudes and high engine speeds was attributed not only to the reduced density of the air at high altitude but also to the fact that at high engine speeds the bearing cooling-air flow decreased with increasing engine speed. Representative data showing the comparison of bearing cooling-air flow with the low-flow and high-flow compressors at a pressure altitude of 30,000 feet are presented in figure 16. The decrease in bearing cooling-air flow at high engine speeds was more rapid with the high-flow compressor than with the low-flow compressor. At maximum engine speed the high-flow compressor delivered from 15 to 25 percent less cooling air to the bearings at all altitudes than the low-flow compressor.

7. High temperatures of the mid bearing (bearing 2) and the rear bearing (bearing 4) were encountered in the runs with the low-flow compressor at engine speeds higher than 7000 rpm at pressure altitudes above 30,000 feet. The bearing cooling was worse with the high-flow compressor than with the low-flow compressor. The high bearing temperatures were caused in part by the reduction in bearing cooling-air flow at high engine speeds.

Figure 16.- Comparison of bearing cooling-air flow with low-flow and high-flow compressors at a pressure altitude of 30,000 feet.

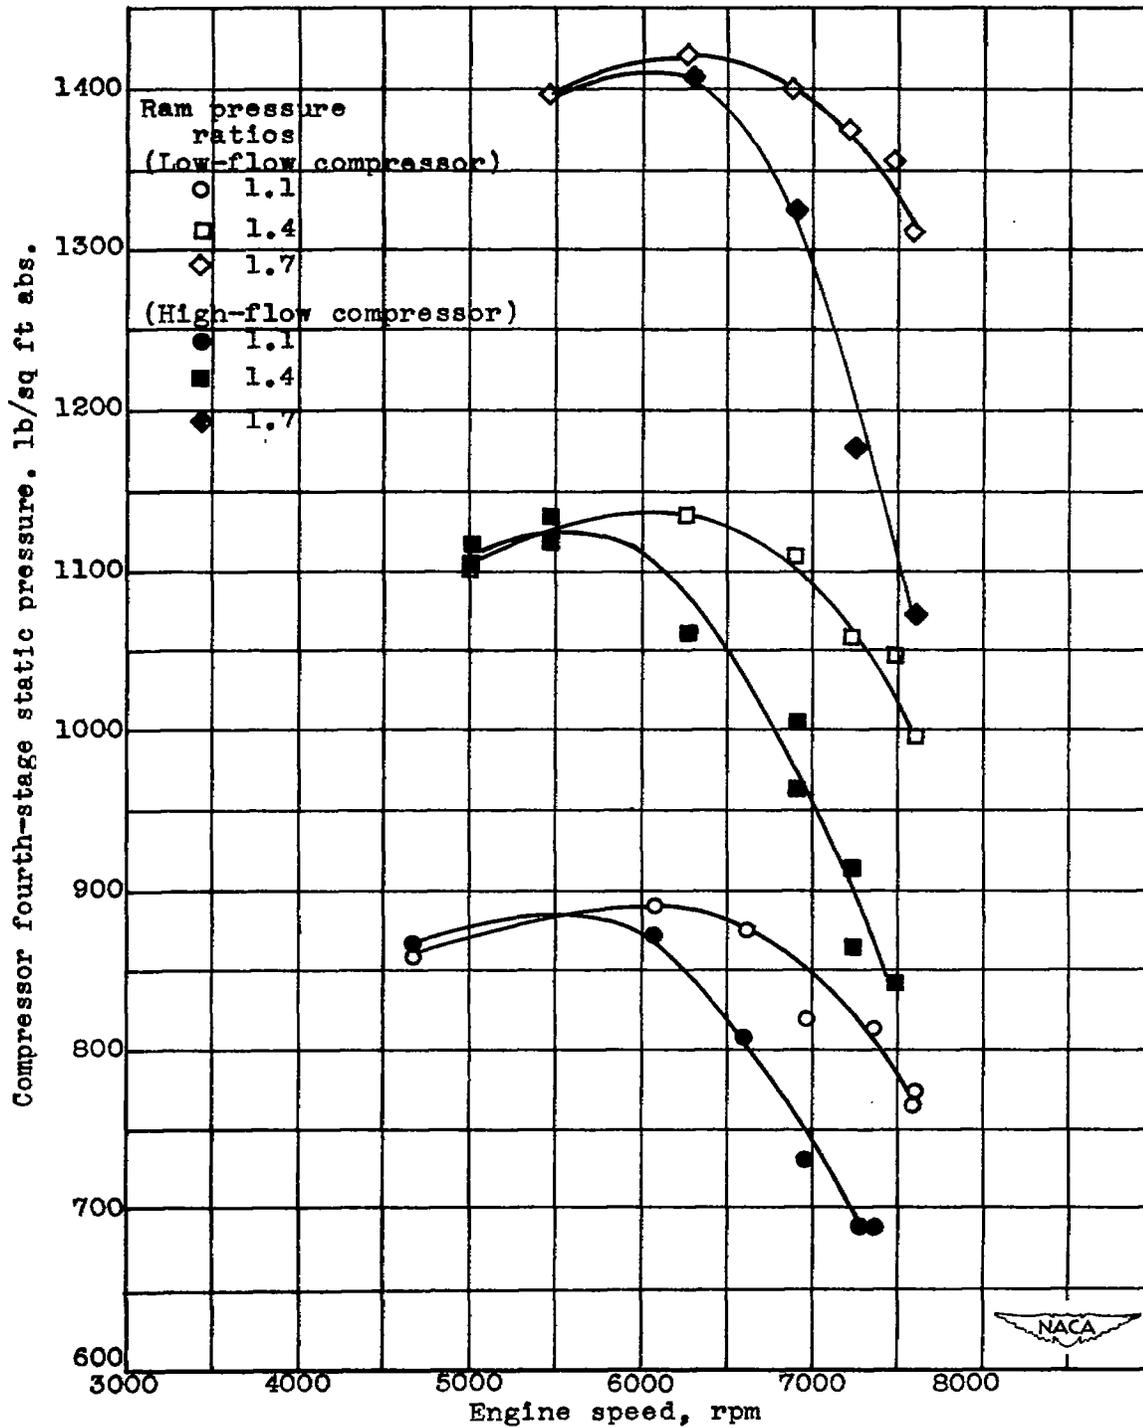
The decrease in bearing cooling-air flow at high engine speeds was attributed to a corresponding decrease in the compressor fourth-stage static pressure, the stage from which the cooling air was bled. A comparison of the fourth-stage static pressures of the low-flow and high-flow compressors at a pressure altitude of 30,000 feet is shown in figure 17.

Figure 17.- Comparison of compressor fourth-stage static pressure with low-flow and high-flow compressors at a pressure altitude of 30,000 feet.

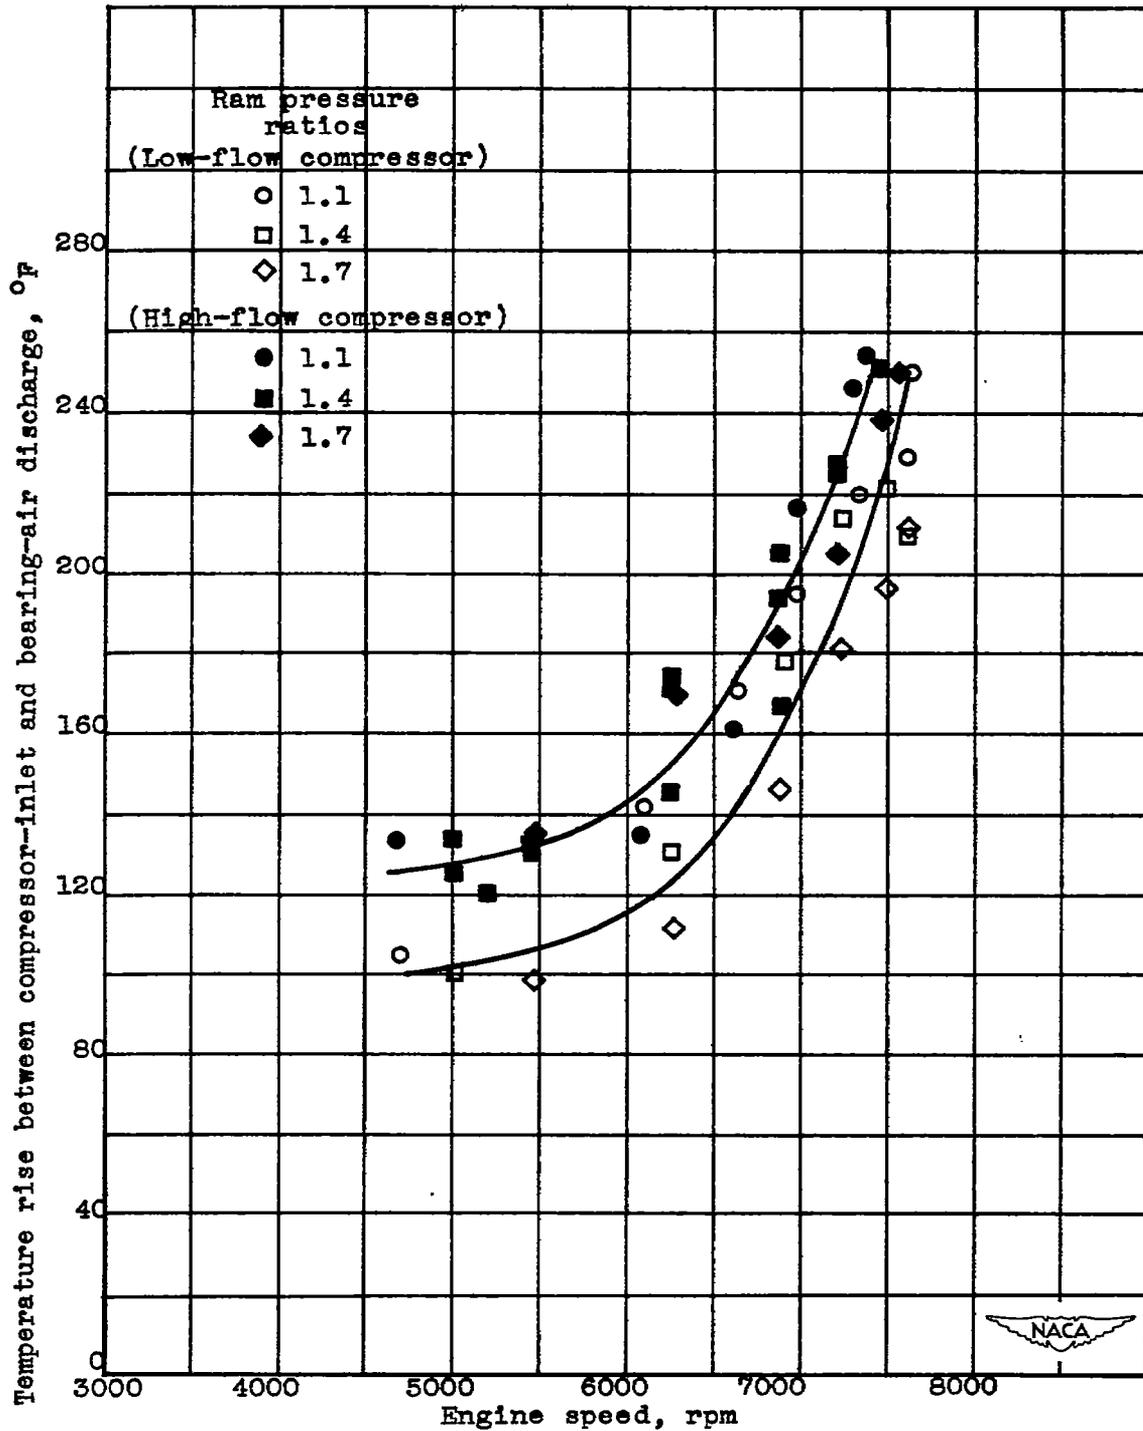
The temperature rise between the compressor inlet and the bearing cooling-air discharge at all altitudes was from 10 to 20 percent greater with the high-flow compressor than with the low-flow compressor. A comparison of this temperature rise for the low-flow and high-flow compressors at a pressure altitude of 30,000 feet is shown in figure 18.

Figure 18.- Comparison of temperature rise between the compressor inlet and bearing-air discharge with low-flow and high-flow compressors at a pressure altitude of 30,000 feet.
