NASA/TM-2005-213231/Version 2.0
NESC-RP-04-01/03-001-E

Cloud-Aerosol LIDAR and Infrared Pathfinder Satellite Observation (CALIPSO) Spacecraft

Independent Technical Assessment

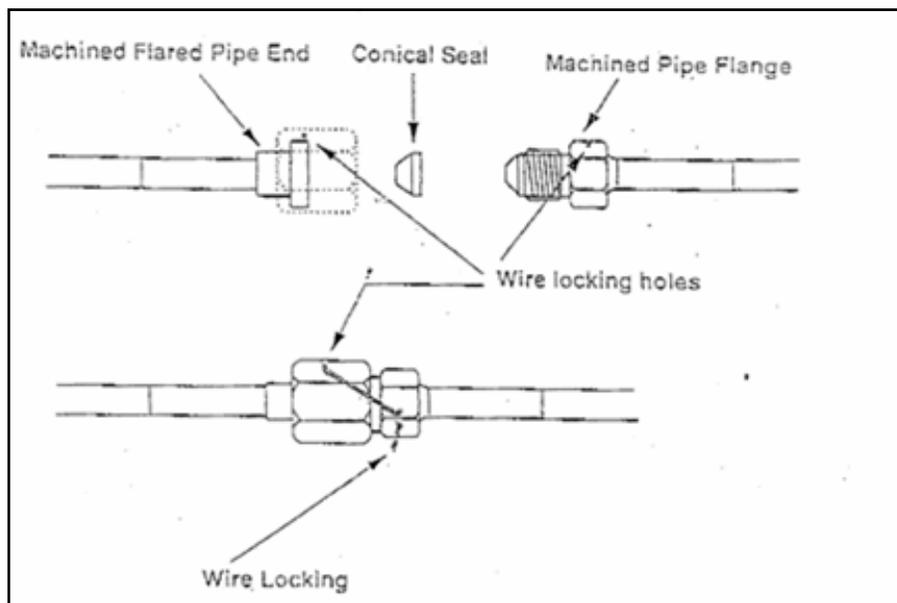
Figure 2. MS 33656 A/N fitting installation detail

Properly welded fluid connections are inherently more reliable than mechanical fittings and should be incorporated in fluid propulsion system designs when possible. There are some circumstances, however, under which mechanical fittings offer an appropriate design solution. Ready interface to off-the-shelf parts, ease of maintenance, or potential for damage to soft goods during welding all may dictate use of threaded joints. MS-33656 type 37° A/N-fittings have been employed successfully in aerospace applications for many years and are acceptable for limited use providing they are (1) properly assembled, (2) validated by leak check as an assembly before use, (3) exposed only to temperature, pressure, vibration and shock environments for which they are certified, and (4) incorporate a secondary locking feature. The Proteus bus uses five such fittings; one at the hydrazine tank outlet and one at each of the thruster inlets (see Figures 2 and 3 for details). While lock-wire is used as a secondary locking feature, it is suitable only for preventing significant rotation of the B-nut and full disengagement of the fitting. Lock-wire alone will not prevent loss of joint preload⁸ with subsequent reduction of clamping force at the sealing surfaces, and thus cannot be counted upon to prevent a fitting from leaking.

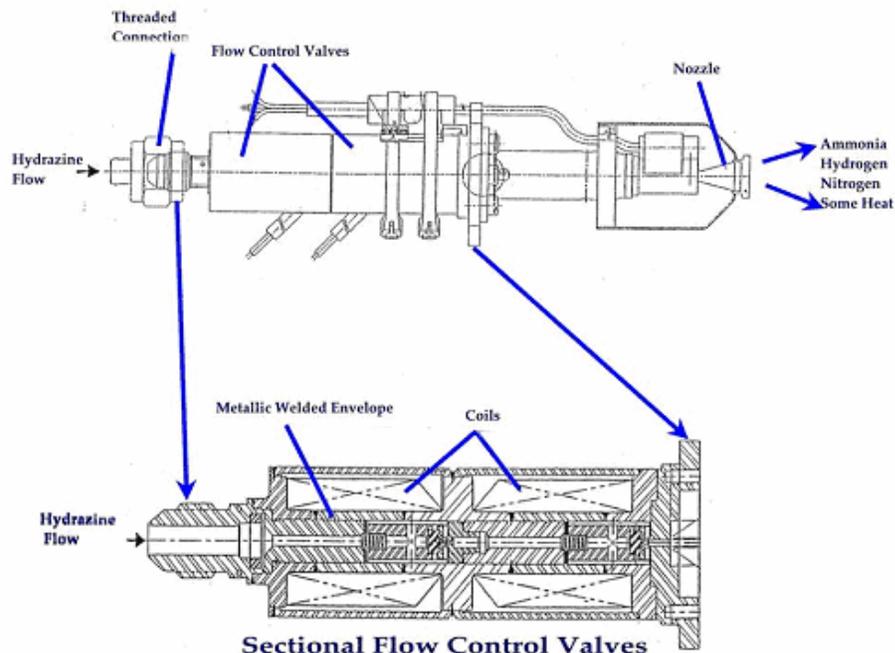
Figure 4. Moog Dual Seat Dual Servo Thruster Valve

Thrusters selected for the Proteus bus are designed with normally closed series-redundant solenoid-actuated flow control valves manufactured by Moog. The thrusters are of a mature design. A schematic of the valve is depicted in Figure 4.

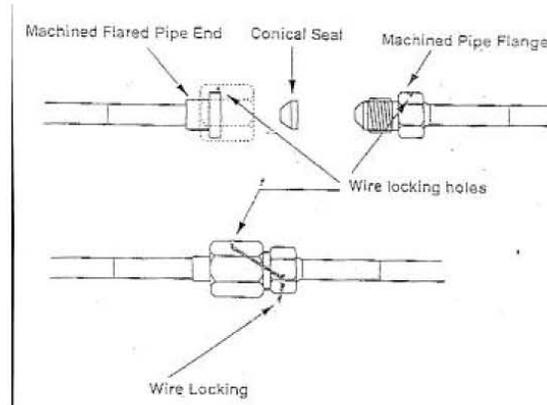
Figure 1 – Schematic of Mechanical Fittings

The propulsion system uses titanium tubing welded to titanium threads. The adjacent tube is flared to a 37° angle with a CRES 304 B-Nut and tube sleeve. A nickel conical seal is secured in between the tube ends to ensure a leak tight seal.

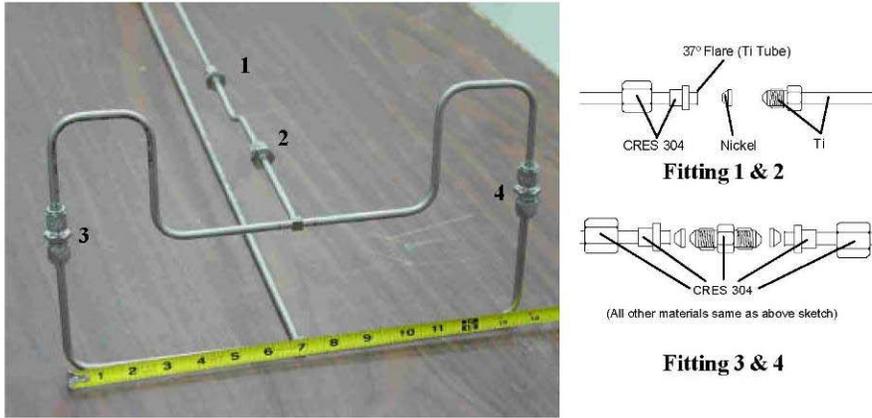
Figure 3 – Test Configuration for the Hot Soak at 225°F With Sketch of Fitting Location

Fitting Number (Refer to Figure 3)	Number of Re-torques	Time Delay for Re-tightening
1	3	1) 1 min after first tightening 2) 2 min after first tightening 3) 24 hrs. after first tightening
2	2	1) 1 min after first tightening 2) 12 hrs. after first tightening
3	2	1) 1 min after first tightening 2) 12 hrs. after first tightening
4	2	1) 1 min after first tightening 2) 12 hrs. after first tightening

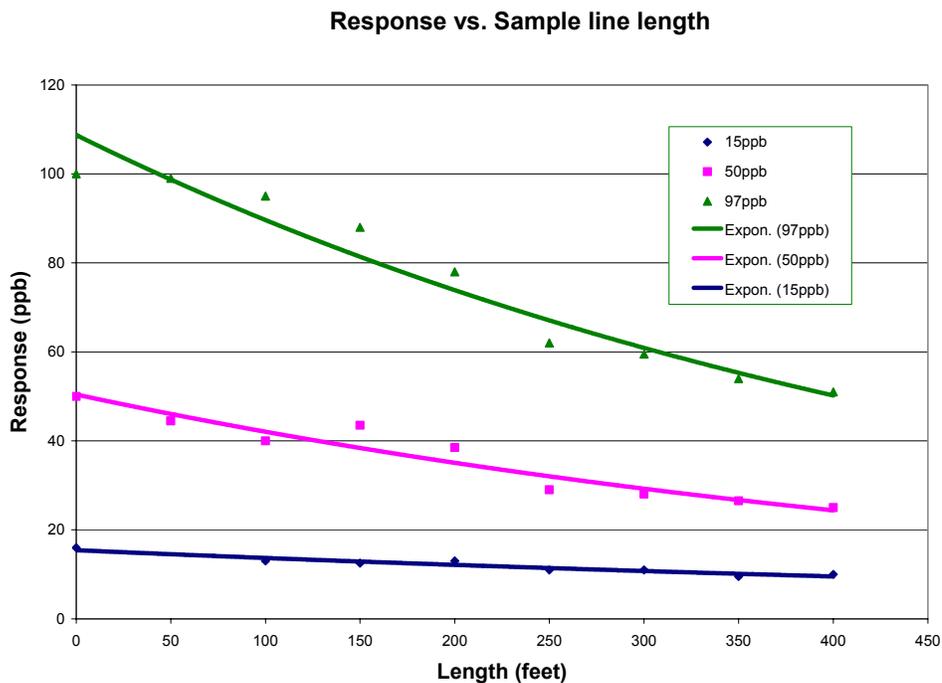
Figure 1. Concentration Response vs. Intake Tubing Length

Figure 1 shows a decreasing concentration when longer tubing is used. In this figure, each data point plotted is an average of several data points. Relative to the values at 1 foot, the 400 foot tubing length responses are down by 41%, 50% and 52% for the 15, 50, and 97 ppb vapors respectively, with smaller decreases at shorter tubing lengths.

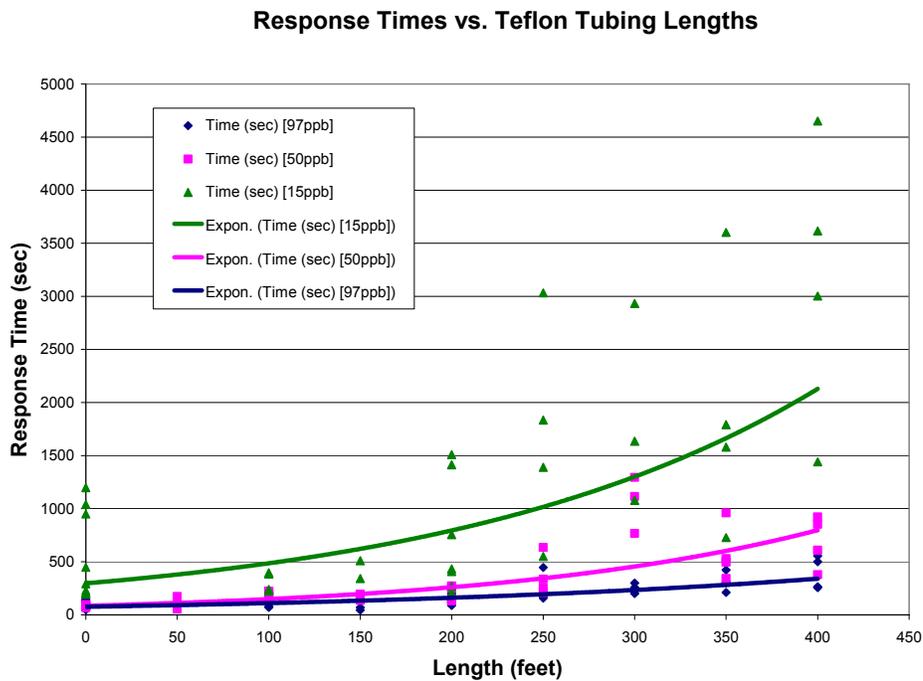
Figure 3. Response Time vs. Tubing Length

Figure 3 shows the response time, defined as the first response above baseline reported by the instrument (~10 ppb), for the three MMH concentrations using various lengths of tubing. Due to

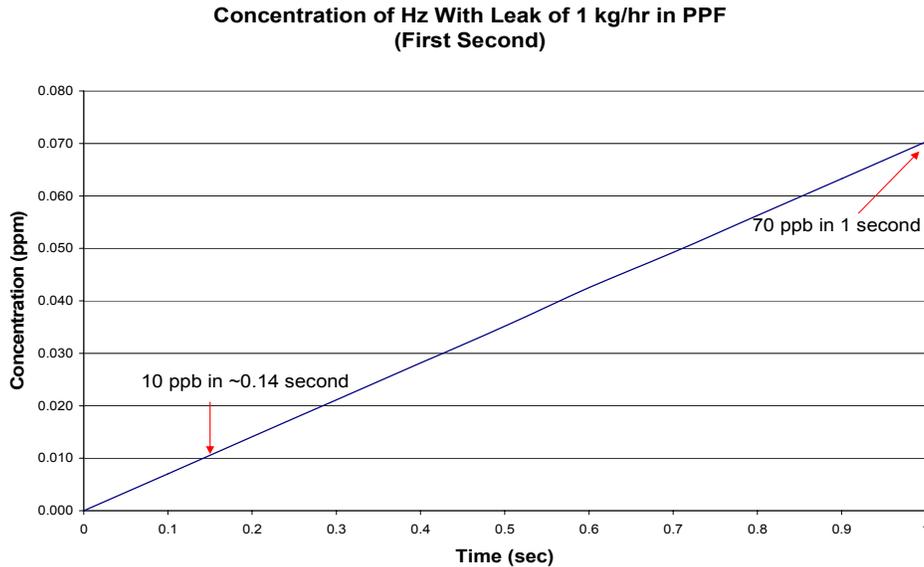
Figure 4. Concentrations of Hz in PPF during First Second of Leak

Figure 4 shows if there is a leak, the PPF will have a concentration of 10 ppb in 0.14 seconds and 70 ppb in 1 second. The number of drops of Hz to yield 10 ppb and 70 ppb can be calculated as follows:

Leak rate per hour = 1000g
 Leak rate per second = $1000 / 3600 = 0.2778\text{g/sec}$
 Take 20 drops are in 1 cc
 Take 1cc liquid Hz equals 1 g (specific gravity of Hz is 1.004)
 Drop for 70 ppb = $0.2778 \times 20 = 5.56$ (at the end of 1 second)
 Drop for 10 ppb = $5.56 / 7 = 0.79$ (at the end of 0.14 second)

The calculation indicates the vapor from a few drops of liquid Hz could achieve a concentration well above the ACGIH TWA value of 10 ppb within 1 second. If the detector is placed close by the leak source and the alarm is set at 10 ppb, the time to alarm will be largely determined by the instrument response time. Therefore, it is paramount to ascertain the response time of the instrument, including any delays due to tubing length.

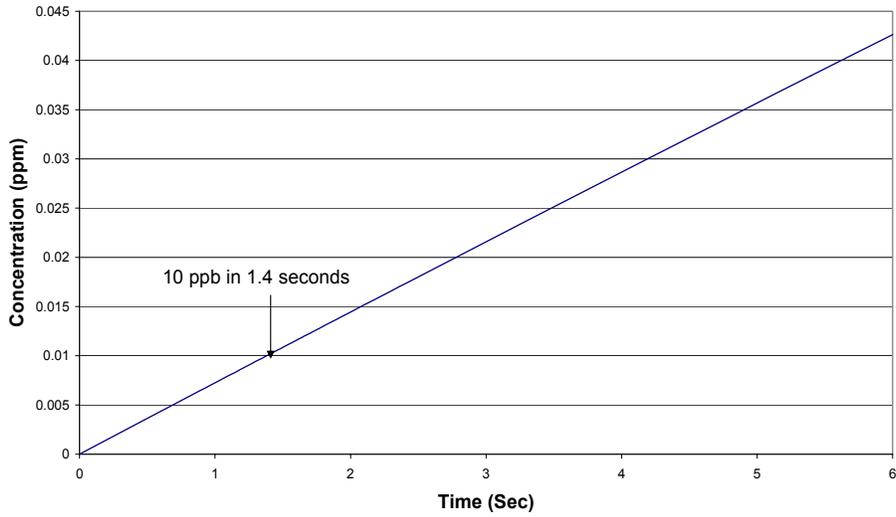
Figure 7. Concentrations of Hz in White Room During First 6 Seconds of Leak

As for the PPF, the calculation for the white room also shows that a leak can produce concentrations that exceed the 10 ppb TWA. It takes vaporization of only a fraction of a drop of Hz to yield this concentration.

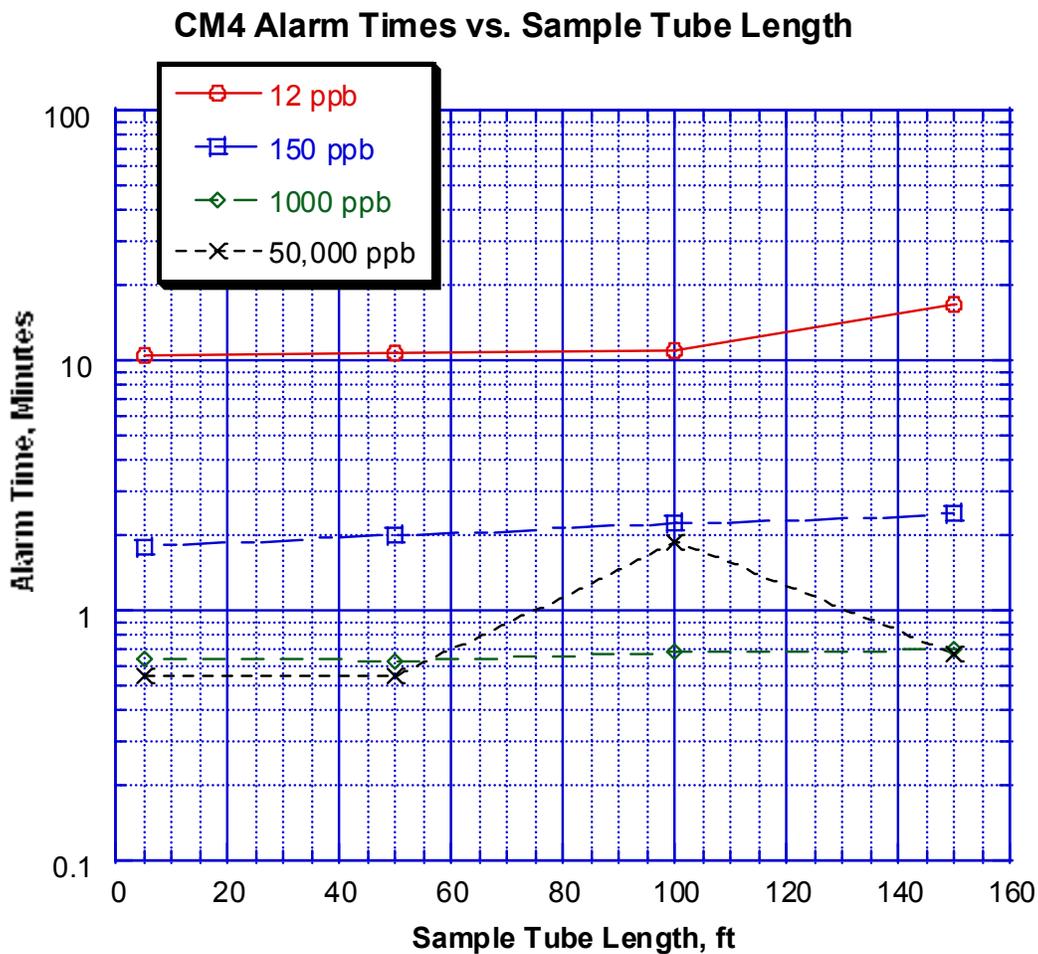
Figure 1. CM4 Alarm Time vs. Tubing Length at Various Hydrazine Concentrations

Figure 1 is a graphical representation of the CM4 alarm times versus the sampling tubing length at each concentration. The alarm level was set at the hydrazine TLV of 10 ppb. One clearly observable trend is the decrease in alarm response time with increasing exposure concentrations. A second noticeable trend is an increase in alarm time with increasing tubing length. This trend is dramatic at low concentrations and nearly indistinguishable at concentrations of 1000 ppb or more.

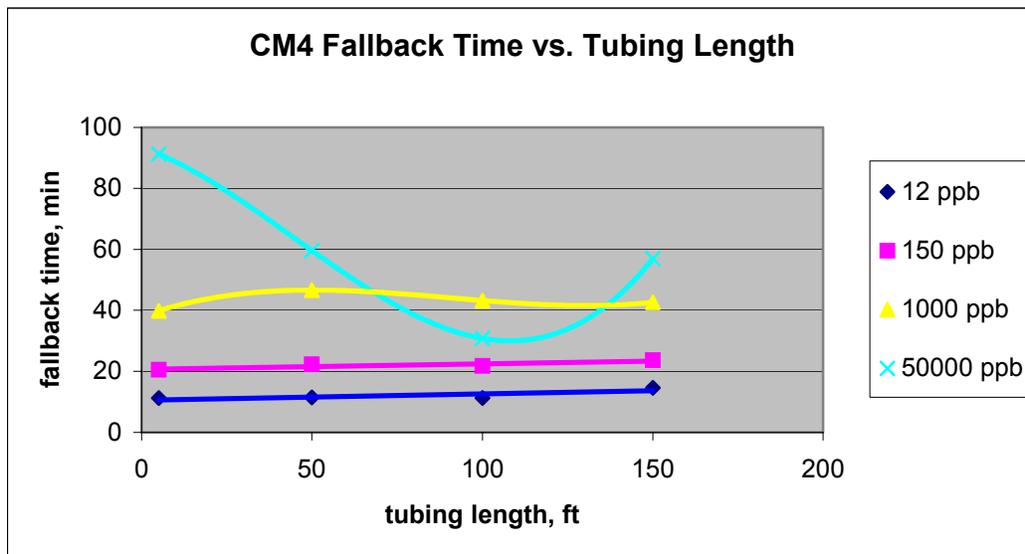
Figure 2. CM4 Fallback Time vs. Tubing Lengths at Various Hydrazine Concentrations

Fallback time is defined as the time required for the CM4 to return to a zero ppb baseline following exposure to hydrazine vapor. Trends in the fallback time are less clearly defined than those of alarm times. Figure 2 is a plot of fallback time versus tubing length at each concentration. At lower concentrations, the tubing length appears to have little effect on the fallback time. Also, we observed a tendency for the fallback times to increase with increasing hydrazine concentration exposure. Fallback time behavior is erratic at hydrazine concentrations of 1000 ppb and especially at the higher 50,000 ppb concentration. It is important to note while studying Figure 2 that the duration of exposure of the 50,000 ppb hydrazine vapors through the 5 ft. tubing was for 5 minutes while the 50,000 ppb exposures through the 50, 100, and 150 ft. tubing were for 1.5 minute durations. This modification was made with time constraints following the observation that it may take up to 128 minutes following a 50,000 ppb exposure to fallback to 0 ppb. This was the maximum fallback time observed in the 5 ft tubing trial.

The unpredictable fallback times at higher concentrations are likely due to the aforementioned "sticky" nature of hydrazine vapors. Residual hydrazine may adsorb within the sampling tubing or on the detector optics during exposure and require more time to be flushed from the system. Several experiments were conducted to elucidate a correlation between exposure time and fallback time. It was determined that duration of exposure has little effect on fallback time at low hydrazine concentrations (≤ 150 ppb). In contrast, fallback time does increase with increasing exposure duration at hydrazine concentrations of 1000 ppb or higher. This was demonstrated by the extended fallback time of the 5 minute 50,000 ppb exposure through the 5ft. tubing versus the 1.5 minute exposures of the same concentration through the 50, 100, and 150 ft tubing. Additional experiments were conducted to determine if hydrazine residue accumulating in the sampling tubing from previous tests affected the fallback times of later test runs. No decrease in the fallback or alarm times was observed when fresh tubing was used.

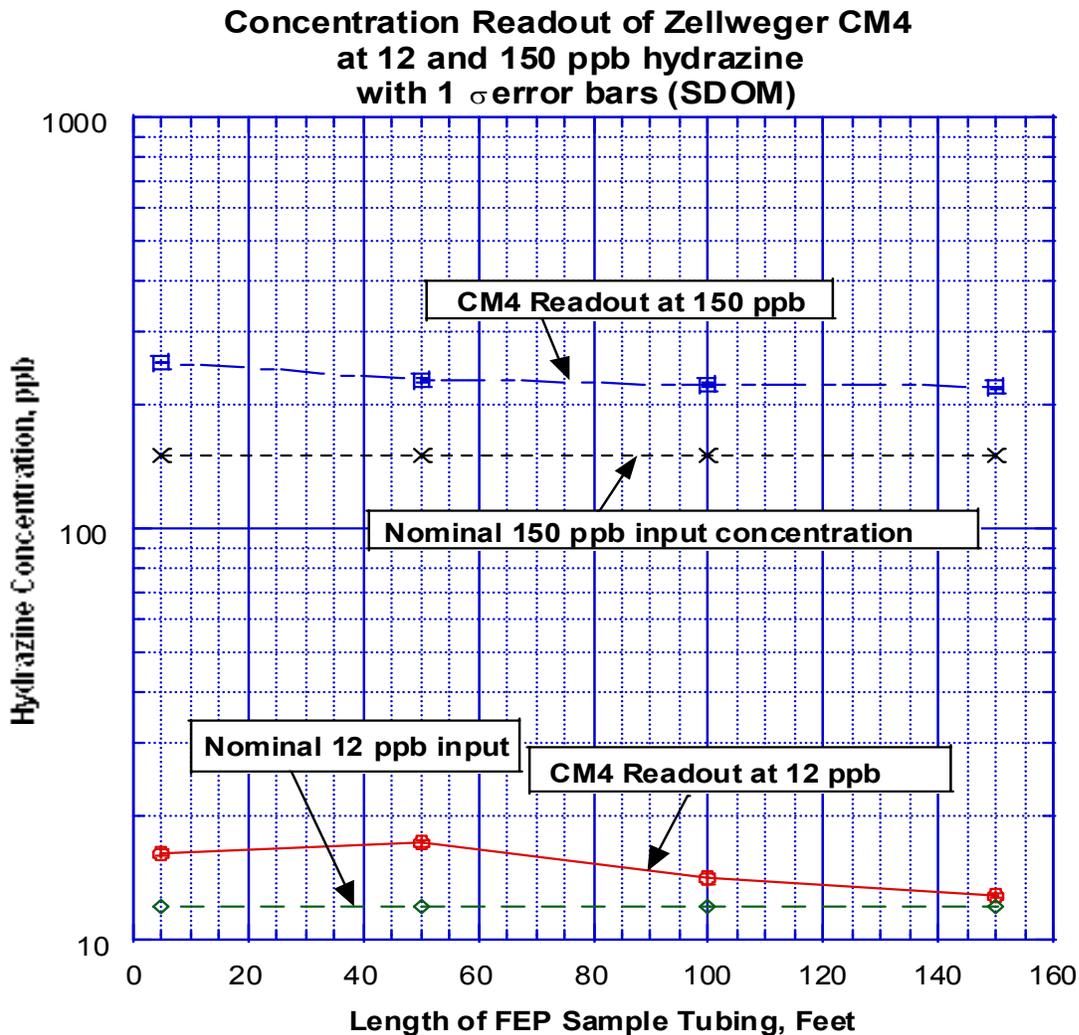
Figure 3. CM4 Concentration Response vs. Tubing Length with Hydrazine Exposure

Figure 3 illustrates a decrease in the CM4 concentration response with increasing tube length when exposed to 12 and 150 ppb hydrazine vapors. Concentration response for hydrazine vapors of 1000 ppb or greater are beyond the capabilities of the CM4. The response for these hydrazine vapor concentrations lying within the range of the CM4 suggest that the additional surface area presented by the longer tubing is responsible for the decreased concentration response. The longer tubing would provide additional adsorption sites for the hydrazine vapor, thus decreasing the concentration of the vapors reaching the detector and resulting in a lower concentration response. If this were the case, one would expect to see a more pronounced effect at the lower concentrations. The data seems to support this theory, as we see a larger change in the 12 ppb response with increased tubing length than we do with the 150 ppb samples.

In addition, hydrazine vapor has the ability to permeate through Teflon tubing. In fact, this property is utilized at high temperatures by the Kin-Tek vapor standard generators that furnish the hydrazine vapors for these experiments. Therefore, a second possibility is that the additional area provided by the longer tubing provides more area for permeation of the hydrazine vapors. This too would result in the observed decreased concentration response. Further testing would be required to determine the actual source of the varying concentration response.
