# **The Application of Electron Microscopy Techniques to the Space Shuttle Columbia Accident Investigation.**

Dr. Sandeep Shah and Greg Jerman  
Materials Diagnostics Team, NASA Marshall Space Flight Center  
[Sandeep.r.shah@nasa.gov](mailto:Sandeep.r.shah@nasa.gov), [Gregory.a.jerman@nasa.gov](mailto:Gregory.a.jerman@nasa.gov)

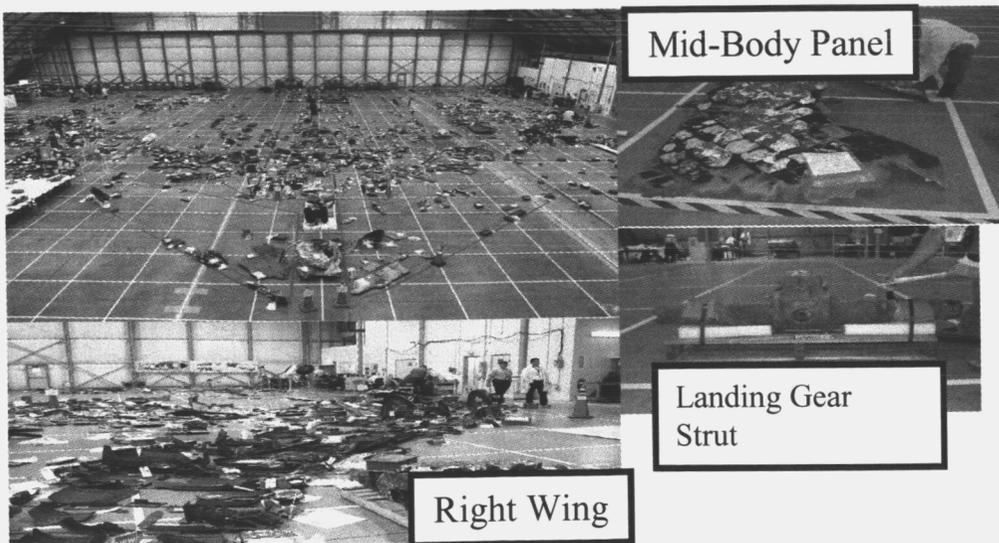
Figure 2: Hardware recovered, identified, and laid in a grid pattern at shuttle's landing facility.

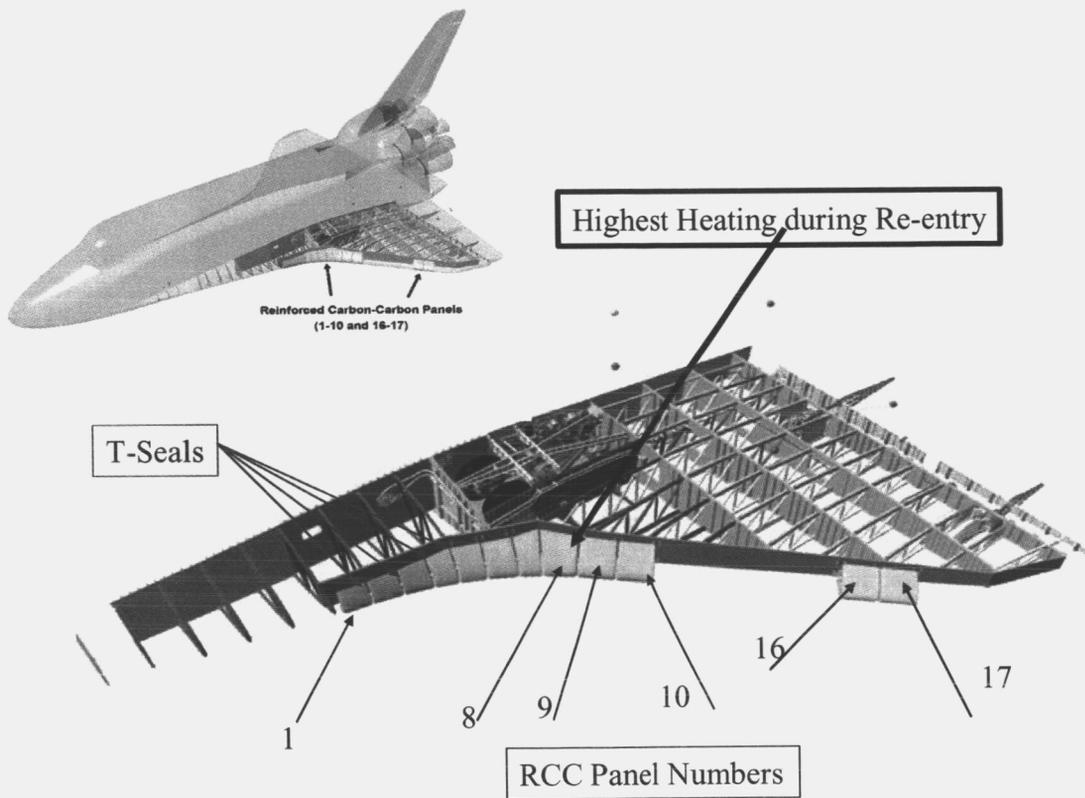
There are 22 RCC panels protecting the leading edge of each wing from hot gasses during re-entry. The gap between each panel is sealed with a short T-shaped RCC seal. The arrangement of the wing leading edge is shown in Figure 4. The highest heating during re-entry occurs in panels 7-10, right where the wing leading edge surface changes direction. After recovery and identification, the reconstructed pieces of Columbia's RCC panels and T-seals were qualitatively examined for damage patterns. The internal surfaces of left wing RCC panels 7 through 10 showed heavy deposition of material that was best described by the metallurgical term slag. The deposits on the RCC panels were expected to originate from Columbia's metal wing structures. Some RCC panels from the right wing also contained slag deposits although to a lesser degree. Figure 5 shows one example of slag deposits on the inside surface of left wing RCC panel 8. There were other visual signs of significant heat damage including melted RCC attachment hardware and knife edge erosion on broken edges of RCC panels. Most of the slag deposits, molten RCC attachments, and eroded RCC were concentrated between RCC panels 7 through 10 on the left wing.

Figure 4: Arrangement of 22 RCC panels and T-seals on the wing leading edge.

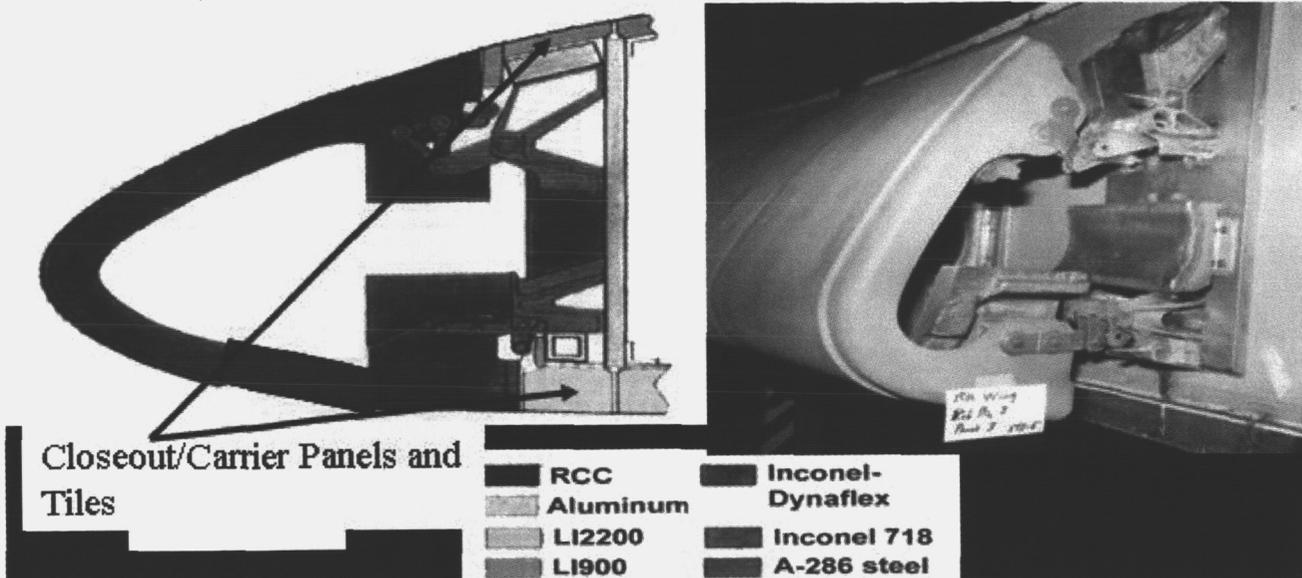
The key to deciphering the sequence of damage events was to understand the origins of the slag deposition. By understanding the composition of the materials in the WLE, it was hoped the origin of the slag deposits could be identified. The major WLE materials and components included RCC, 2024 aluminum wing spar, A286 steel attachment fittings, Inconel 718 spanner beams and bolts, 6061 aluminum carrier panels, Inconel 601 foil around flexible cerachrome insulation, Inconel 625 insulation attachment clips, and silica thermal protection tiles. Figure 6 shows a cross-section of the WLE including material identification. Slag specimens were extracted from many RCC panels from both the left and right WLE with the underlying RCC intact and quantitatively analyzed to determine their chemistry and morphology.

Figure 6: Cross-section through the wing leading edge including major component materials.
