# Space Shuttle Body Flap Actuator Bearing Testing for NASA Return to Flight

## Abstract

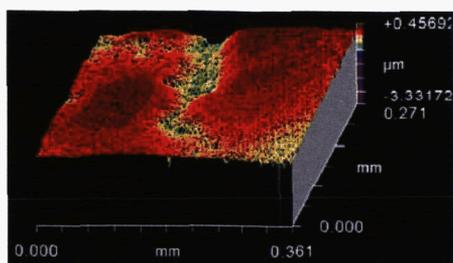
Higher magnification of the ball revealed some particles present on the ball (Figure 6). The presence of aluminum and silicon, in addition to other elements detected by EDS on these particles, were likely attributed to the bentonite clay additive present in the Braycote 601 grease and not contamination as was originally proposed. Analysis of the inner and outer raceways showed surfaces similar to the black ball. EDS performed on those surfaces detected the carbon iron oxide coating found on the black balls. Examination of the inner raceway away from the burnished band showed the original finishing marks which gradually translated into a smoother region as the burnished area was approached (Figure 7). Figure 8 shows the surface for the coating present on the black ball obtained by surface profilometry.

**Figure 8. Surface profilometry trace showing the coating present on the black ball including a segment of the grain boundary-like structure in the center**

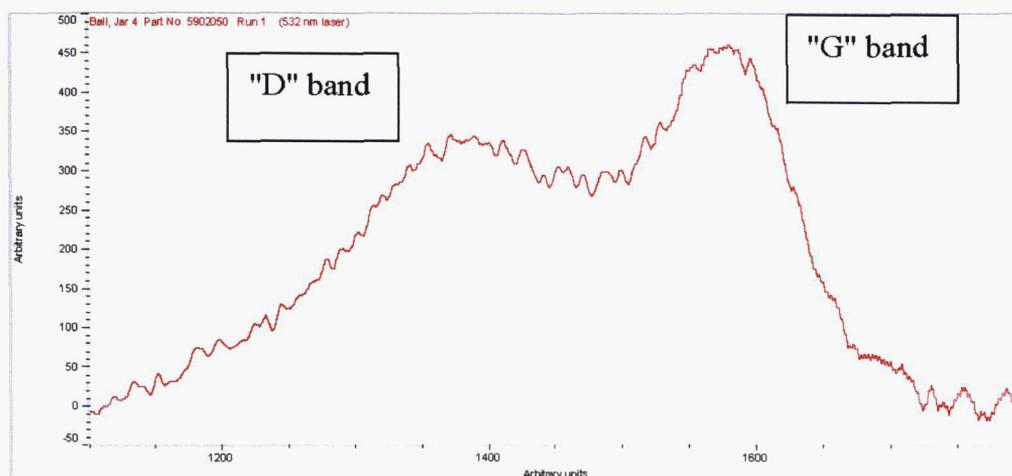
Raman spectroscopy of the black balls showed carbonaceous peaks from the carbon coating on the surface of the complex iron oxide, black, tribological coating [6]. Specifically, the diamond, D, and graphitic, G, peaks were observed confirming the presence of amorphous carbon (Figure 9).

**Figure 9. Raman spectrum for black ball showing the graphitic (G) and diamond (D) peaks associated with amorphous carbon.**

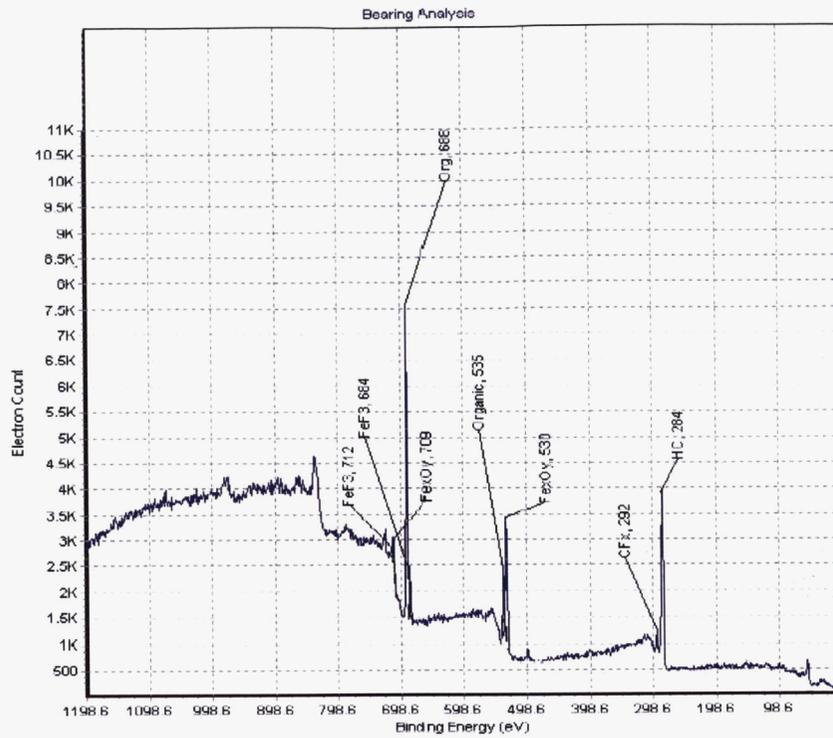
XPS was performed on the black ball at three different locations and on the inner race. Following the initial scans, depth profiling was performed by application of fifteen sputtering cycles, each lasting ten seconds, and a total sputter time of 450 seconds per location. The results show a carbon-rich coating on top of an iron oxide-rich surface. The carbon-rich top surface forms during the tribological decomposition of Braycote 601 grease and contains fluorine and sodium from the grease [7, 8]. The Raman spectrum of the carbon-rich coating is reported in the Raman spectroscopy section. Below the carbon-rich coating is the black tribological iron oxide-rich coating that also contains fluorine from the grease. At the end of the sputtering cycles, sodium was no longer present and chromium was observed in both locations in addition to carbon oxygen, fluorine, and iron (Figure 10).

Figure 10. An XPS spectrum for black ball

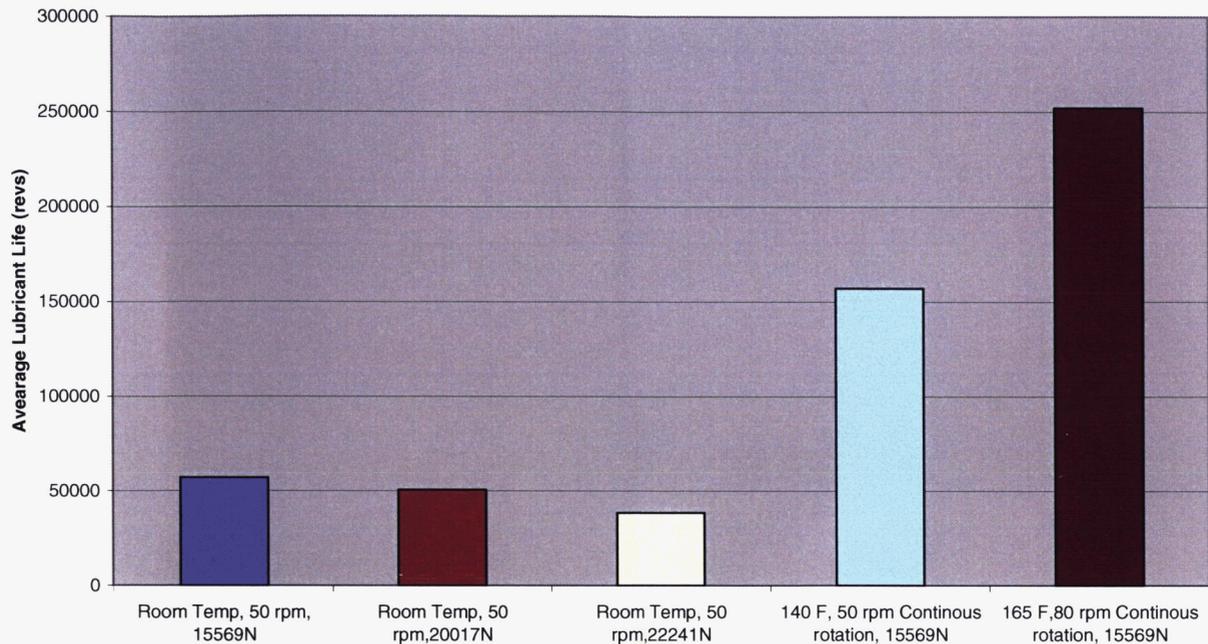
**Figure 20. The effect of temperature on lubricant life**

The results of this testing indicated that temperature had a significant effect on bearing life. Increased temperature yielded a significant increase in bearing life. The cause of this effect has not been determined. One theory is the higher temperature afforded better lubrication either by a decrease in apparent grease viscosity or by an increase in oil separation rate. This resulted in more oil available in wear contact area thus extending bearing life.

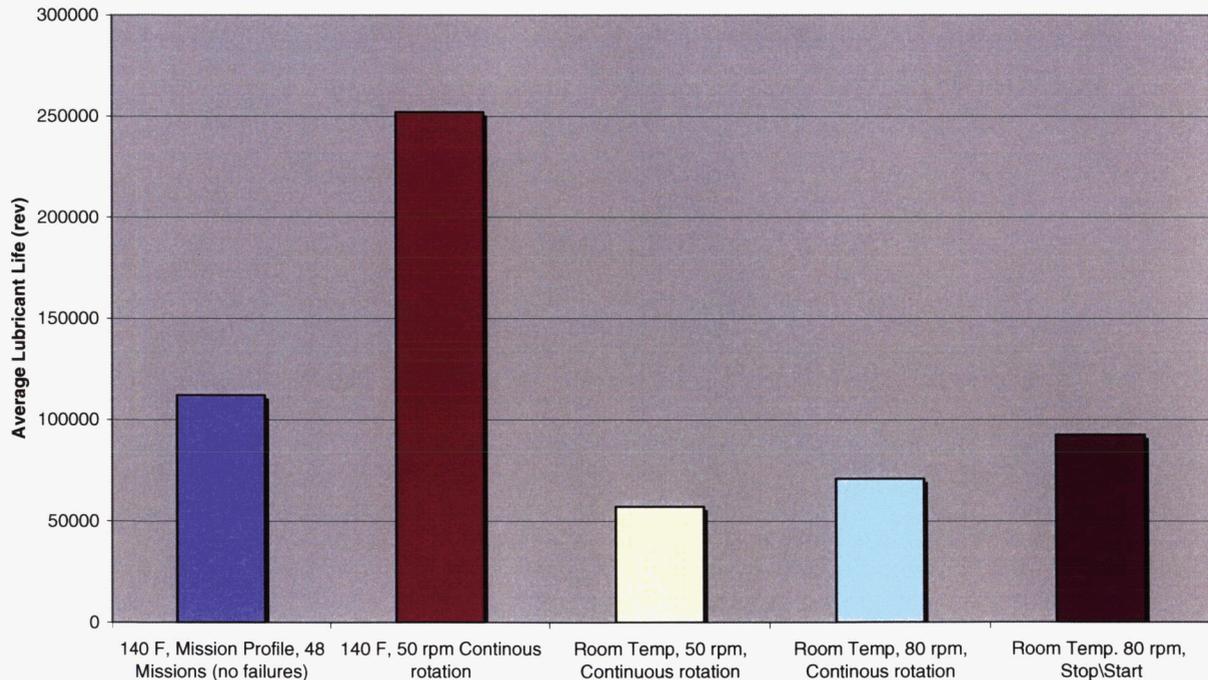
**Figure 21. Results of start/stop lubricant life testing**

The start/stop testing at 80 rpm most closely simulated the actual BFA operation. The majority (92%) cycles on the BFA are applied during ground operation under stop/start conditions. All of these cycles occurred at 80 rpm with 15569-N axial load at room temperature. The remaining cycles occurred during flight. The BFA was never operated under maximum load (22241-N load). This load occurred during ascent when the actuator is in a lock position. The actuator was operated for several seconds in space to test the actuator, but the remainder of cycles occurred during re-entry where temperature probably
