**HIGH MISALIGNMENT CARBON SEALS FOR
THE FAN DRIVE GEAR SYSTEM TECHNOLOGIES**

Dennis Shaughnessy and Lou Dobek
United Technologies—Pratt & Whitney
East Hartford, Connecticut

2005 NASA Seal/Secondary Air Delivery Workshop

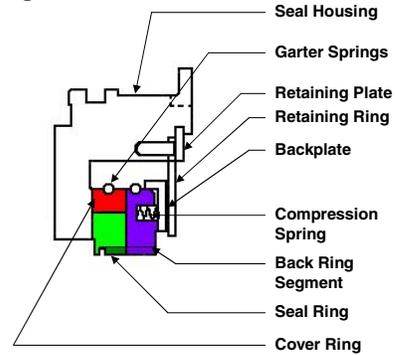
3-Piece Segmented Circumferential (Advanced Design)

- 1 Piece design resulted in wear rates that exceeded project limit goals.
- Base material (Carbon X) is suspect to be inappropriate for this application.
- Alternate design & material need to be investigated.

- Carbon X repeatedly exceeds 100 hour wear limit.
- 1. Excessive coking indicated negative wear.
- 2. Test terminated after two attempts resulted in broken seal segments.

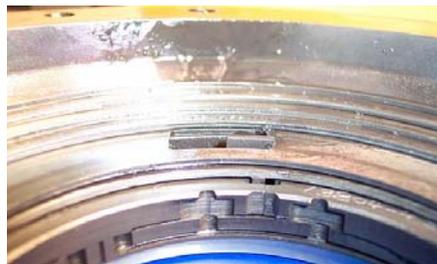
Seal Assembly

Backplate stress crack identified after test with the largest combination of Radial and Angular misalignment. Modification increased the corner radii at the keys.

Backplate Tab Failure

Seal Ring Notch Wear

Back Ring Tab Failure

Photos of the seal assembly and signs of wear that occurred during misalignment testing.

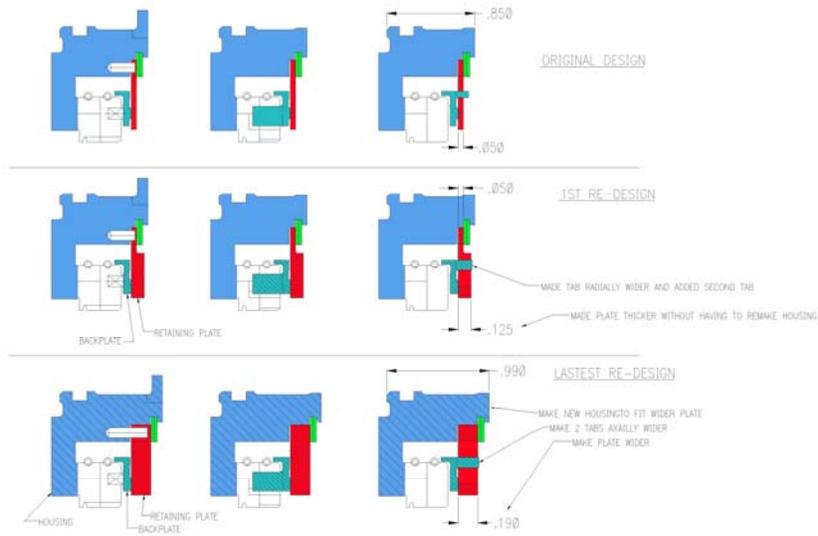
Sections through the test seal illustrate the original design, modifications made during the phase 3 test program and the latest re-design for the current tests phase.
