Helios Prototype Vehicle Mishap: Technical Findings, Recommendations, and Lessons Learned

Aerospace Control and Guidance Systems Committee Meeting No. 100

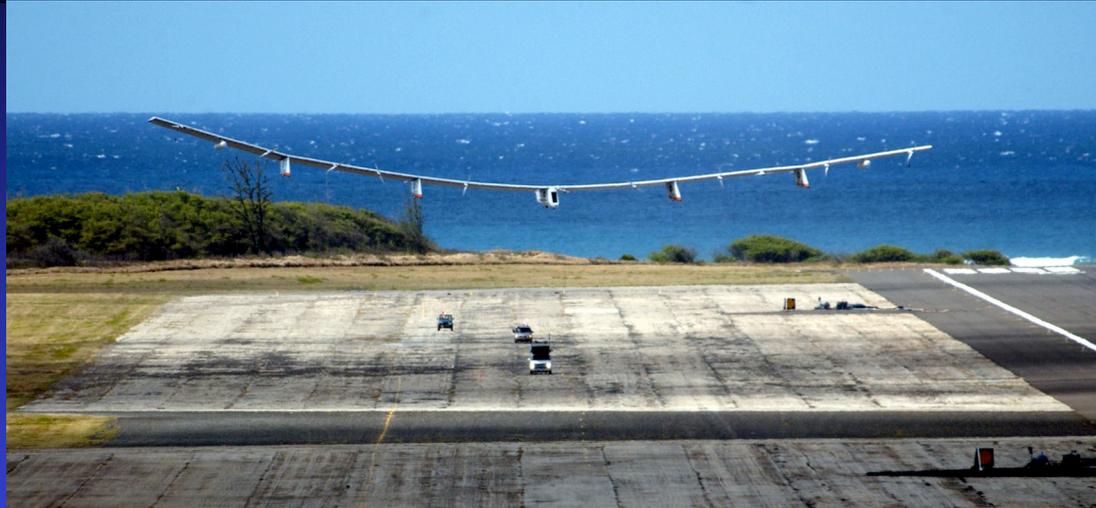
Photos Taken of HP03-2 June 26, 2003

HP03-2 on take-off

- On June 26, 2003 at approximately 10:35am at an altitude of about 2,800 feet, HP03-2 encountered turbulence associated with wind shear lines around the island of Kauai
- Turbulence initiated a persistent high wing dihedral causing an unstable pitch oscillation
- Airspeed excursions were around ± 2 ft/sec; main wing spar strain gauge reading 103% of limit load
- Following pilot procedures to reduce dihedral, wing dihedral decreased slightly, but then grew to over 30 feet
- Large airspeed fluctuations of about ± 10 ft/sec now observed, an indication the aircraft was experiencing large pitching motions
- Airspeed excursions began to double every cycle

- Vehicle became oriented at extreme attitudes relative to the air stream (wing dihedral of about 40 feet with the airspeed nearing 90 ft/sec)
- High dynamic loads broke the right wing leading edge foam secondary structure near the hydrogen fuel tanks
- Solar cells and the wing skin began to rip off the upper surface of the wing resulting in loss of lift
- Vehicle entered a more severe attitude resulting in additional secondary structural failure
- Aircraft continued to come apart as it fell to the Pacific Ocean
