EVALUATION OF RISK AND POSSIBLE MITIGATION SCHEMES FOR PREVIOUSLY UNIDENTIFIED HAZARDS

William Linzey, Micah McCutchan, and Michael Traskos
Lectromechanical Design Company

Preface

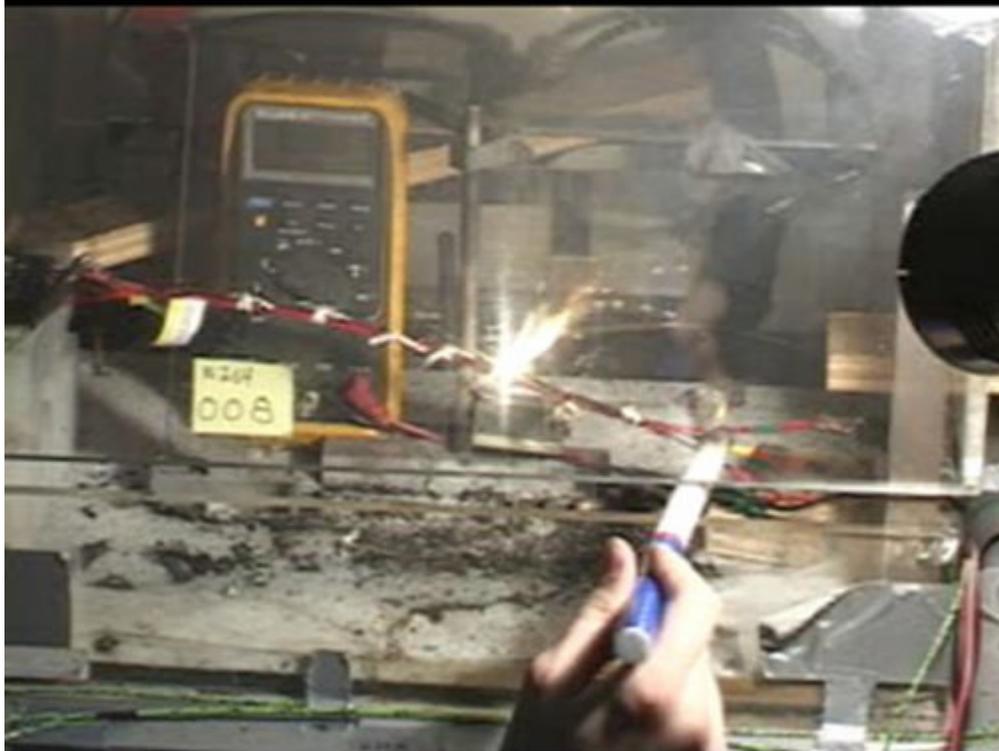
Figure 5. Test N264-008 In Progress

After all preliminary checks were performed, the heater circuits were energized and the oil/graphite mixture was used to initiate the arc. The arc was allowed to propagate the length of the sample. The arc event tripped the circuit protection, self-extinguished the arc, or stopped when it reached the end of the sample. After the power was turned off, the specimen was removed from the testing chamber and all test information was recorded. A visual inspection of the sample gave preliminary indications of the effectiveness of the protection scheme. For each sample, wet dielectric voltage withstand (DVW) test was used to determine if the insulation of the fuel/ox wires was actually compromised. Figure 5 is a still shot (captured from video) of Test N264-008 in progress.
