Friction-Stir Welding – Heavy Inclusions in Bi-metallic welds of Al 2219/2195

Ward W. Rietz, Jr., Lockheed Martin Michoud Space Systems
Department 4610, P.O. Box 29304, New Orleans, LA USA 70189
Phone: (504) 257-1636 Fax: (504) 257-4430 e-mail: ward.w.rietz@maf.nasa.gov

Heavy Inclusions (HI) were detected for the first time by radiographic examination in aluminum alloy 2219forging/2195plate (advancing/retreating side) Friction Stir Welds (FSW) for the Space Shuttle External Tank (ET) Program. Radiographic HI indications appear as either small (~0.005” – 0.025”) individual particles or clusters of small particles.

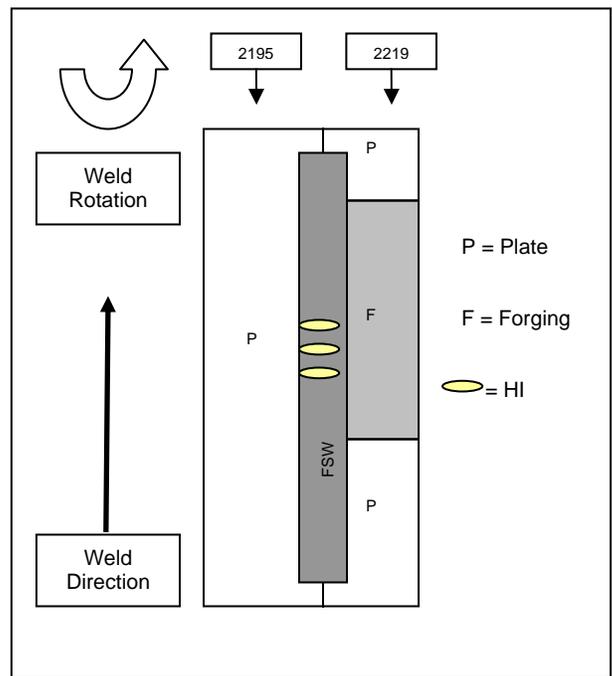
Figure 4: FSW top view layout for Test Panels

A test plan was generated to recreate and test the HI indications using materials and configurations matching flight hardware. Remnant forged Al2219 material, Al2219 plate and Al2195 plate panels were welded (Figure 4), inspected, and had mechanical property testing performed.

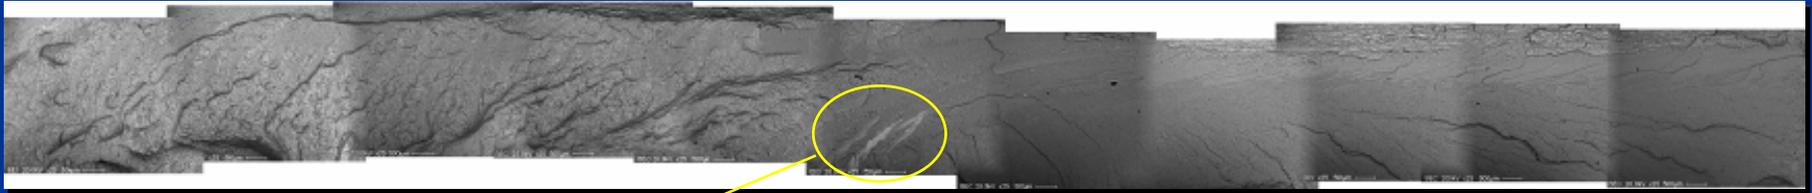
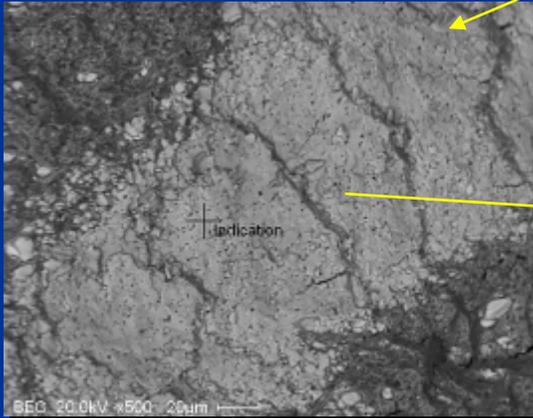
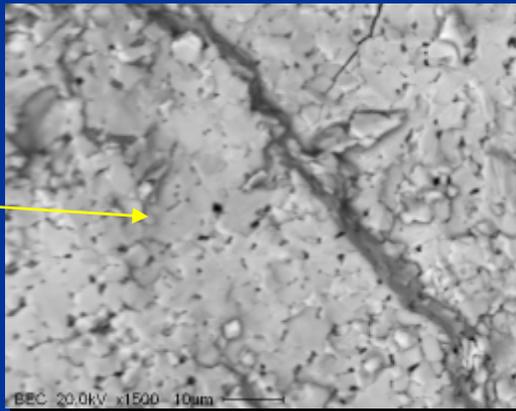
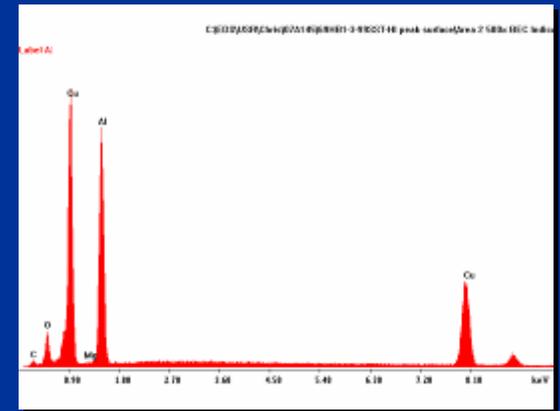
SEM Results - -423F SST

Simulated Service Test (SST) residual strength results were in family to typical Al2219f/2195p FSW cryogenic (-423F) results. SEM/EDS examination showed that one region of agglomerated θ phase on the fracture face correlated to the radiographically detected HI as seen in Figures 14-17.
