NASA/TM-2008-215530

# Fracture Testing of Integral Stiffened Structure

*Laboratory testing was conducted to evaluate safety concerns for integrally-stiffened tanks that were found to have developed cracks during pressurization testing. Cracks occurred at fastener holes where additional stiffeners were attached to the integrally-stiffened tank structure. Tests were conducted to obtain material properties and to reproduce the crack morphologies that were observed in service to help determine if the tanks are safe for operation. Reproducing the cracking modes observed during pressurization testing required a complex loading state involving both a tensile load in the integrally-stiffened structure and a pin-load at a fastener hole.*

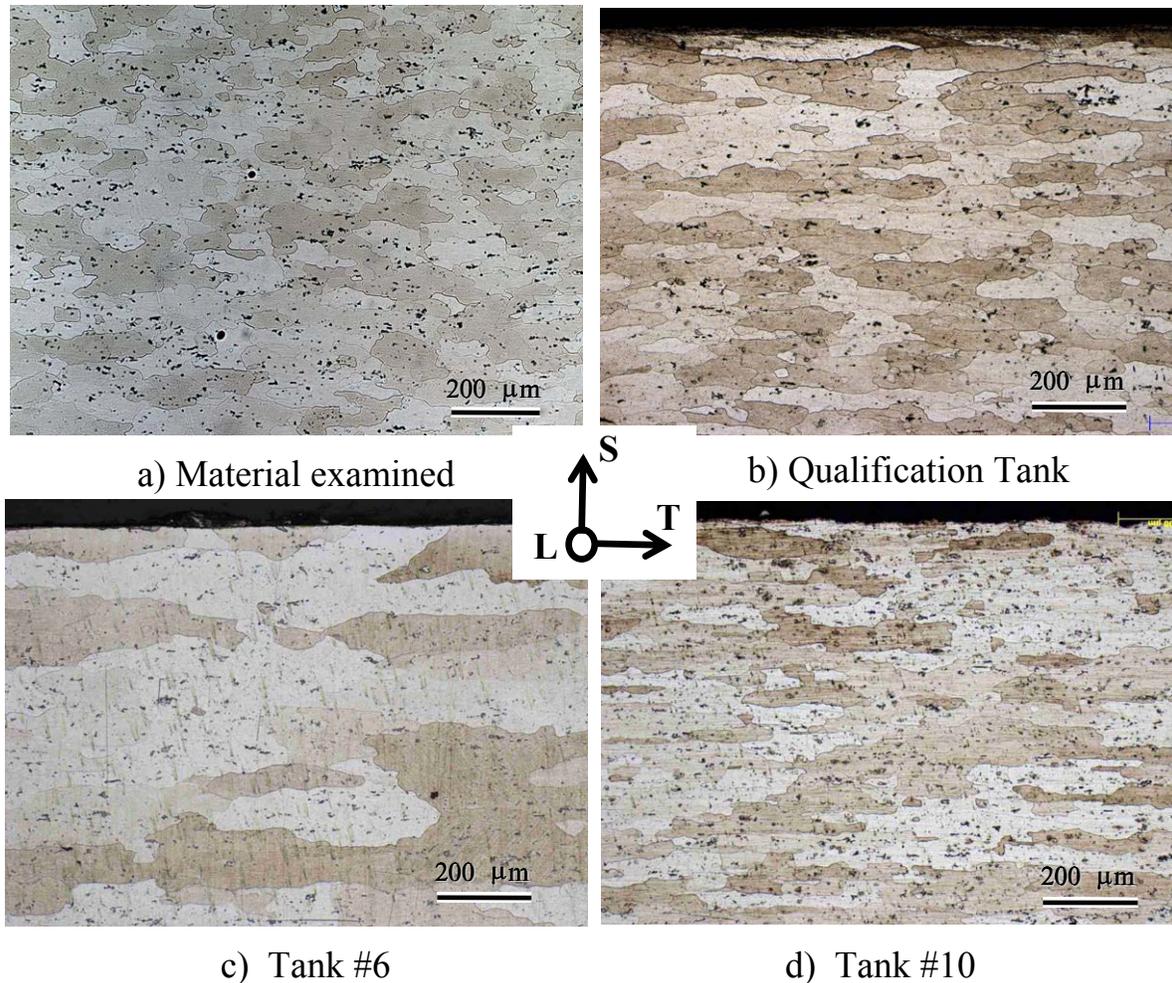
average microstructural dimension, it appears that the grain size for the material of tank #6 (Figure 3c) is significantly larger than the others. In comparison, little difference is observed between microstructural scales of tank #10 (Figure 3d), the material used for this study (Figure 3a), and the qualification tank (Figure 3b). The images in Figure 3 are normal to the longitudinal (L) plate direction, such that the plate short-transverse (S) direction is vertical and the long-transverse (T) direction is horizontal.

Figure 3. Optical metallographs of 2014 aluminum samples taken near the plate surface ( $t/16$ ) for (a) the product acquired for this testing program, (b) the qualification tank, (c) tank #6, and (d) tank #10.

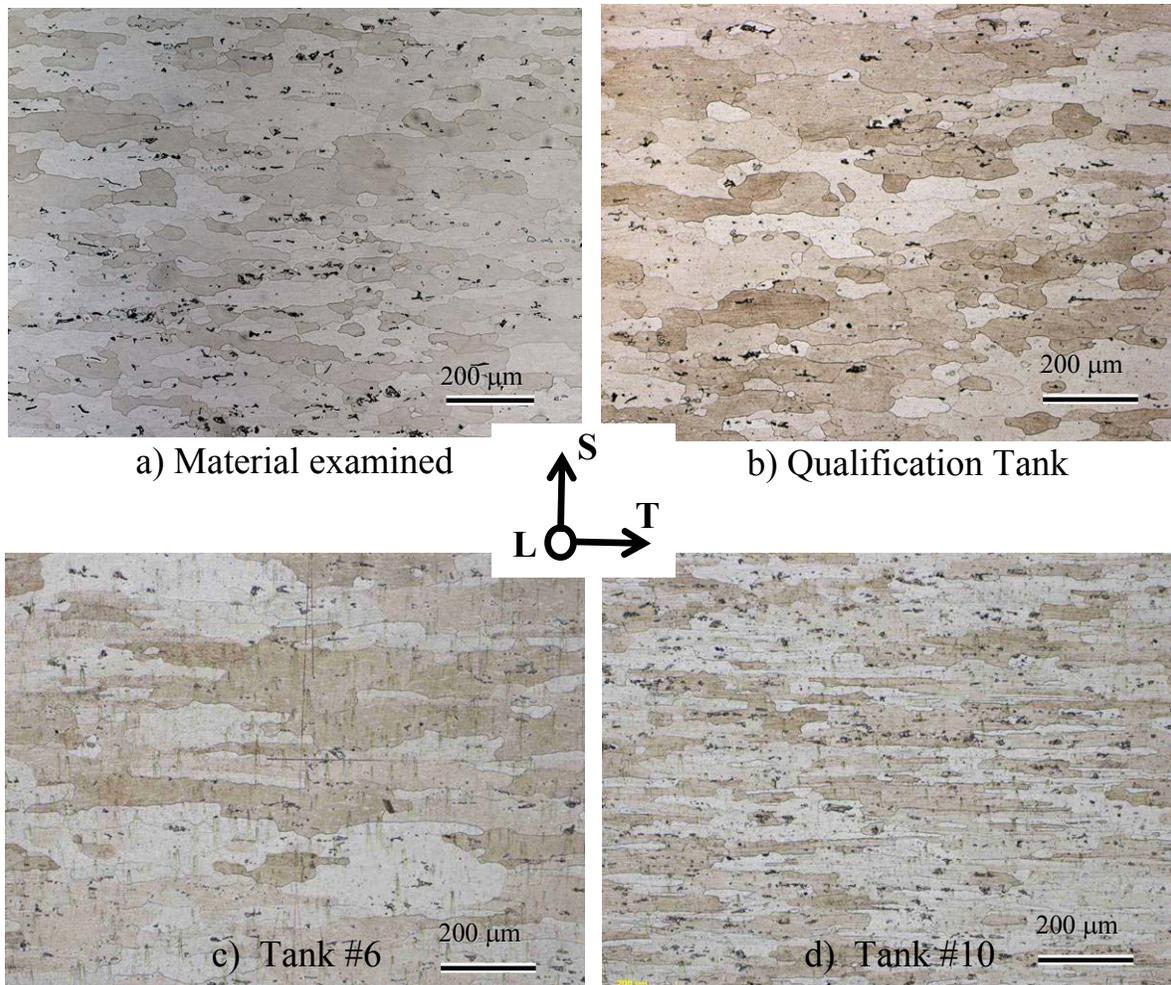
Optical metallographs of samples taken near the plate centerline ( $t/2$ ) are shown in Figure 4. Images corresponding to (a) the material used for this study, (b) the qualification tank, (c) tank #6, and (d) tank #10 are shown together for comparison. The variation in microstructure seen here is similar to that of Figure 3. Specifically, the grains depicted for the tank #6 material appear to be coarse (Figure 4c) and little difference in microstructural scale is observed between tank #10 (Figure 4d), the material used in this study (Figure 4a), and the qualification tank (Figure 4b). The images in Figure 4 are normal to the longitudinal (L) plate direction, such that the plate short-transverse (S) direction is vertical and the long-transverse (T) direction is horizontal.

Figure 4. Optical metallographs of 2014 aluminum samples taken near the plate center-line ( $t/2$ ) for (a) the product acquired for this testing program, (b) the qualification tank, (c) tank #6, and (d) tank #10.
