# Lunar Module Environmental Control System Design Considerations & Failure Modes Part II

# Objectives

- ❑ Describe the Lunar Module (LM) Environmental Control System (ECS) subsystem testing and redesign.
- ❑ Summarize the Lunar Module (LM) Environmental Control System (ECS) in-flight failures.

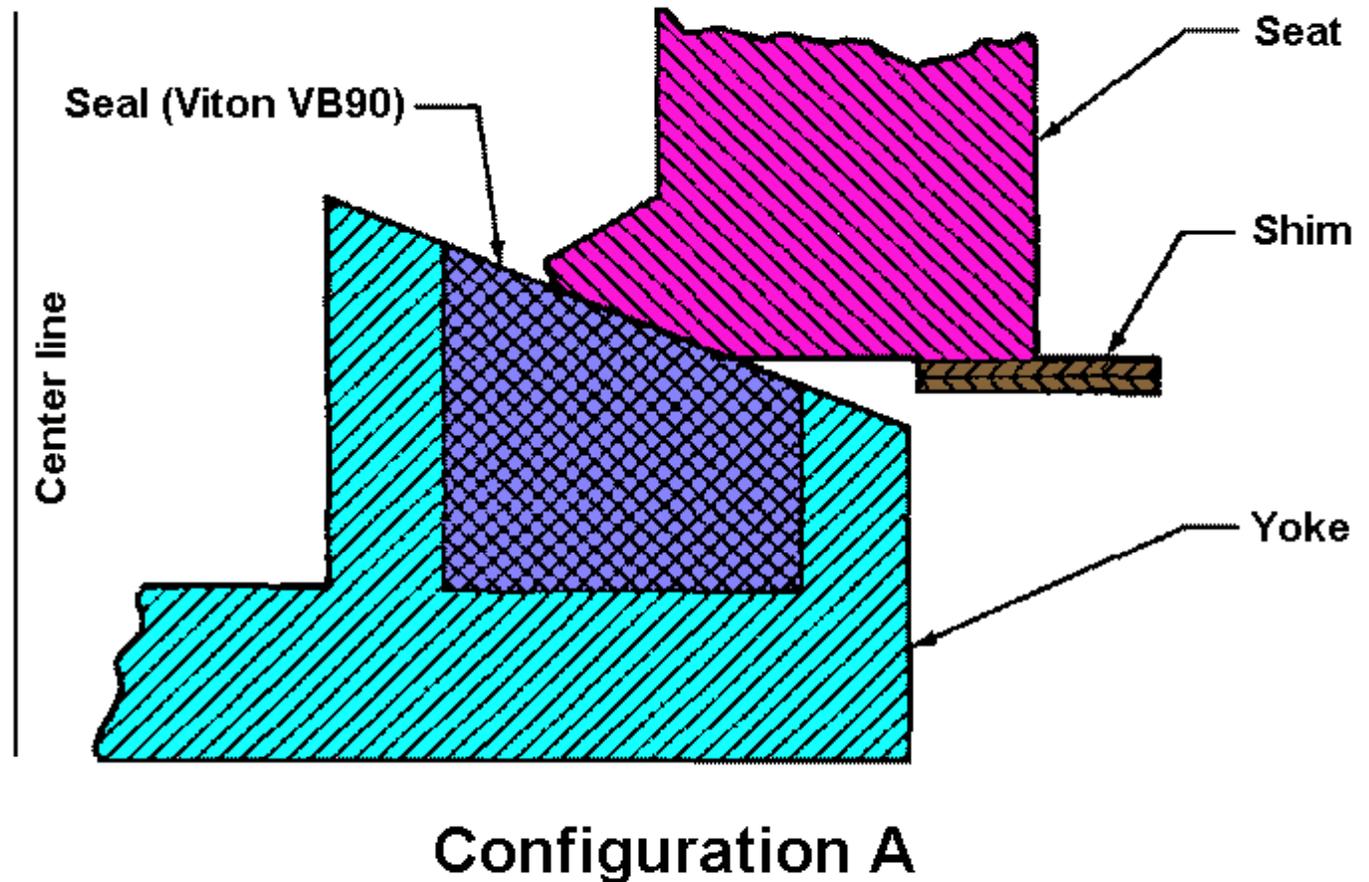
- The Cabin Repress and Emergency Oxygen Valve had some problems during feasibility testing, showing the valve seat to be susceptible to permanent seating.

- First, they changed the valve seal material from Viton B to Viton VB90.

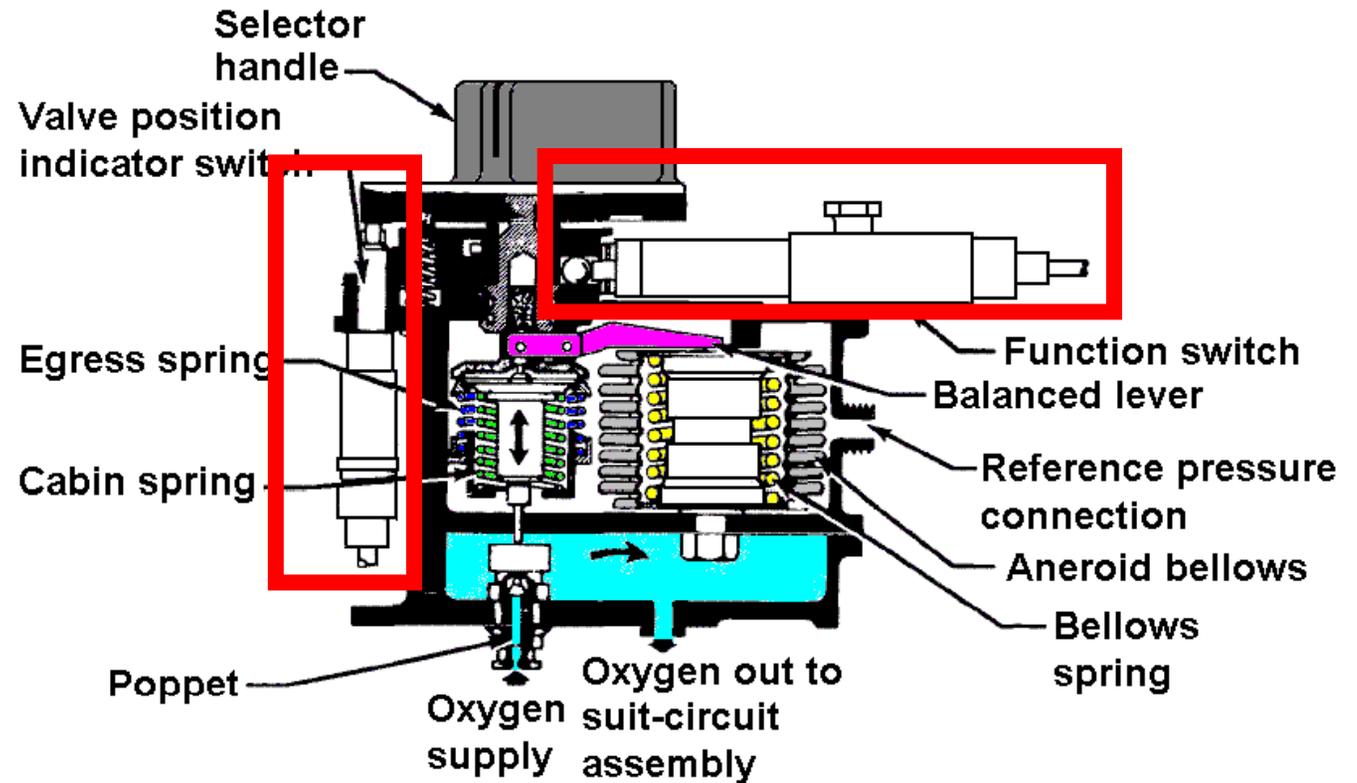
Cutaway View of Oxygen Demand Regulator

- The Oxygen Demand Regulators provided suit loop pressure regulation.
  - ♦ original design sensitive to vibration
  - ♦ various aneroids and mass-balancing techniques reduced the leakage to acceptable levels

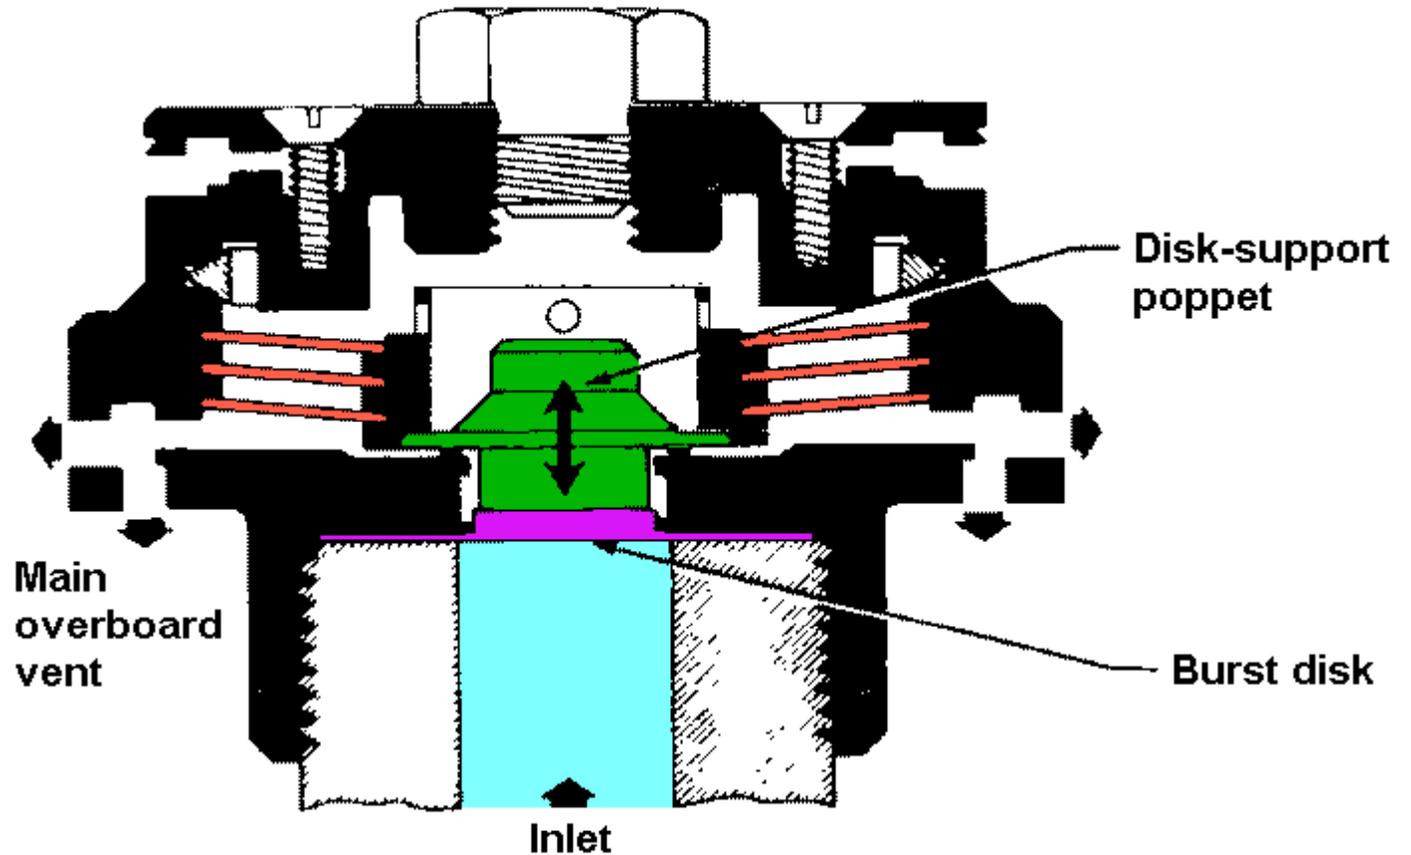
Normal Sealed Position

- The **Reseating Burst Disks** in the descent stage high-pressure O2 system provided worst-case pressure relief for tank overpressure.

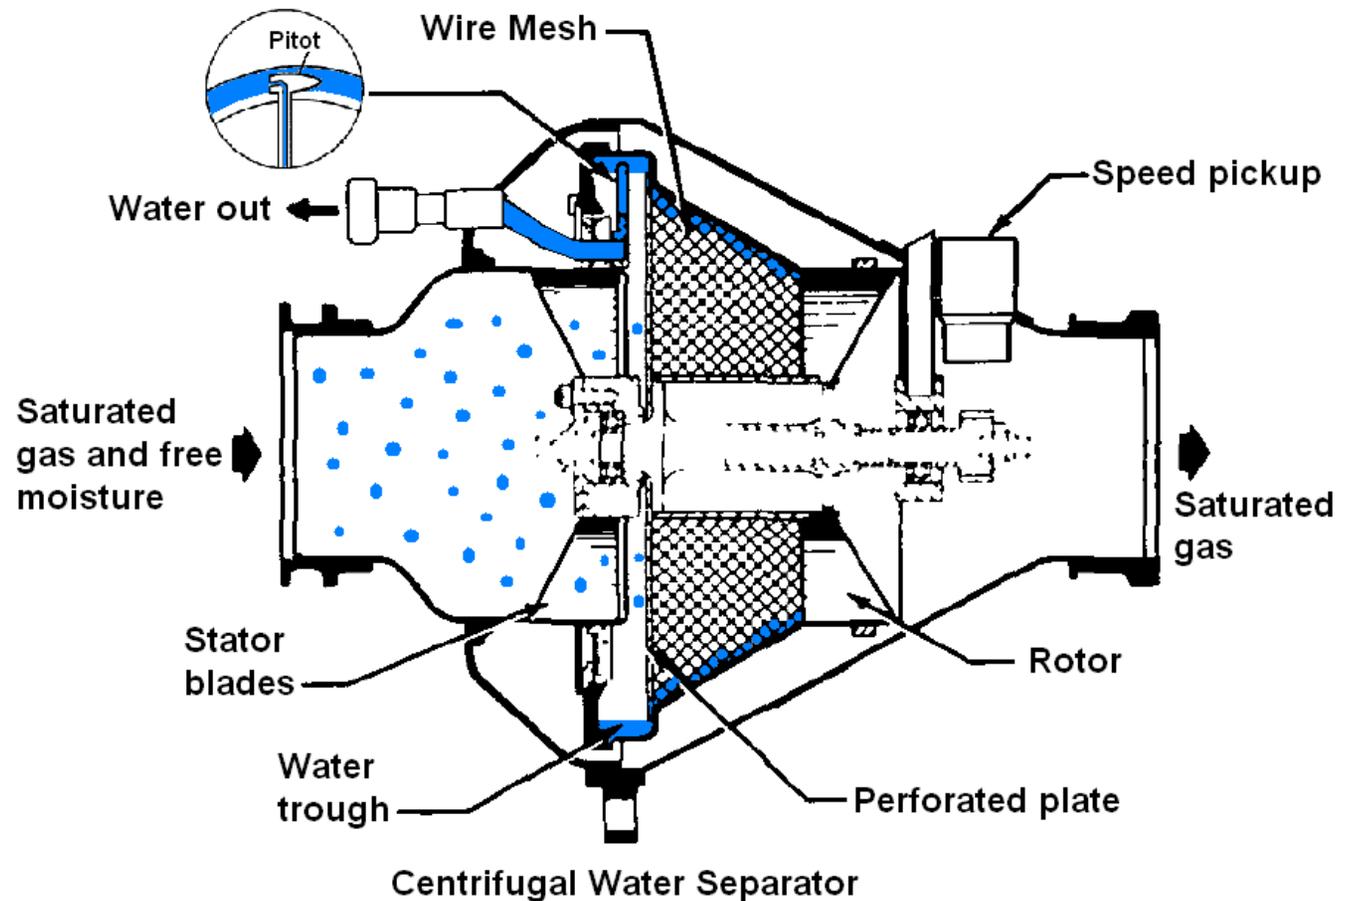
- ❑ The **Water Separators** underwent several changes:
  - ◆ gas-side pressure drop was reduced
  - ◆ pitot tube improved
  - ◆ bearing supports upgraded
  - ◆ assembly method changed

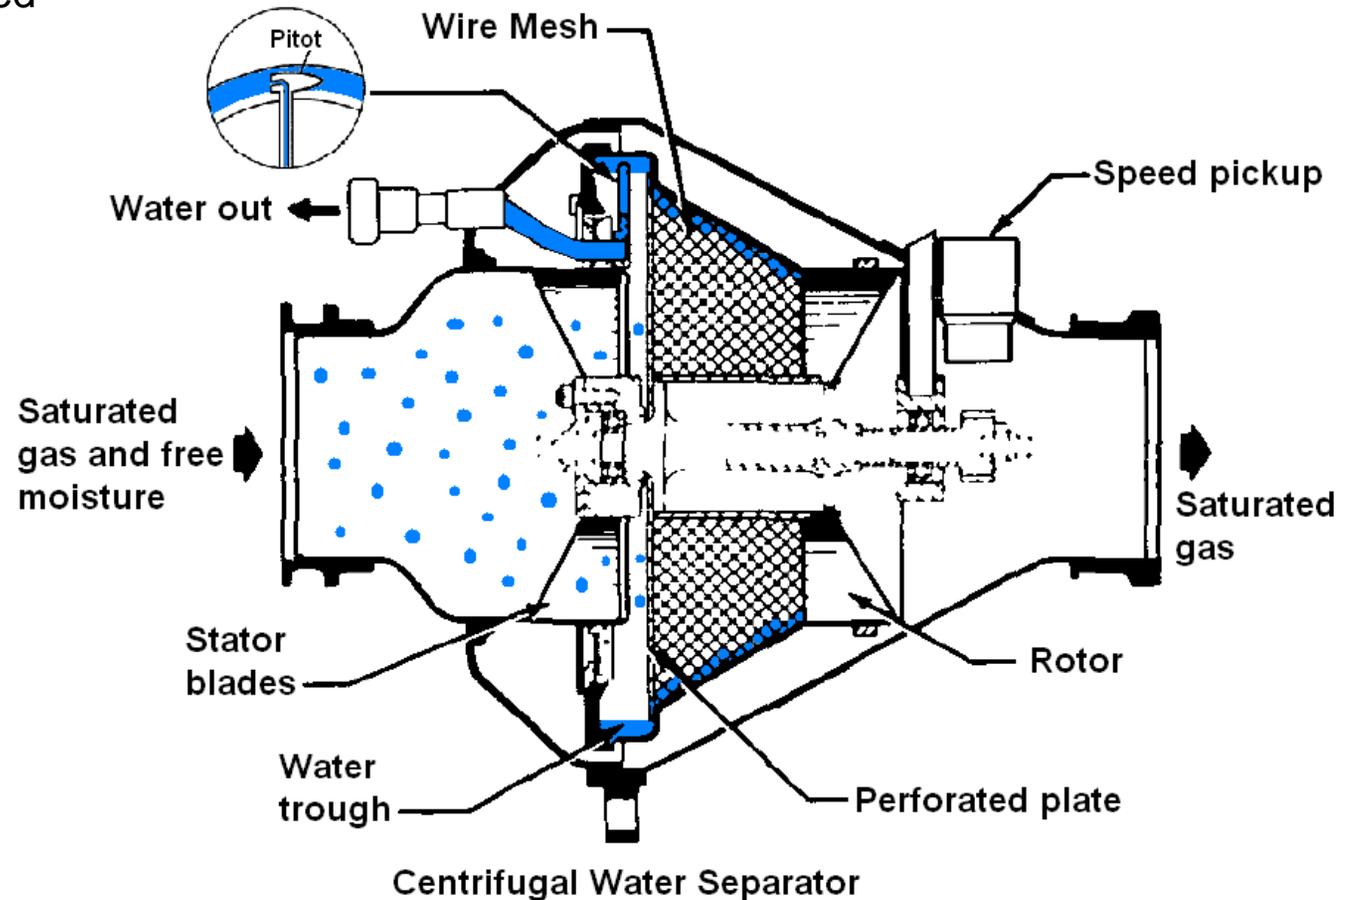
- In the later stages of development:
  - ◆ several stator blades were blocked to increase the speed of the gas into the turbine blades
  - ◆ blade angle was changed
  - ◆ wire mesh added

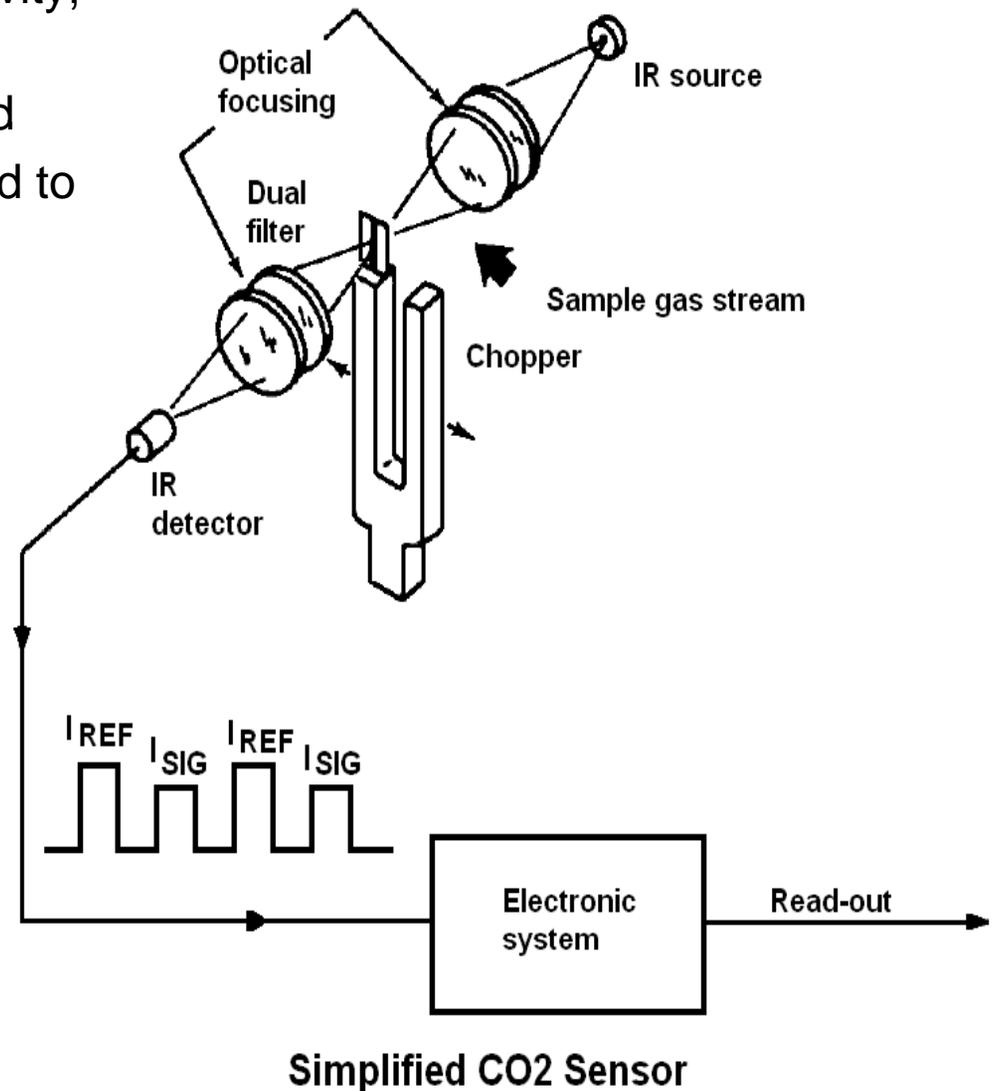
- The **CO2 Sensor** had several problems:
  - ♦ to compensate for vibration sensitivity, was mounted on isolators
  - ♦ a more rugged IR source was used
  - ♦ an AC ground (R-C network) added to eliminate EMI

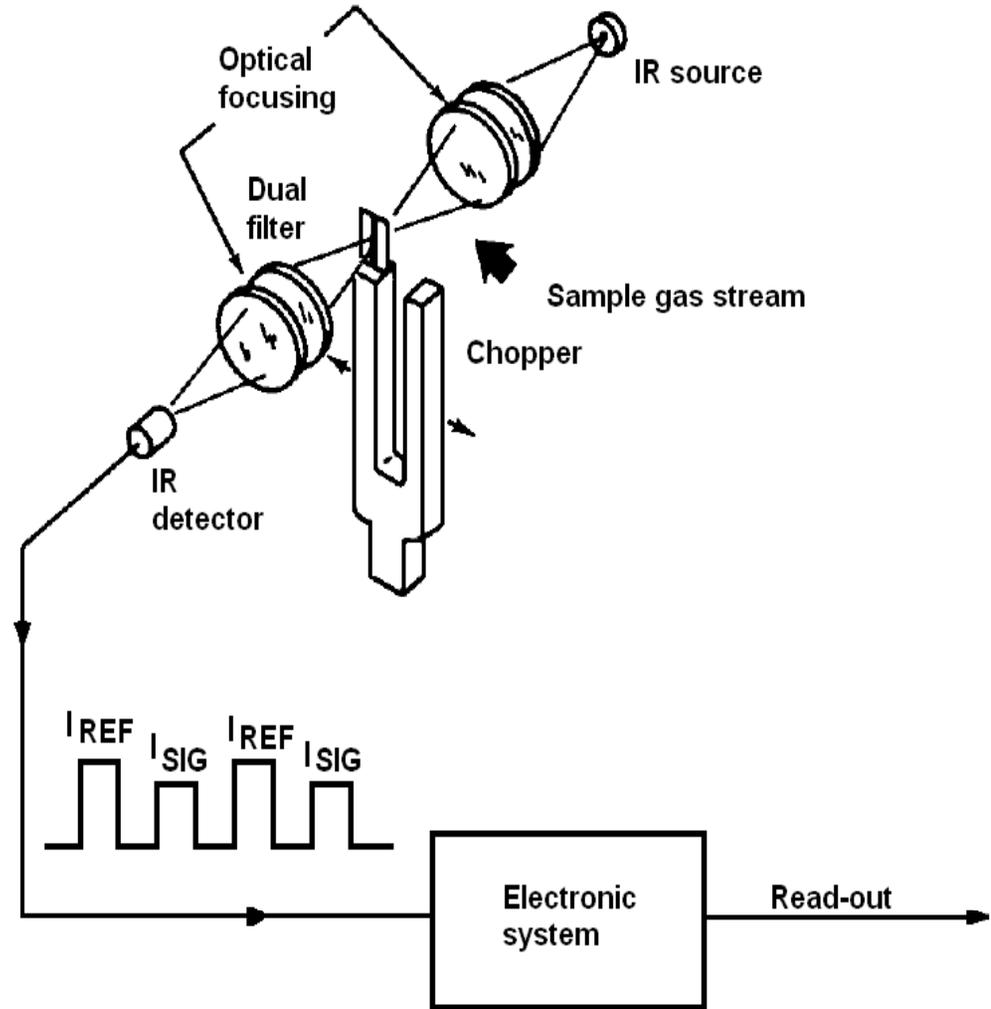
Simplified CO2 Sensor

- ♦ to prevent corrosion from water exposure, metal surfaces were epoxyed.
- ♦ cal changes due to out-gassing from the conformal coating required it be changed
- ♦ thermistor added to compensate for temperature changes

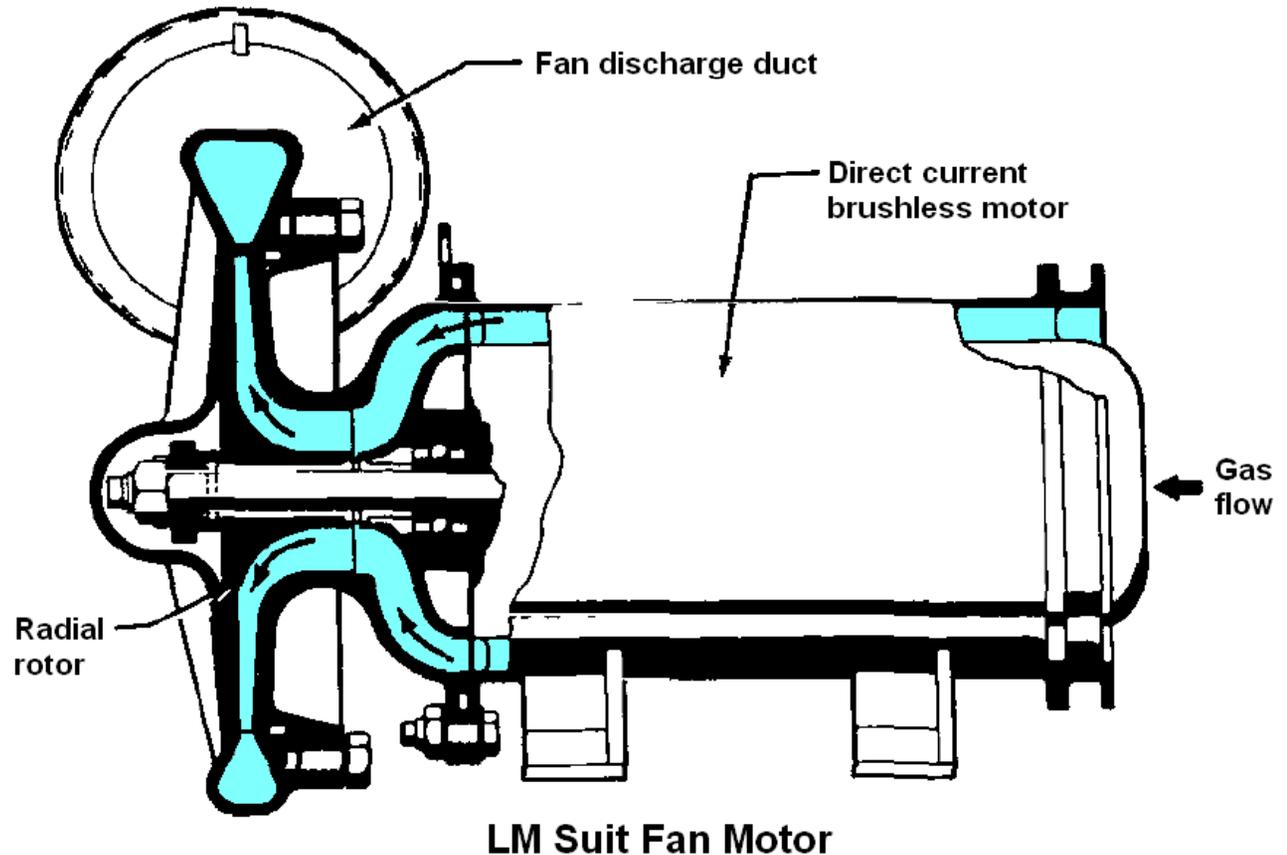
- failures of power transistors
- a tendency to start rotating the wrong direction
- fan wheel rubbed during testing and the clearances were changed

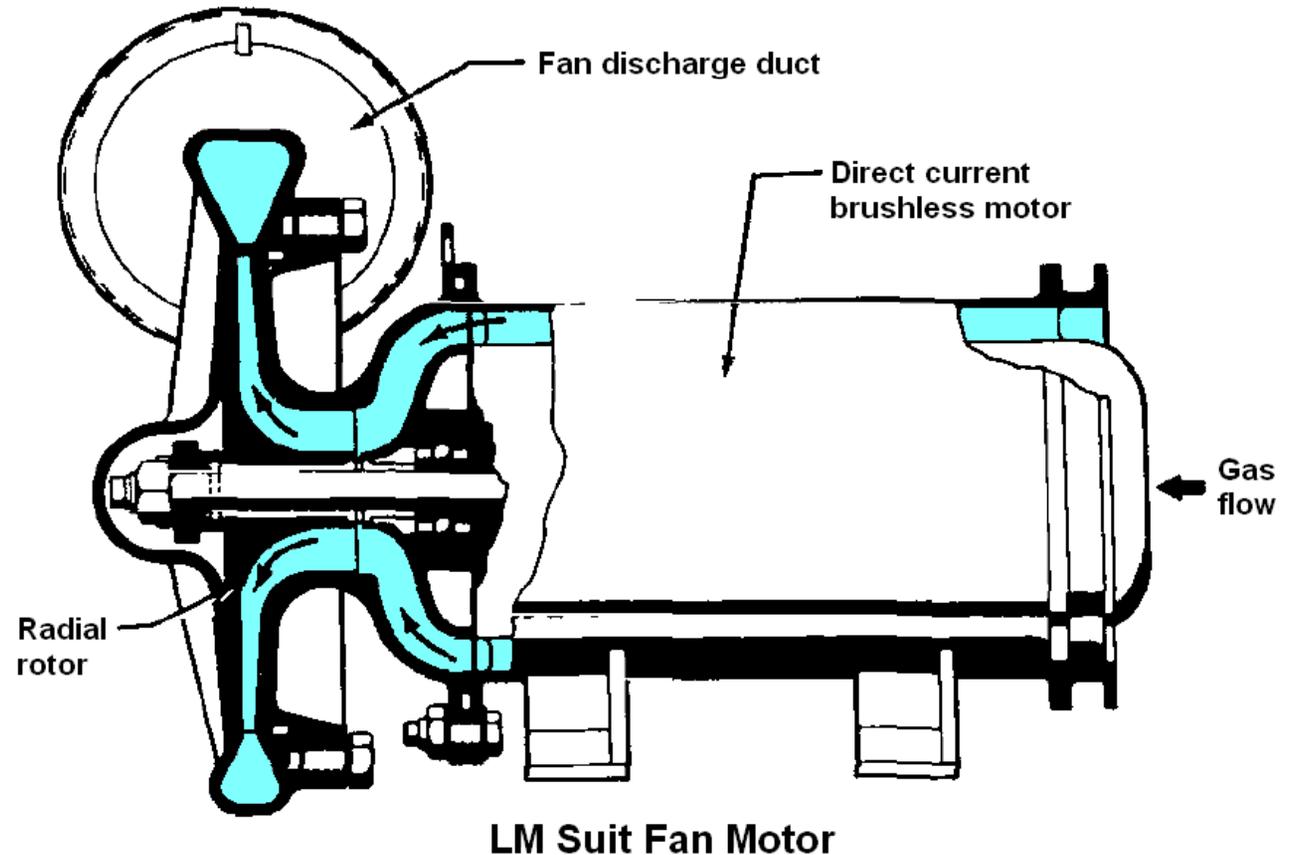
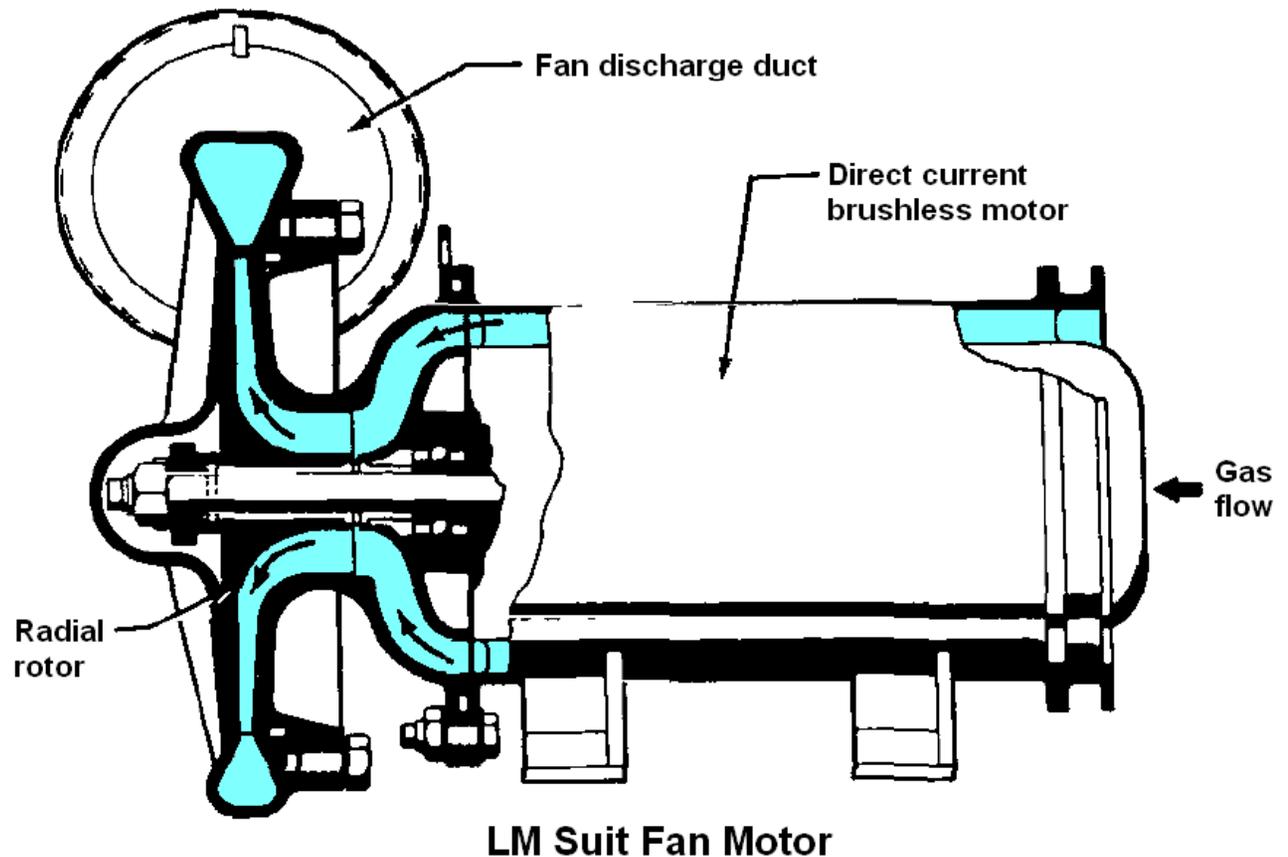
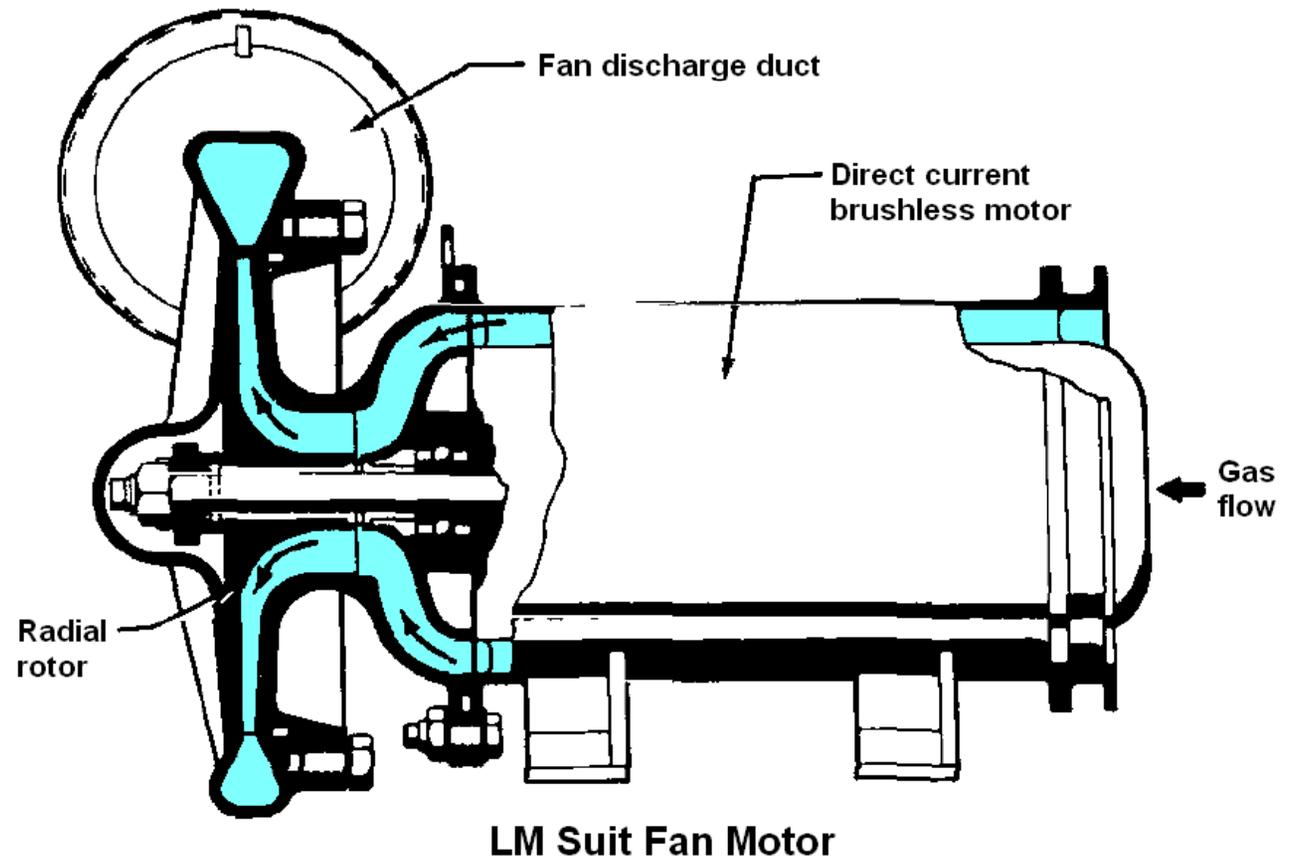
- bearing problems from contamination, inadequate lubrication, and bearing race brinelling. These were fixed by:

- bearing problems from contamination, inadequate lubrication, and bearing race brinelling. These were fixed by:  
better cleaning

- bearing problems from contamination, inadequate lubrication, and bearing race brinelling. These were fixed by:
  - better cleaning
  - a different grease

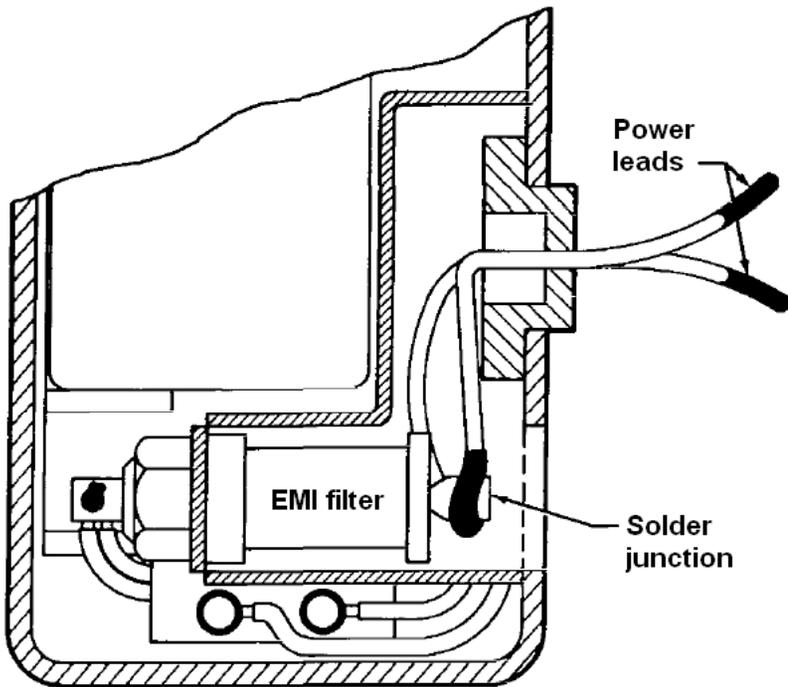
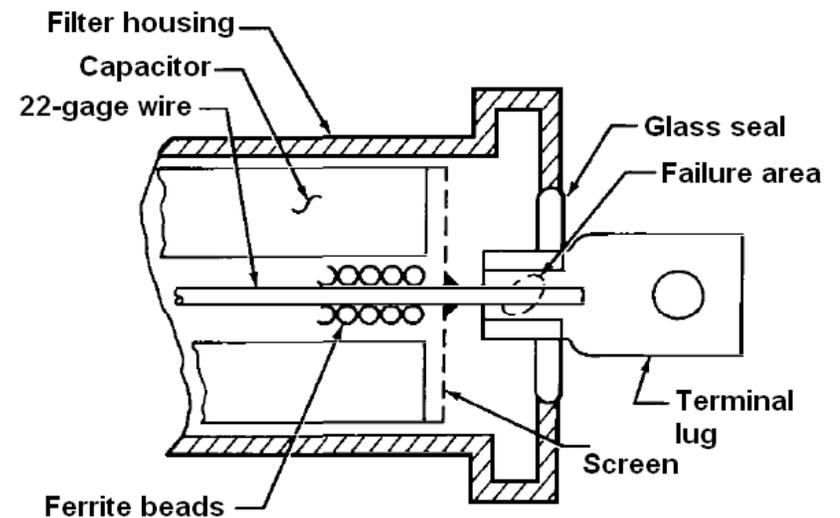
**Suit Fan EMI Filter Configuration**

- ❑ Replacement of the old type units already installed in vehicles was only successful when performed by one specific, meticulous technician. The highly skilled technician was awarded a Snoopy award for his efforts.

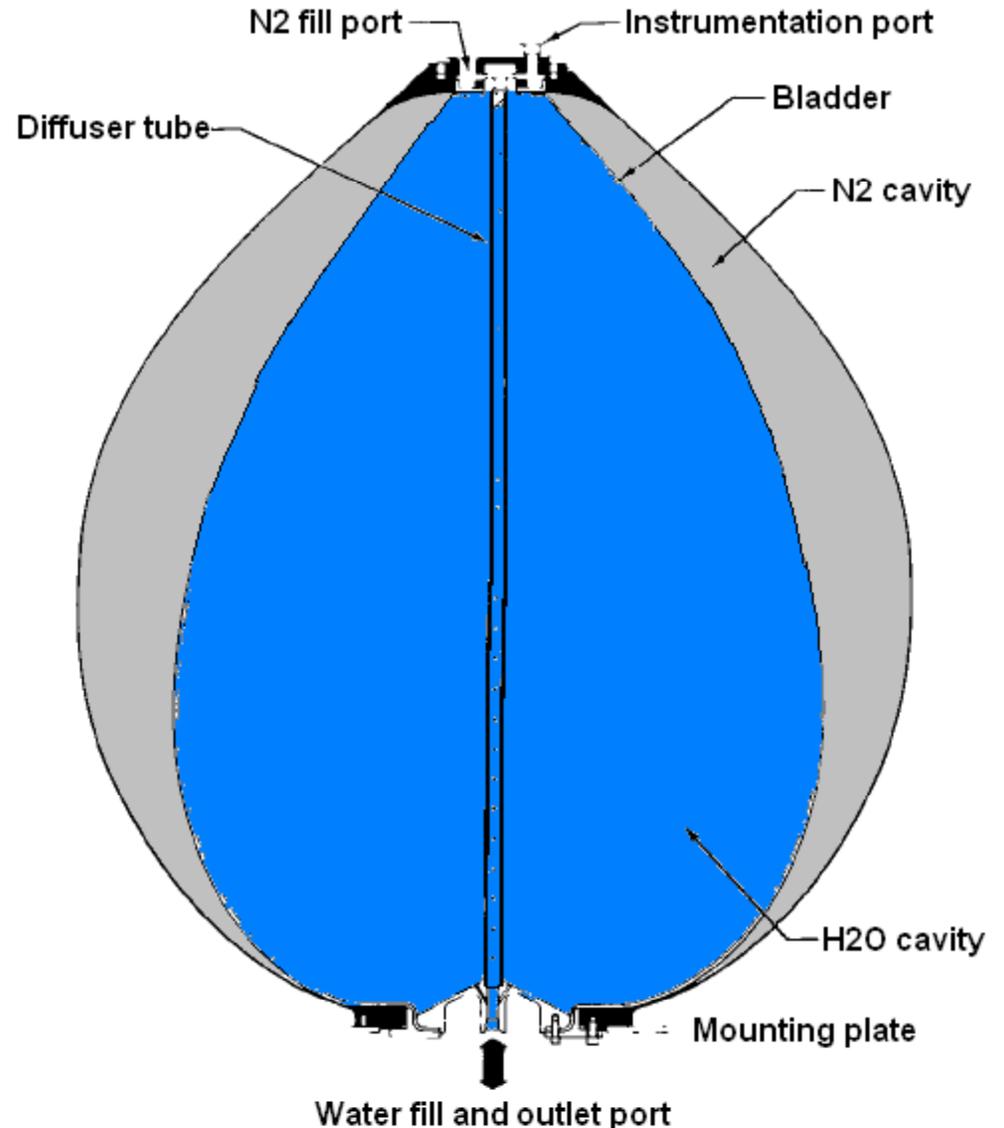
**Descent Water Tank**

- All the LM water was loaded before launch:
  - ◆ chlorine could not be used as a bacteriocide -- incompatible with the sublimators
  - ◆ iodine was introduced
  - ◆ iodine depletion (via diffusion of iodine vapor from the water through the bladder) rate increased with each iodine addition
  - ◆ the only iodine-containing water introduced into the tank was the flight load

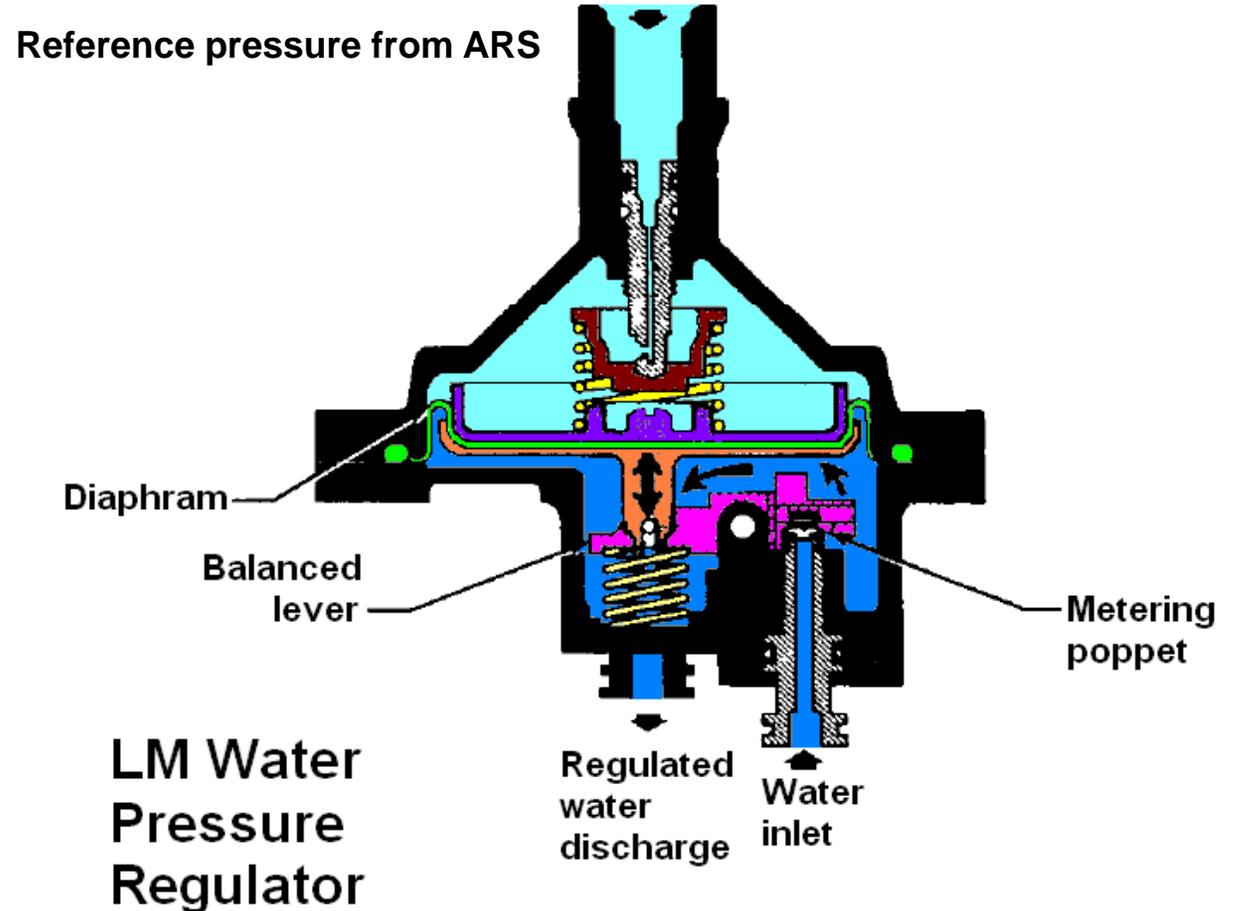
- The Water Pressure Regulator experienced particulate contamination and corrosion. Corrective measures were to:
  - minimize exposure time to water during testing
  - dry the system thoroughly

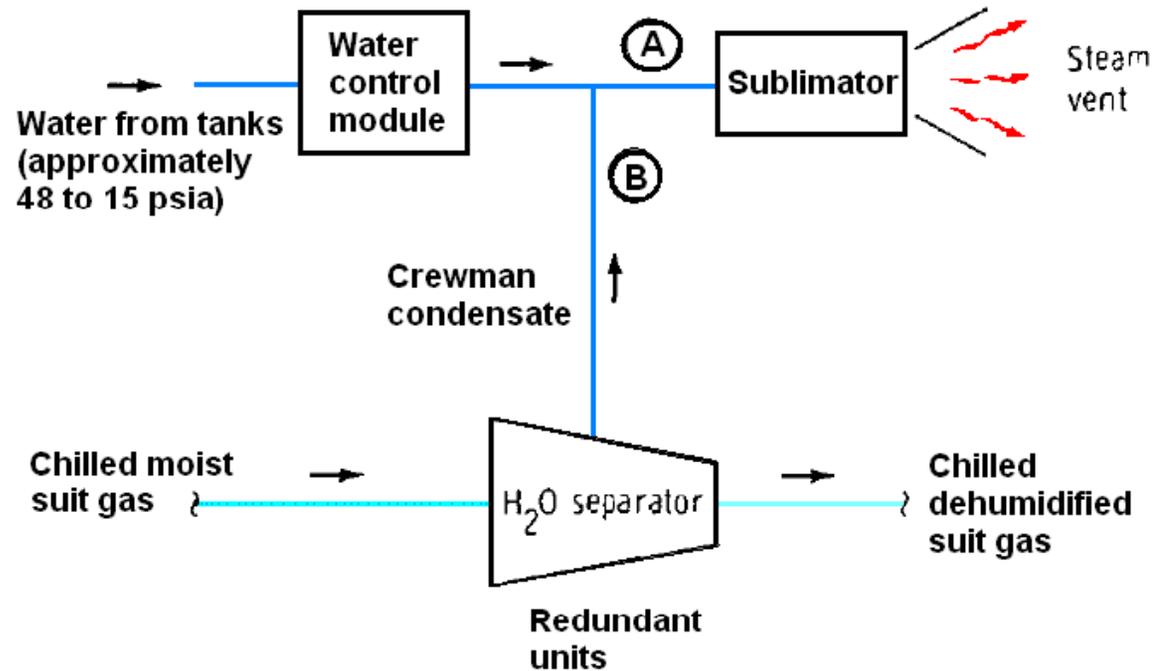
Water Bacterial Filter

- ❑ The requirement that no viable organism be deposited on the moon called for a **Bacteria Filter** in the water system.
  - ♦ gas from N<sub>2</sub> dissolved in the water blocked the 0.22 micron filter
  - ♦ requirement was relaxed for the sublimator line
  - ♦ bacterial filter was used on the cabin dump valve for Apollo 11
  - ♦ requirement was dropped for subsequent missions

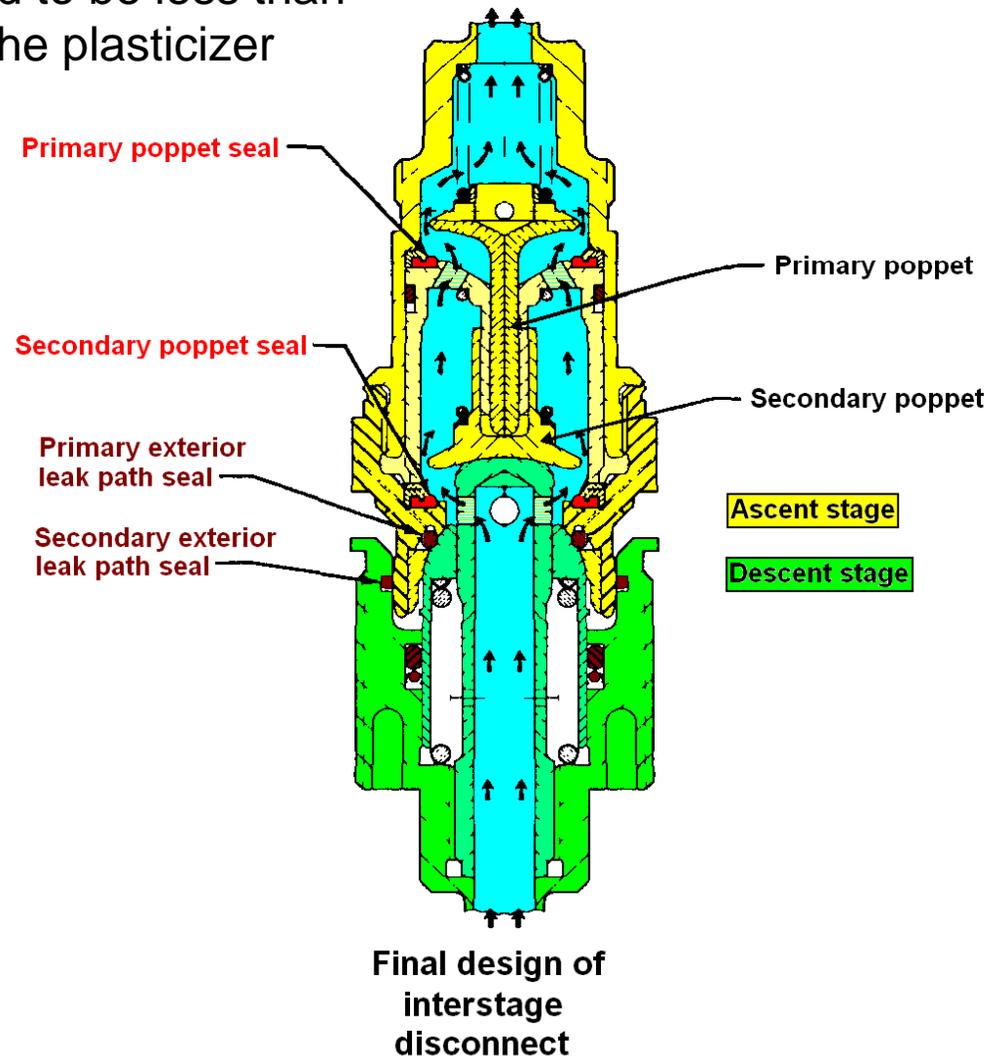
- The alcohol flushes of the system also caused a plasticizer in the polymers in the QDs to shrink.
  - ♦ alcohol flush times were controlled to be less than the minimum time seen to affect the plasticizer

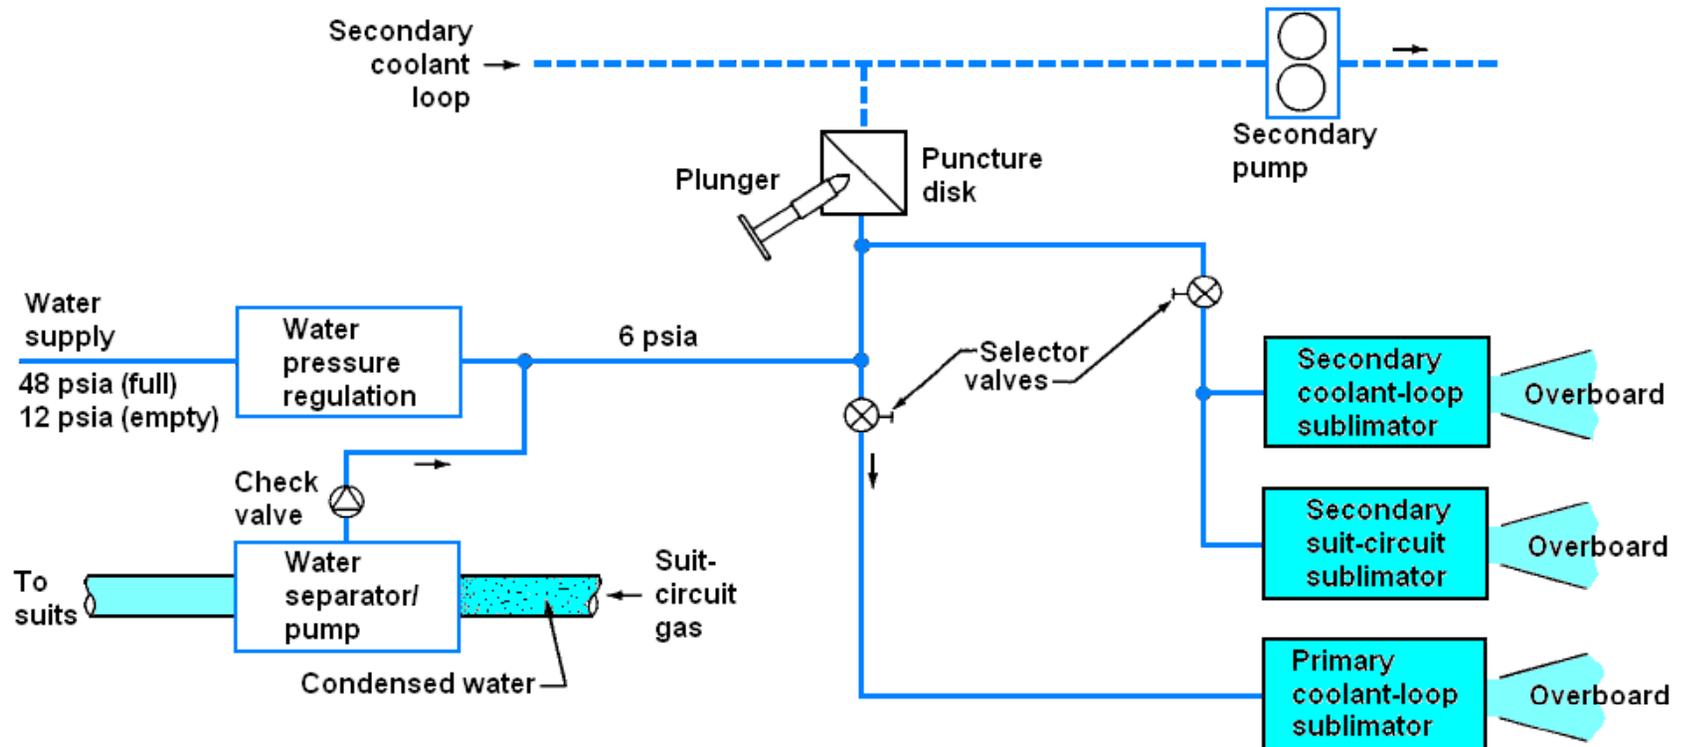
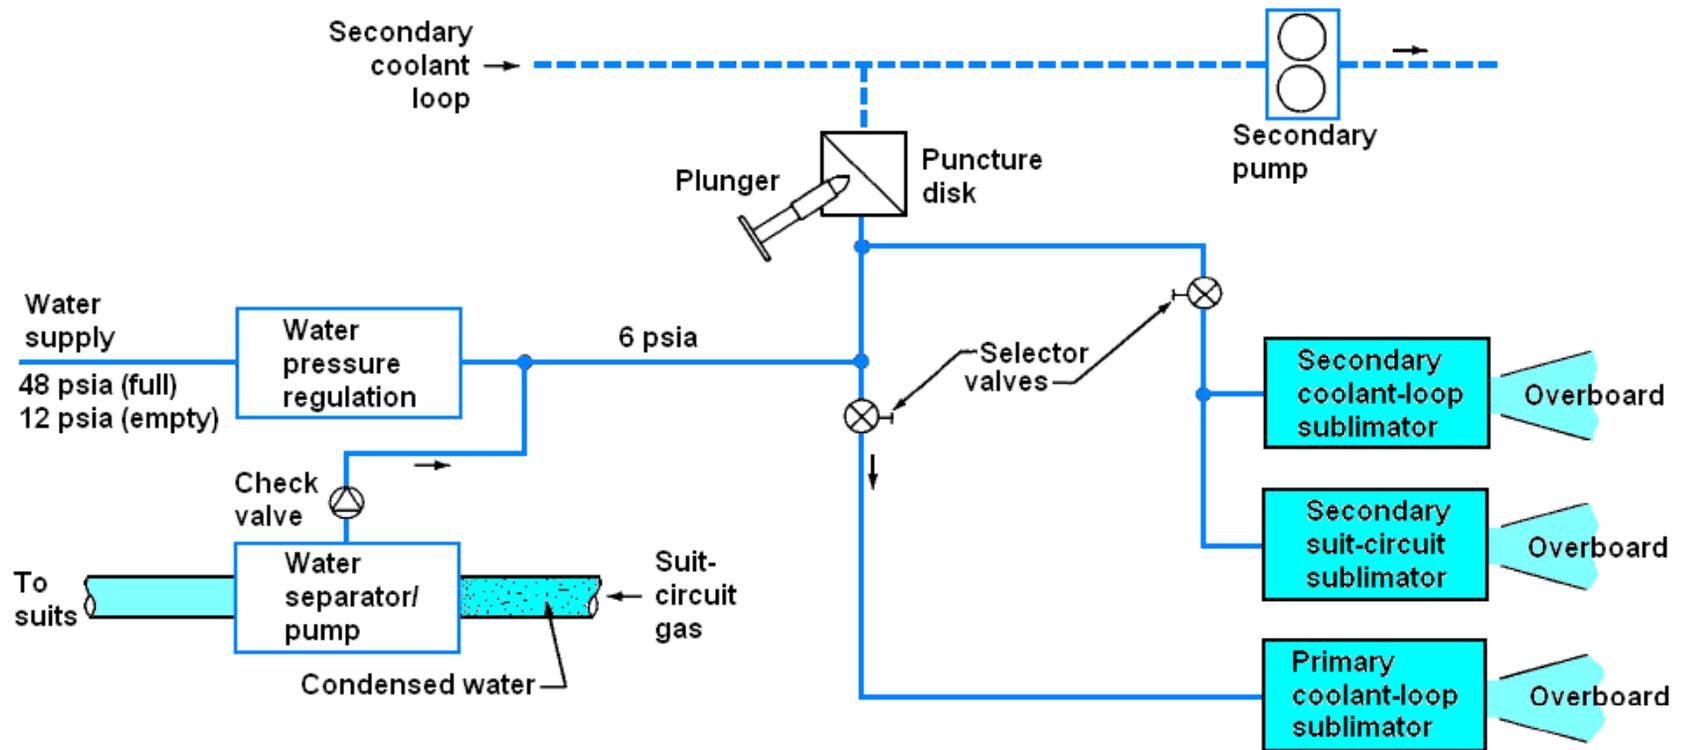
Original Design of Cooling Loop System

- The original design of the cooling loop did not include an accumulator.
  - ♦ had the potential to interconnect the water system with the glycol system (via a puncture disk) so that the water system could act as an accumulator, if needed

- The original design of the cooling loop did not include an accumulator.
  - ◆ not only was this irreversible, happened inadvertently several times during ground operations

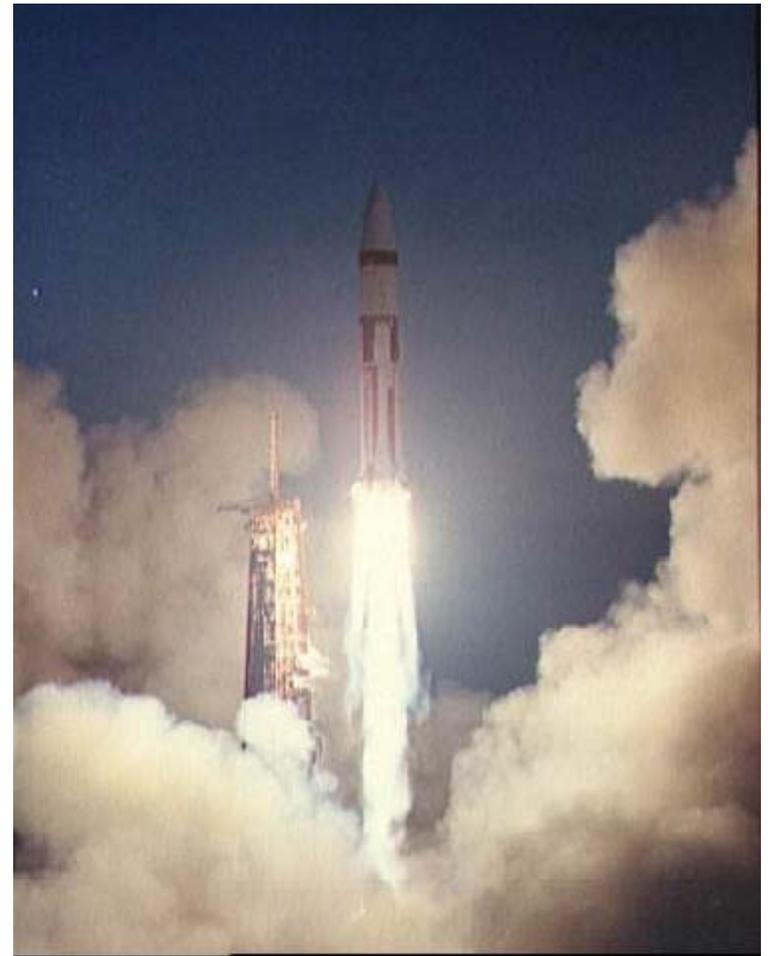
- ◆ Ascent water tank 2 leak indication, even before launch
- ◆ No leakage seen
- ◆ Tank pressurant suspected
- ◆ Quantity great enough for mission, even at leak rate; so, no action taken

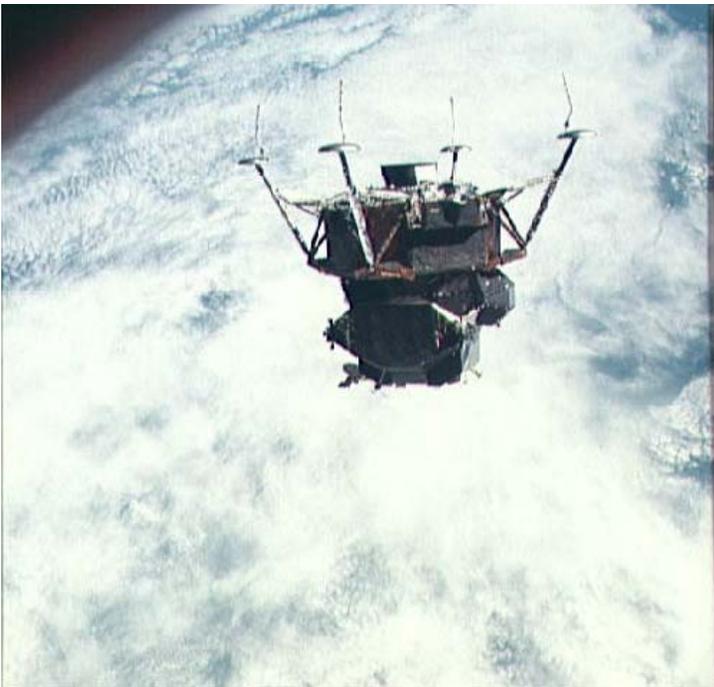
- ◆ Cabin fans were also contributors
- ◆ Subsequent missions used only one fan at a time
- ◆ Crew were fitted with earplugs with 10 dB noise suppression

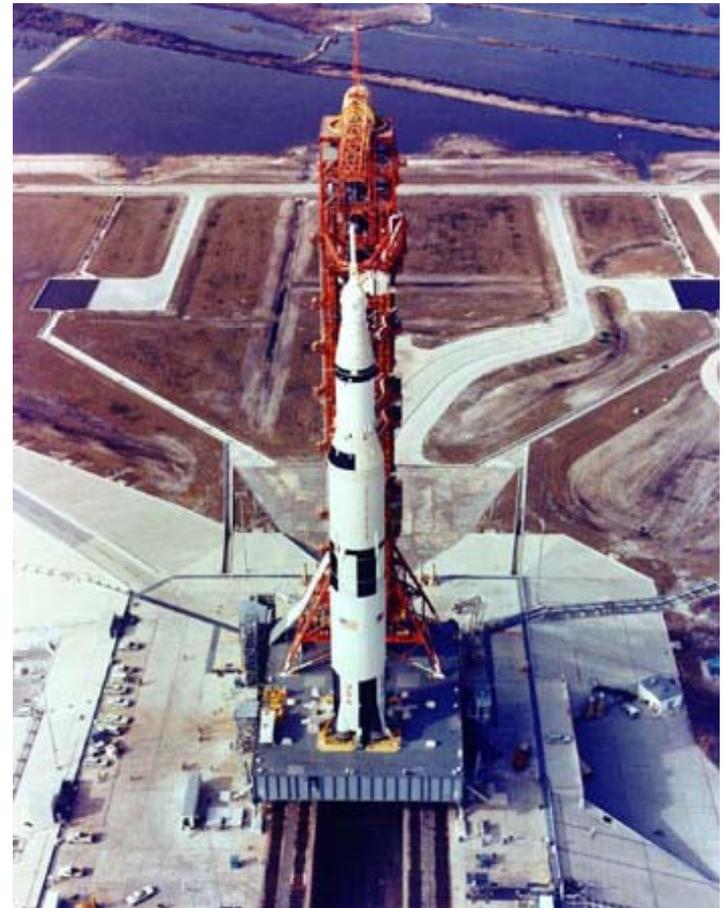
- ◆ High cabin noise
- ◆ Resulted in cabin fan being powered off after 30 minutes
- ◆ Post-flight tests performed on LM-8 to test use of flexible hoses to acoustically decouple the glycol pumps, but resulted in only a slight reduction
