# Lunar Module Environmental Control System Design Considerations & Failure Modes Part II

# Objectives

- ❑ Describe the Lunar Module (LM) Environmental Control System (ECS) subsystem testing and redesign.
- ❑ Summarize the Lunar Module (LM) Environmental Control System (ECS) in-flight failures.

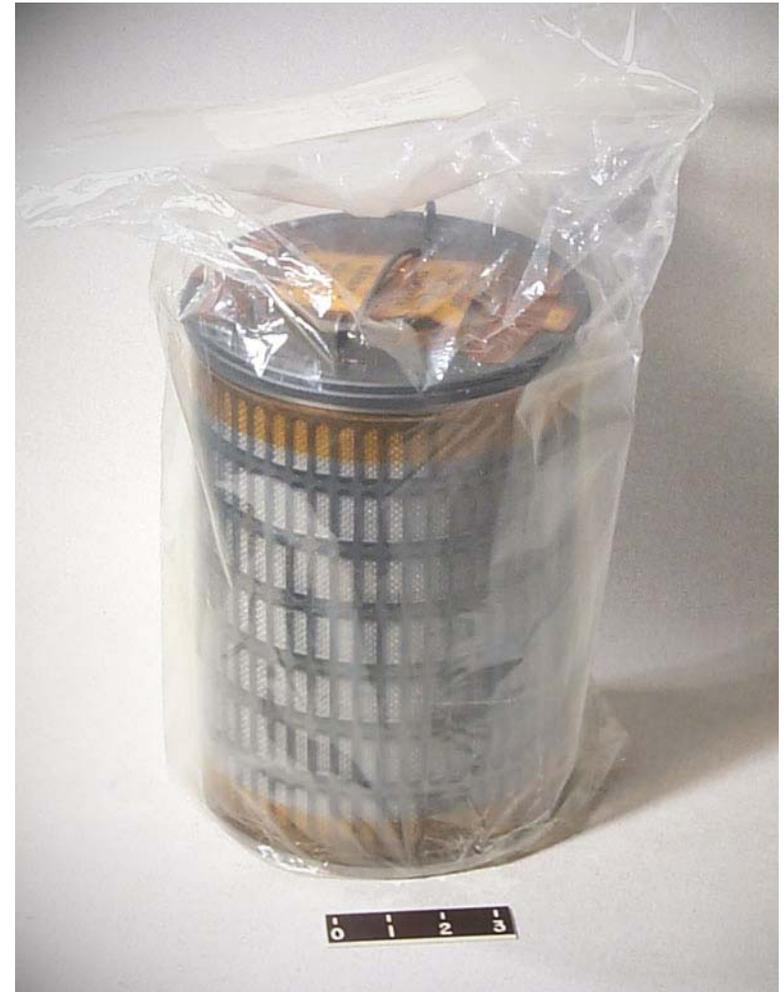
- ♦ Lithium hydroxide cartridge performance (CO<sub>2</sub> level) was anomalous
- ♦ Cartridge was returned for analysis
- ♦ Cartridge may have had variances in moisture content (the manufacturing cause for this was not fully understood)
- ♦ CO<sub>2</sub> transducer tolerance was 10% of full-scale
- ♦ In combination with the variance in the cartridge, explained the flight data

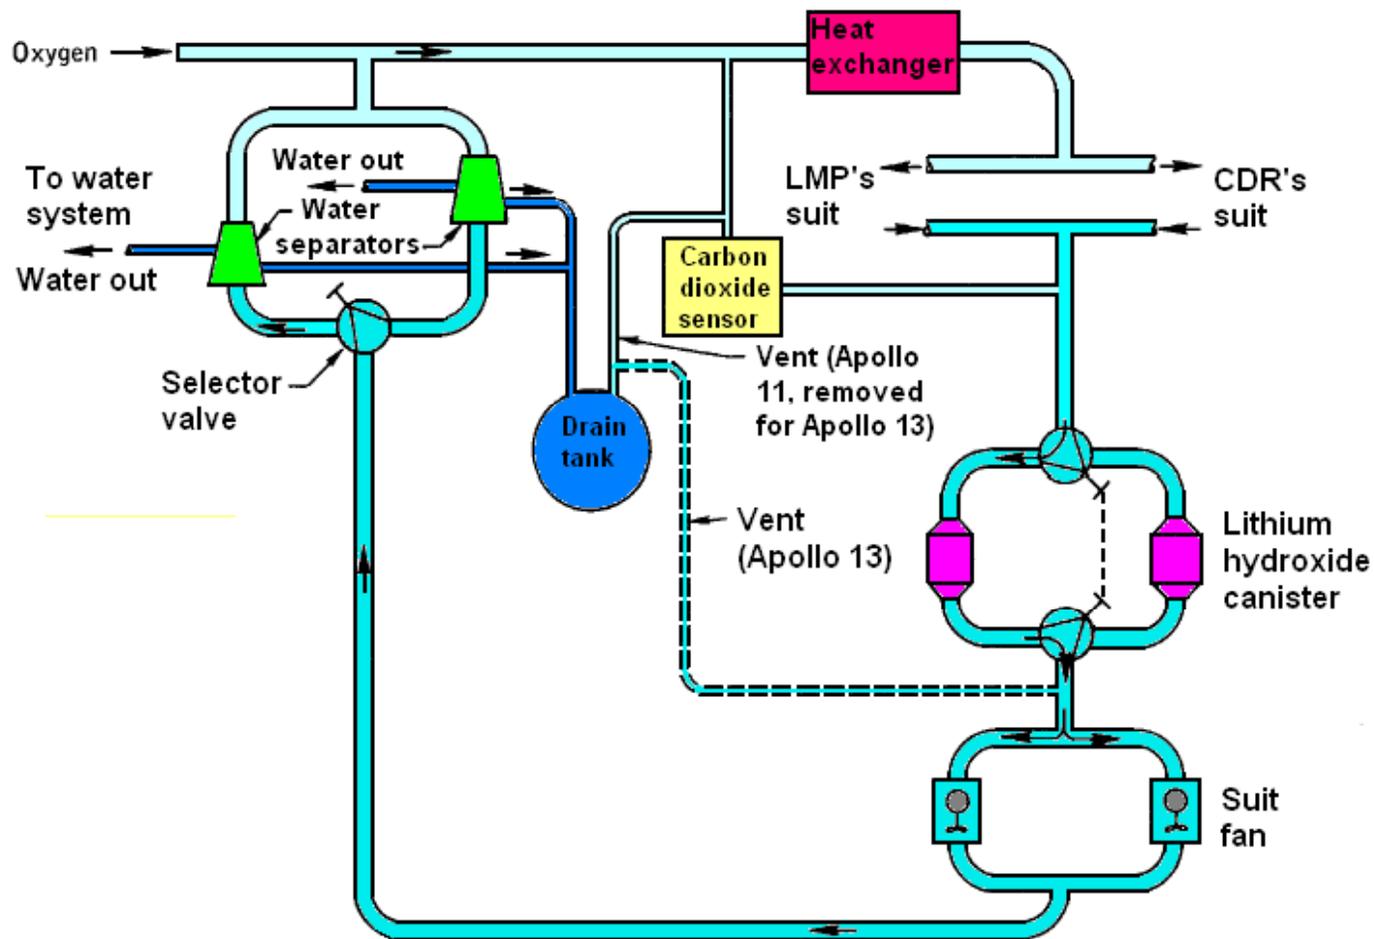
- ♦ **High CO<sub>2</sub> indicated** shortly after lunar module ascent
- ♦ Selection of secondary LiOH canister did not help
- ♦ C&W indication when primary LiOH was reselected
- ♦ Prior to lunar EVA, the ECS had been stopped
- ♦ Allowed condensate in the separator to drain into a tank
- ♦ If the tank was not quite big enough, water could enter the suit loop (CDR noted water in his suit)
- ♦ Any liquid in the line would adversely affect CO<sub>2</sub> measurements

High CO<sub>2</sub> indications – continued. To preclude this, the vent line was relocated upstream of the fans, effective for Apollo 13.
