Investigation of Orbital Debris Impacts on Shuttle Radiator Panels

Abstract

This paper documents the data collected from two hypervelocity micro-meteoroid orbital debris (MMOD) impact events where the shuttle payload bay door radiator sandwich panel was completely perforated. Scanning Electron Microscope/Energy-Dispersive x-ray Spectroscopy (SEM/EDS) analysis of impact residue provided evidence to identify the source of each impact. Impact site features that indicate projectile directionality are discussed, along with hypervelocity impact testing on representative samples conducted to simulate the impact event. The paper provides results of a study of impact risks for the size of particles that caused the MMOD damage and the regions of the orbiter vehicle that would be vulnerable to an equivalent projectile

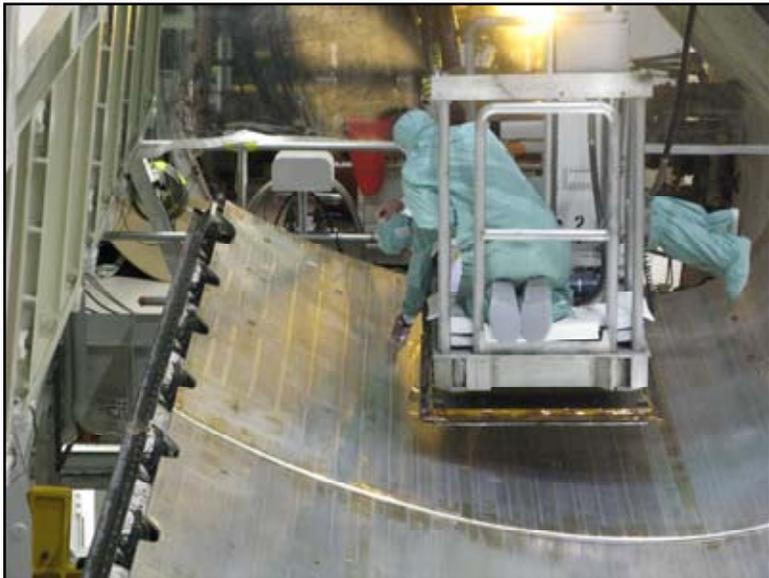
Figure 1. Payload bay door radiator inspection.

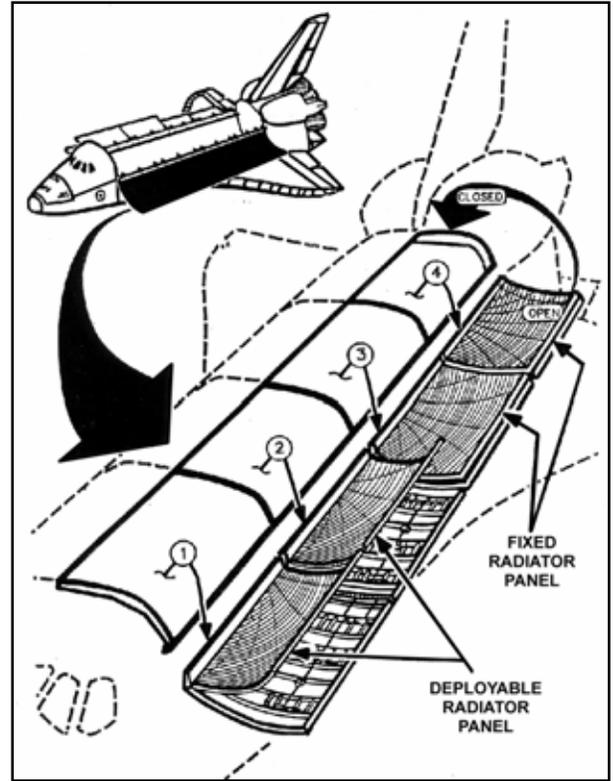
The forward radiator panels (labeled 1 and 2 in Figure 2) are an aluminum honeycomb sandwich construction with an overall thickness of 2.3 cm while the aft panels (3 and 4 in Figure 1) are 1.3 cm thick. The panels have 0.028cm thick 2024-T81 aluminum face sheets and 5056-H39 aluminum honeycomb cores. The 35.5° deployable forward radiator panels incorporate 68 parallel Freon-21 coolant tubes with 34 tubes per side, while the fixed aft panels are configured with 26 coolant tubes on one side. Figure 3 shows the locations of the coolant tubes in the panels. The figure also illustrates the aluminum doublers that have been added to the top of the flow tubes to augment protection from MMOD impacts (1).

Figure 2. Orbiter radiator configuration.

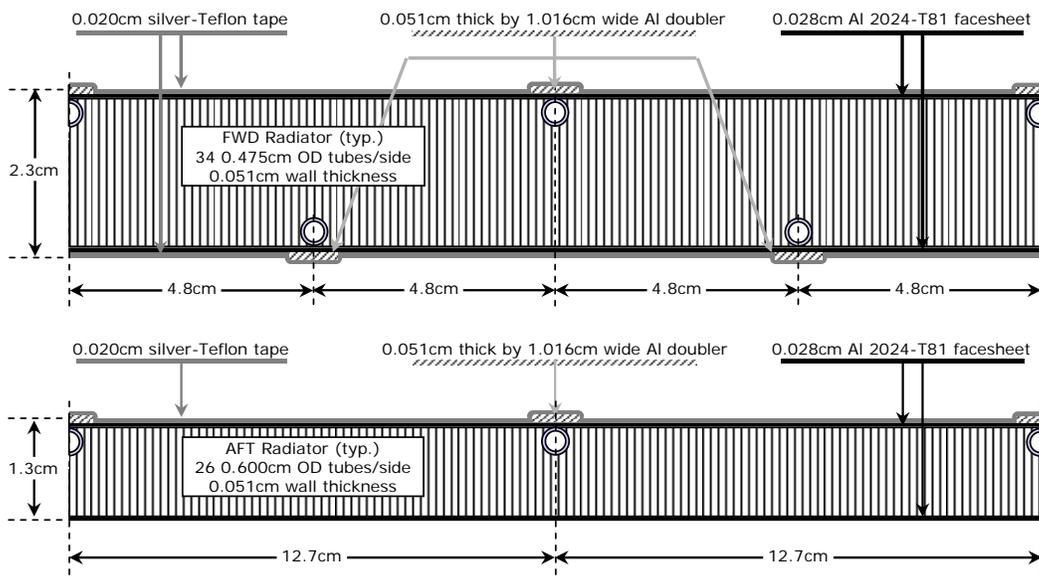
Figure 3. Radiator panel construction.

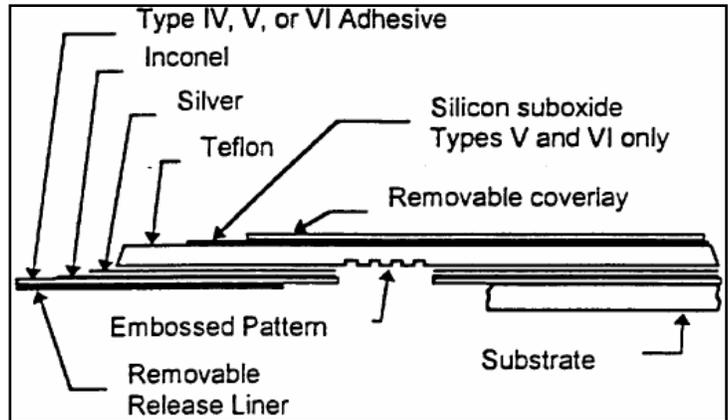
Details of the type VI silver-Teflon® thermal control tape that covers the radiator face sheets can be found in figure 4 (2).

Figure 4. Cross section of silver-Teflon type VI tape.

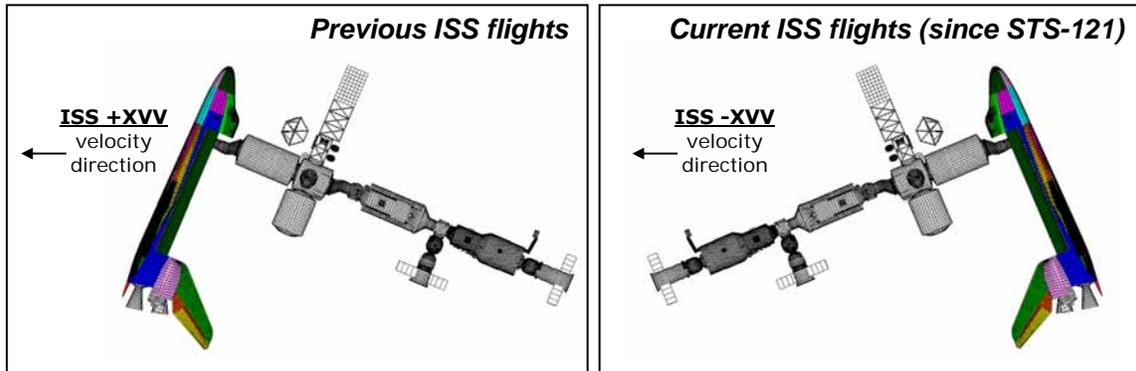
After the Columbia accident, NASA implemented an alternate Space Station docking attitude strategy for the shuttle. With the intent of protecting the lower surfaces of the wing leading edge reinforced carbon-carbon (RCC) panels from MMOD damage (Figure 30), the shuttle/station stack is now rotated 180° about the station yaw axis (Figure 29). While significantly reducing the loss of crew/vehicle risk while docked to station, the change from a “belly forward” attitude to a “belly aft” attitude orients the payload bay door radiators more directly into the orbital debris flux. This contributes to a higher impact risk for the upper surfaces of the vehicle, which would include the radiators.

Figure 29. Post STS-114 changes in orbiter docking attitude.

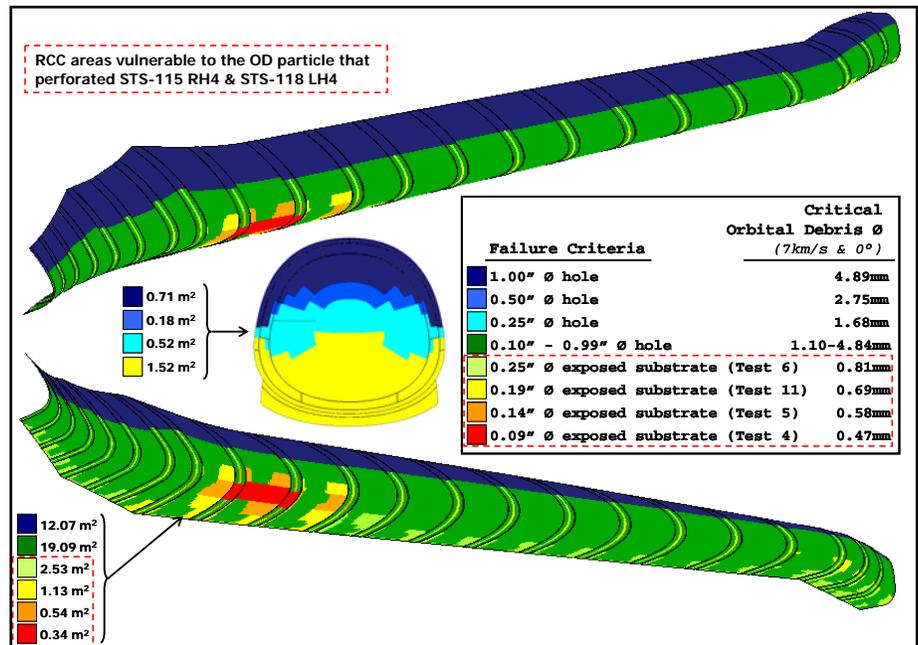
The MMOD critical failure criteria for the orbiter wing leading edge RCC were updated for Bumper risk assessments performed on STS-114 and subsequent missions (Figure 28) after testing and analysis indicated that certain areas of the RCC were very sensitive to hypervelocity impact damage. The highlighted red, orange, yellow & light green areas in figure 30 would have experienced critical damage if impacted by a particle such as the one that hit the RH4 radiator panel on STS-115 or the LH4 panel during STS-118.

Figure 30. MMOD failure criteria for RCC: wing leading edge, nose cap & chin panel.
