# RESEARCH MEMORANDUM

## CYCLIC ENGINE TEST OF CAST VITALLIUM TURBINE BUCKETS - I

Aircraft Engine Research Laboratory  
Cleveland, Ohio

NACA RM No. E7B07

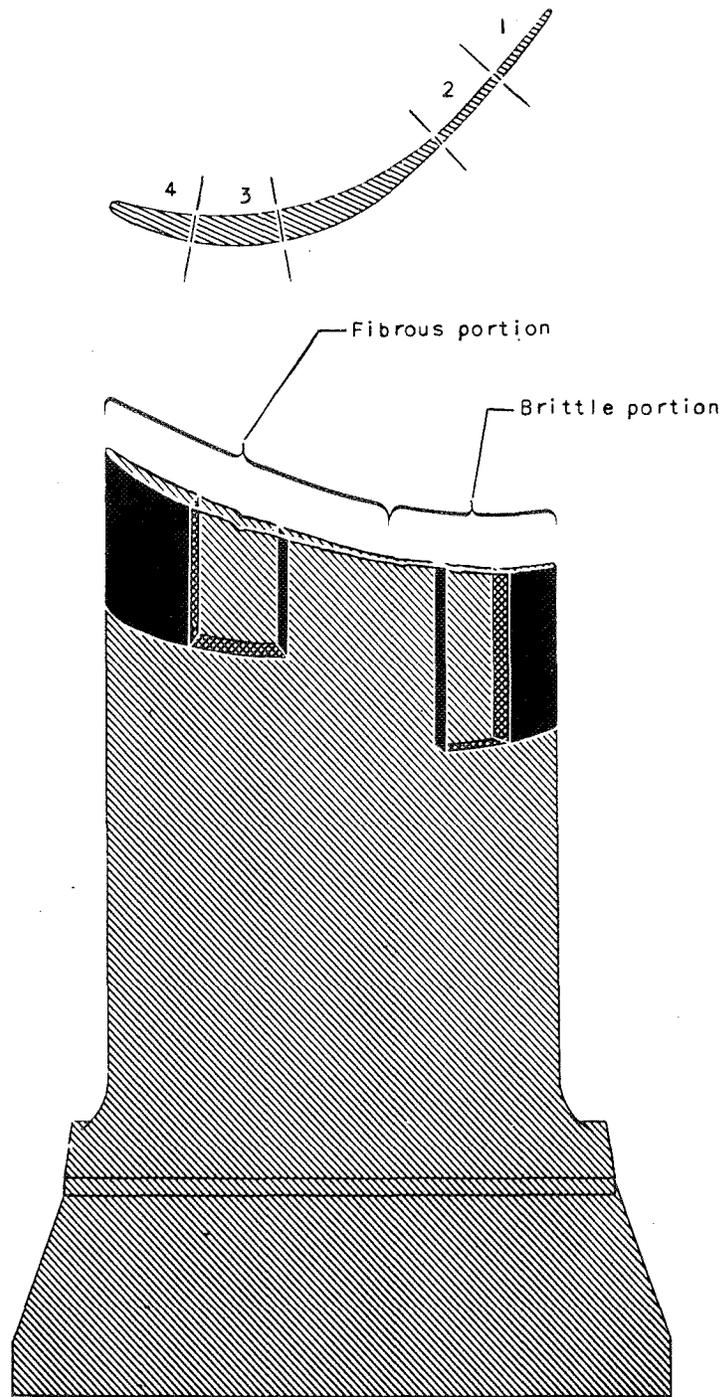
Figure 5. - Sketch showing location of samples cut from broken turbine buckets for microexamination. Black areas indicate polished surfaces.

Microexamination. - Two samples were cut from both the leading and the trailing edges of the broken buckets. The locations from which the samples were taken are shown in figure 5. The samples were polished and electrolytically etched in hydrochloric acid.

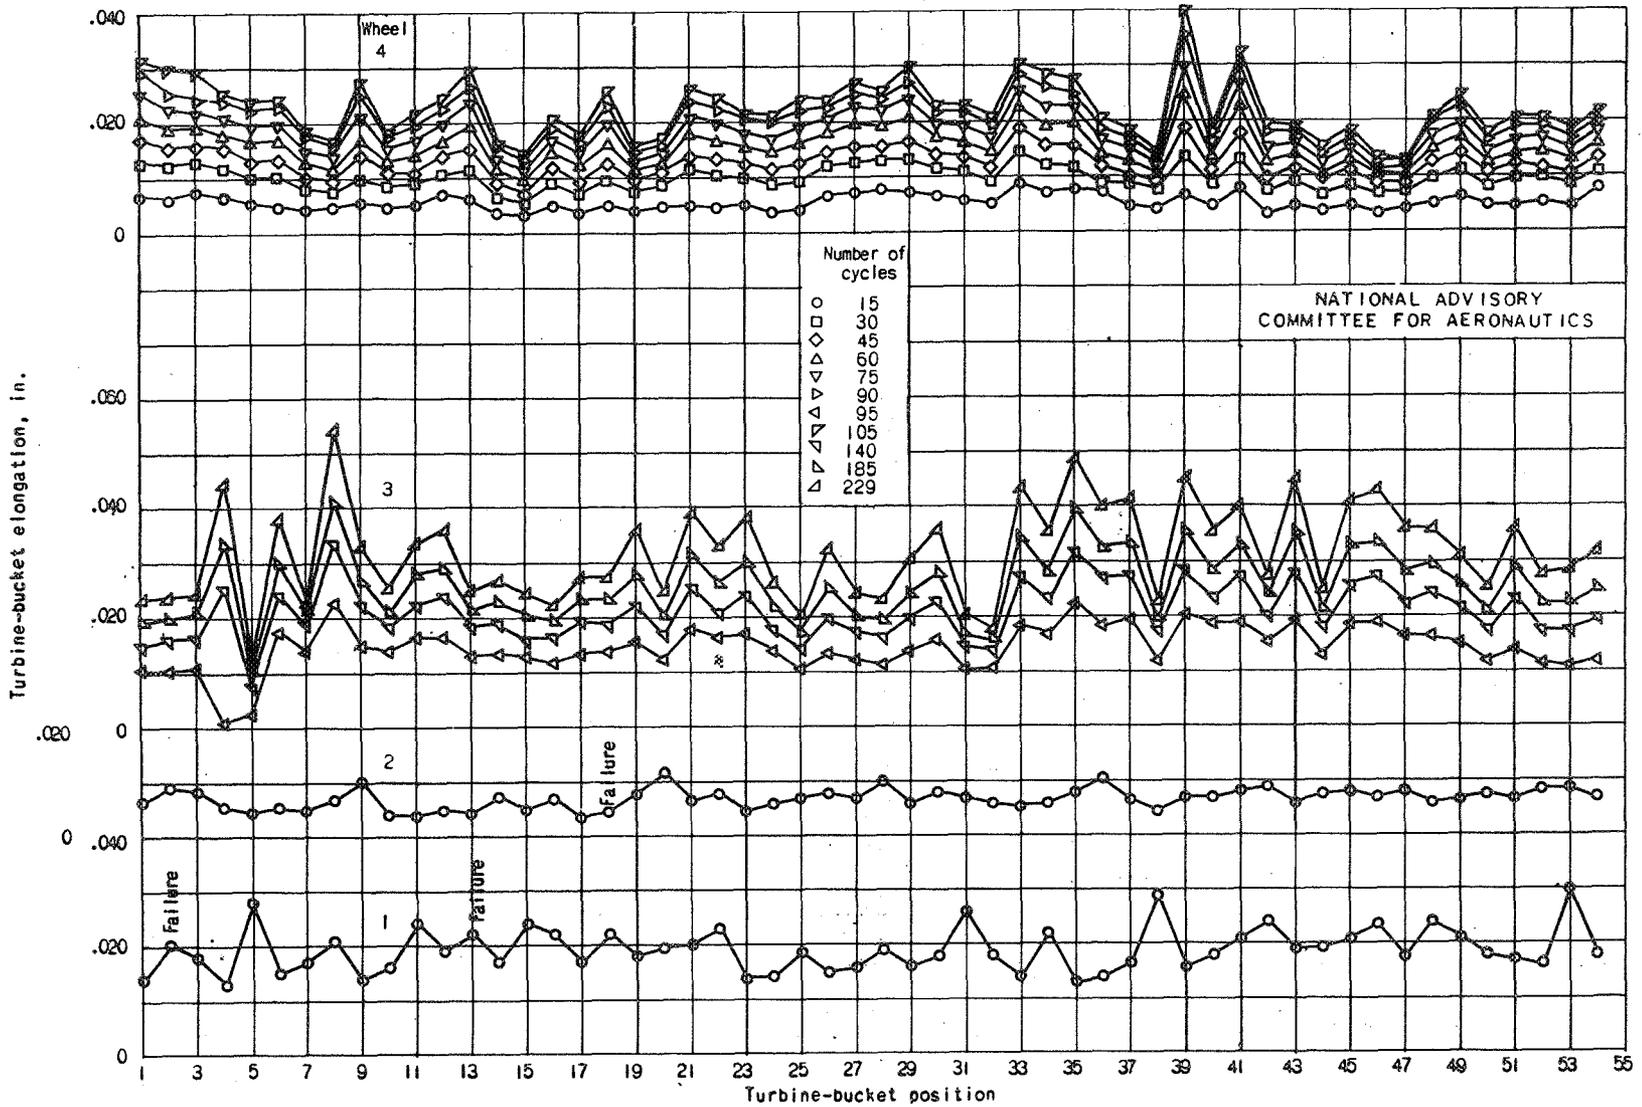
Figure 12. - Variation of turbine-bucket elongation with time for four wheels investigated.

Turbine-bucket elongation. - The elongation of the turbine buckets for the four wheels is plotted in figure 12; the bucket failures are also indicated. The first bucket failures on wheels 1 and 2 so damaged the tips of all the other buckets that further measurements could not be made. The elongation data on wheels 3 and 4 are more complete; no bucket failures, however, have yet occurred on these wheels. All failures occurred at about the same distance from the bucket roots and the type of failure was the same in all cases (fig. 13).

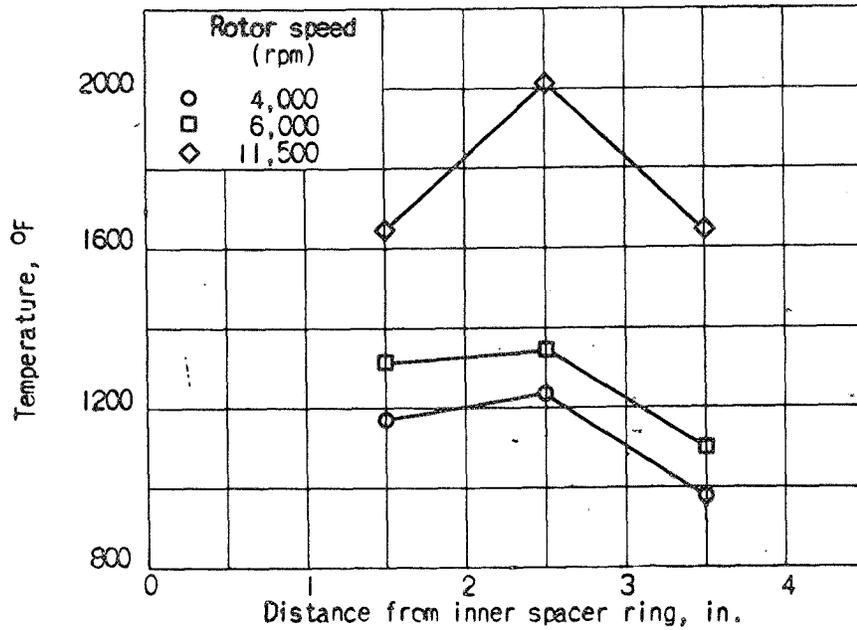
Figure 14. - Temperature variation along leading edge of turbine-nozzle blade on center line of burner 1 in I-40 engine at various rotor speeds.

Nozzle-blade temperature. - The temperature variation along the leading edge of a turbine-nozzle blade located directly behind burner 1 is shown in figure 14. These temperatures were obtained by three chromel-alumel thermocouples located as shown in figure 14. The location of a thermocouple  $2\frac{1}{2}$  inches from the inner spacer ring was chosen because in previous nozzle-blade failures most of the cracks were near this position. The data indicate that the hottest portion of the nozzle blade is about  $2\frac{1}{2}$  inches from the inner spacer ring. The fractures on the trailing edge of the turbine buckets are approximately  $2\frac{1}{2}$  inches from the root. Because the turbine-nozzle
