International Space Station USOS Potable Water Dispenser On-Orbit Functionality vs. Design

The International Space Station (ISS) currently provides potable water dispensing for rehydrating crewmember food and drinking packages. There is one system located in the United States On-orbit Segment (USOS) and one system in the Russian Segment. Shuttle mission STS-126 delivered the USOS Potable Water Dispenser (PWD) to ISS on ULF2; subsequent activation occurred on November 2008. The PWD is capable of supporting an ISS crew of six, but nominally supplies only half this crew size. The PWD design provides incremental quantities of hot and ambient temperature potable water to US food and beverage packages. PWD receives iodinated water from the US Water Recovery System (WRS) Fuel Cell Water Bus, which feeds from the Water Processing Assembly (WPA). The PWD removes the biocidal iodine to make the water potable prior to dispensing. A heater assembly contained within the unit supplies up to 2.0 L of hot water (65 to 93 °C) every 30 min. During a single meal, this quantity of water supports three to four crewmembers' food rehydration and beverages. The unit design has a functional life expectanc

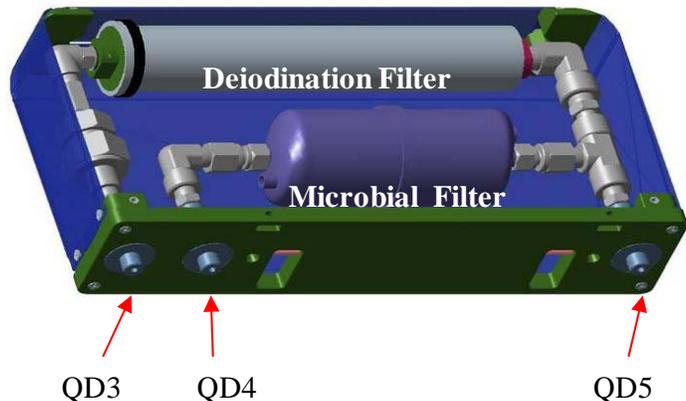
Figure 3. PWD Filter ORU

Although the disinfection process appeared thorough at the time, the PWD project team determined some possible flaws with the disinfection process of the PWD Filter ORU and the PWD unit itself. Specifically, the dwell times used in both disinfection procedures for the PWD and the PWD Filter ORU was only 5 minutes. The PWD was disinfected with iodine, and the Filter ORU was disinfected with H₂O₂. During PWD troubleshooting for possible causes for microbial contamination, the JSC Microbiology Lab determined that the dwell times were

insufficient for both pieces of hardware, The Microbiology Lab recommended a minimum of 1 hr dwell disinfection time to achieve a successful disinfection. Since the PWD flight unit will not be reprocessed, this realization was too late. However, the team modified the applicable PWD Filter ORU process procedures to correct this issue for future flights. The PWD Filter ORU is delivered roughly every 8 months due to life time expiration.

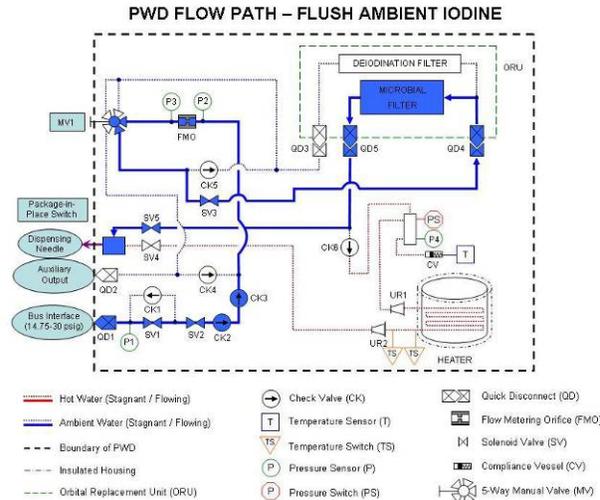
Figure 4. PWD Flush Iodine Mode, Ambient

While these theories explained the root cause of the microbial contamination within the PWD, the crewmembers still required immediate remediation, as ISS only had one of two potable water sources available. With the PWD unfit for crew consumption, they relied upon the Russian potable water source. The PWD team suggested a variety of remediation options to swiftly accommodate the crew and ISS Program's needs. The quickest and most affordable solution was to flush iodinated water from the WRS Fuel Cell Water Bus into the PWD, using the PWD Flush Iodine Mode, on January 7, 2009 (see Fig. 5). The PWD design included this mode in order to have the capability to flush biocidal, iodinated water (1 to 4 ppm I_2) into the PWD, bypassing the PWD Filter ORU Deiodination Filter by going in through QD4. The flush continues through the Microbial Filter and downstream of the ambient leg of the PWD. Nominally, the ambient leg does not show residual biocide in the water (see Fig. 4); it does in this mode, due to the Deiodination Filter bypass.

Although this solution provides hope for remediation of the ambient leg of the PWD, the PWD team recognized potential issues prior to success. The first known issue was the JSC Microbiology Lab determination that the low amount of I_2 (1 to 4 ppm) from the Bus was not capable of remediating a known contaminated system. This low concentration of I_2 was only sufficient to maintain an already clean system. Additionally, the team knew prior to delivery of the PWD that I_2 was not compatible with the Microbial Filter

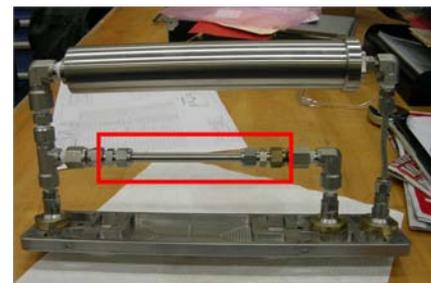
Figure 9. PWD Filter Tube Assembly (boxed in red)

In the event that the Microbial Filter did not recover with the deiodinated water 10 L flush, the PWD team conceptualized a recovery backup plan. The PWD Tube Assembly (Fig. 9) was designed to replace the Microbial Filter within the PWD Filter ORU, if the filter was not fit for use due to the inability to desorb all the highly-concentrated I_2 . The crew would only use the PWD Tube Assembly in worst case scenarios to recover the PWD, since removing the PWD Microbial Filter would mean that the water would no longer filter bacteria. Therefore, the PWD could still deliver water to the crew, but there would always be a risk of illness to a crew member

because the Microbial Filter would not be in line for a water dispense. To date, the PWD Tube Assembly has never been used.

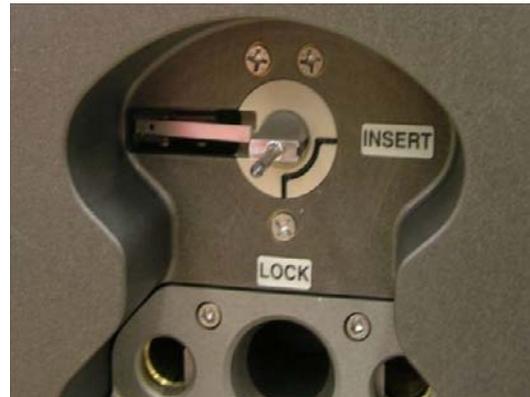
Figure 12. Behind the Beverage Adapter, PIP Switch

On June 6, 2009, the crew reported to Houston Mission Control Center (MCC) that the PWD stopped dispensing. One possible cause for a no dispense scenario includes a not fully active Package In Place (PIP) Switch. The PIP Switch resides behind the Beverage Adapter (see Fig. 11 and 12). The PIP Switch is a safety feature for the PWD, designed to prevent inadvertent dispense. The PIP Switch ensures that a food or drink package is in place before a dispense can occur (see Fig. 12). The PIP Switch activates via a plunger on the back of the Beverage Adapter, which fully extends when a food or drink package is in place, signaling the switch to allow a dispense to occur (see Fig. 13).

To validate the cause for the PWD malfunction, the team recommended that a crewmember use their finger to lightly press the PIP Switch, which would confirm that a dispense could occur with switch activation. The crewmember reported back that when they manually pressed the PIP Switch, the PWD began to dispense nominally. This verified why the PWD stopped dispensing, but did not establish a root cause for the Beverage Adapter Plunger failure to fully extend and actuate the PIP Switch. While the team continued to investigate the anomaly, the Operational Support Officer (OSO) recommended a temporary resolution to the problem. The OSO requested the crew add a small layer of tape on top of the PIP Switch to increase the area between the Beverage Adapter Plunger and PIP Switch. This would allow the plunger to make contact with the switch and actuate a dispense (see Fig. 14). This temporary workaround allowed the crewmembers to continue to use the Beverage Adapter nominally, while troubleshooting continued on the ground.

Although the temporary workaround was a good short-term fix, team concerns remained regarding the untested and unknown stresses induced on the PIP Switch, due to the off-nominal configuration of the layer of tape on the switch. The team requested a stress analysis to verify that the tape configuration on the switch was safe for continued use. The stress analysis found that the life of the PIP Switch potentially reduced from 1,000,000 cycles to less than 5000, if the switch continued in this off-nominal configuration. The PWD team created instructions for tape removal and a return to nominal switch configuration, while continuing to research the length of the Beverage Adapter plunger more closely.

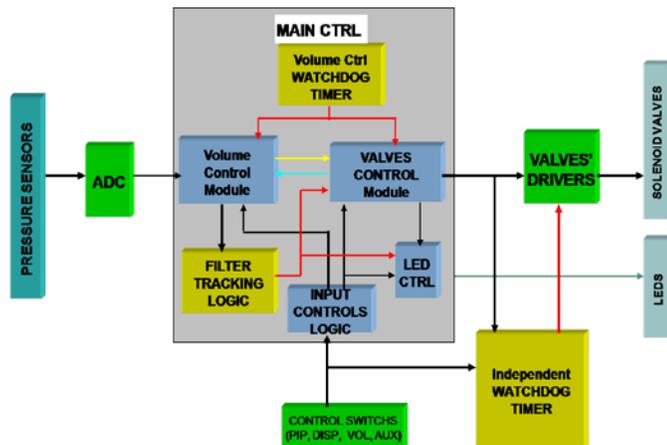
Figure 23. PWD Flow Control Electronics

A fault tree analysis of the PWD Flow Control electronics (see Fig. 23) shows an early termination of the water flow cycle and a reduced dispense volume. Dr. Barrett’s video recording of the experiment allowed the PWD team on the ground to observe the behavior of the PWD LED lights. Through this observance of how the PWD LED lights responded during dispense, the engineers determined the probable/improbable failures within the Flow Control electronics.

The final leg of the fault tree analysis to be considered was the volume control module (VCM), a part of the Flow Control components. If the VCM fails, either the internal pressure sensor, the ADC, or the internal flow calculation logic failed. Failure of these components would result in one of the following: a low delta-pressure reading or a high delta-pressure reading. A low delta-pressure reading would result in a calculated flow rate lower than actual with a longer dispense time. The watchdog timer would abort the cycle with a higher than selected dispensed volume. A high-delta-pressure reading would result in a calculated flow rate larger than the actual rate, with a reduced dispense time. The dispensed volume would be lower, but the watchdog would not activate. Neither of these events occurred, pointing to the improbability of VCM failure.

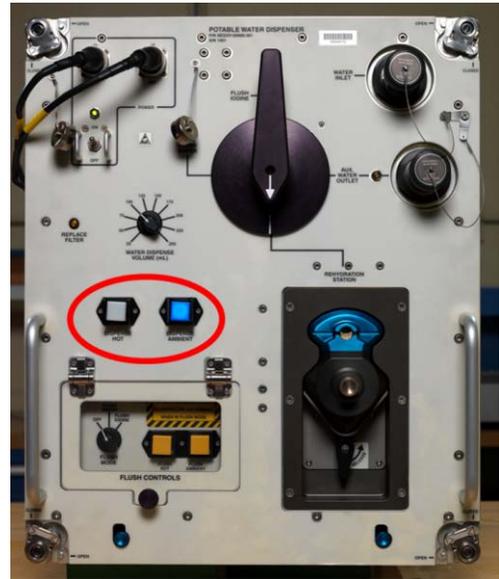
Figure 24. Front Panel of the PWD, LEDs (RED)

Engineers noticed at the end of every dispense cycle, both of the PWD LEDs (see Fig. 24) stopped blinking and went to steady-state prior to the PIP Switch release. This showed a watchdog timer override, a clear indication that the problem was not an early release of the PIP Switch. Observing the start and stop of the blinking LEDs during Dr. Barrett’s 250 mL dispense, the lapse time was approximately 30 seconds. The PWD watchdog timer is set at a fixed rate of 500 mL/min, which corresponds to the behavior of the LED lights going to steady state at the end of a dispense. The LED observation eliminated the volume control watchdog early timeout event as a root cause failure. The same manner of PWD LED observation indicated the improbability of an independent watchdog early timeout as a root cause, because the controls would not have functioned. (I get it, but this is a lot to digest. You may want to add clarification for other readers.)
