Space Station Control Moment Gyroscope Lessons Learned

Abstract

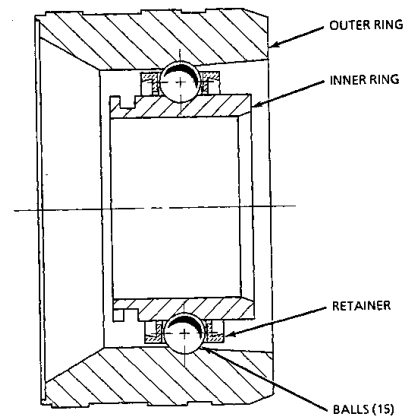
Figure 3. CMG Spin Bearing Assembly

The Spin Bearings, shown in Figure 3, are single angular-contact ball bearings with modified inner and outer races. There are 15 steel balls mounted in a retainer to maintain consistent ball motion. The spin bearings are lubricated with KG80, a super refined mineral oil, in an active oiler system. Pairs of cartridge heaters mounted near the outer race of each bearing are provided to maintain the lubricant above the pour point temperature and in the range of 15.6°C to 26.7°C (60°F to 80°F) during cold orbital conditions.

The SM side bearing (non-failed side) was in good condition. Adequate lubrication was noted in the ball race contact zone and at the retainer pad and inner race land interface. The balls were bright with some wear tracks that are considered consistent with operation time. Except for one uneven wear track on the outer race, the wear tracks on both races are considered nominal for the operational time. A ring of degraded lubricant was noted on the inner race land, which is abnormal for the accumulated operating time. The retainer was not damaged and did not contain any evidence of unstable operation or distress. Inspection verified the location of the SM bearing wear tracks were consistent with CMG1's lifetime load conditions. Additionally, testing of the active oiler system verified that the lubricant flow was consistent with the presence of fresh oil in the bearing.
