Failure Analysis at the Kennedy Space Center

Victoria L. Salazar and M. Clara Wright*

National Aeronautics and Space Administration, Kennedy Space Center, FL, 32899

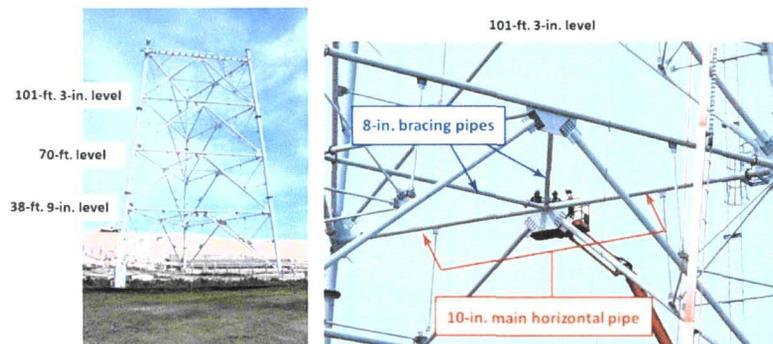
During installation of the new launch pad lightning protection towers for the Constellation program, inspectors found toe cracks along a total of nine welds on all three of the towers at various elevations. Cracking occurred along one third or less of the perimeter of each weld between the 10-in. diameter main horizontal pipe joining two 8-in. diameter bracing pipes, which are shown in Fig. 8. A representative coupon sample was removed from one of the towers at the 101-ft, 3-in. elevation crack area for analysis. Temperature measurements were taken during cutting operations to ensure that the part was not overheated such that no microstructural changes were induced. The pipes were specified as ASTM A 500 Grade B carbon steel. Photodocumentation, stereomicroscopy, SEM analysis, chemical analysis and metallography were performed on three specimens created from the removed coupon to determine the cause of weld toe cracking.

Figure 8. Images of the partially assembled lightning towers at the launch pad.

Loading configuration of this joint design should be evaluated to determine if the joint was overloaded, with the weld toe considered to be a significant point of stress concentration. Future assembly operations should eliminate the possibility of stress overload during fit-up and existing cracks should be repaired.

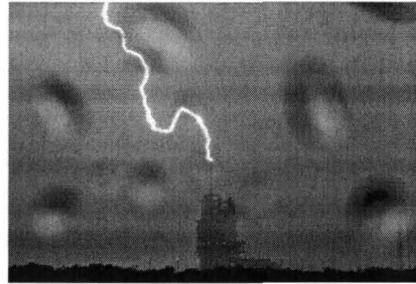
- Sections of wire rope from the lightning protection system at the launch pads were submitted for inspection to determine potential future usage of similar wire rope².
 - Wire rope was type 316 stainless steel.
 - Installed in 2001 and removed in 2008.
- Visual observation of the wire rope revealed damage that was due to two separate environmental problems: corrosion and possible lightning damage.

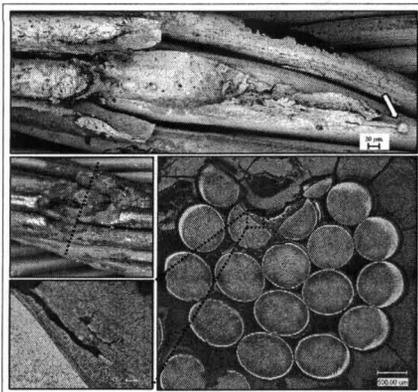
- Visual observation revealed locally melted and fused wires.
- SEM examination of one of these areas of damage revealed a melted bead of metal.
- Metallographically prepared cross-section of the damaged area indicated that five of the nineteen wires in the strand were affected.
 - Typical weld-like dendritic microstructure.
 - Microhardness measurements indicated that the heat affected zone was extremely localized.

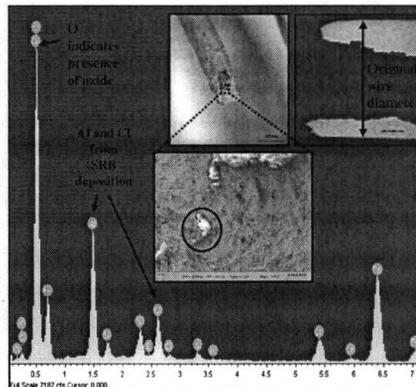
- Stereomicroscopic inspection of one of the ropes revealed pitting of approximately one quarter of the wires in one of the strands of the wire rope cross-section.
 - The morphology and composition of deposits observed within the pit via SEM/EDS were typical of solid rocket booster (SRB) combustion product deposit.
 - Approximately two-thirds of the interior portion of the cross-section was removed.
- Grain boundary attack caused the wormhole-like pitting of the interior of the wire since the corrosion mechanism acted longitudinally with the grain structure.

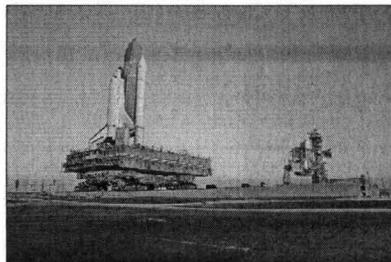
- The crawler transporter is used to move the shuttle transportation system to the launch pad after mating operations in the Vehicle Assembly Building (VAB).
- A spherical bearing from a steering cylinder of the crawler transporter (CT) was submitted for failure analysis when a crack was observed during maintenance³.
- The spherical bearing was composed of AISI E52100 bearing steel (UNS G52986).

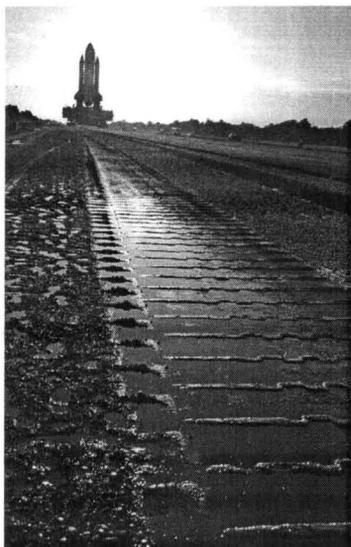
- The bearing failed in a progressive manner, likely the result of misalignment.
- The lubricant analysis indicated severe degradation due to age and contamination with environmental particles.
- The misalignment could have been caused by the failure of the grease to properly transfer the load, leading to the bearing binding in its race.

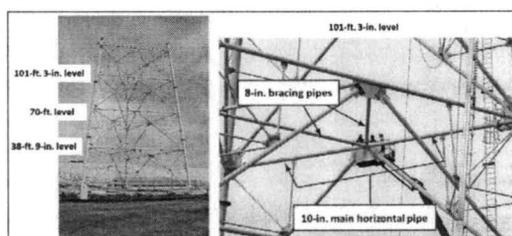
- During installation of the new launch pad lightning protection towers for the Constellation program, inspectors found toe cracks along a total of nine welds on all three of the towers at various elevations⁴.
- The pipes were specified as ASTM A 500, Grade B, carbon steel⁵.
