STS-131
KSC S&MA

LC-39A High Pressure Gas Storage Facility (HPGF) Net Damage	Presenter R. Margasahayam	
	Date 03/08/2010	Page 1

STS-130 Ice Detection Camera FOD concern

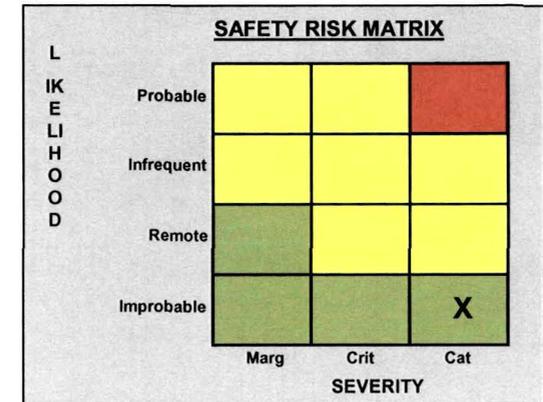
- **STS-130 LH2 Bonnet closure timing was out of family fast (but within Spec.) at: 1.121 seconds.**
 - Expected range: approx 1.2 seconds
 - Specification range: 1.1 to 1.3 seconds

- **Concern: bonnet contacting carrier plate during closure if too fast (Bellow 1.1 Sec.)**
 - Bonnet contacting Umbilical Carrier Plate during closure could generate FOD

- **Cause: Different lot of bonnet closure thrusters is providing more closing thrust**
 - Inventory indicates that all Lot EAJ thrusters have been used and must now use Lot EAK thrusters for the TSM bonnet.

- **CONSTRAINTS:** None
- **S&MA RATIONALE & RECOMMENDATION:**
 - Not a Constraint to flight
 - At worst, change will extend TSM bonnet closure time too much and damage GSE

- Change will error on the side of not producing FOD

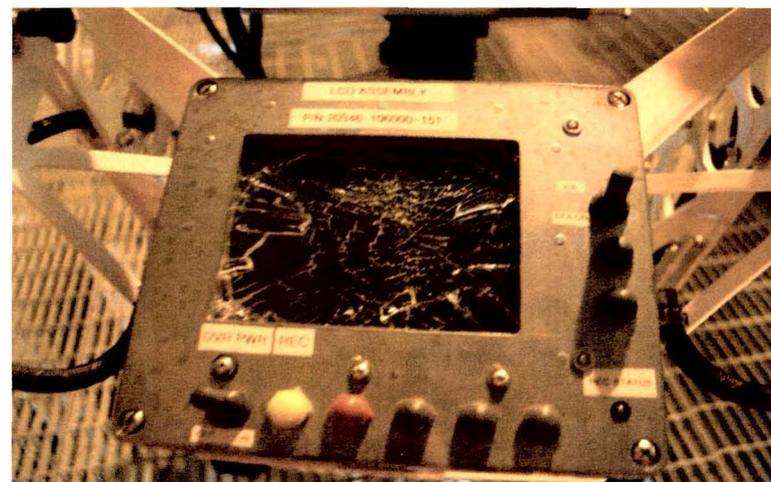
- If used improperly, ice detection equipment can liberate FOD during pre-launch ice inspections
- Consequence: Marginal (after controls in place, catastrophic without controls due to FOD and personnel injury)

- During the STS-130 pre-launch ice inspections, an LCD readout screen from the prototype ice detection camera broke, liberating small pieces of glass on the 255' level of the fixed service structure
- All FOD was collected prior to launch
- A close call/mishap investigation was performed. The immediate cause was overpressure from the GN2 purge bottle. The root causes were determined to be procedural as well as operator error.

- STS-131 and subsequent are safe to fly
- KSC-PH has decided to never use the prototype equipment again for shuttle launches
 - The equipment is not required for ice inspections
