Metallographic Preparation of Space Shuttle Reaction Control System Thruster Electron Beam Welds for Electron Backscatter Diffraction

A Space Shuttle Reaction Control System (RCS) thruster failed during a firing test at the NASA White Sands Test Facility (WSTF), Las Cruces, New Mexico. The firing test was being conducted to investigate a previous electrical malfunction. A number of cracks were found associated with the fuel closure plate/injector assembly (Fig 1). The firing test failure generated a flight constraint to the launch of STS-133. A team comprised of several NASA centers and other research institutes was assembled to investigate and determine the root cause of the failure. The JSC Materials Evaluation Laboratory was asked to compare and characterize the outboard circumferential electron beam (EB) weld between the fuel closure plate (Titanium 6Al-4V) and the injector (Niobium C-103 alloy) of four different RCS thrusters, including the failed RCS thruster.

Background

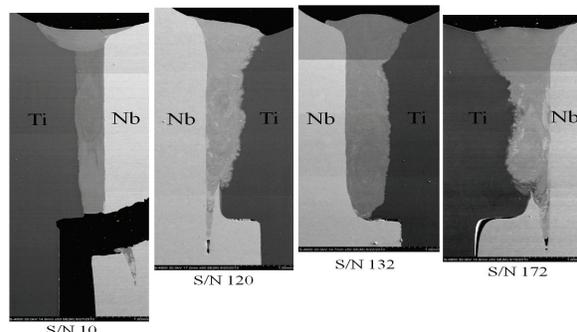
Fig 2. SEM BSE Comparison of 4 Injectors Outboard Fuel Closure Welds

Once polished, each sample was micrographed using bright field, differential interference contrast optical microscopy, and scanning electron microscopy (SEM) using a backscatter electron (BSE) detector. No typical weld anomalies were observed in any of the cross sections. However, areas of large atomic contrast were clearly visible in the weld nugget, particularly along fusion line interfaces between the titanium and the niobium. This prompted the need to better understand the chemistry and microstructure of the weld (Fig 2). Energy Dispersive X-Ray Spectroscopy (EDS) was used to confirm the chemical composition of the variations in contrast in these areas.

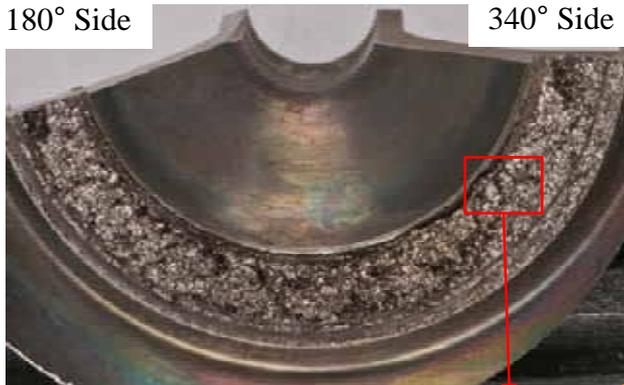
Red Crack, Fuel Closure Side (180-340°)

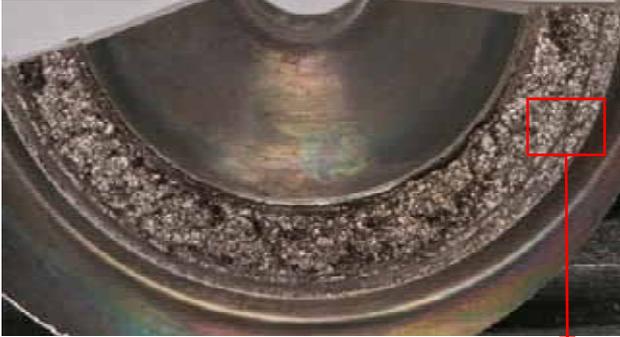
Red Crack, Fuel Closure Side (180-340°)

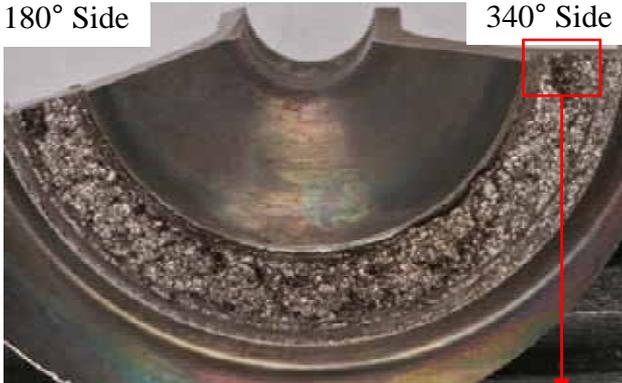
- **No thumbnails evident**
 - No conventional fatigue observed
 - No intergranular cracking observed
 - No unexplained discoloration
- **Continuous shear band evident along inboard and outboard welds**
 - Shear dimples evident along bands
 - No significant interruptions in shear bands
- **Fracture surface across niobium**
 - Mostly cleavage-like facets
 - Occasional shear dimples between facets
