Compression After Impact on Honeycomb Core Sandwich Panels with Thin Facesheets, Part 1: Experiments

Thomas D. McQuigg¹ and Rakesh K. Kapania²
Virginia Polytechnic Institute and State University, Blacksburg, VA, 24060

Stephen J. Scotti³ and Sandra P. Walker⁴
NASA Langley Research Center, Hampton, VA, 23681

A two part research study has been completed on the topic of compression after impact (CAI) of thin facesheet honeycomb core sandwich panels. The research has focused on both experiments and analysis in an effort to establish and validate a new understanding of the damage tolerance of these materials. Part one, the subject of the current paper, is focused on the experimental testing. Of interest are sandwich panels, with aerospace applications, which consist of very thin, woven S2-fiberglass (with MTM45-1 epoxy) facesheets adhered to a Nomex honeycomb core. Two sets of specimens, which were identical with the exception of the density of the honeycomb core, were tested. Static indentation and low velocity impact using a drop tower are used to study damage formation in these materials. A series of highly instrumented CAI tests was then completed. New techniques used to observe C

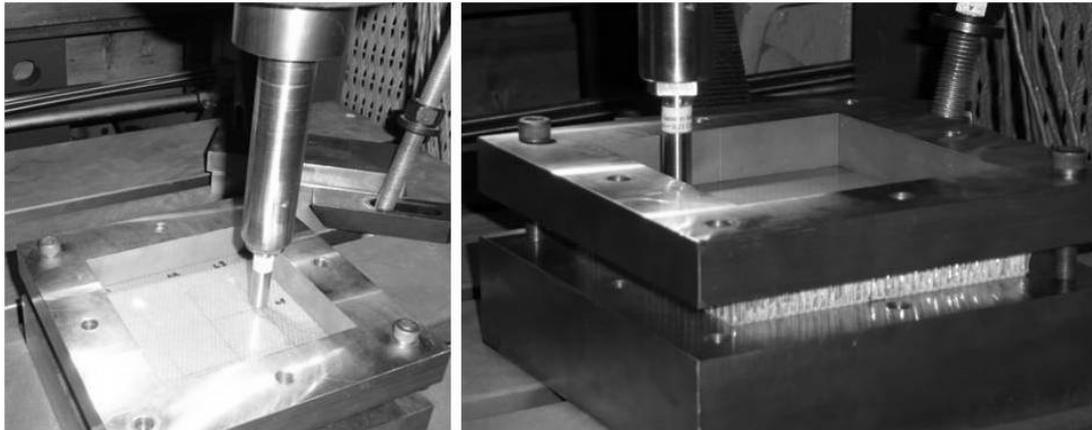
Fig. 3 Static indentation of 3PCF-XX (right) and 6PCF-XX (left) series sandwich coupons.

Indentations of 3PCF-XX and 6PCF-XX series materials were conducted while the coupons were clamped on all four edges using a metallic frame which allowed for the coupon to be suspended with the rear, undamaged facesheet unsupported. The test frame used to prescribe these conditions to the static indentation coupon and can be seen in Fig. 3. One coupon of each material was used for static indentation and several indentations were made in each coupon at various locations. The quasi-static loading was displacement controlled and applied at a rate of 0.05 inch per minute. The applied displacement and the reaction force were recorded for each indentation.

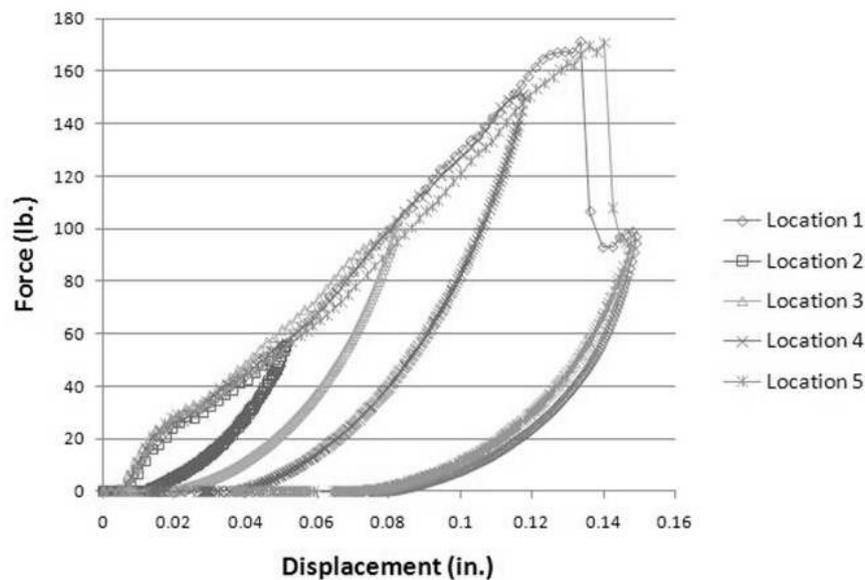
Facesheet fracture occurred in tests at *Location 1* and *Location 5* and can be seen as a sudden drop in resultant force while the applied displacement is still being increased. Tests were also conducted to 50, 100, and 150 lbs. nominally, for *Locations 2, 3, and 4*, respectively.

Fig. 5 Results of static indentation of 3PCF-XX series material coupons: resultant force vs. applied displacement.

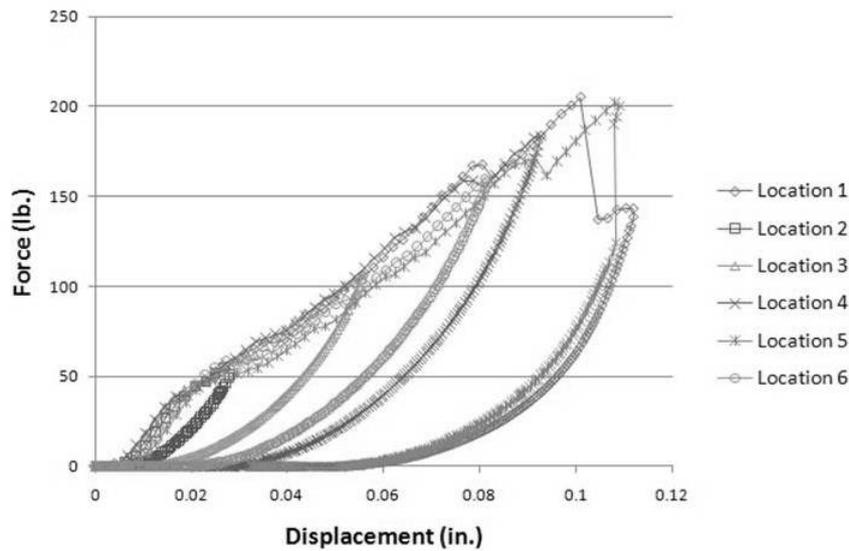
tation tests are shown in Fig. 7. The first indentation was again used to determine the load and energy required for facesheet fracture. Failure occurred at 205.1 lbs. and 0.101 in. of indentation. By integration, the energy absorbed was found to be 0.891 ft-lb. The resulting damage found in this material is similar to damage in 3PCF-XX materials, at similar energy levels. In addition to indentations made to facesheet failure at *Locations 1* and *5*, indentations were made to 50, 100, 150 and 180 lbs. at *Locations 2, 3, 6, and 4*, respectively. More static indentation results can be found for both 3PCF-XX and 6PCF-XX materials in the Ph.D. Dissertation by McQuigg [3].

Fig. 7 Results of static indentation of 6PCF-XX series material coupons: resultant force vs. applied displacement.

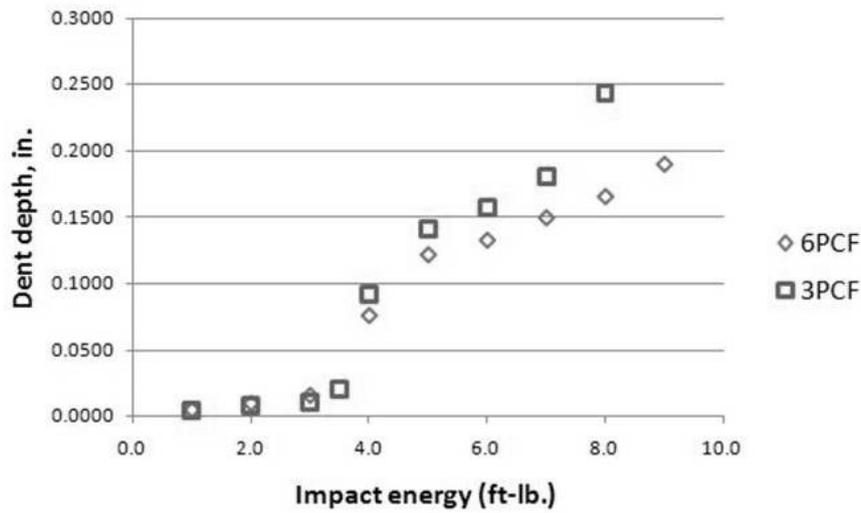
Fig. 9 Results of drop tower impact testing on 3PCF-XX and 6PCF-XX series materials: variation of the dent depth vs. the impact energy.

facesheet and almost imperceptible residual dents in the facesheet, which are shown graphically in Figs. 9 and 10. These levels are considered barely visible impact damage (BVID) as they would be difficult to find even during routine inspection, especially if the facesheets were coated with paint. The maximum impact energy level associated with BVID is about 3 ft-lb. for both sets of materials; although, for the less stiff 3PCF-XX materials it may extend marginally higher. At higher energy levels, the facesheet fracture is very noticeable. At levels of 6 ft-lb. and higher, there is practically

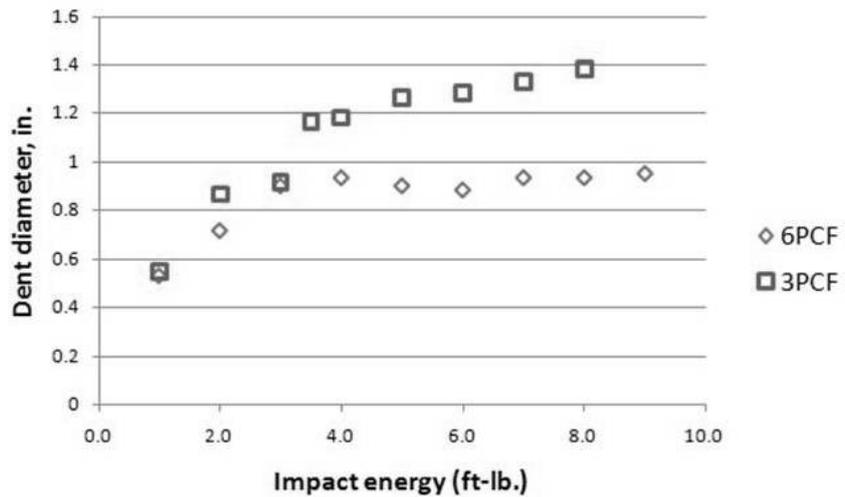
Fig. 10 Results of drop tower impact testing on 3PCF-XX and 6PCF-XX series materials: variation of the dent diameter vs. the impact energy.

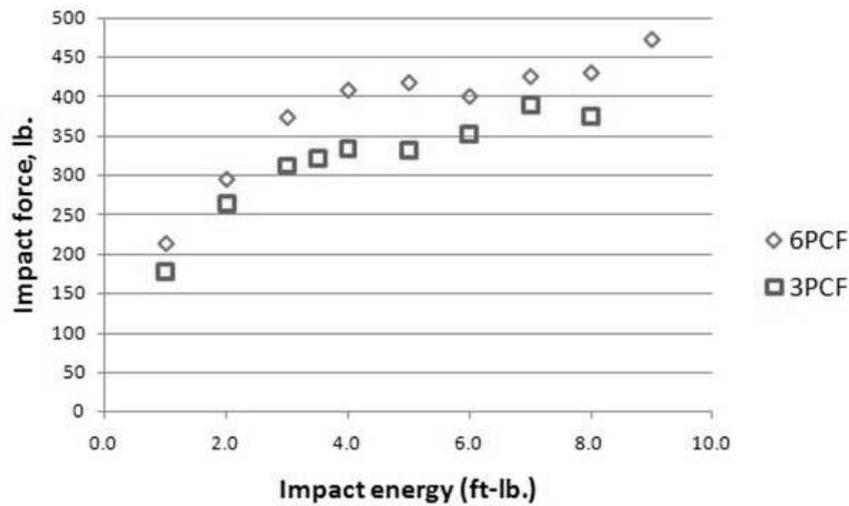
Fig. 11 Results of drop tower impact testing on 3PCF-XX and 6PCF-XX series materials: variation of the maximum impact force vs. the impact energy.

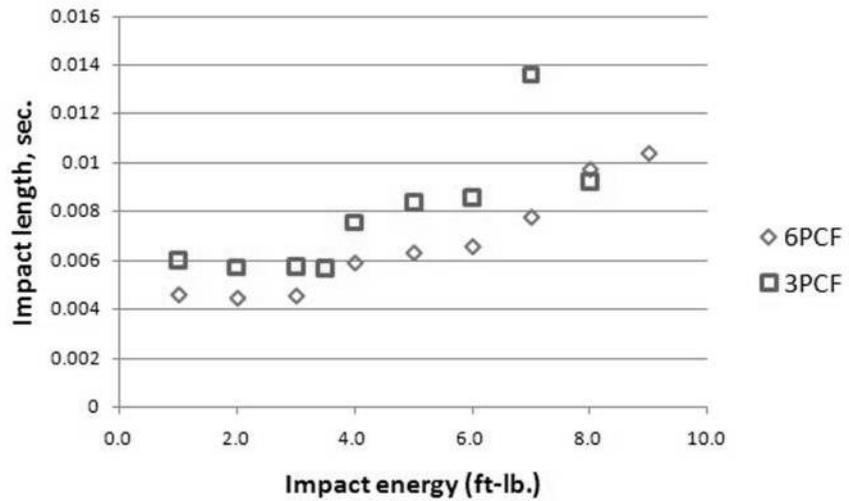
then reaches a maximum. Impact length is longer for impacts where fracture occurred due to the decreased rebound speed as more energy is absorbed by the panel, contributing to damage. Core damage was considered in detail for 3PCF-XX and 6PCF-XX panels. Figure 13 shows that the width of the damaged core region is higher for 3PCF-XX panels than for 6PCF-XX, in general. Also, the maximum thickness of the crushed core region is higher for damage regions in 3PCF-XX materials. The conclusion can be made from these results that the higher strength and stiffness of

Fig. 12 Results of drop tower impact testing on 3PCF-XX and 6PCF-XX series materials: variation of the impact length vs. the impact energy.

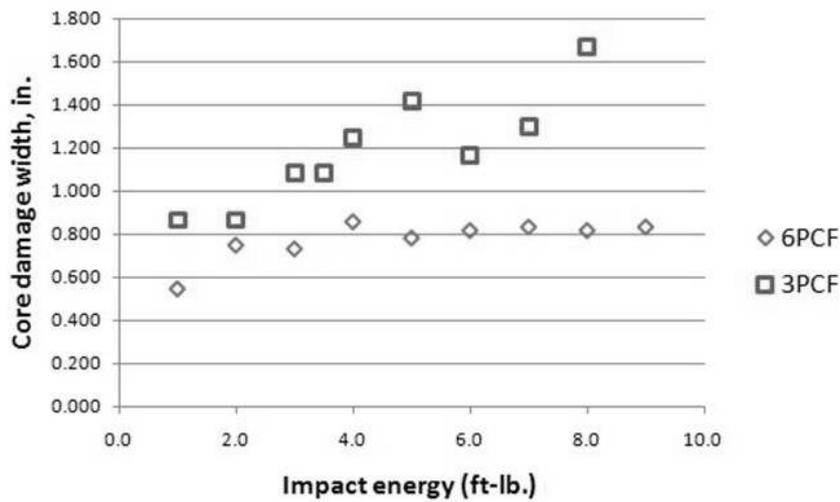
the 6PCF-XX material's core has a significant effect on the impact resistance of the sandwich panel. It is also interesting to note that the depth of the core crush region beneath the indented facesheet stays about the same for all levels of impact energy.

Fig. 13 Results of drop tower impact testing on 3PCF-XX and 6PCF-XX series materials: variation of the core damage width vs. the impact energy.

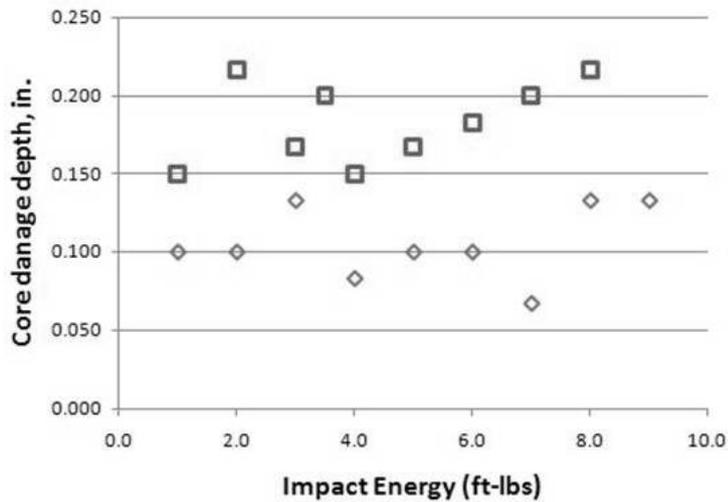
Fig. 14 Results of drop tower impact testing on 3PCF-XX and 6PCF-XX series materials: variation of the core damage depth vs. the impact energy.

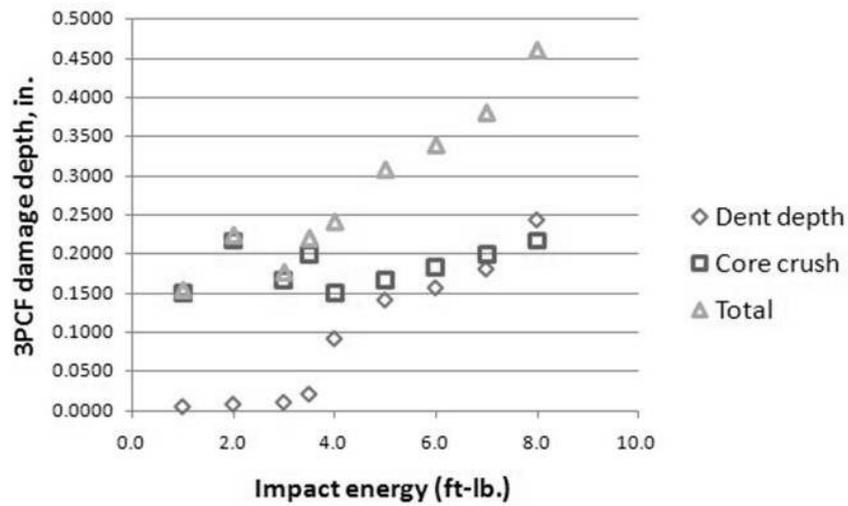
Fig. 15 Results of drop tower impact testing on 3PCF-XX and 6PCF-XX series materials: variation of the total dent depth for 3PCF-XX materials vs. the impact energy.

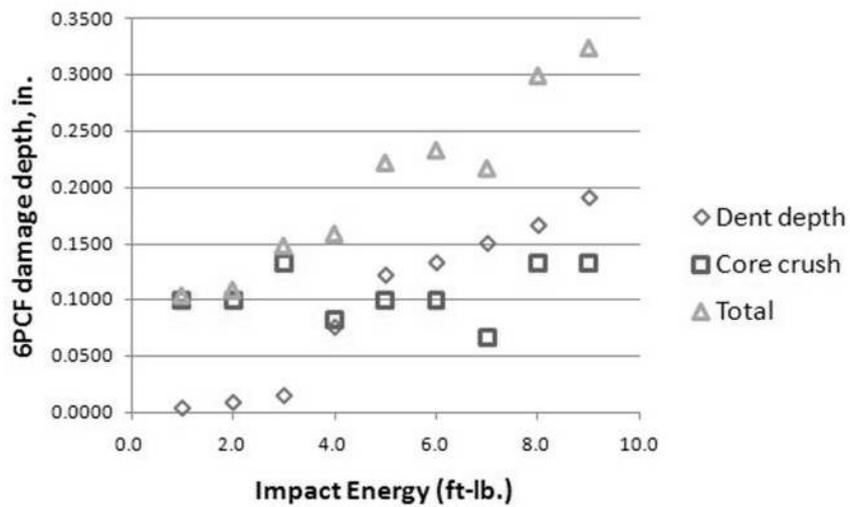
Fig. 16 Results of drop tower impact testing on 3PCF-XX and 6PCF-XX series materials: variation of the total dent depth for 6PCF-XX materials vs. the impact energy.

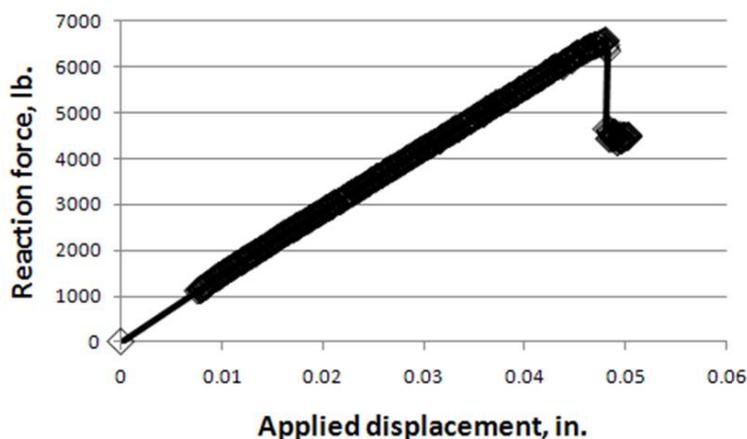
and the resulting failure loads are shown in the Appendix of Ref. [3]. A displacement controlled compressive load was applied to each coupon until failure occurred, marked by a sudden drop in the measured reaction force, as shown in Fig. 22. The region with no data points at the beginning of the test is due to the CAI test data recording beginning with some load applied. The reason for this is some load (around 1500 lb.) is applied during specimen alignment, and this was only reduced to 1000 lb. before the beginning of the test.

Fig. 22 Sample force vs. displacement results for a CAI test.

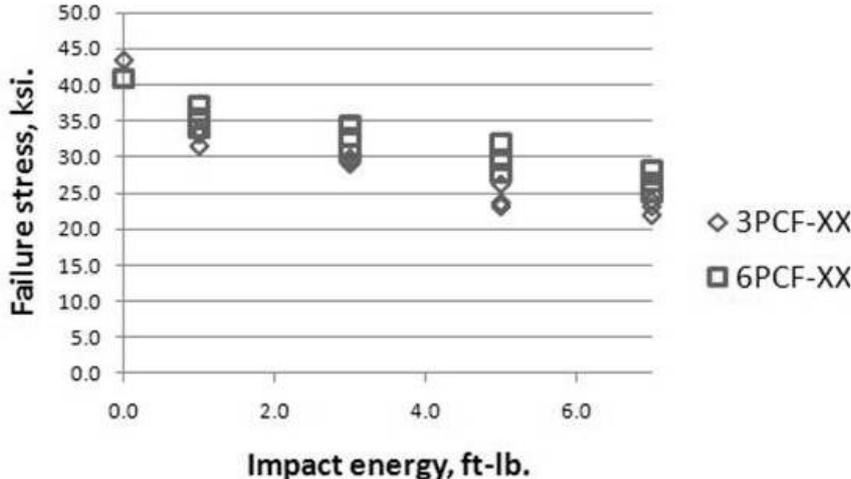
Fig. 27 CAI test results: failure stress vs. impact energy.

The failure strength of both 3PCF-XX and 6PCF-XX series coupons is shown to drop dramatically even for lightly impact-damaged specimens. The reduction in coupon strength of roughly 10 ksi from undamaged specimens to damaged specimens impacted at 1.0 ft-lb. energy levels was higher than any subsequent drop, even in the most damaged sandwich panels. The drop of failure strength is shown to decrease in severity with further increasing levels of damage. Tests of 3PCF-XX series panels with a given damage level were more repeatable in terms of their failure level than tests at 6PCF-XX series panels. It is also important to note that failure of 6PCF-XX panels impacted at a

given energy level occurred at higher stress and strain levels than 3PCF-XX panels. This suggests that the higher density honeycomb core found in 6PCF-XX panels contributes to the increased CAI strength. It was shown previously that the residual dent increases dramatically in size for the 3PCF-XX specimens, while the dent does not increase in size noticeably for the 6PCF-XX specimens. This is likely due to the higher strength and stiffness of the higher density core in response to out-of-plane compressive loads. This loading occurs when the already indented facesheets press inwards at the edges of the initial dent due to the applied compressive load to the panel. The higher out-of-plane stiffness precludes the indentation propagation failure mode; instead, the panels fail due to crack propagation due to in-plane stress concentrations in the facesheet which cause material fiber and matrix failure.
