WHITE SANDS TEST FACILITY

Auto Ignition Temperature Test Chamber Fire Investigation

Based on Report DAA-33855

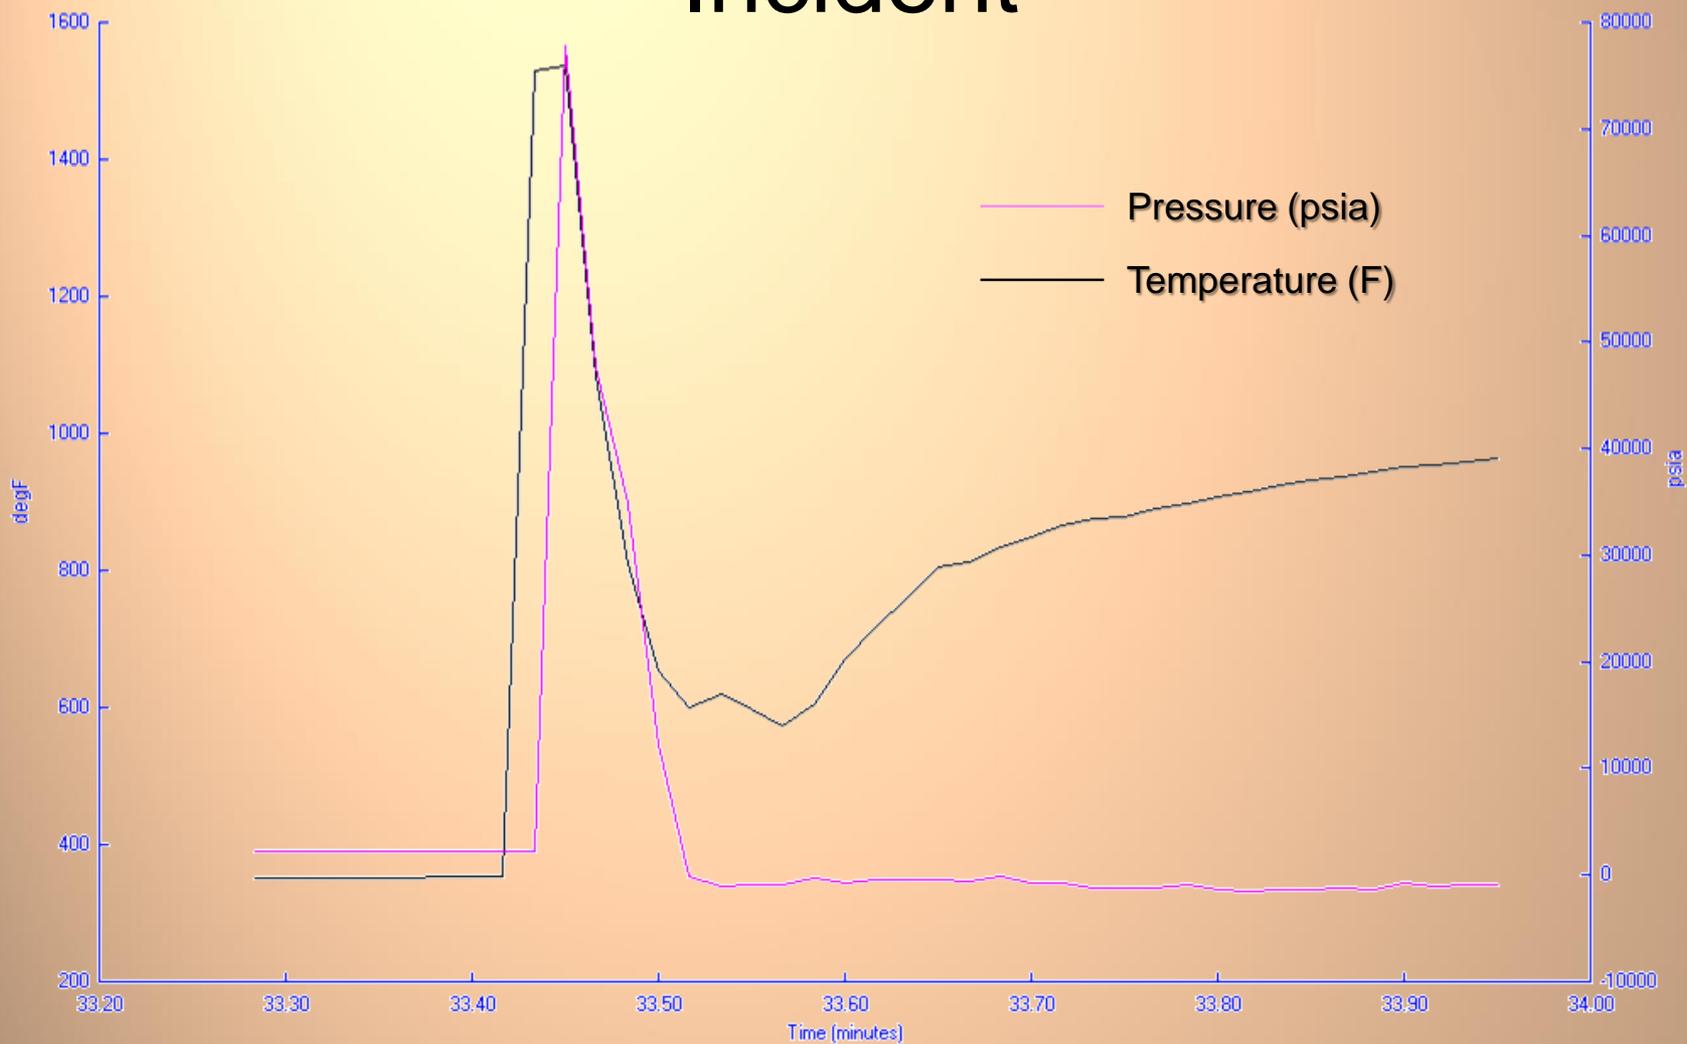
Incident

- Chemical Analysis
 - Sample weight of dodecane insufficient to cause full pressure rise alone.
 - Gordon-McBride Model
 - After 0.2g sample consumption, predicted chamber pressure 41.4 Mpa
 - Near sample 3,126 °C flame temperature @ 139 Mpa
 - Melting point of 304 SS 1400-1455 °C¹
 - ~3.5 g of SS would have to burn to increase chamber to 69 Mpa
 - ~28 g of SS was missing from inside of the reaction head
- Temperature rise happened before pressure rise.
- Secondary fire in RV-10 may have been due to rapid pressurization of contamination from previous testing.

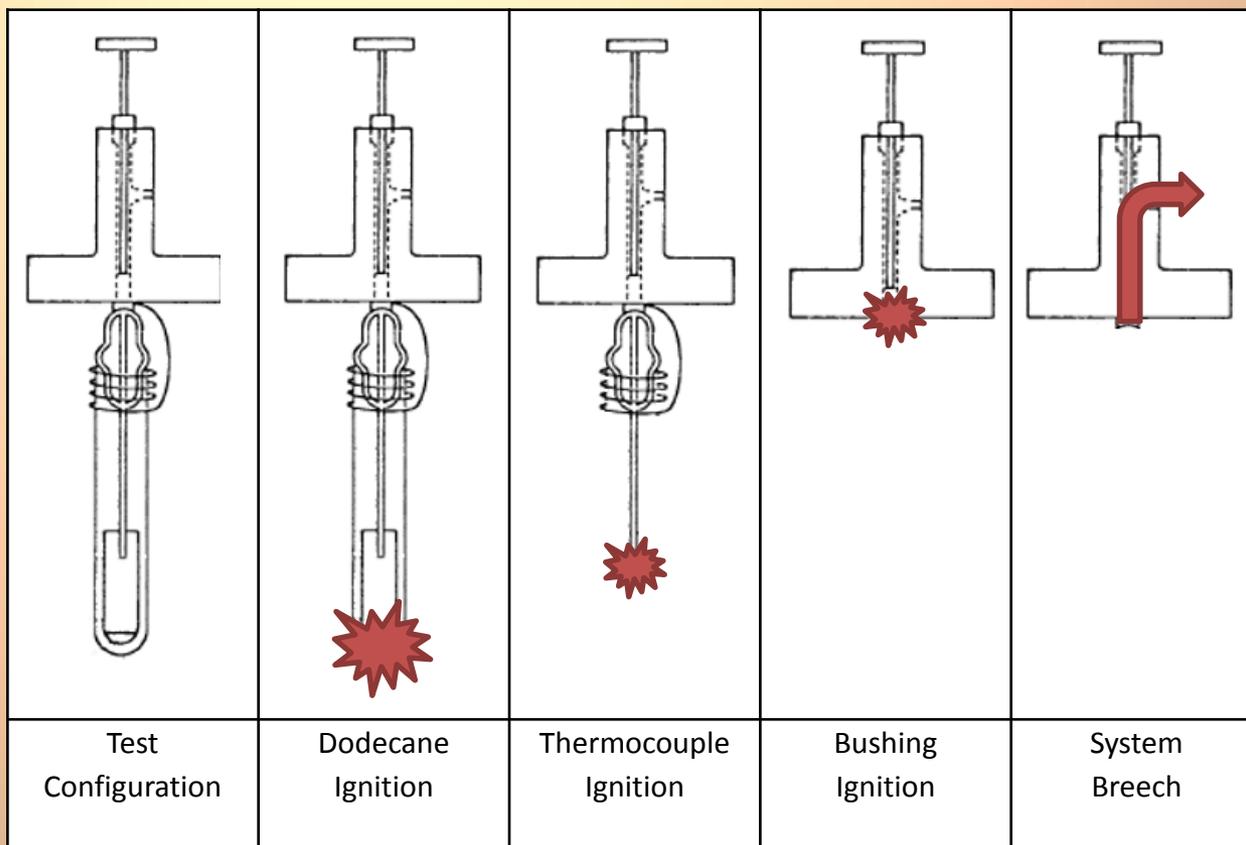
Proposed Series of Events

- TJE Type Transducer
 - Published Overpressure (Burst)
 - 172 Mpa (20 ksi)
- Data indicated large pressure rise between samples ~1 Hz
- Sufficient to mechanically rupture pressure transducer
- Fine Solidified Metal Spray found through out system increasing reaction rate. (Line dia 3.125 mm)

- The stainless busing was replaced with brass to quench possible TC ignition events in the future.
- Contamination found down stream needs to be evaluated for cross contamination issues.
- Fire risks related to unexpected overpressure from contained sprayed metal fires is not well understood.
- The space suit POR was extremely robust.
