NASA TN D-1402

X-15 FLIGHT CONTROL SYSTEM

TECHNICAL NOTE D-1402

OPERATIONAL EXPERIENCES AND CHARACTERISTICS OF THE X-15 FLIGHT CONTROL SYSTEM

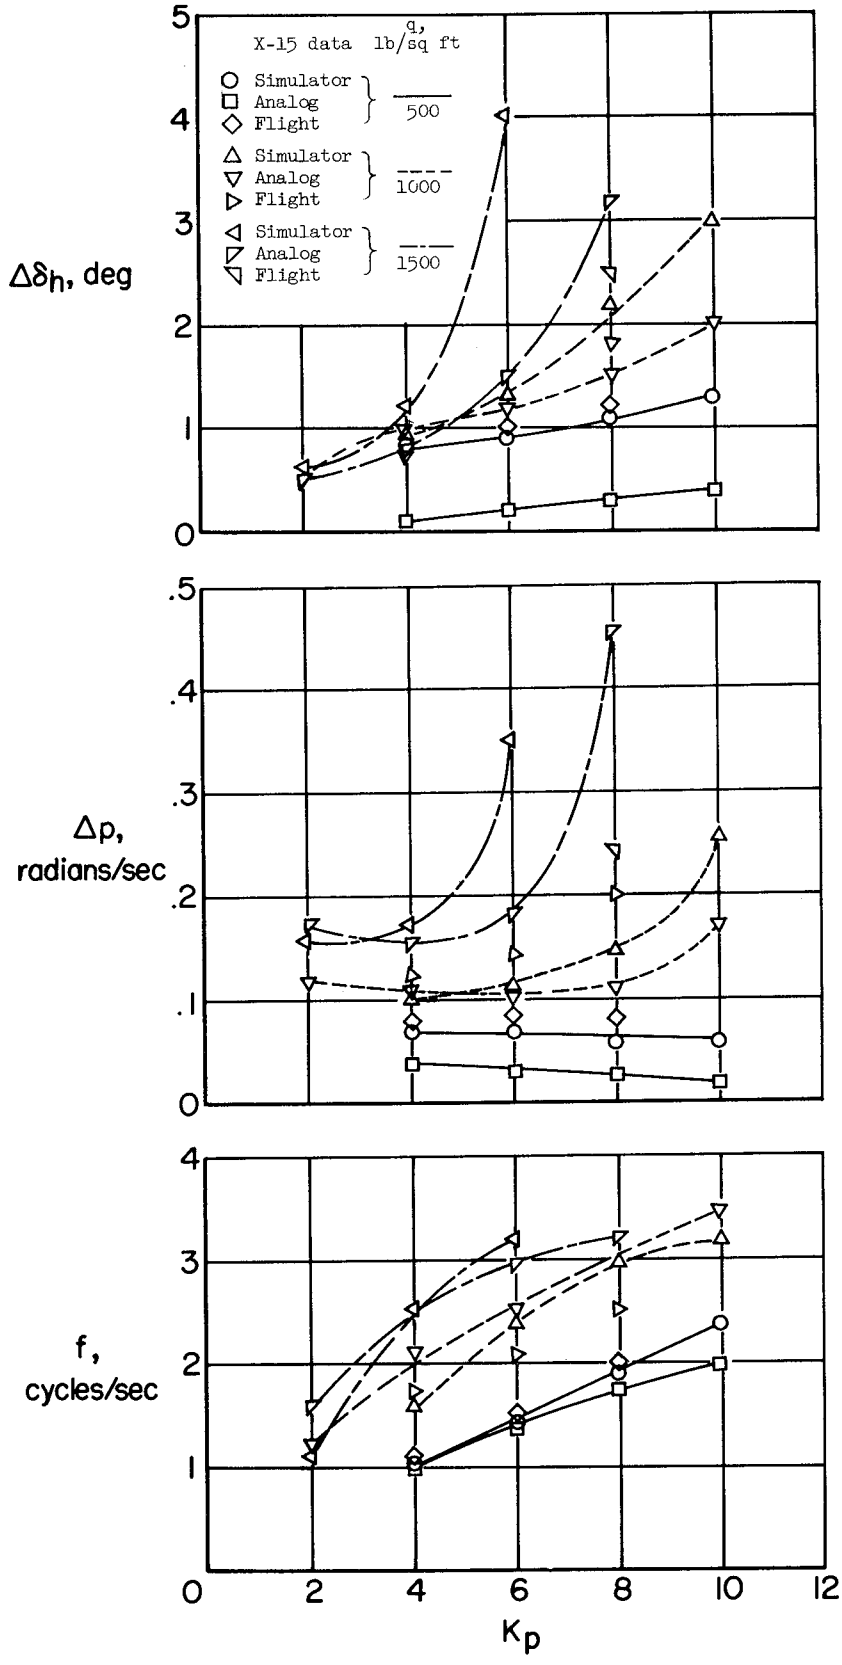
Problems.- Limit cycles, or residual oscillations, caused by the stability augmentation system were encountered first in the X-15 flight simulator. Phase lag produced by the hysteresis and dead band at very small amplitudes caused the limit cycles, which existed in all three axes when the damper gain and control power were high. The hysteresis is the result of the free play in the control linkages between the bungees and the walking beams of the basic control system. In the early flight program, limit cycles of small amplitude were observed in the flight records, but were unnoticed by the pilots. In subsequent flights to higher dynamic pressure, the pilots reported limit-cycle oscillations in roll. Generally, the limit-cycle appeared when the roll-damper gain setting was greater than 6 and the dynamic pressure greater than 500 lb/sq ft. These limit cycles are a function of SAS gain and control effectiveness (ref. 4). The pitch limit cycle occurred at a higher gain than in roll at a given dynamic pressure. Although the pilots have been aware of the yaw limit cycle on occasion during the higher performance flights, it has not been a problem. The roll limit cycle produced the largest amplitude; however, this amplitude was less than 1° change in bank angle at frequencies of 1 cps to 3 cps.

Figure 9 compares the limit-cycle characteristics of the X-15 airplane ground tests (aerodynamics were simulated by an analog computer), the X-15 flight simulator, and the available X-15 flight data. In general, these three types of data are comparable, but the limit-cycle characteristics are more severe for the X-15 flight simulator than for actual X-15 flight at the same given conditions. In an initial effort to alleviate the limit-cycle problem, phase lead was increased in the system by removing the original shaping which had provided system lag. Subsequent flights with this configuration resulted in a limit cycle of lower amplitude at higher frequency. Although this was a more acceptable system in regard to limit cycles, the SAS then became susceptible to a high-frequency (12 to 13 cps) vibration, discussed in the following paragraph. Additional analysis and discussion of the limit-cycle problem are presented in reference 4.

Figure 9.- Limit-cycle characteristics. $M = 2.0$; $K_q = 0$.

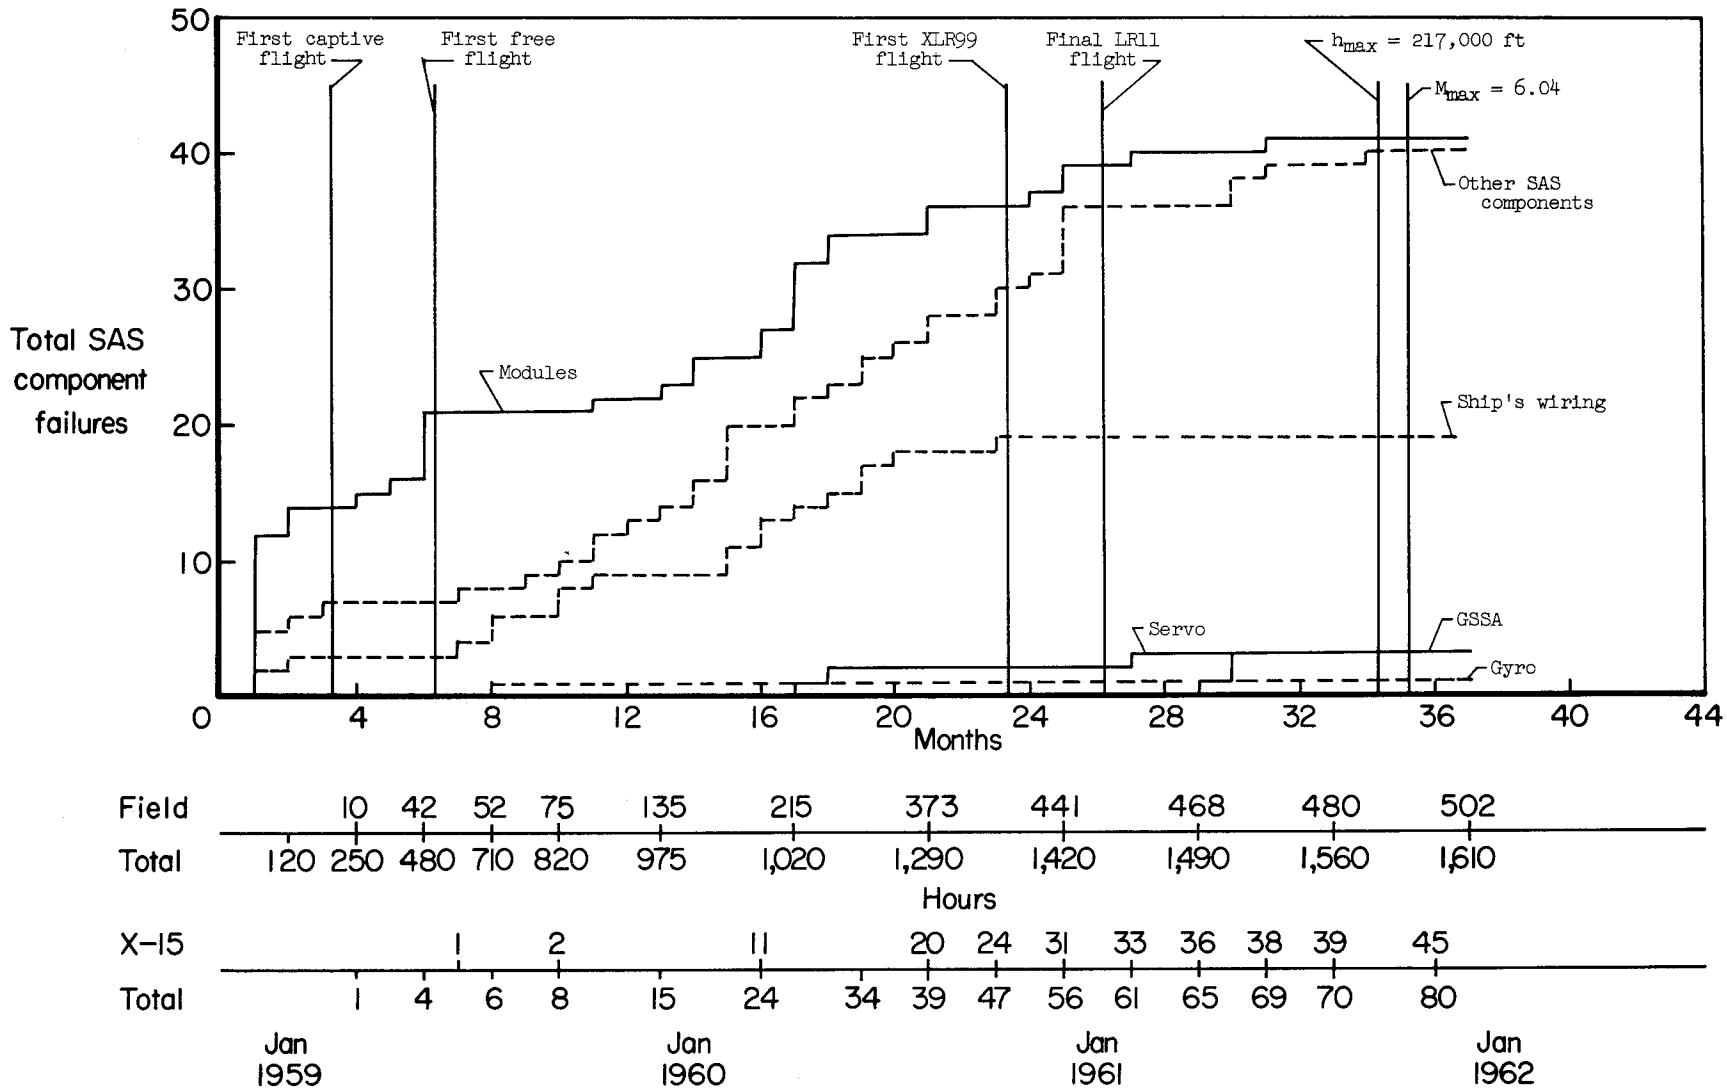
During the total operational period of 1,610 SAS hours, 107 individual SAS components failed. Of these, 100 failed during ground servicing, and 7 failed after the system was closed out for flight. Figure 10 is the complete failure record for the X-15 program. As expected, most of the failures occurred early in the program when operation was at a maximum and technical experience at a minimum. Of the components, the modules failed most frequently. Detailed study of the failed modules revealed that transistor malfunction was the most common cause of the failures.

Figure 10.- Failure history of SAS components.

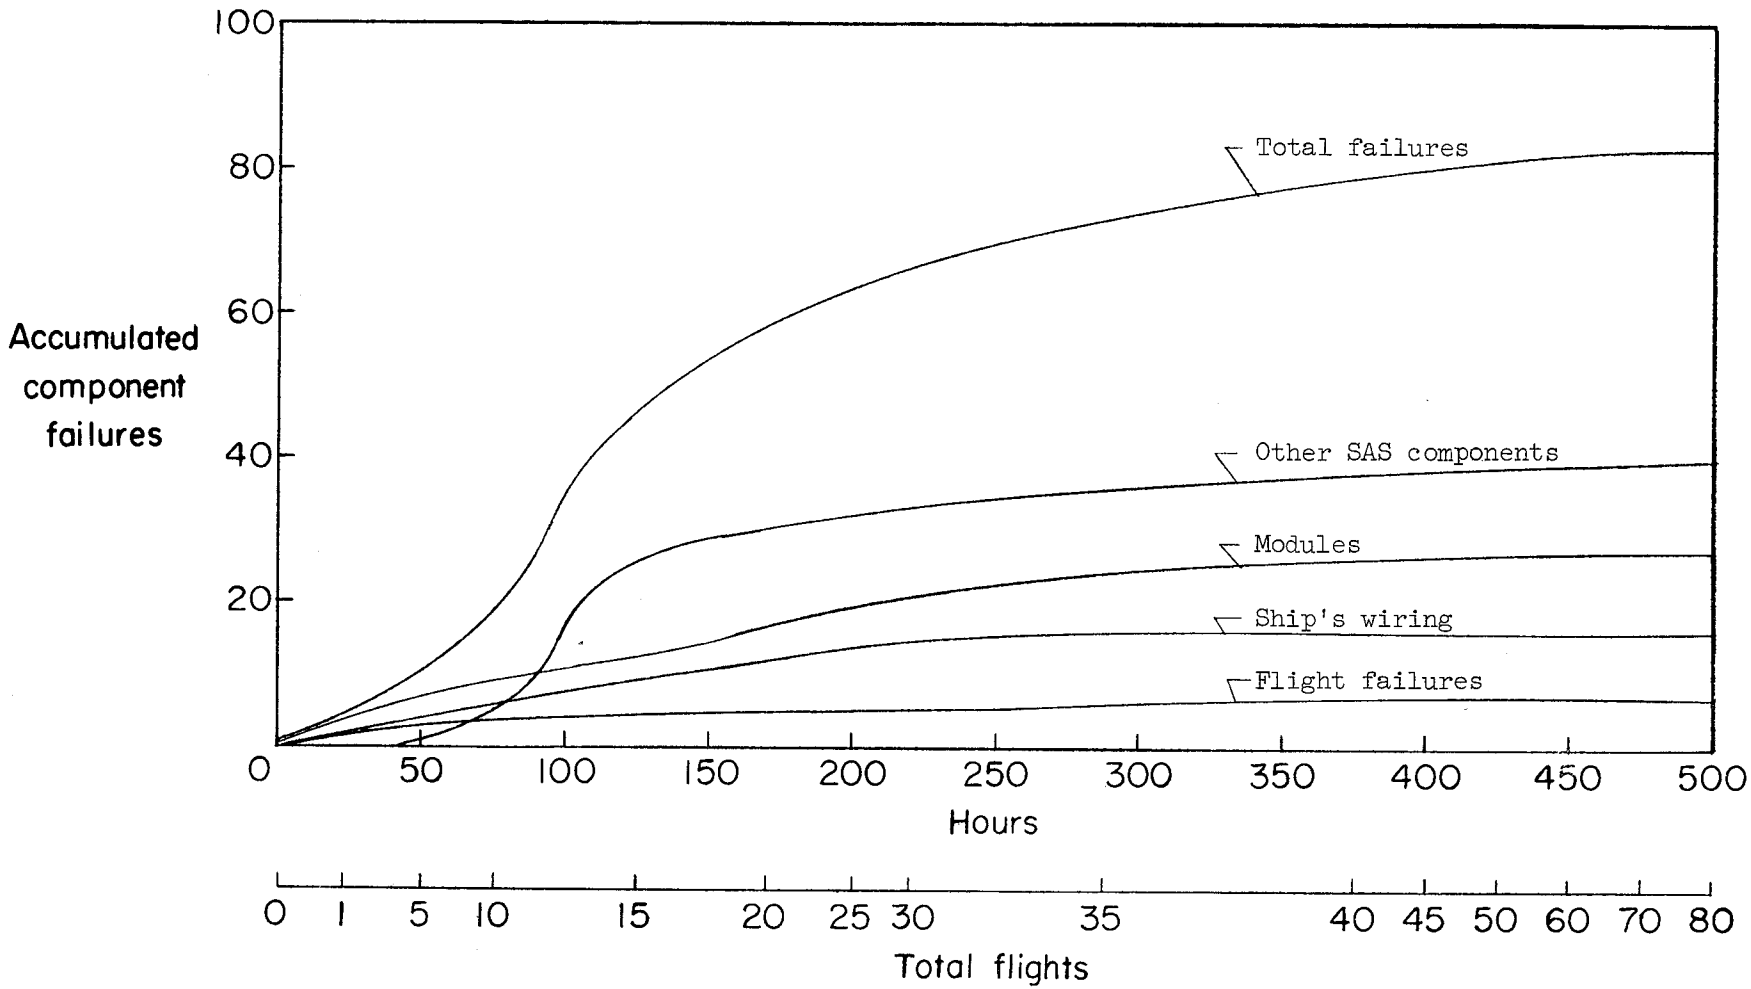
Figure 11 presents faired curves of component failure for the field service period. Also included, for comparison, is the flight-failure curve. It can be readily seen that the failure rate is decreasing, as evidenced by the slope of the curves approaching zero.

Figure 11.- SAS component failures during the field operation period.

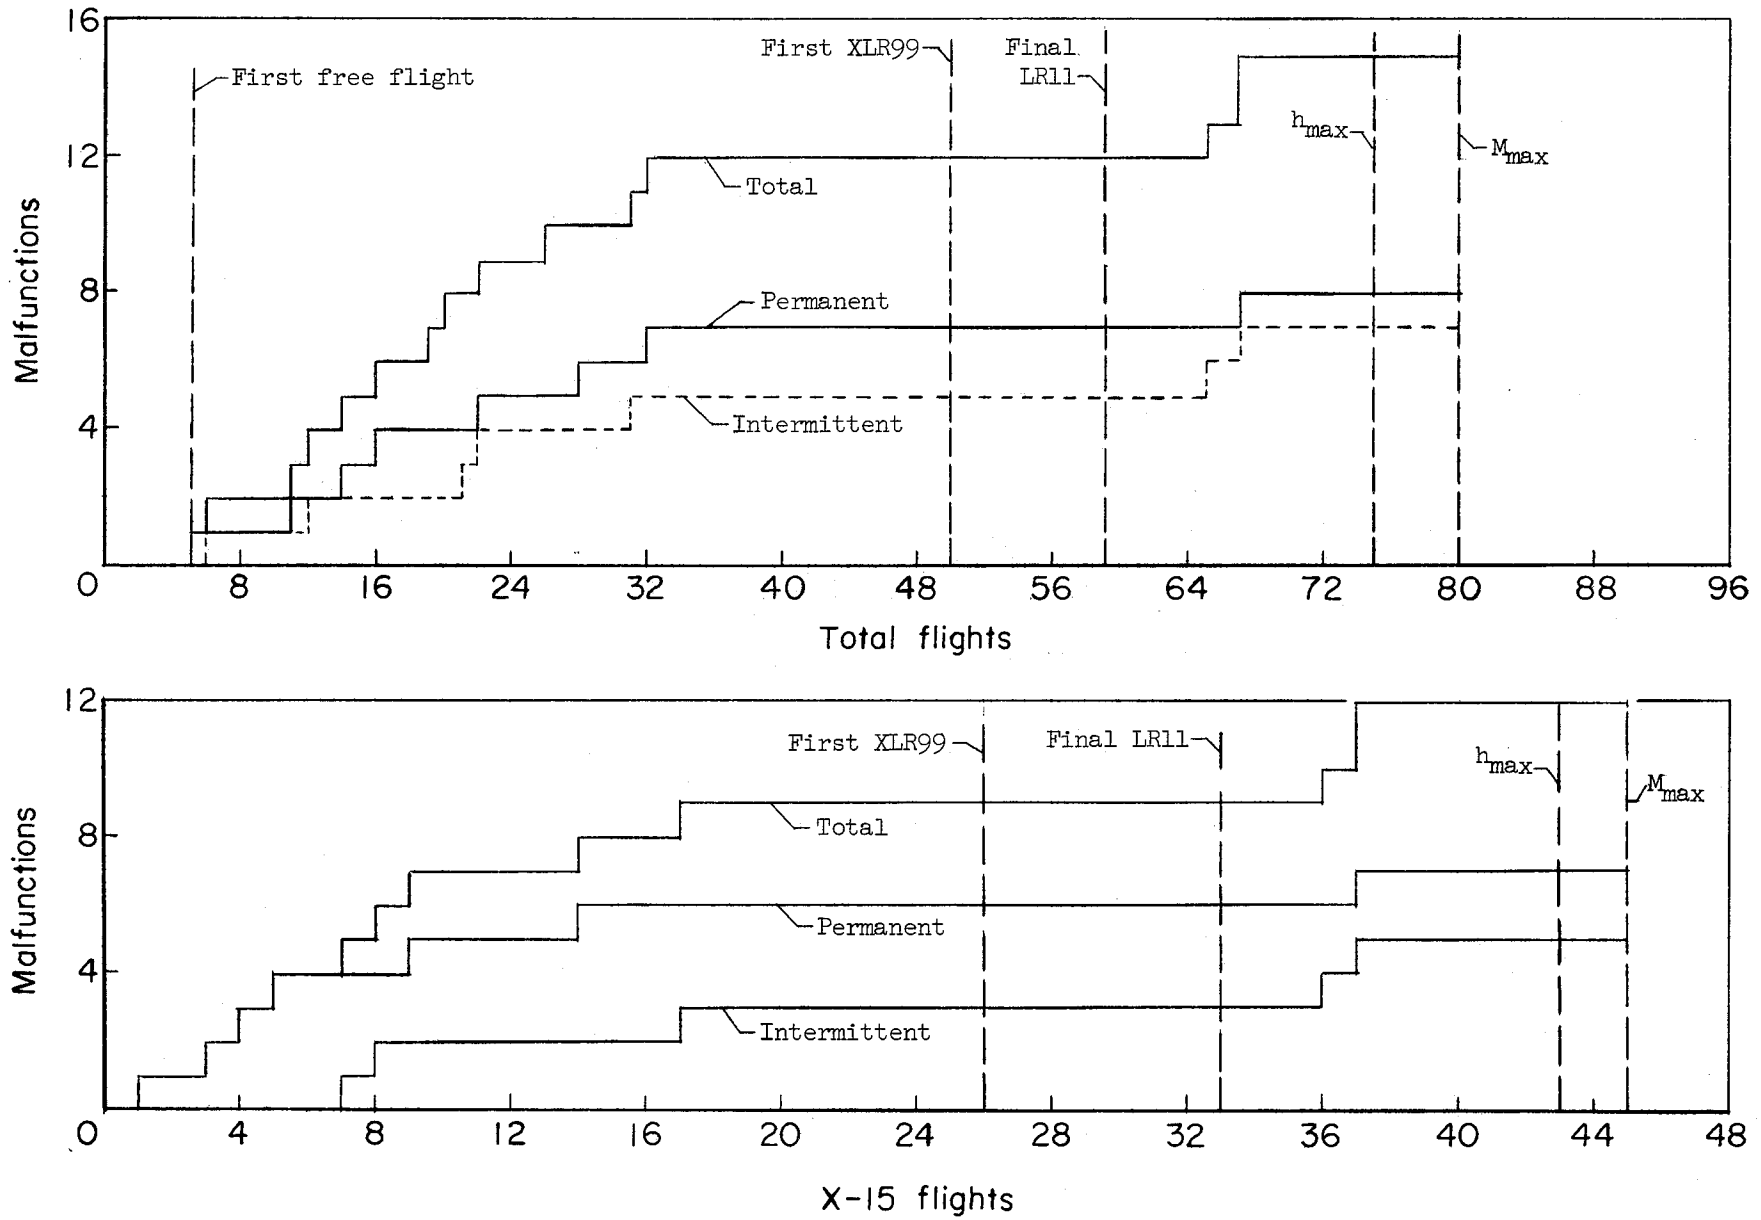
Table III presents a breakdown of the malfunctions affecting flight and the period in which the malfunction occurred, regardless of the time of discovery. Permanent failure was the predominant malfunction and occurred, in all but one instance, during the captive flight phase. The overall flight reliability in relation to system malfunction has been 86.1 percent.

Figure 12.- SAS malfunctions affecting flight.
