Saturn S-II

Problem Resolution History Report

September 1971

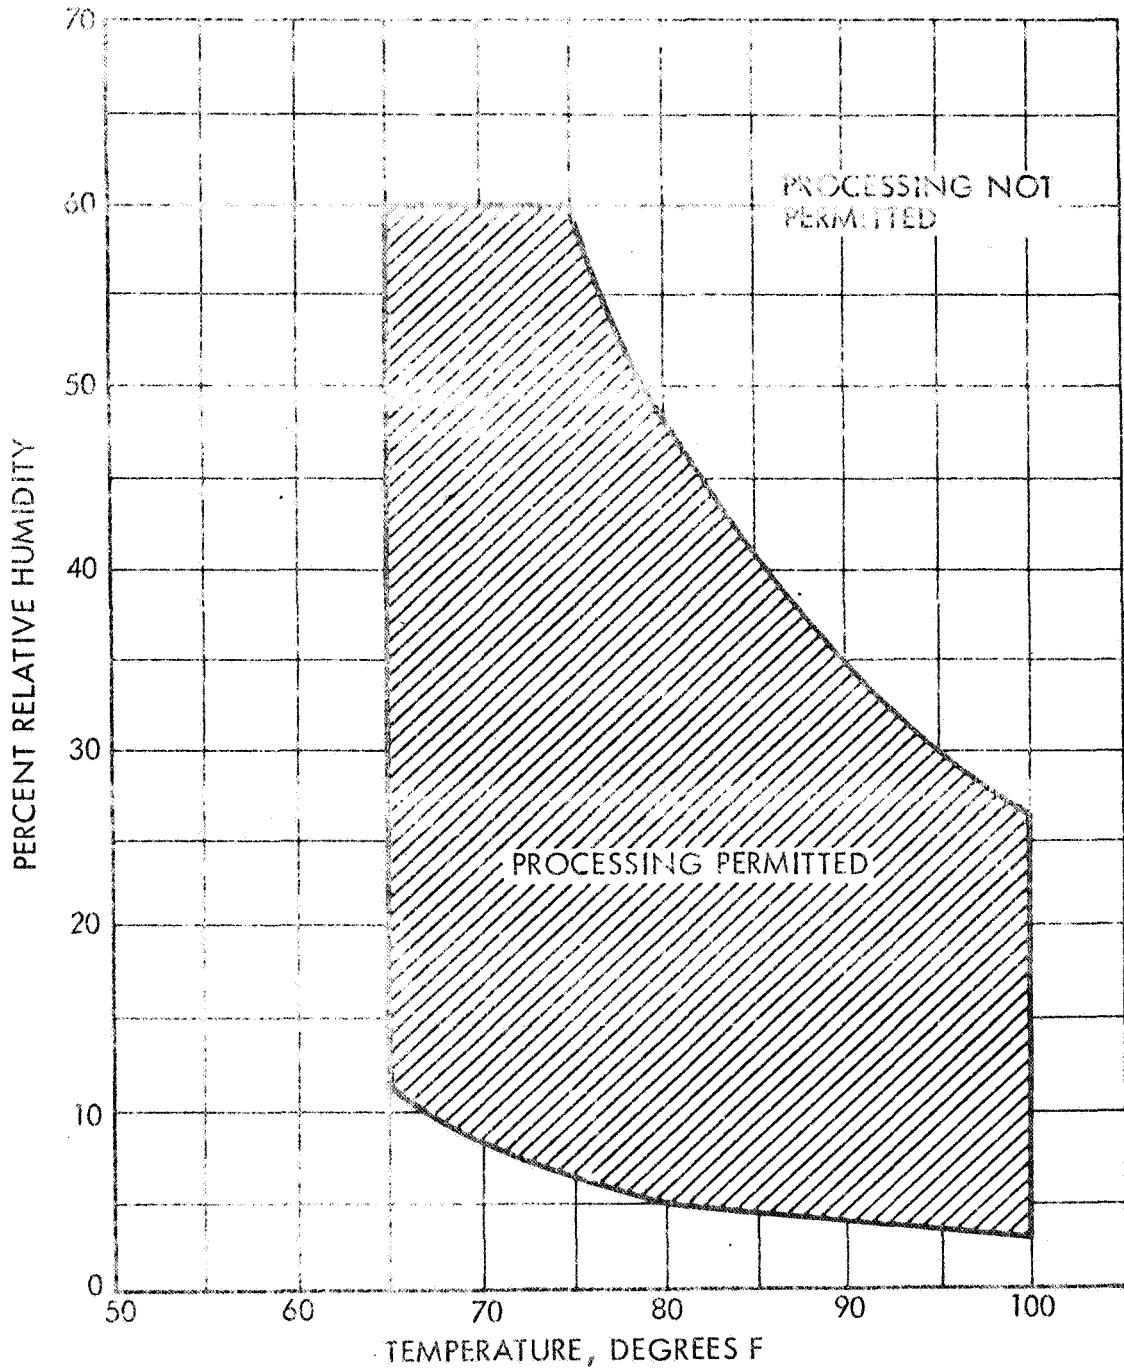
Figure 33. Temperature and Relative Humidity Requirements

It is recommended that all specifications governing the use of moisture sensitive organic materials contain this type of environmental requirements for processing (Figures 33 and 34).
