## PRACTICAL ASPECTS OF DESIGNING FOR AND EVALUATING STRUCTURAL INTEGRITY

By Marcel Peyrony and Daniel Chaumette  
Avions Marcel Dassault  
Saint-Cloud, France

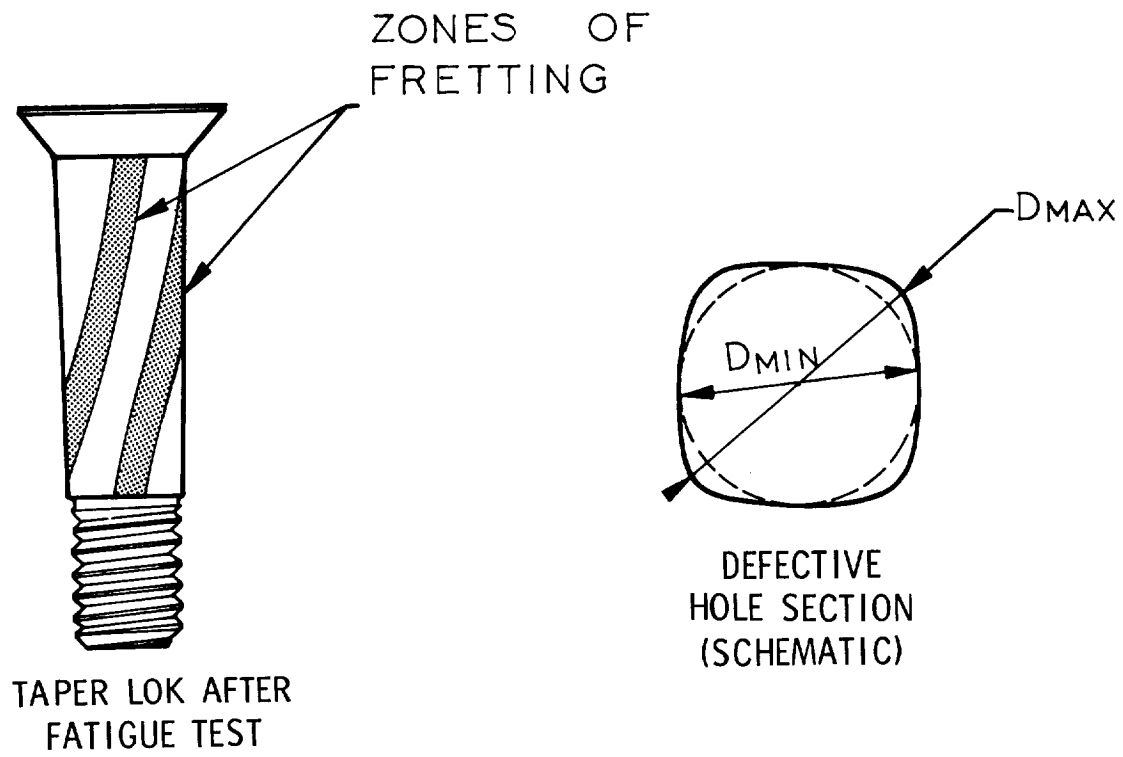
Figure 3.- Defective installation of Taper Lok.

The first test results (fig. 2) were most encouraging, until a test specimen broke after a disappointingly low number of cycles. A more thorough inspection of the test piece (which had been inspected prior to testing) showed a reaming fault as in figure 3. The bolt bears only on four regions.

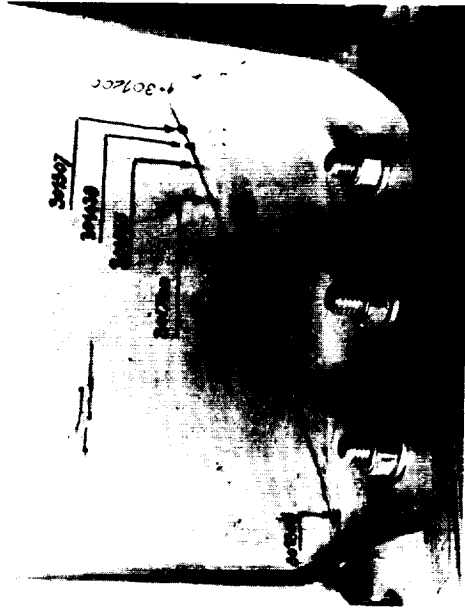
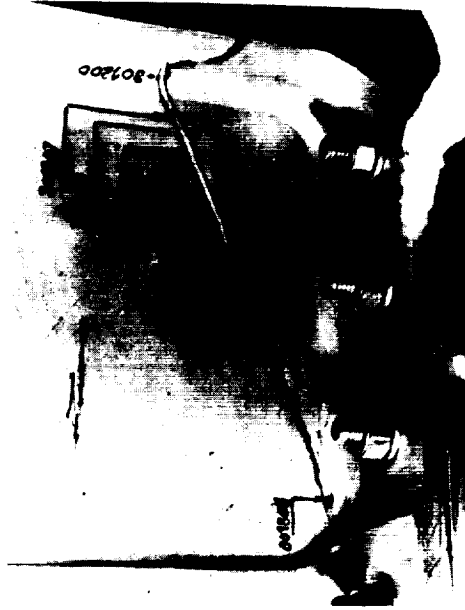
Overall view without load.

Overall view under load.

Closeup view without load.

Closeup view under load.

Figure 14.- Test of development of a crack in longeron no. 2.

Next we artificially provoke cracks in critical areas – that is, areas where calculations and photostress investigations show stress concentrations. (See fig. 14.) The crack growth rate is plotted against time in order to define a schedule of inspections that will provide detection in service before the risk of dangerous failure is encountered. This implies that the tests are based on particular conditions.
