NATIONAL ADVISORY COMMITTEE FOR AERONAUTICS

## EFFECT OF MAXIMUM CRUISE-POWER OPERATION AT ULTRA-LEAN MIXTURE AND INCREASED SPARK ADVANCE ON THE MECHNICAL CONDITION OF CYLINDER COMPONENTS

MEMORANDUM REPORT

Air Technical Service Command, Army Air Forces

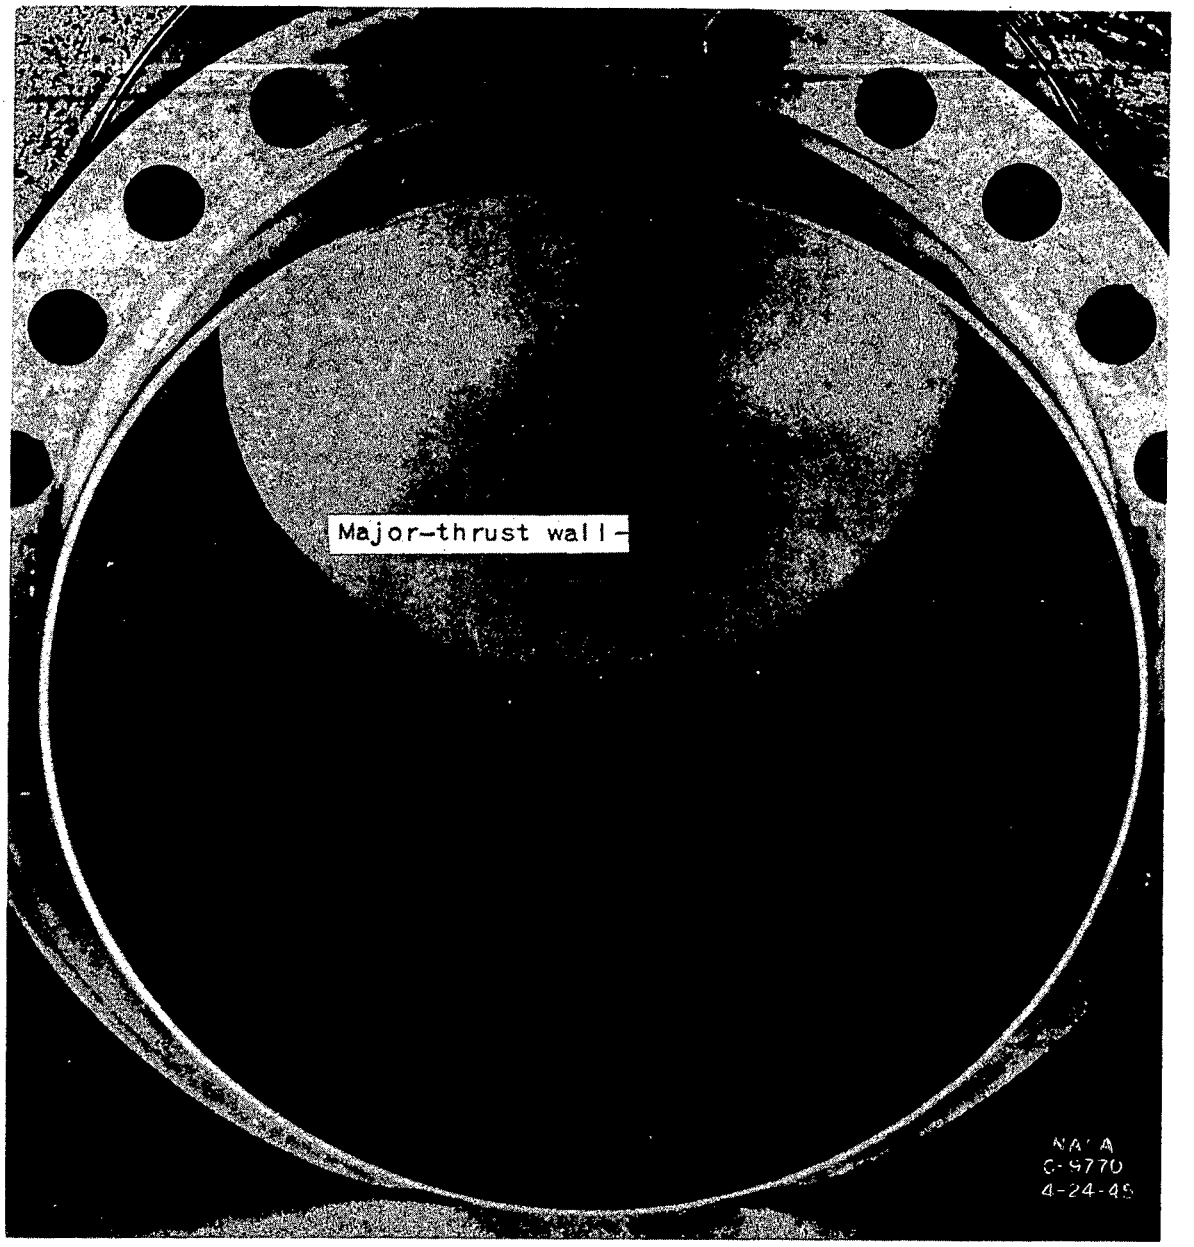
Cylinders. - Inspection of the cylinder components after engine disassembly indicated that they were in good condition. The cylinder barrels were in good condition. All the barrels were lightly lacquered and had a few light scuff marks on the major-thrust wall. The major-thrust wall of a typical cylinder barrel is shown in figure 5. The cylinder-bore wear in both the thrust and nonthrust directions resulting from the test is shown in table I. Cylinder wear, which was heaviest in the choke, was very light on the thrust and nonthrust diameters. The valve seats were in good condition. The cylinder domes had a light carbon coating with a few localized heavy-lead deposits (fig. 6). In the cylinder photographed, the localized-lead deposits were near the junction of the head and barrel between the front spark-plug bushing and the intake-valve seat insert. The localized-lead deposits in the rest of the cylinders were heavier and occurred near the junction of the head and barrel but in different places around the cylinder.

Figure 5. - Condition of bore of typical cylinder after 50-hour test of nine-cylinder air-cooled radial engine. Brake horsepower, 750; engine speed, 1900 rpm; brake mean effective pressure, 172 pounds per square inch; fuel-air ratio, 0.052; spark advance, 30° B.T.C.; maximum rear-spark-plug-bushing temperature, 400° F.

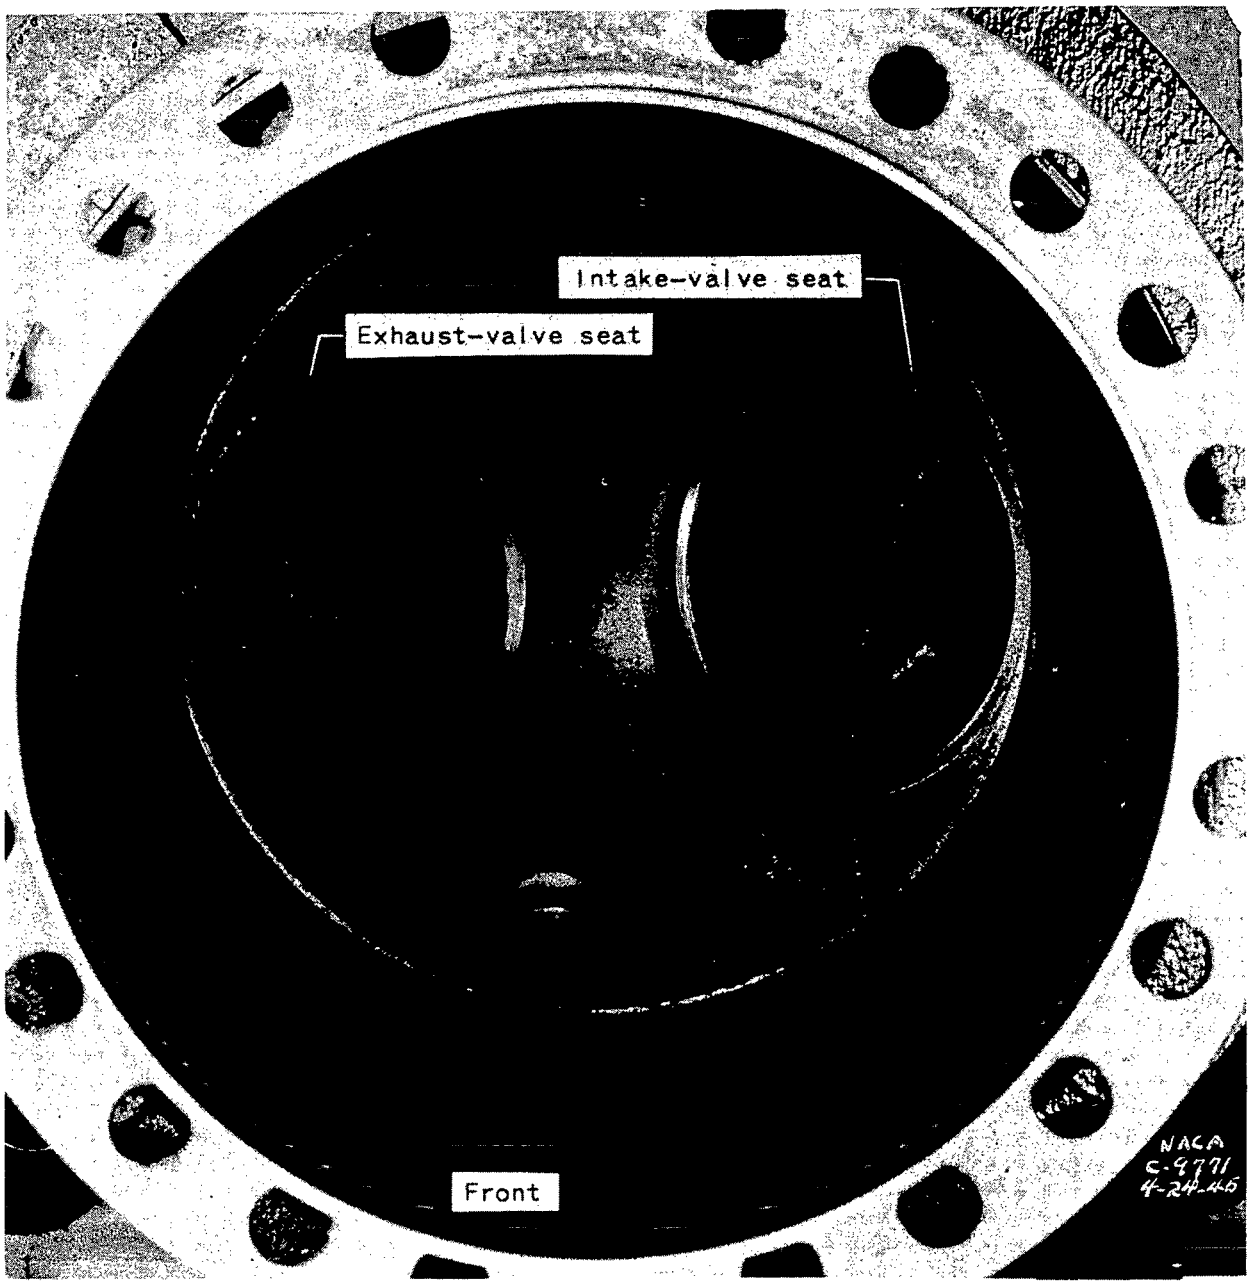
Figure 6. - Condition of combustion chamber of typical cylinder after 50-hour test of nine-cylinder air-cooled radial engine. Brake horsepower, 750; engine speed, 1900 rpm; brake mean effective pressure, 172 pounds per square inch; fuel-air ratio, 0.052; spark advance, 30° B.T.C.; maximum rear-spark-plug-bushing temperature, 400° F.

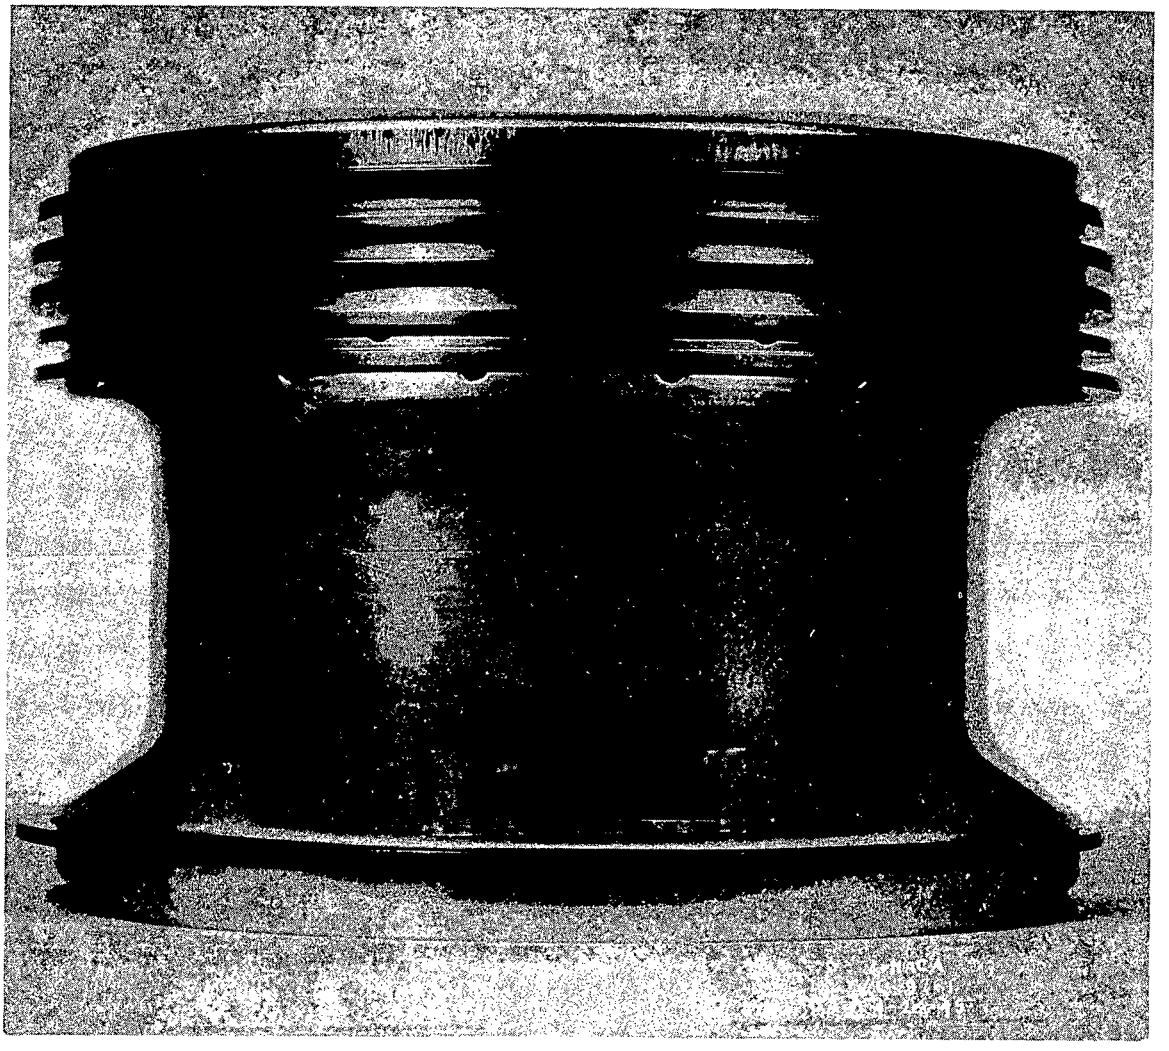
(a) Major thrust.

Pistons and piston rings. - The pistons were in very good condition at the end of the test. The piston crowns were covered with a light carbon deposit and small localized-lead deposits similar to those on the dome of the cylinders. The major-thrust and minor-thrust faces of a typical piston with rings after cleaning at the end of the test are shown in figure 7. These photographs show the light face contact at the top and bottom of the thrust faces and the light scuff marks on the piston thrust face. Piston wear resulting from the test was too small to measure. No pounding out of the ring lands existed as shown by the values of piston-ring side clearance in table II.

Figure 7. - Condition of typical piston and rings after cleaning following 50-hour test of nine-cylinder air-cooled radial engine. Brake horsepower, 750; engine speed, 1900 rpm; brake mean effective pressure, 172 pounds per square inch; fuel-air ratio, 0.052; spark advance, 30° B.T.C.; maximum rear-spark-plug-bushing temperature, 400° F.

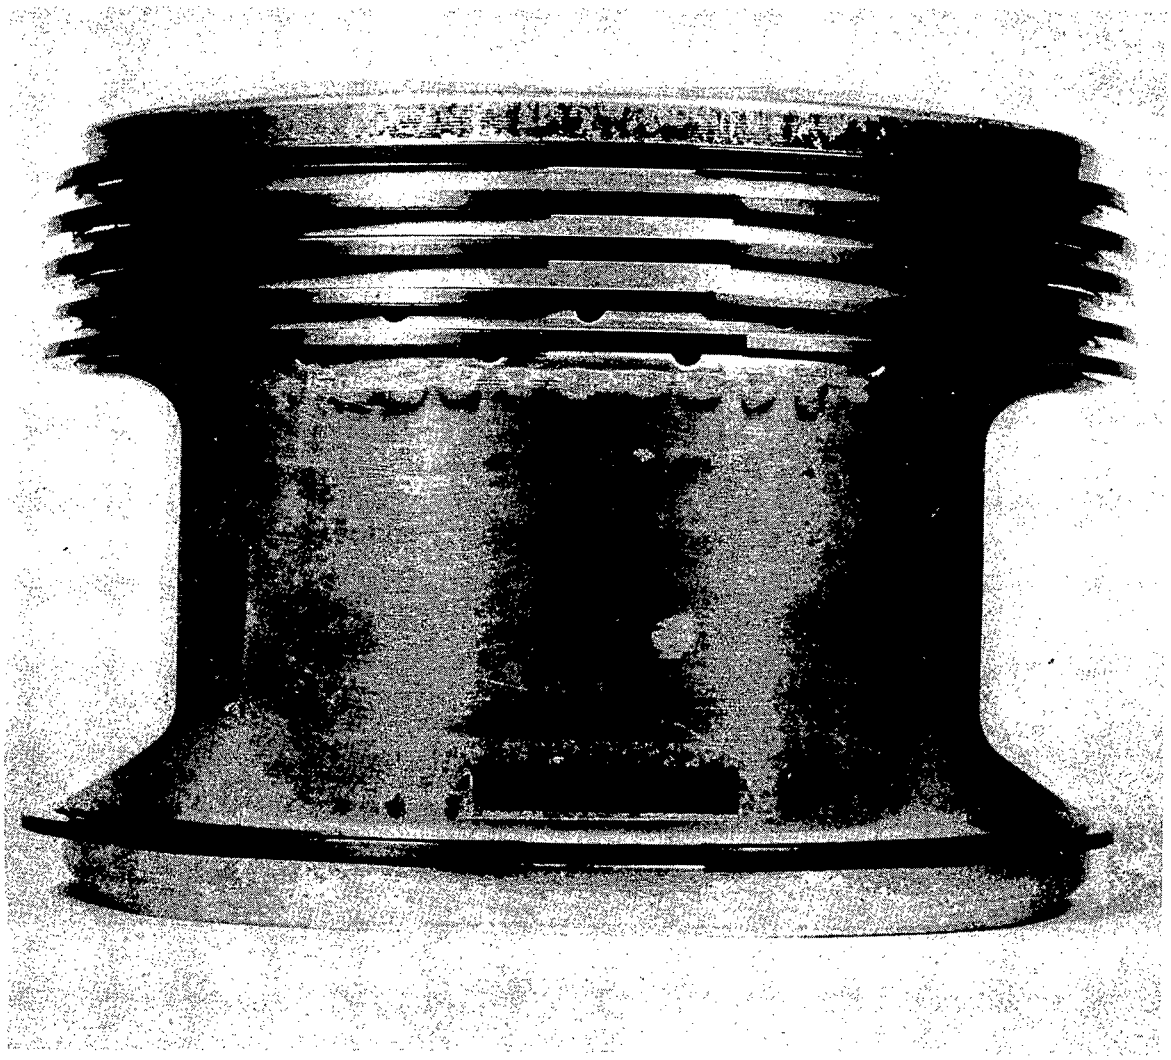
(b) Minor thrust.

The condition of the piston rings after the test was very good. No ring scuffing, scoring, or sticking was evident. The piston-ring wear data are presented in table II. The ring wear as indicated by weight loss was small and nonuniform in the different cylinders.

Figure 7. - Concluded.

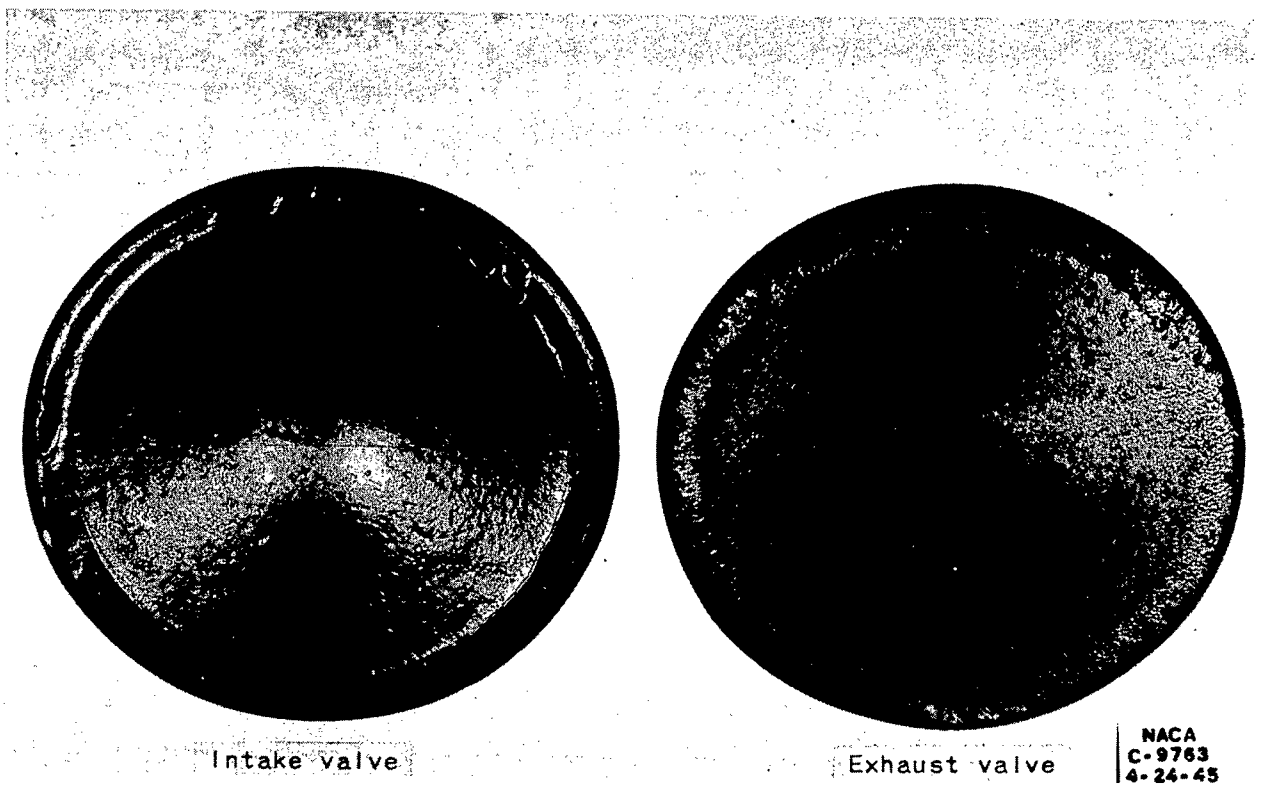
Valves. - All the valve heads were covered with a heavy deposit when they were removed from the engine. The typical heavy deposits on the heads of both the intake and exhaust valves are shown in figure 8. The deposits on the intake valves were greenish-yellow with a

glazed surface and completely covered the concave portion of the valve head. The coating on the exhaust valves varied from the smooth greenish-yellow deposits shown on the valve in figure 8 to the dark red globular deposits shown on the valve head in figure 9. The weight of the deposits on the valves is given in table III. The average weight of deposit was 4.15 and 7.26 grams for the exhaust and intake valves, respectively.

A spectrographic analysis made of the deposits on the intake and exhaust valves indicated that lead was the chief constituent. (See table IV.) A chemical analysis was then made according to the method of reference 9 to determine in what compounds the lead appeared. The composition of the lead deposit on the valves is shown in the following table:

The under side of the exhaust-valve heads had a light even coating of yellow lead oxide. A factor contributing in part to the heavy lead deposits may have been the small excess of tetraethyl lead indicated by the fuel analysis, which is discussed in a later section.

Figure 8. - Valve heads of cylinder 7 typical of intake and exhaust valves after 50-hour test of nine-cylinder air-cooled radial engine. Brake horsepower, 750; engine speed, 1900 rpm; brake mean effective pressure, 172 pounds per square inch; fuel-air ratio, 0.052; spark advance; 30° B.T.C.; maximum rear-spark-plug-bushing temperature, 400° F.

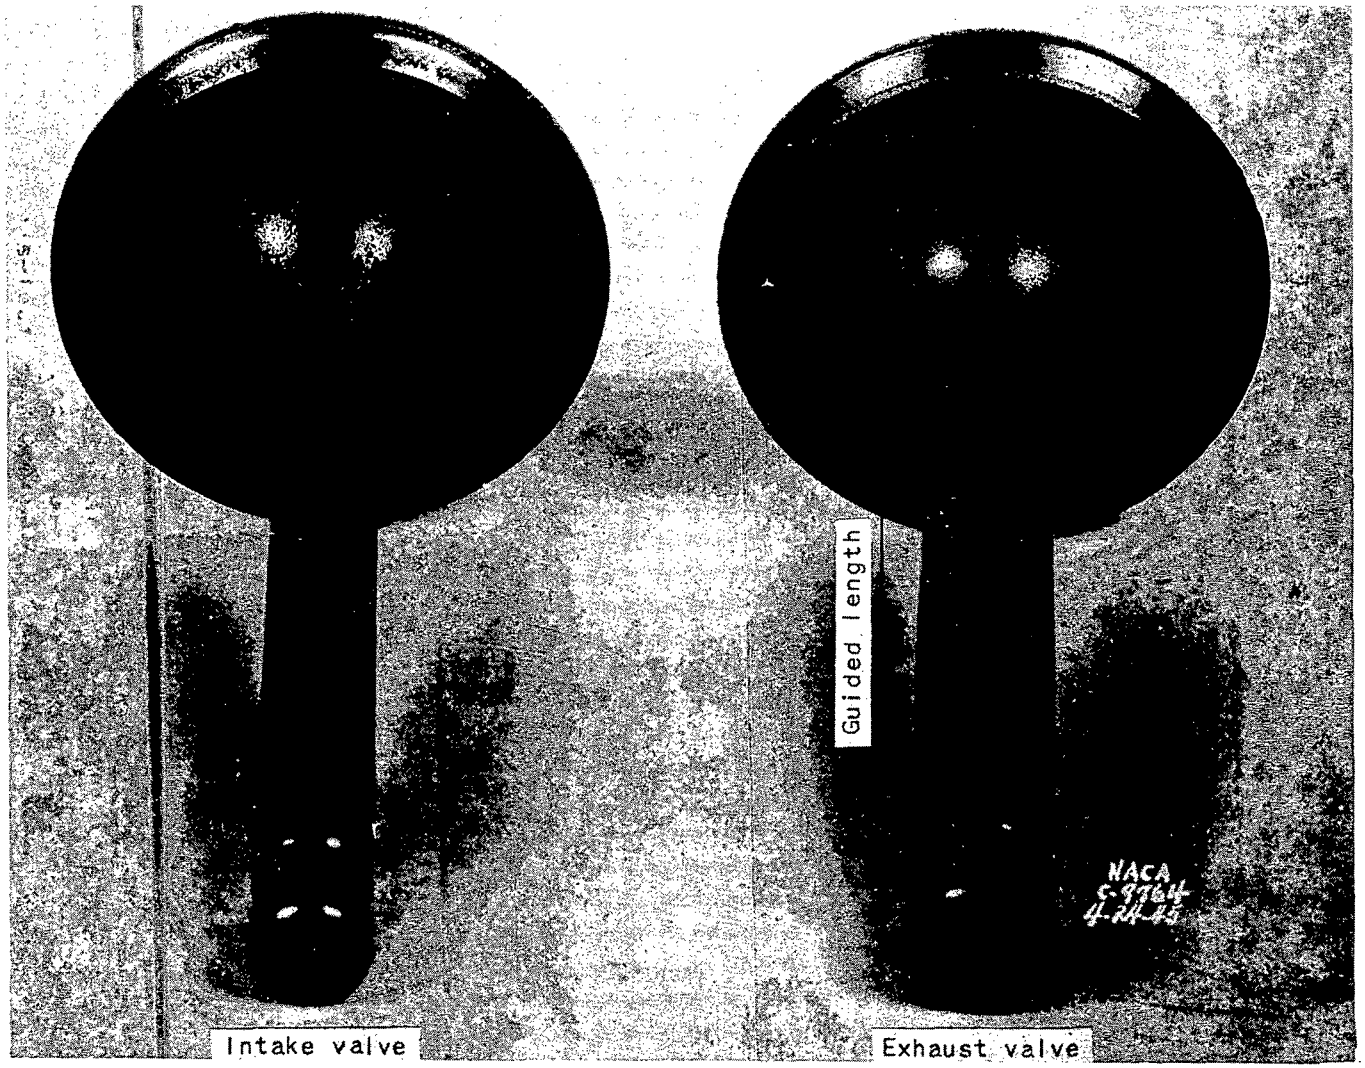
The stems and seating faces of a typical intake and exhaust valve after removal from the engine are shown in figure 10. An examination of the valves after cleaning showed that all of the exhaust-valve faces were in good condition with the exception of the valve from cylinder 9, which was lightly burned in one spot. The burn was very shallow and before cleaning was filled with a hard deposit so that the valve face formed an unbroken seal and the mating seat showed no evidence of burning. It is therefore improbable that the light valve-face burning would progress further. The lightly burned portion of the exhaust-valve face of cylinder 9 after the deposits had been removed is shown in figure 11.

Heavy carbon and lead-oxide deposits and light bronze pickup from the exhaust-valve guide were present for one-half inch at the head end of the exhaust-valve stem guided length. All the exhaust-valve guides were worn to a bellmouth beyond the Army limits stated in reference 10. Three of the valve guides were worn beyond the manufacturer's bellmouth limit (reference 11), which is less severe

than the Army's limit. The bellmouthing of the exhaust-valve guides is believed to have been a result of heavy carbon and lead-oxide deposits on the head end of the valve stem. All the intake-valve faces were in excellent condition. Light soft carbon deposits were present on the under side of the intake-valve heads (fig. 10). The intake-valve stems were in excellent condition and the intake-valve guides were not excessively worn. No indication of valve sticking as a result of the heavy stem deposits was evident at any time during the test.

Figure 10. - Condition of valve stems and necks from cylinder 7 typical of intake and exhaust valves after 50-hour test in nine-cylinder air-cooled radial engine. Brake horsepower, 750; engine speed, 1900 rpm; brake mean effective pressure, 172 pounds per square inch; fuel-air ratio, 0.052; spark advance, 30° B.T.C.; maximum rear-spark-plug-bushing temperature, 400° F.

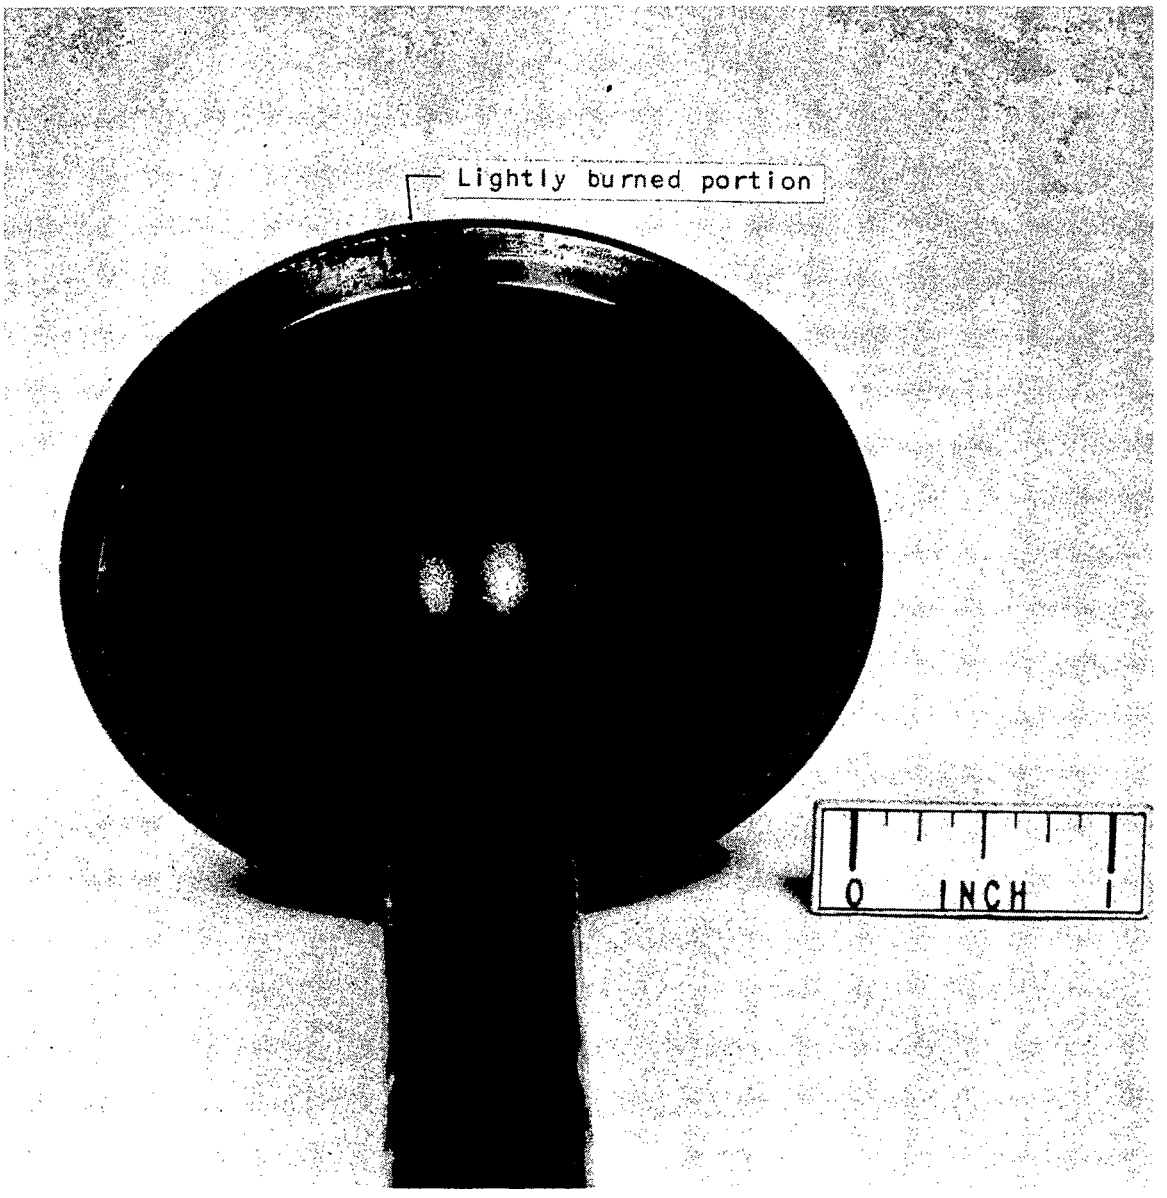
Figure 11. - Condition of exhaust-valve face from cylinder 9 after 50-hour test in nine-cylinder air-cooled radial engine. Brake horsepower, 750; engine speed, 1900 rpm; brake mean effective pressure, 172 pounds per square inch; fuel-air ratio, 0.052; spark advance, 30° B.T.C.; maximum rear-spark-plug-bushing temperature, 400° F.
