RELATIONSHIP OF ROOF FALLS IN UNDERGROUND COAL MINES TO FRACTURES MAPPED ON ERTS-1 IMAGERY

Charles E. Wier, *Indiana Geological Survey*; Frank J. Wobber, Orville R. Russell, Roger V. Amato and Thomas V. Leshendok, *Earth Satellite Corporation*

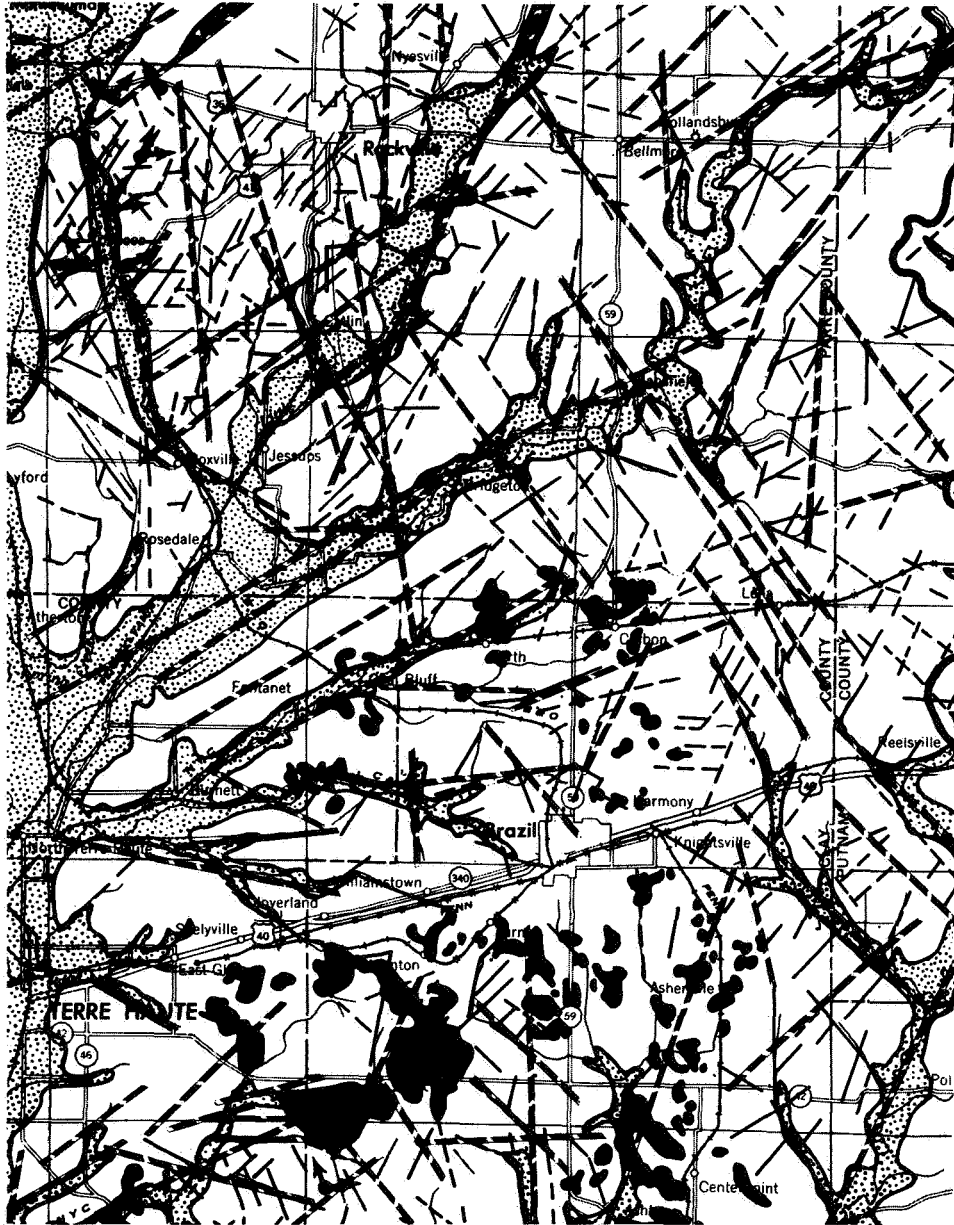
Figure 3. This portion of the Indianapolis 1x2° Quadrangle is representative of the fracture and lineament data derived from ERTS and aircraft imagery. The heavy diagonally dashed lines represent interpreted lineaments from ERTS imagery and the thin lines from small-scale aerial photography. Black areas are coal strip mines. Maps of this type have been prepared for the entire Indiana coal field.

A lineament map was prepared for southwestern Indiana (Figure 3). The lineaments were mapped on both ERTS imagery and color infrared aerial photography (Scale of 1:120,000). In general, orientation of lineaments from the two sources agree but are not identical. The aircraft and ERTS imagery complement each other in that fractures were mapped on each that were not found on the other. The most common set of lineaments trend northeast-southwest and northwest-southeast. Some areas show a paucity

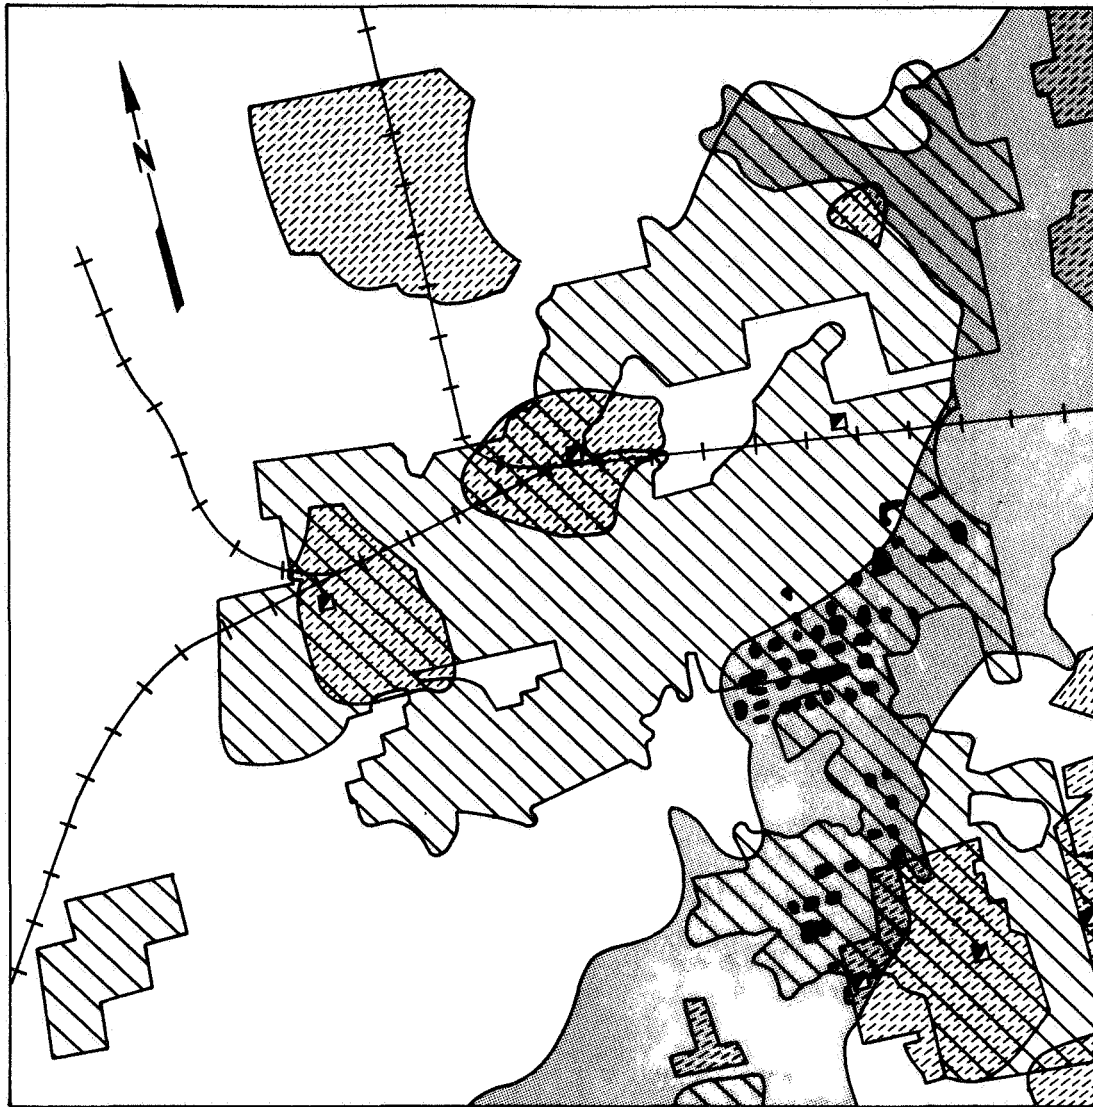
Approximate Scale 1:40,000

Figure 4. Map of a part of Sullivan County, Indiana, showing area from which coal has been mined by underground methods, and area of subsidence derived from analysis of image in Figure 5.

Subsidence in an area east of Sullivan, Sullivan County, Indiana, was noted on the 1:30,000 scale color infrared photography. Extensive underground mining has occurred in the Sullivan area during the first half of this century, but nearly all mining had ceased operation by 1950. Coal was extracted mainly from Coal V, (Figure 4) which in this area is about 200 feet beneath the surface. A lesser amount of mining was done in Coal VI which occurs about 70 feet higher in the stratigraphic section.

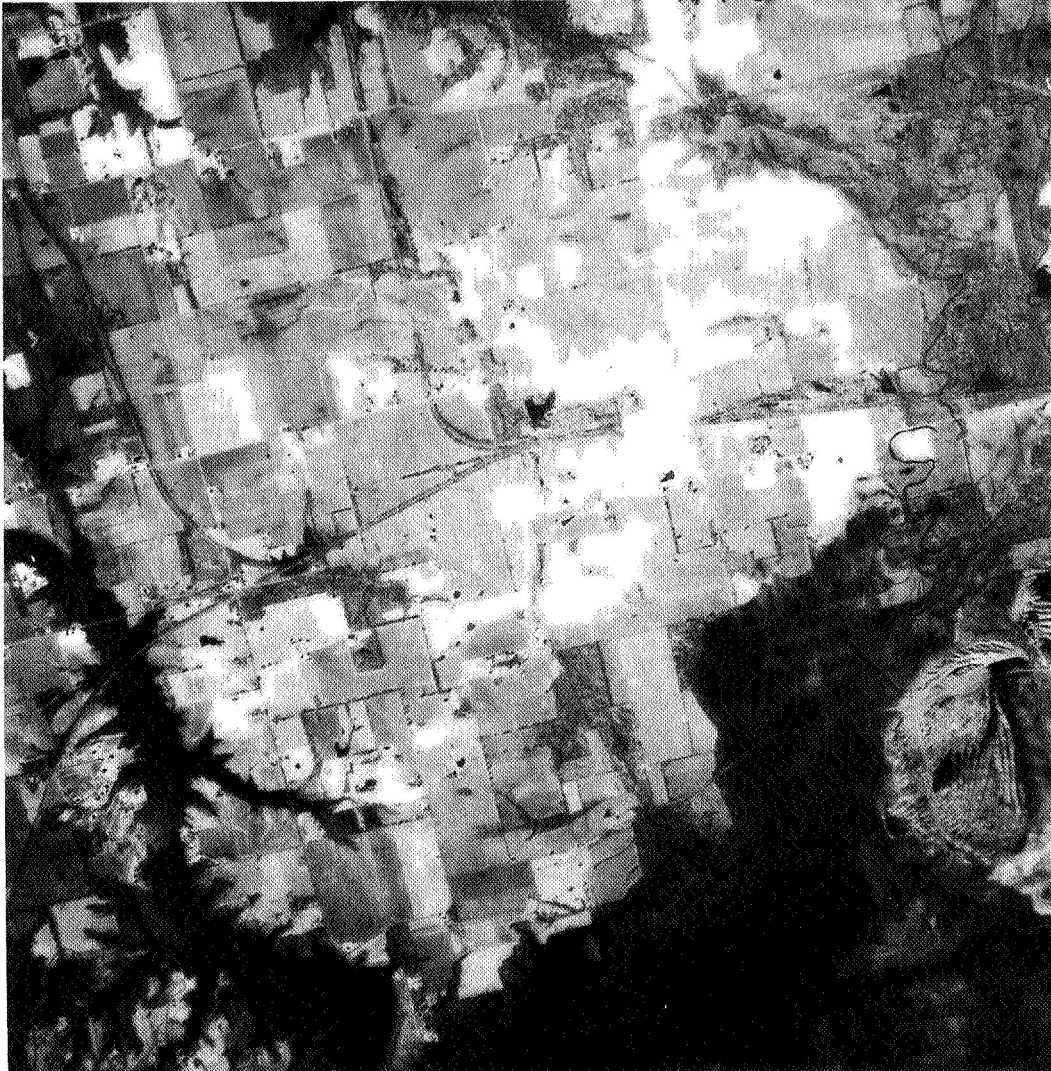
Figure 5. Black and white infrared image of part of Sullivan County, Indiana, showing extensive surface subsidence along Busseron Creek caused by underground coal mining.

The black and white infrared photography (Figure 5) was taken in March 1973, (NASA C-130 underflight) after considerable rainfall and when most surface depressions were filled with water. These depressions, predominantly on the floodplain of Busseron Creek, reflect the room and pillar configuration conventionally used in underground coal mining. The area along Busseron Creek appears to be unusually susceptible to subsidence. It is a broad low-lying valley filled to a substantial depth with unconsolidated sand, silt, and clay which hold moisture longer than the surrounding uplands. In this area, the downward percolation of water through the overlying bedrock, possibly along zones of fracturing has caused the mine supports to weaken

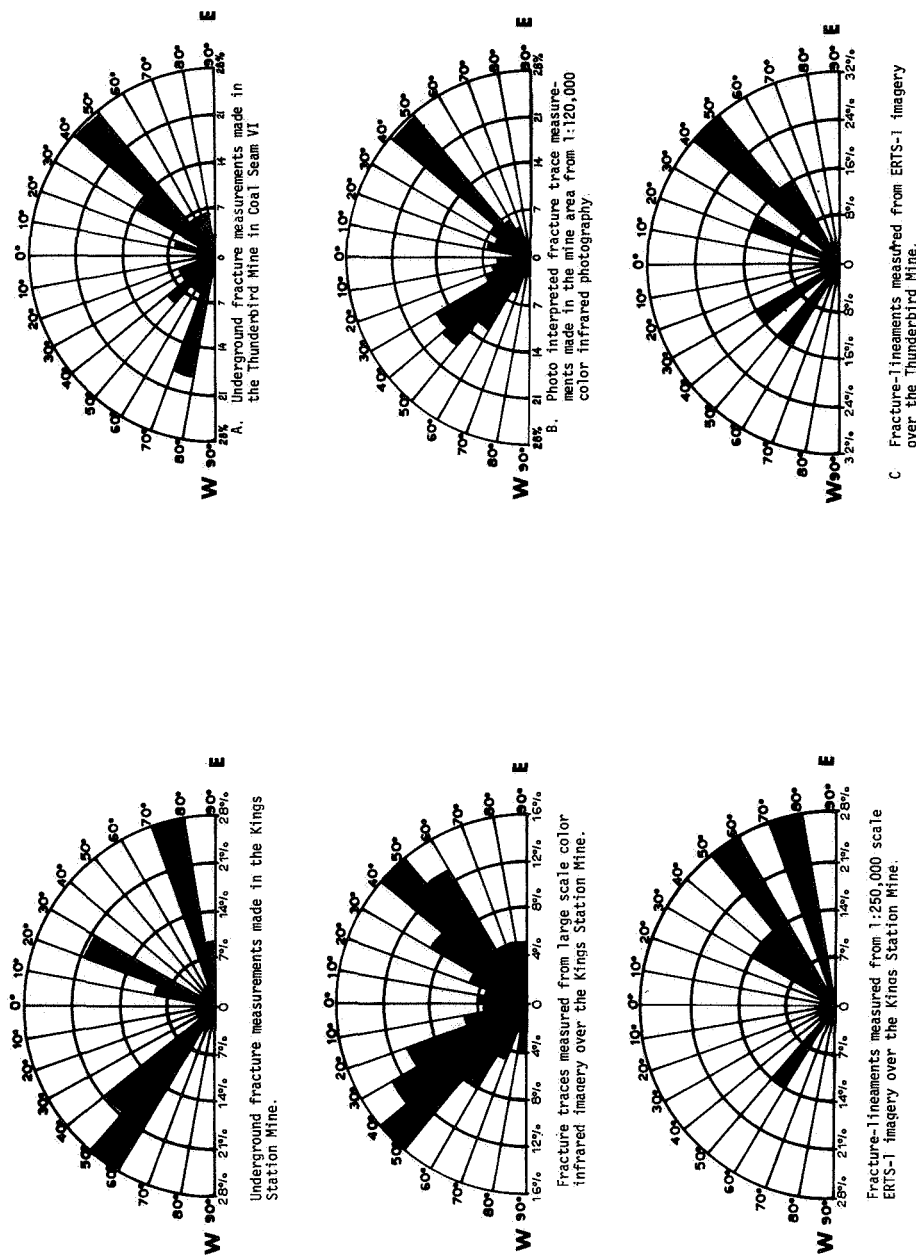
FIGURE 6. ROSE DIAGRAMS OF FRACTURE MEASUREMENTS FROM THE KINGS STATION MINE AREA, GIBSON COUNTY (LEFT COLUMN) AND THE THUNDERBIRD MINE AREA, SULLIVAN COUNTY, INDIANA (RIGHT COLUMN).

A preliminary fracture analysis of the Kings Station Mine was done in late 1972 and refined in early 1973. A serious roof fall in November 1972 claimed the life of a miner and injured three others. The investigators visited the mine in April 1973 and discussed the various types of roof fall problems with the mine operators. Three of the four main areas of concentrated and intersecting fractures were also areas of frequent roof falls. The pre-dominant fracture directions mapped from ERTS and high altitude color infrared photography are N 40° to 60° E and N 20° to 60° W (Figure 6). These correlate well with joints measured in the field which occur in two dominant directions of N 20 to 30° E, N 70 to 80° E, and N 40 to 60° W.

A summary of the directions of the fractures measured in the Thunderbird Mine are shown in Figure 6. Major fractures associated with clay squeezing in the eastern part of the mine were measured in Coal VI with trends averaging N 40° E. Several smaller fractures were measured with trends in a northwesterly direction. Dominant fracture directions of N 40° to 50° E and N 70° to 80° W later were measured in Coal VI in the western part of the mine.

Surface fracture traces have been compiled from ERTS and aircraft imagery and summarized (Figure 6). A total of 119 fracture traces were mapped and the rose diagrams indicate two predominant directions -- a major set of fractures oriented at N 40° to 50° E and a sub-ordinant set at N 30° to 50° W. This correlates very closely with the underground fracture data.

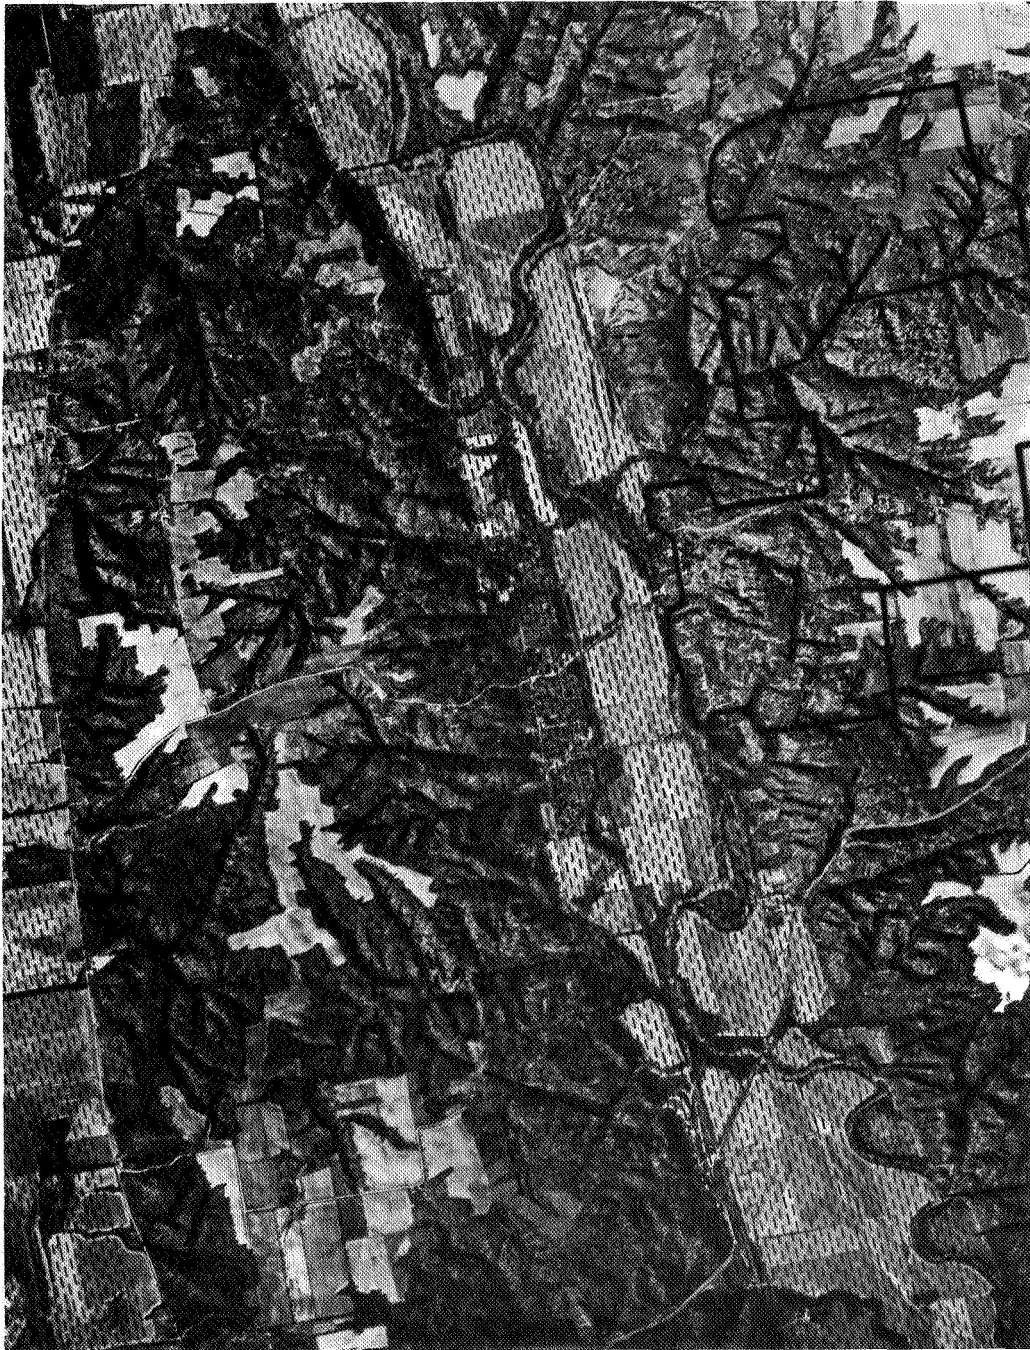
Figure 7. Black and white rendition of a color infrared image of the Mecca Mine area, Parke County, Indiana, showing area of underground mining and fractures mapped.

The Mecca Mine lies in an area of relatively rugged terrain in which the fracture-controlled drainage system is deeply incised and is easily recognized on both ERTS imagery and high altitude photography (Figure 7). The test site is actually a series of closely-spaced mine shafts which have been abandoned since the early 1900's; however, large reserves of coal remain in the area, and it is reasonable to assume that additional mining will take place in the future.
